ARBORICULTURAL IMPACT ASSESSMENT (AIA) REPORT V4

Prepared For:	Hyecorp Property Group
Site Address:	13-19 Canberra Avenue, St Leonards
Inspection Dates:	8 February 2021 (Preliminary Tree Inspection) & 15 June 2021 (Additional trees added)
Report Date	25 June 2021 Updated 29 June 2021 Plan revision 42 - 13/10/2021

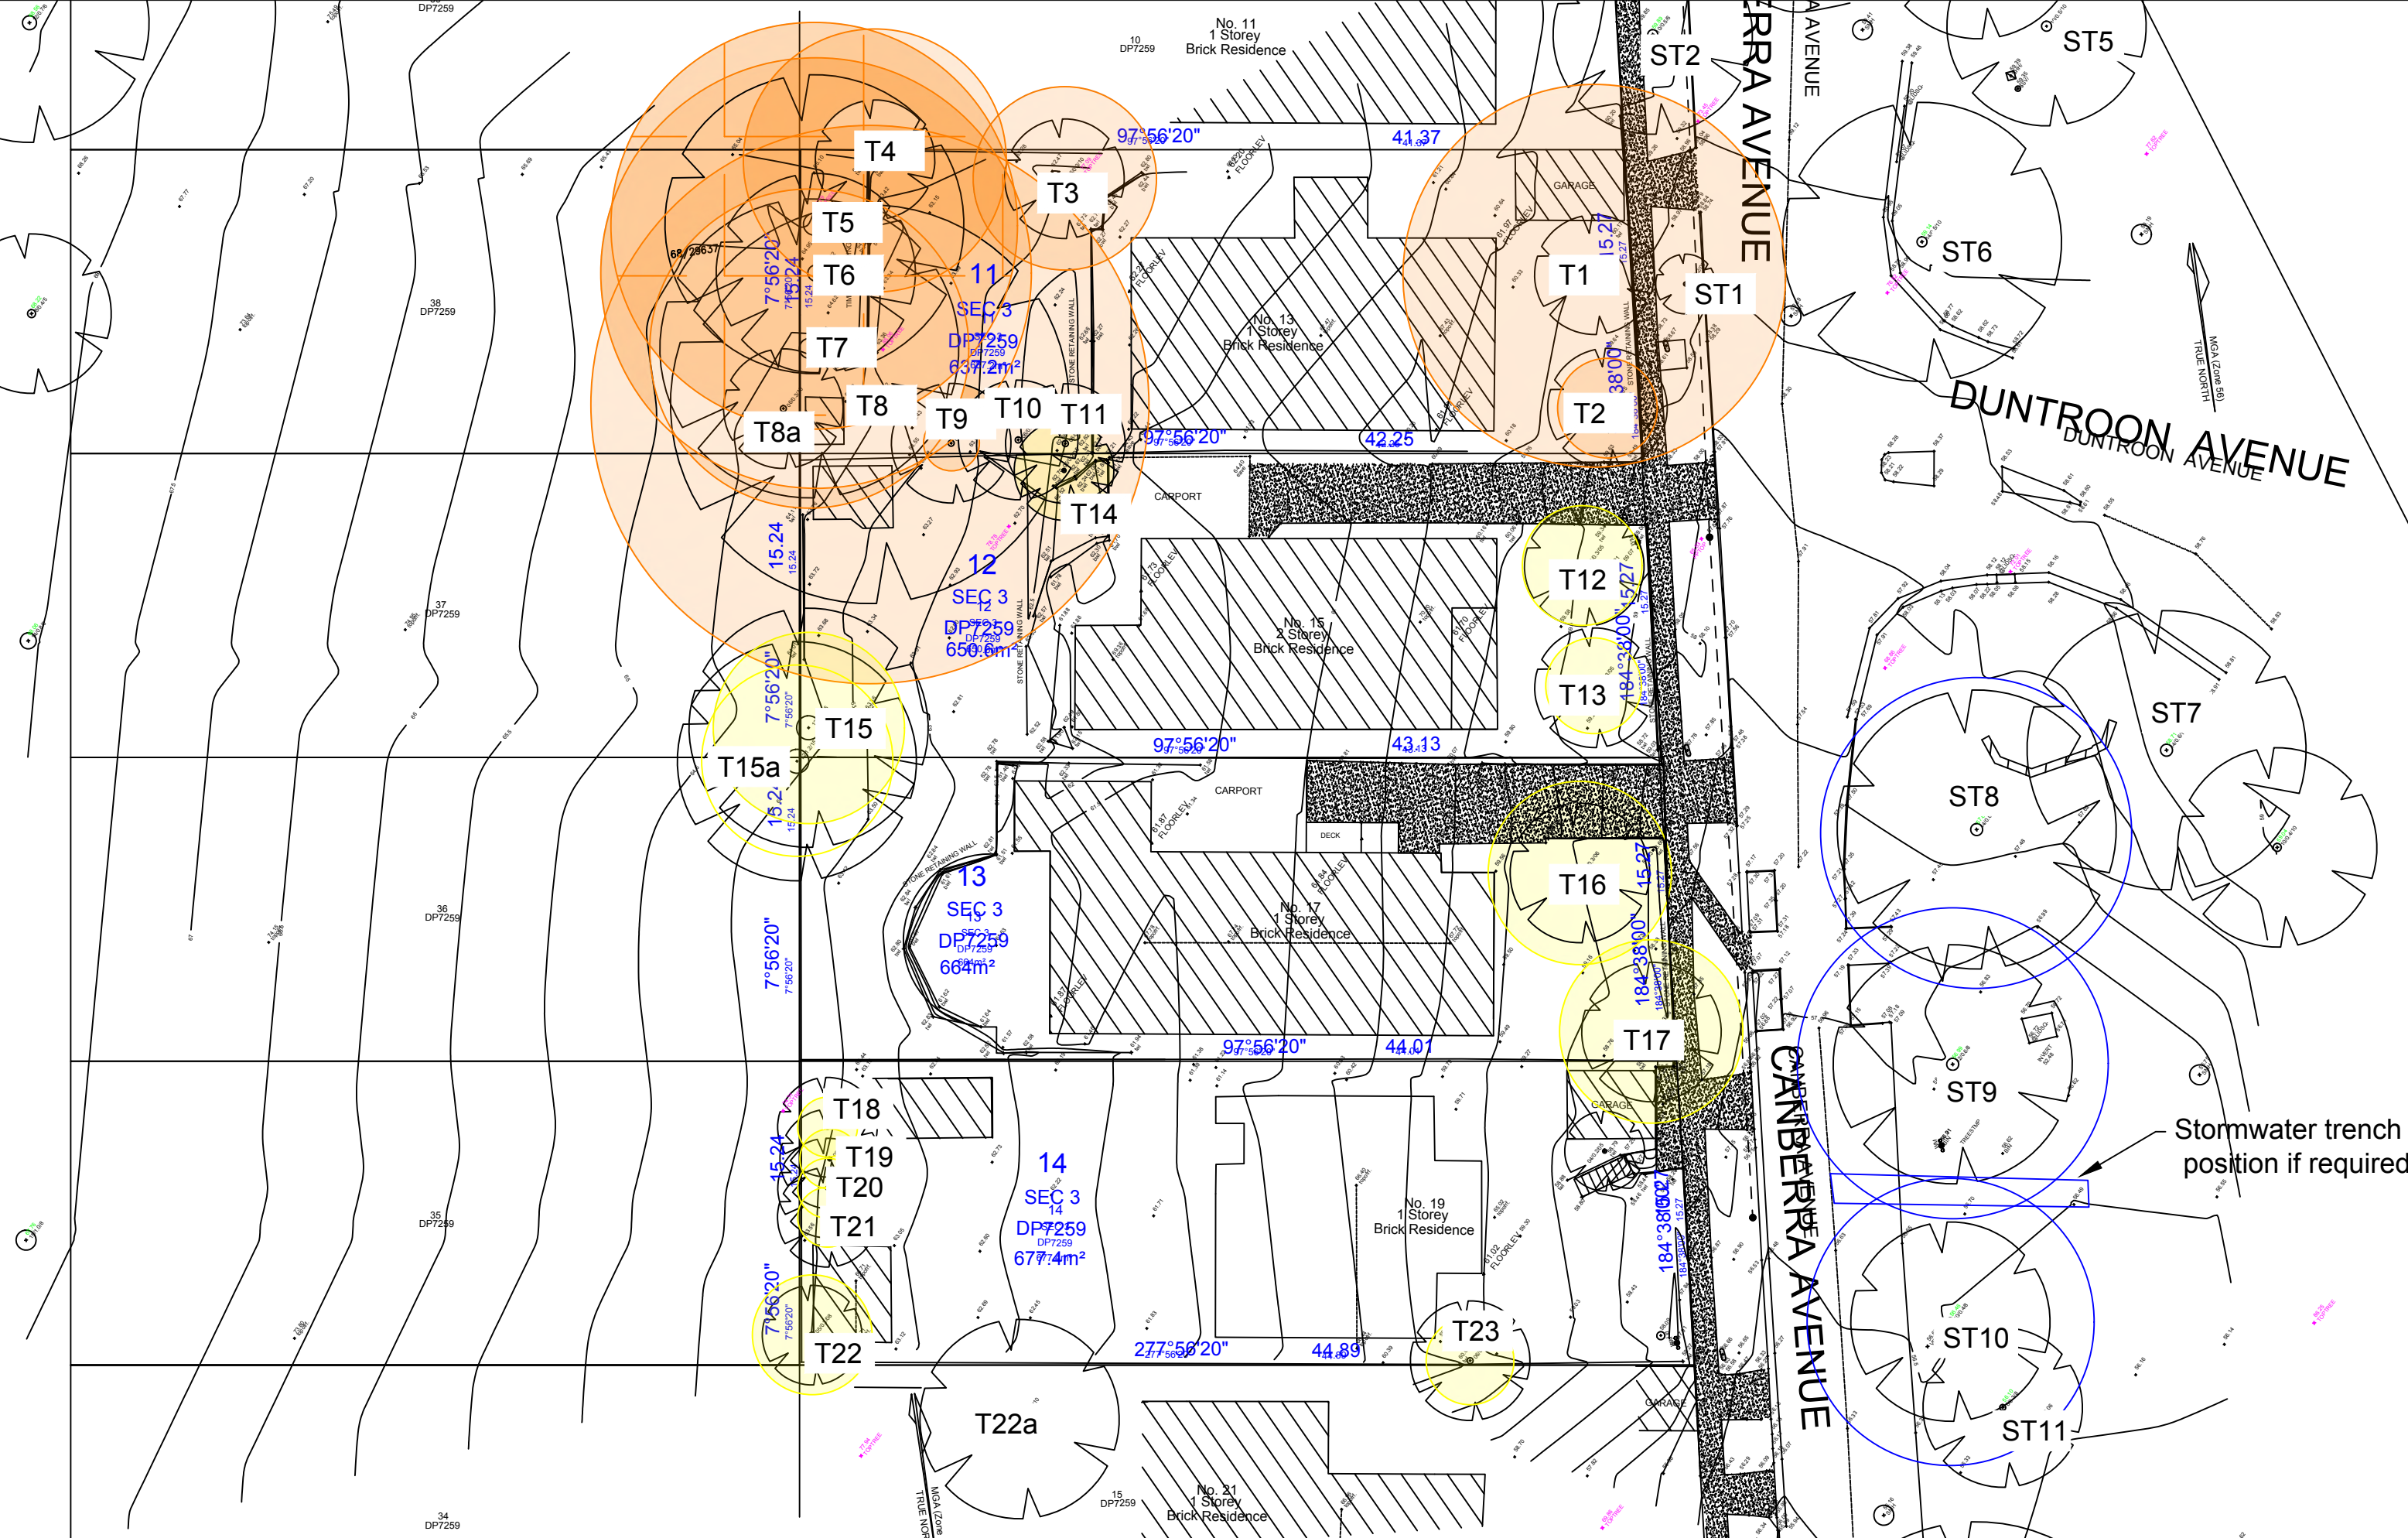
Margot Blues Consulting Arborist
Title: Tree Identification
DATE: 6/27/2021
Project: A2 13-19 Canberra St, St Leonards.dwg
Scale: Relative to supplied documents

- Key:
- Tx = Tree Number
 - Moderate Retention Value
 - Low Retention Value
 - Possible Stormwater trench
