## Hazardous Materials Survey

67 Mars Road, Lane Cove West NSW

**Report No:** E25663.E10\_Rev0

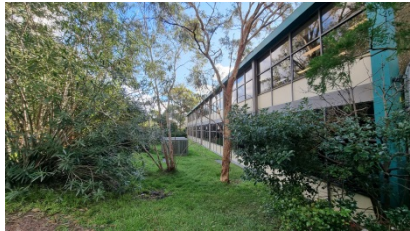
Description	Photo
<b>67 Mars Road</b>  Contained a two-storey warehouse building. The building had a corrugated asbestos roof, brick / concrete external walls, brick / concrete / fibre cement sheeting internal walls, timber / metal / fibre cement sheeting / SMF ceilings and concrete / vinyl tile / wooden flooring. There were no additional structures on this property.
