# SCHEDULE OF CONSERVATION WORKS

*Former Roche Facility*

**100 South Creek Road**

**Cromer**

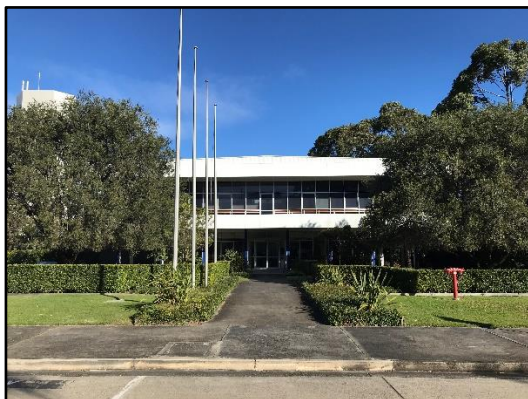
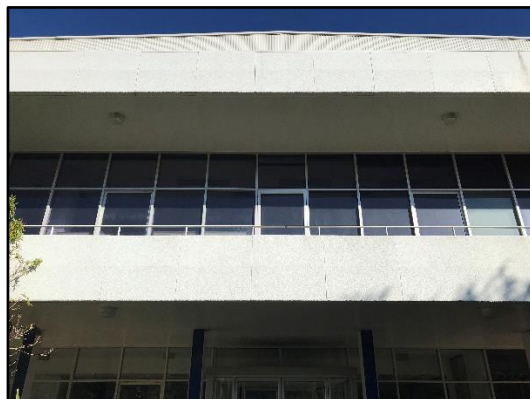
DESCRIPTION	The flat roof of Building 1 comprises Colorbond sheeting.				
SIGNIFICANCE	EXCEPTIONAL	HIGH	MODERATE	LITTLE	INTRUSIVE
CONDITION	VERY GOOD	GOOD	FAIR	POOR	VERY POOR
	Fair condition, access to the roof would be required.				
VISUAL SURVEY

Colorbond	<ul style="list-style-type: none"><li>Periodically inspect for condition. Undertake repairs quickly (physical damage, oxidisation, loose or missing fixings, separation washers, galvanic reactions etc.); and</li><li>Allow the heritage architect to carry out intermediate and final inspection of the work as it ensues.</li></ul>				
Rainwater Goods	<ul style="list-style-type: none"><li>Retain original rainwater goods;</li><li>A hydraulic engineer is to inspect and review all broken and deteriorated gutters, headers and downpipes as necessary. In case of insufficiency, a new drainage plan is to be developed subject to the appointed heritage</li></ul>

<p>architect's specification in relation to construction, fixing, sizing, materials, placement and reversibility;</p> <ul style="list-style-type: none"><li>• Downpipes which do not comply with current standards and/or are damaged are to be removed and replaced with complying downpipes;</li><li>• Where gutters and downpipes are to be removed, the original profiles and shapes are to be reinstated;</li><li>• Where downpipes are to be replaced, they are to be located in a way to minimise visual disruption of the façade;</li><li>• Ensure that gutters, rainwater heads, downpipes and the roof are all of the same metal. Do not mix electrolytically non-compatible metals;</li><li>• Ensure all gutters, rainwater heads and downpipes are clear of leaves or other debris;</li><li>• Ensure stormwater drainage complies with current standards;</li><li>• Rainwater goods are to be in accordance with AS 3500 Plumbing and Drainage and AS/NZS 2311; and</li><li>• Allow the heritage architect to carry out intermediate and final inspection of the work as it ensues.</li></ul>

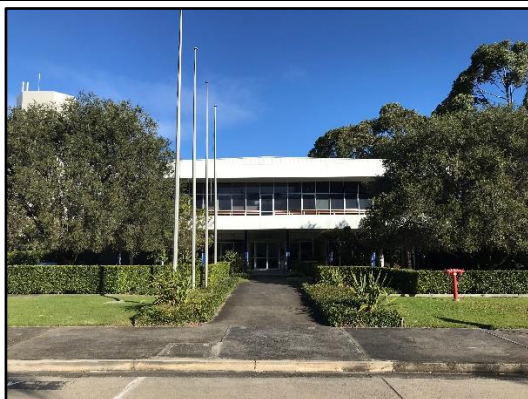
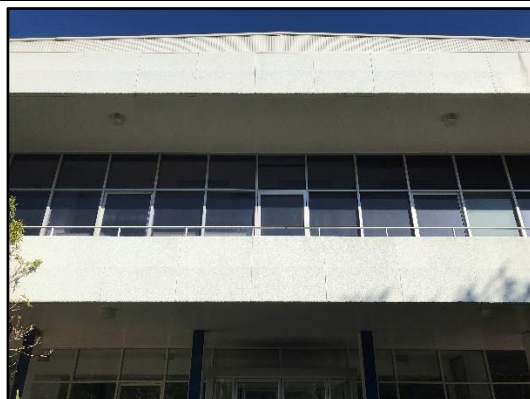
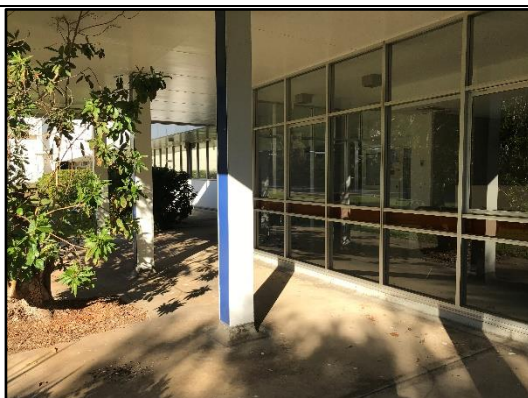
DESCRIPTION	The walls of Building 1, constructed 1963-64, comprise off-form concrete.				
SIGNIFICANCE	EXCEPTIONAL	HIGH	MODERATE	LITTLE	INTRUSIVE
CONDITION	VERY GOOD	GOOD	FAIR	POOR	VERY POOR
	Good condition, little signs of deterioration.				
VISUAL SURVEY

Figure 43. Close-up view to ground floor of Building 1, facing east.					
ELEMENT	CONSERVATION ACTION				
General Recommendations	<ul style="list-style-type: none"><li>• Original concrete is to be retained and made good;</li><li>• The works to be carried out under the approval should in general, involve the least possible level of physical intervention to significant fabric.</li><li>• Designer/architect to provide details of changes to concrete walls to appointed Heritage Architect for approval.</li><li>• The heritage architect is to carry out intermediate and final inspection of the work as it ensues.</li></ul>

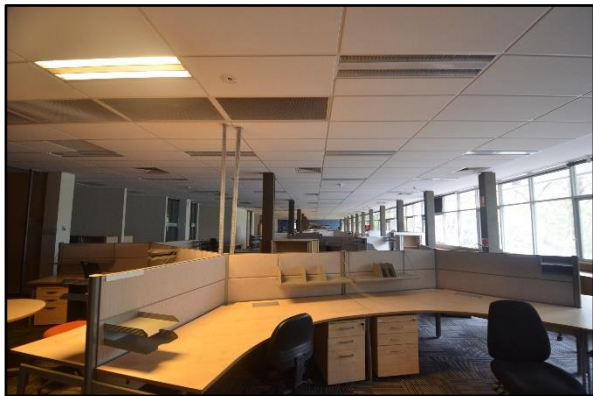
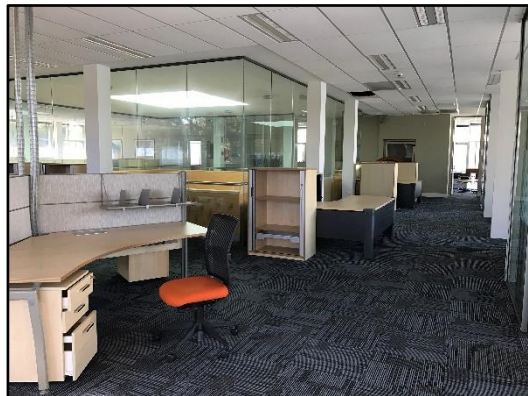
DESCRIPTION	Lighting comprises of fluorescent light fixtures.				
SIGNIFICANCE	EXCEPTIONAL	HIGH	MODERATE	LITTLE	INTRUSIVE
CONDITION	VERY GOOD	GOOD	FAIR	POOR	VERY POOR
	Good condition, general signs of wear and tear.				
VISUAL SURVEY

Figure 72. View to the interior of Building 1 ground floor, facing south-east.			Figure 73. Close-up view the internal terrazzo stair.		
ELEMENT	CONSERVATION ACTION				
General Recommendations	<ul style="list-style-type: none"><li>Fitting of new electrical installations should have regard for the historic fabric of the place and avoid unnecessary damage. Careful planning is needed to avoid the unsightly exposed runs of cabling, internally and externally. No chasing into walls will be allowed. All new services are to be wall-mounted and not chased into the historic fabric; and</li><li>Allow the heritage architect to carry out intermediate and final inspection of the work as it ensues.</li></ul>

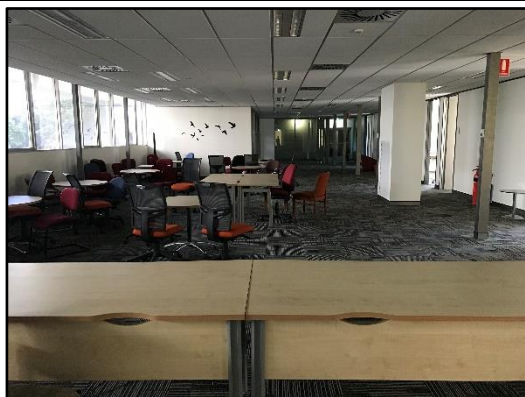
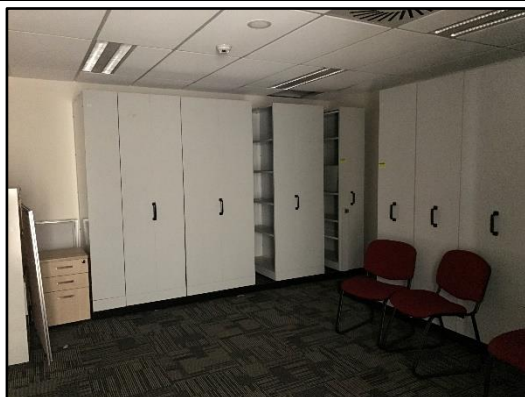
DESCRIPTION	Lighting comprises of fluorescent light fixtures.				
SIGNIFICANCE	EXCEPTIONAL	HIGH	MODERATE	LITTLE	INTRUSIVE
CONDITION	VERY GOOD	GOOD	FAIR	POOR	VERY POOR
	Good condition, general signs of wear and tear.				
VISUAL SURVEY

Figure 95. View to the interior of Building 2.			Figure 96. View to the interior of Building 2.		
ELEMENT	CONSERVATION ACTION				
General Recommendations	<ul style="list-style-type: none"><li>Fitting of new electrical installations should have regard for the historic fabric of the place and avoid unnecessary damage. Careful planning is needed to avoid the unsightly exposed runs of cabling, internally and externally. No chasing into walls will be allowed. All new services are to be wall-mounted and not chased into the historic fabric; and</li><li>Allow the heritage architect to carry out intermediate and final inspection of the work as it ensues.</li></ul>

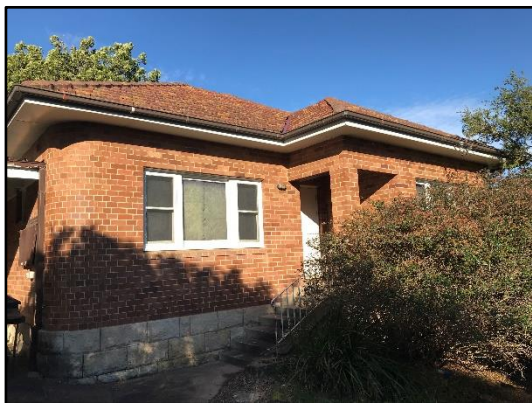
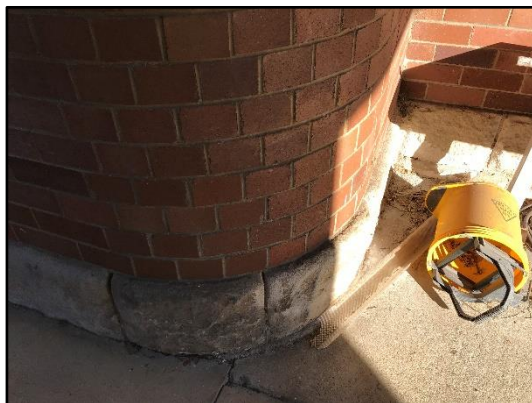
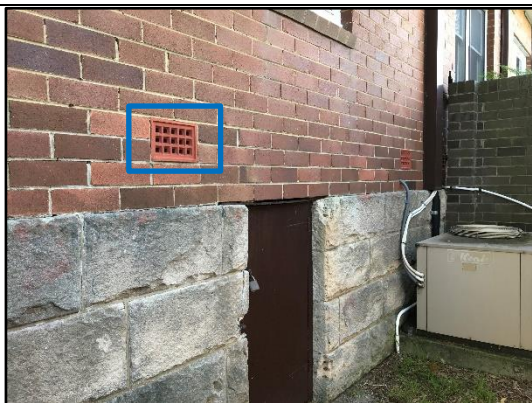
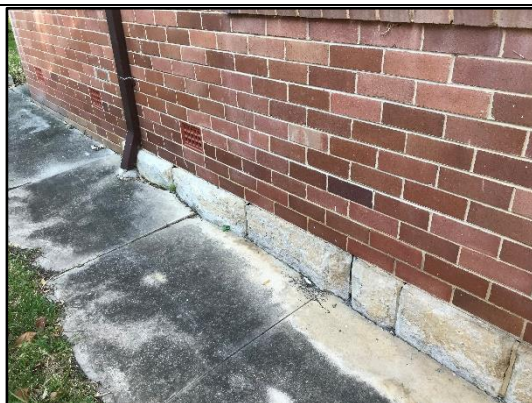
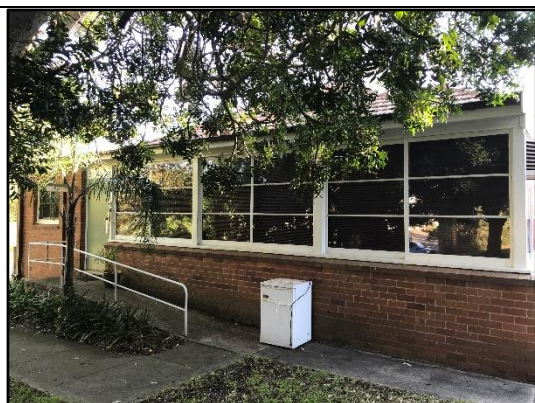
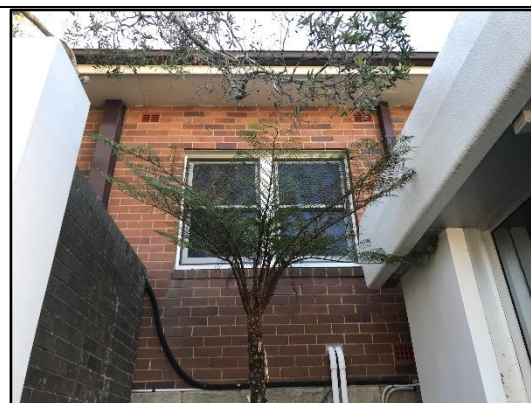
DESCRIPTION	Single-storey brick cottage, set upon a sandstone plinth. Ventilation grilles comprise of terracotta.				
	Masonry Walls & Ventilation Grilles				
SIGNIFICANCE	EXCEPTIONAL	HIGH	MODERATE	LITTLE	INTRUSIVE
	VERY GOOD	GOOD	FAIR	POOR	VERY POOR
CONDITION	The brickwork is in good condition, with little signs of deterioration. Ventilation grilles are in good condition, no sign of deterioration.				
	Sandstone Plinth				
SIGNIFICANCE	EXCEPTIONAL	HIGH	MODERATE	LITTLE	INTRUSIVE
	VERY GOOD	GOOD	FAIR	POOR	VERY POOR
CONDITION	The sandstone is in poor condition, with evidence of efflorescence, due to the existing concrete slab and concrete stairs.				
VISUAL SURVEY

Figure 101. View to the western elevation of Building 05 from within the site, facing east.			Figure 102. Close-up view of brickwork and sandstone, facing east.

Figure 103. Close-up view of brickwork and sandstone of the southern elevation, facing north. A ventilation grille is outlined in blue.			Figure 104. View to the northern elevation of Building 05, facing east from within the subject site.

ELEMENT	CONSERVATION ACTION
<p><b>General Recommendations</b></p>	<ul style="list-style-type: none"> <li>• Remove any vegetation if found. Mortar joints where vegetation is found should be repointed so as to reduce the risk of further growth;</li> <li>• Original masonry is to be retained and made good where necessary;</li> <li>• Existing damage to brickwork or mismatched later infill is to be retained as is, in order to communicate the history of the building to future users;</li> <li>• Make good will only occur where the masonry poses a risk to the structure or to the building's users, as well in excepted cases where previously discussed with a qualified Heritage Consultant;</li> <li>• Unpainted and unrendered masonry surfaces are not to be painted over or rendered;</li> <li>• Avoid the use of waterproof or water repellent paints as they can trap water in the substrate, accelerating deterioration;</li> <li>• Where masonry is to be removed, it is to be removed using hand demolition only and it is to ensure the protection of existing fabric;</li> <li>• When repairing masonry material, the replacement should match the original fabric as closely as possible in colour grain, bedding durability, porosity, and chemical composition;</li> <li>• Works are to be carried out by a suitably-qualified tradesperson with experience in heritage masonry, under the guidance of heritage architect;</li> <li>• Do not use acid to clean masonry, surfaces should only be cleaned to remove harmful substances and to reveal deterioration. Low pressure methods with water spray and soft natural bristle brushes should be used;</li> <li>• Efflorescence: A moisture meter should be used to investigate the presence of dampness. Where necessary, Cocoon, a poulticing medium by Westox should be applied to the surface to remove the presence of salts and water damage before any pointing work is undertaken;</li> <li>• Maintain existing damp proof courses and flashings, unless they are ineffective and need to be replaced;</li> </ul>

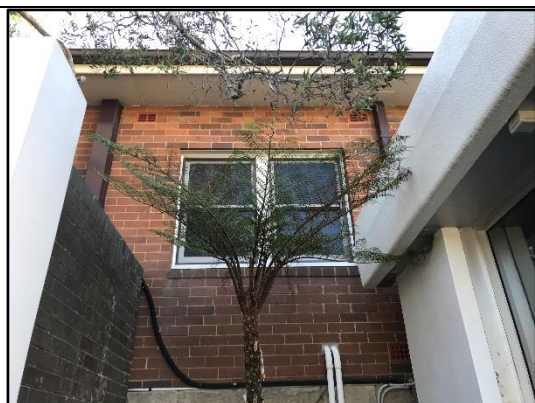
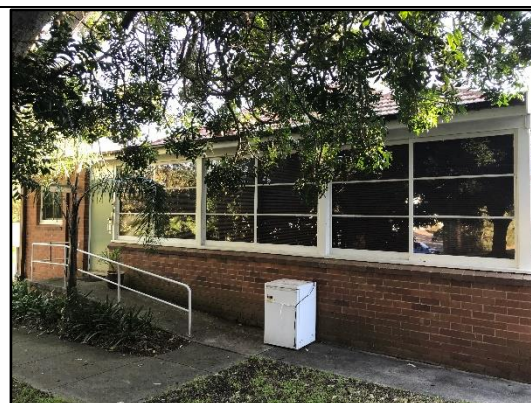
**Figure 111.** View towards the southern elevation of Building 05, facing north-west from within the subject site.

**Figure 112.** View towards the eastern elevation of Building 05, facing south-west.

ELEMENT	CONSERVATION ACTION
<p><b>General Recommendations for Timber</b></p>	<ul style="list-style-type: none"> <li>• A qualified heritage carpenter is to inspect all existing timber elements and determine condition of each element including the window frames and door frames;</li> <li>• The works to be carried out under the approval should in general, involve the least possible level of physical intervention to significant fabric;</li> <li>• Timber is to be protected with protective material during demolition and conservation works to other fabric;</li> <li>• Original timber elements are to be retained, conserved and made good in situ;</li> <li>• Where repairs are required to timber, works are to be taken in situ using the geometric splicing method. This includes removing the entire thickness of the damaged area and geometrically splice in a matching section exactly to the thickness, shape, profile, form and species of the original timber;</li> <li>• If the element is structurally unsound, unstable, subject to white ant and/or dry rot, either partially or fully replace applying the Burra Charter principle “to remove as much as necessary but as little as possible”. Timber elements are to be repaired as necessary, by introducing as little new fabric as is needed. If decayed timber needs to be removed to form a splice or patch repair, take off just enough timber to allow an effective repair. Always fit the new material to the profile of the existing. Any structurally unsound works are to be flagged with the structural engineer before the commencement of any works;</li> <li>• Where damage to fabric is small (less than 5mm), infill is not necessary;</li> <li>• All new sections of timber introduced into original components are to be date stamped;</li> <li>• Sand all repaired and sound timber elements to timber substrate and prepare for repainting in accordance with the paint manufacturer’s specifications and AS 2311. Colours to be chosen in consultation with the heritage architect;</li> </ul>

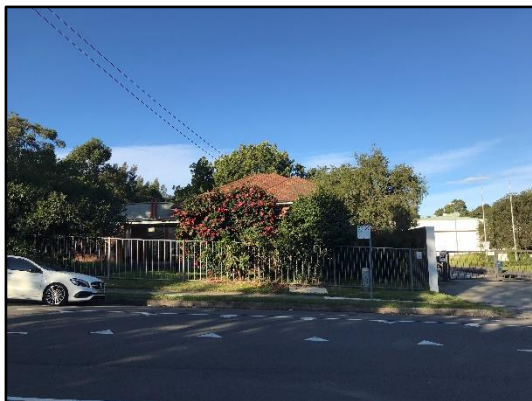
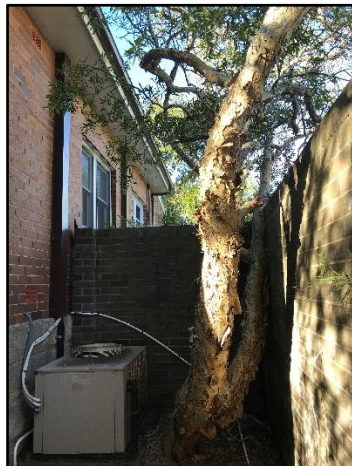
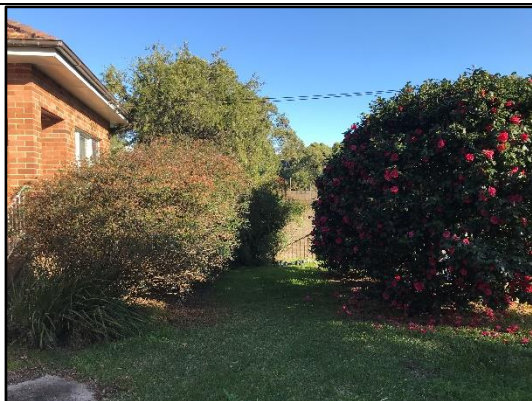
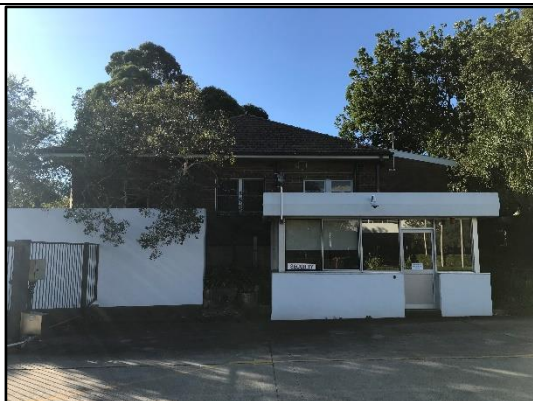
DESCRIPTION	Soft landscaping surrounding the existing cottage comprises mature trees, plantings and a grassed area.				
SIGNIFICANCE	EXCEPTIONAL	HIGH	MODERATE	LITTLE	INTRUSIVE
CONDITION	VERY GOOD	GOOD	FAIR	POOR	VERY POOR
	Landscaping well maintained and mature plantings appear to be in good condition.				
VISUAL SURVEY

Figure 119. View to the soft landscaping within the site, situated along Inman Road, facing south-east.			Figure 120. View to the southern elevation of Building 05, note the mature trees and plantings.		
ELEMENT		CONSERVATION ACTION			
General Recommendations		<ul style="list-style-type: none"><li>The advice of an arborist is to be obtained to ascertain the species of trees within the landscape. Native trees are to be retained and conserved;</li><li>An appropriate landscaped area within the subject site is to be retained as it is considered significant to the heritage significance of the site. The advice of a Landscape Architect is to be obtained with regards to the required landscaped area surrounding the building;</li><li>Where a native tree is to be removed due to decay, it is to be replaced with the same species of tree; and</li></ul>

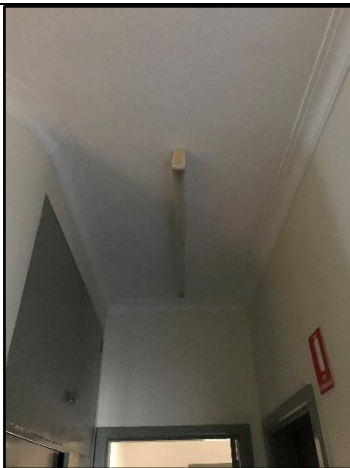
<p><b>Figure 123.</b> View to the interior of the corridor. Note the plasterboard.</p>			<p><b>Figure 124.</b> View to the interior of room in use as a storage space. Note the suspended ceiling tiles.</p>		
ELEMENT		CONSERVATION ACTION			
General Recommendations		<ul style="list-style-type: none"><li>Retain and conserve original ceilings;</li><li>Engage an expert plasterer to assess the condition of the plaster ceilings and cornices on a room by room basis and identify causes (s) of failure (damp or structural failure). Decisions regarding the viability of repairs, wholesale replacement or a combination of both need to be made under the guidance of the appointed heritage architect;</li><li>Where ceilings/cornices are damaged, they are to be made good;</li></ul>

<ul style="list-style-type: none"> <li>Where surfaces are patchy, remedial action to be taken if required and monitor for further deterioration;</li> <li>Decorative plaster ceiling pendants, roses to be retained and made good.</li> <li>Intrusive elements may be removed;</li> <li>Prepare and paint in accordance with approved heritage colour scheme;</li> <li>Allow the heritage architect to carry out intermediate and final inspection of the work as it ensues.</li> </ul>
<b>Early Plasterboard</b>	<ul style="list-style-type: none"> <li>Where plasterboard ceiling is not original, remove and reinstate original;</li> <li>An industrial hygienist is to investigate the ceilings for presence of asbestos;</li> <li>Where asbestos is found on site, it is to be removed in accordance with pertinent Australian authority's guidelines and standards as well as in accordance with EPA regulations;</li> <li>All asbestos is to be removed from site prior to any consecutive trades commencing. Upon removal, the industrial hygienists is to return to site and certify (after testing) that the asbestos has been removed. Only at that point shall consecutive trades commence on site; and</li> <li>Allow the heritage architect to carry out intermediate and final inspection of the work as it ensues.</li> </ul>

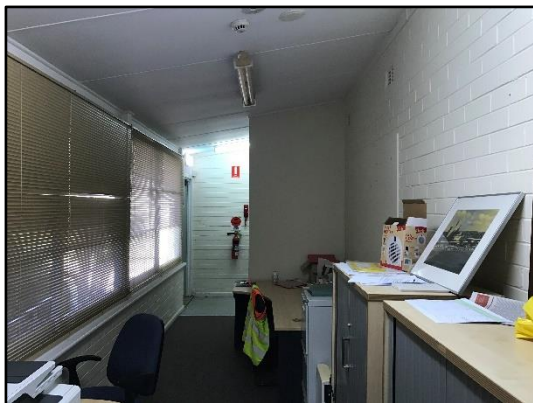
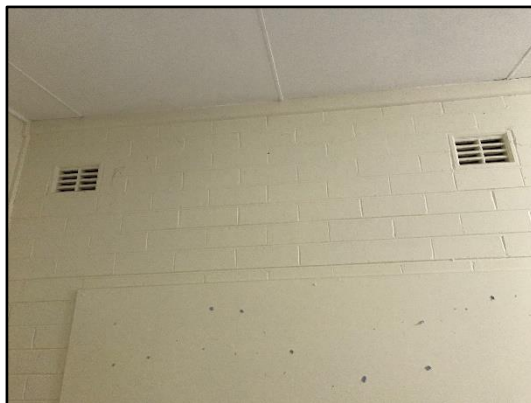
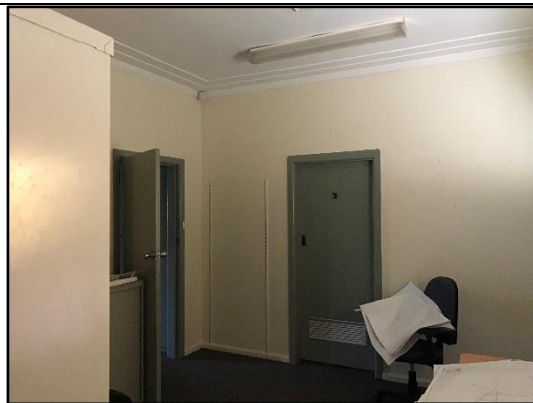
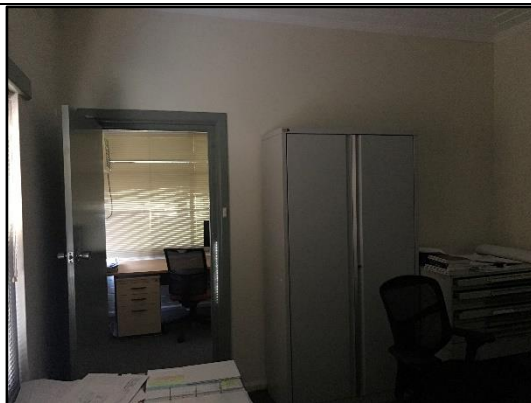
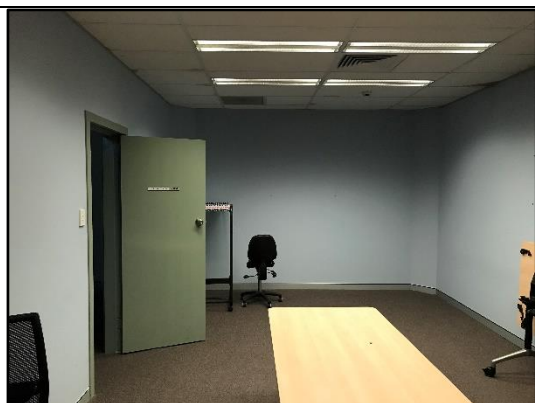
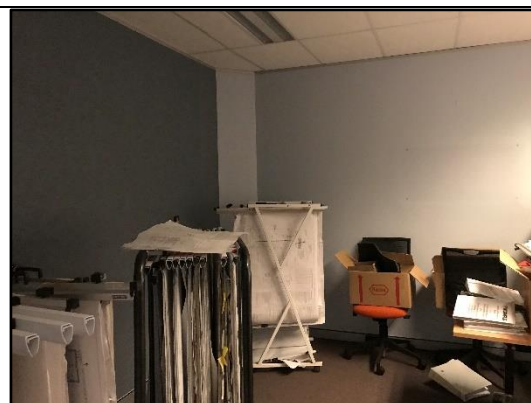
DESCRIPTION	Combination of masonry walls, plasterboard and curved masonry walls.				
	Masonry Walls				
SIGNIFICANCE	EXCEPTIONAL	HIGH	MODERATE	LITTLE	INTRUSIVE
CONDITION	VERY GOOD	GOOD	FAIR	POOR	VERY POOR
	Good condition, general signs of wear and tear.				
	Plasterboard Walls				
SIGNIFICANCE	EXCEPTIONAL	HIGH	MODERATE	LITTLE	INTRUSIVE
CONDITION	VERY GOOD	GOOD	FAIR	POOR	VERY POOR
	Fair condition, general signs of wear and tear.				
VISUAL SURVEY

ELEMENT	CONSERVATION ACTION
General Recommendations	<ul style="list-style-type: none"> <li>Original masonry is to be retained and made good where necessary;</li> <li>Existing damage to brickwork or mismatched later infill is to be retained as is, in order to communicate the history of the building to future users;</li> </ul>

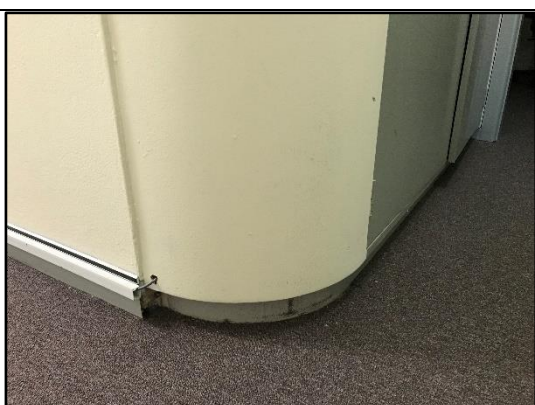
**Figure 133.** Close-up view to curved masonry walls, note the alterations due to the installation of services.

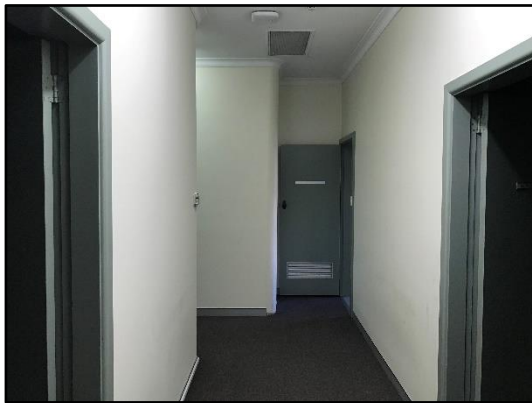
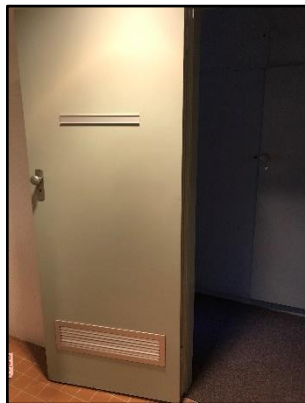
DESCRIPTION	Timber and aluminium framed windows. Timber doors, with architraves and skirting.				
SIGNIFICANCE	EXCEPTIONAL	HIGH	MODERATE	LITTLE	INTRUSIVE
CONDITION	VERY GOOD	GOOD	FAIR	POOR	VERY POOR
	Good condition, general signs of wear and tear.				
VISUAL SURVEY

<b>Doors and Windows</b>	<ul style="list-style-type: none"> <li>• A qualified heritage carpenter is to inspect all existing timber elements and determine condition of each element including doors, door frames, architraves, and other timber elements;</li> <li>• Original timber windows, doors, and all their elements including any decorative glazing, transoms, side lighting, are to be retained and made good. All doors are to be of the interwar period as indicated below;</li> </ul>

<ul style="list-style-type: none"> <li>• Retain and conserve timber window and door frames in situ. Make good where necessary;</li> <li>• Where the infill between window frame and brickwork has failed, existing mortar is to be removed and gaps are to be re-pointed. Plastic-based products are not to be introduced;</li> <li>• Inspect doors to check that they open freely, and hinges and locks are lubricated and working effectively. Also check that the lock and the strike plate are aligned so that the door closes properly;</li> <li>• Repairs must match existing in material, size and profile. Replacement doors and windows should be like for like;</li> <li>• All doors, windows and shutters to be eased and counterweights and sash boxes checked to ensure that the upper and lower sashes slide fully up and down. They are to be repaired as necessary;</li> <li>• Repaint timber surfaces periodically (every five years at least);</li> <li>• Allow the heritage architect to carry out intermediate and final inspection of the work as it ensues.</li> </ul>

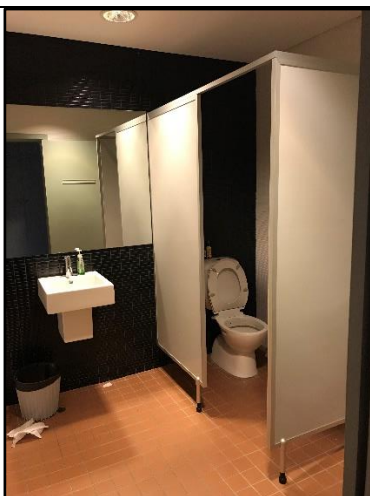
Figure 141. View to the tiling in the main bathroom.			Figure 142. View to the carpet within the main corridor and linoleum in the kitchen.		
ELEMENT		CONSERVATION ACTION			
General Recommendations		<ul style="list-style-type: none"><li>Remove non-original carpets or vinyl matting to expose original flooring underneath;</li></ul>

- Retain and conserve timber flooring and make good all blemishes. Check structural stability of floor structure in consultation with a registered structural engineer. Allow to replace elements as directed by the structural engineer;

- Damaged original floorboards are to be made good;
- Limit repairs only to members which are structurally unsound or dangerous;
- Where damage to fabric is small (less than 5mm), infill is not necessary;

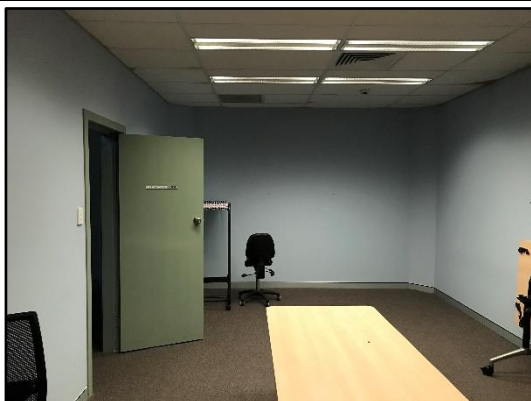
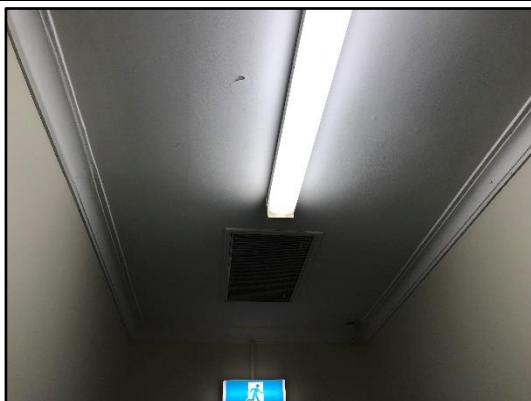
DESCRIPTION	Fluorescent lighting throughout, additional fixtures include fire services and air conditioning units.				
SIGNIFICANCE	EXCEPTIONAL	HIGH	MODERATE	LITTLE	INTRUSIVE
CONDITION	VERY GOOD	GOOD	FAIR	POOR	VERY POOR
	Good condition, general signs of wear and tear.				
VISUAL SURVEY

Figure 143. View to the fluorescent lighting within board room.			Figure 144. View to fluorescent lighting within main corridor.

Figure 145. View to fluorescent lighting within main corridor.			Figure 146. View to lighting system within bathroom.		
ELEMENT	CONSERVATION ACTION				
General Recommendations	<ul style="list-style-type: none"><li>Non-original uncharacteristic light fixtures to be removed and replaced with more sympathetic to suit period;</li><li>Non-original uncharacteristic light switches and power points to be removed and replaced with more sympathetic switched to suit period; and</li><li>Fitting of new electrical installations should have regard for the historic fabric of the place and avoid unnecessary damage. Avoid the use of historical recreations. Careful planning is needed to avoid the unsightly exposed runs of cabling, internally and externally. No chasing into walls</li></ul>

<p>will be allowed. All new services are to be wall-mounted and not chased into the historic fabric; and</p> <ul style="list-style-type: none"><li>• Allow the heritage architect to carry out intermediate and final inspection of the work as it ensues.</li></ul>
--	--

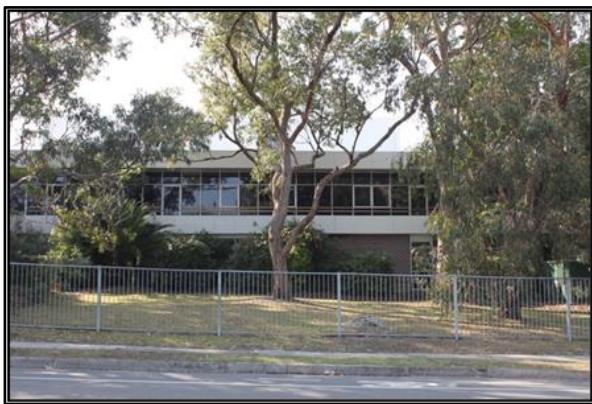
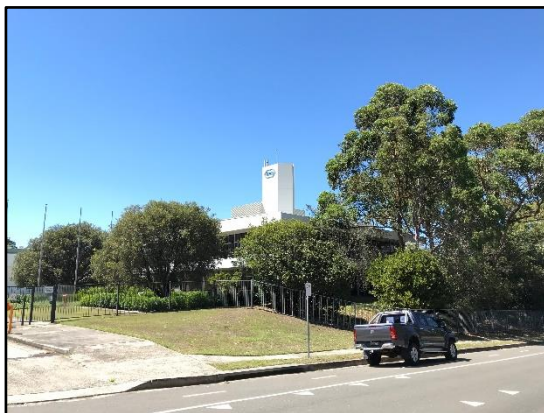
DESCRIPTION	The flat roof of Building 6 comprises Colorbond sheeting.				
SIGNIFICANCE	EXCEPTIONAL	HIGH	MODERATE	LITTLE	INTRUSIVE
CONDITION	VERY GOOD	GOOD	FAIR	POOR	VERY POOR
	Fair condition, access to the roof would be required.				
VISUAL SURVEY

Figure 147. View to Building 6 from Inman Road, facing north-east.			Figure 148. Close-up view to Buildings 5 & 6 from Inman Road, facing east.		
ELEMENT		CONSERVATION ACTION			
General Recommendations		<ul style="list-style-type: none"><li>• Retain and conserve roof forms, materials and pitch;</li><li>• Conserve and retain original timber beams, rafters and purlin where possible. Engage a structural engineer and pest exterminator to assess and advise respectively as to structural soundness and pest control;</li><li>• Conserve and retain original timber eaves, fascia and bargeboards;</li><li>• New elements and materials used for the conservation works are to match existing details in all respects;</li><li>• Key maintenance objective for the roof is to keep roof planes free of debris – good practice is to regularly sweep lower angle sections and to periodically clean upper roof section; and</li><li>• Allow the heritage architect to carry out intermediate and final inspection of the work as it ensues.</li></ul>

Colorbond		<ul style="list-style-type: none"><li>• Periodically inspect for condition. Undertake repairs quickly (physical damage, oxidation, loose or missing fixings, separation washers, galvanic reactions etc.); and</li><li>• Allow the heritage architect to carry out intermediate and final inspection of the work as it ensues.</li></ul>			
Rainwater Goods		<ul style="list-style-type: none"><li>• Retain original rainwater goods;</li><li>• A hydraulic engineer is to inspect and review all broken and deteriorated gutters, headers and downpipes as necessary. In case of insufficiency, a new drainage plan is to be developed subject to the appointed heritage</li></ul>

<p>architect's specification in relation to construction, fixing, sizing, materials, placement and reversibility;</p> <ul style="list-style-type: none"><li>• Downpipes which do not comply with current standards and/or are damaged are to be removed and replaced with complying downpipes;</li><li>• Where gutters and downpipes are to be removed, the original profiles and shapes are to be reinstated;</li><li>• Where downpipes are to be replaced, they are to be located in a way to minimise visual disruption of the façade;</li><li>• Ensure that gutters, rainwater heads, downpipes and the roof are all of the same metal. Do not mix electrolytically non-compatible metals;</li><li>• Ensure all gutters, rainwater heads and downpipes are clear of leaves or other debris;</li><li>• Ensure stormwater drainage complies with current standards;</li><li>• Rainwater goods are to be in accordance with AS 3500 Plumbing and Drainage and AS/NZS 2311; and</li><li>• Allow the heritage architect to carry out intermediate and final inspection of the work as it ensues.</li></ul>

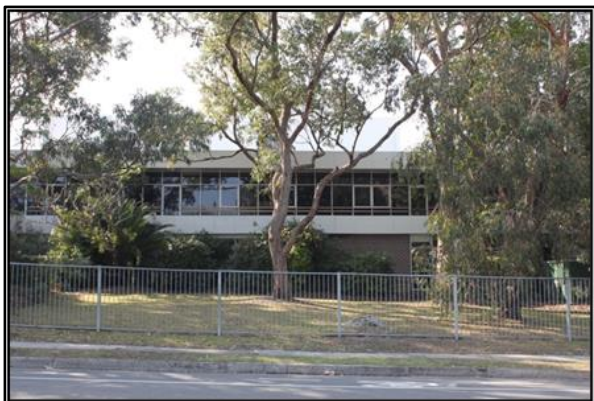
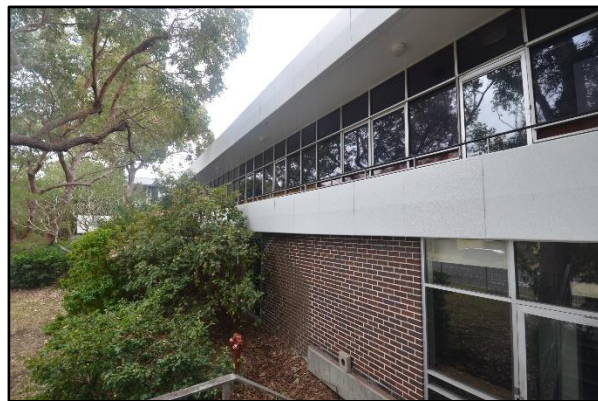
DESCRIPTION	Two-storey off form concrete walling with masonry along the ground floor elevation, along Inman Road.				
SIGNIFICANCE	EXCEPTIONAL	HIGH	MODERATE	LITTLE	INTRUSIVE
CONDITION	VERY GOOD	GOOD	FAIR	POOR	VERY POOR
	Good condition, little signs of deterioration.				
VISUAL SURVEY

Figure 149. View to Building 6 from Inman Road, facing north-east.			Figure 150. Close-up view to Buildings & 6 from Inman Road, facing east.		
ELEMENT		CONSERVATION ACTION			
General Recommendations		<ul style="list-style-type: none"><li>• Original concrete is to be retained and made good;</li><li>• The works to be carried out under the approval should in general, involve the least possible level of physical intervention to significant fabric.</li><li>• Designer/architect to provide details of changes to concrete walls to appointed Heritage Architect for approval.</li><li>• The heritage architect is to carry out intermediate and final inspection of the work as it ensues.</li></ul>

Masonry		<ul style="list-style-type: none"><li>• Painted and rendered masonry is to be retained, if paint it is to be removed due to damage, it is to be done using the Peel-Away system, in accordance with the manufactures specifications and pertinent AS standards;</li><li>• Where brickwork is to be repainted, age-appropriate colour schemes are to be applied;</li><li>• Existing saw cuts from prior chasing of wiring and services into the brick wall is to be retained, as it forms part of the history of the building and fabric;</li><li>• Where the face of a brick is damaged and needs to be replaced, the brick is to be removed. In the first instance, the tradesperson undertaking the work is to inspect the rear face of the brick for damage. If the rear face is deemed to be in good condition, the brick is to be re-laid using the rear face at the façade. If the rear face is also damaged, a new brick of matching colour should be used as a replacement;</li></ul>

<ul style="list-style-type: none"><li>• Make good will only occur where the masonry poses a risk to the structure or to the building's users, as well in excepted cases where previously discussed with a qualified Heritage Consultant.</li><li>• Obtain advice of a Structural Engineer in relation to shifted/out of alignment brickwork. Where brickwork is to be returned to original position, consideration may be given to the limited relaying of brickwork. Note – details of any repair or stabilisation works specified by the Structural Engineer should be reviewed by a Heritage Consultant;</li><li>• When repairing masonry material, the replacement should match the original fabric as closely as possible in colour grain, bedding durability, porosity, and chemical composition;</li><li>• Repointing brickwork is needed where mortar joints have deteriorated. While evidence of age to mortar joints is acceptable, re-pointing of some sections of the walls may be necessary;</li><li>• Maintain existing damp proof courses and flashings, unless they are ineffective and need to be replaced;</li><li>• Where holes are to be introduced to brickwork for the introduction of pipes as part of wall wetting external sprinklers, minimise the number of bricks to be damaged. Ensure that no heavy machinery is to be used for the introduction of the wall wetting sprinkler system.</li><li>• If brick is identified as the only feasible substrate for fixing new fabric, in the first instance the possibility of fixing into the mortar joints should be considered. Fixing to the brick face itself should be seen as a 'last resort' option.</li><li>• Where fixing would be required to brick or mortar, any fixings used should be of a non-ferrous material, and as few penetrations as possible should be made to the brick in order to minimise damage.</li><li>• Allow the heritage architect to carry out intermediate and final inspection of the work as it ensues.</li></ul>

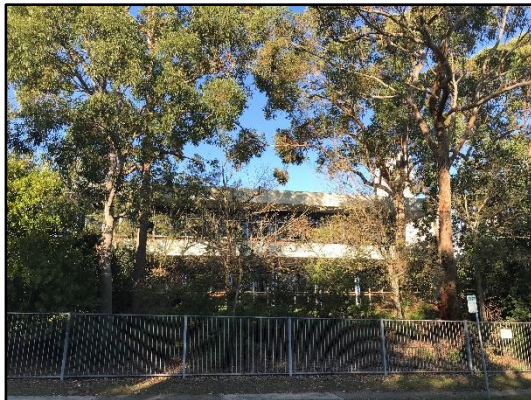
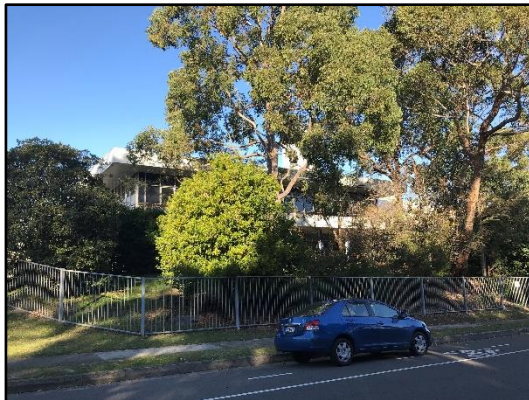
DESCRIPTION	Soft-landscaping includes mature trees and grass.				
SIGNIFICANCE	EXCEPTIONAL	HIGH	MODERATE	LITTLE	INTRUSUVE
CONDITION	VERY GOOD	GOOD	FAIR	POOR	VERY POOR
	Fair condition, well maintained despite the vacancy of the site. Significant mature trees line the Inman Road elevation.				
VISUAL SURVEY

Figure 154. View to Building 06, facing north-east from Inman Road.			Figure 155. View towards Building 06, facing east from Inman Road.		
ELEMENT		CONSERVATION ACTION			
General Recommendations		<ul style="list-style-type: none"><li>The advice of a suitably qualified arborist with heritage experience is to be obtained to ascertain the species of trees within the landscape. Native trees are to be retained and conserved;</li><li>An appropriate landscaped area within the subject site is to be retained as it is considered significant to the heritage significance of the site. The advice of a Landscape Architect is to be obtained with regards to the required landscaped area surrounding the building;</li><li>Where a native tree is to be removed due to decay, it is to be replaced with the same species of tree; and</li><li>Allow the heritage architect to carry out intermediate and final inspection of the work as it ensues.</li></ul>

Additional Considerations		<ul style="list-style-type: none"><li>Regular maintenance schedule to be established with the soft landscaping.</li></ul>

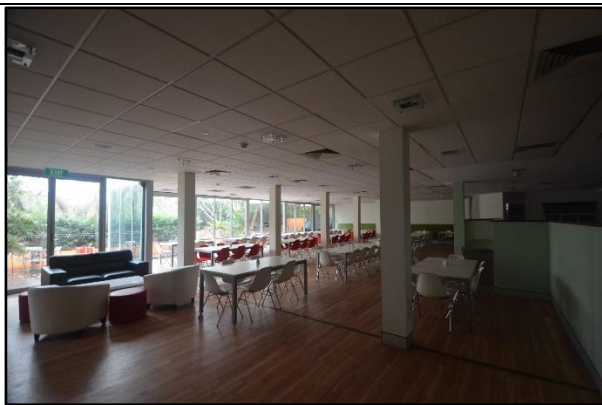
DESCRIPTION	Steel framed structure for the two-storey rectangular building, constructed 1969, as an extension to Building 01.				
SIGNIFICANCE	EXCEPTIONAL	HIGH	MODERATE	LITTLE	INTRUSIVE
CONDITION	VERY GOOD	GOOD	FAIR	POOR	VERY POOR
	Good condition, little signs of deterioration.				
VISUAL SURVEY

Figure 158. View to the interior of Building 06, ground floor, former cafeteria.			Figure 159. View to the interior of Building 06, ground floor, former cafeteria.		
ELEMENT		CONSERVATION ACTION			
General Recommendations		<ul style="list-style-type: none"><li>Retain original metal elements;</li><li>Only missing or unsound elements are to be formed, or recast and replaced;</li><li>Maintain protective coatings on ferrous metals;</li><li>Do not alter the colour, texture, tone or patina of a metal through inappropriate cleanings. It is important to note that all metal cleaners are abrasive to a degree.</li></ul>

<ul style="list-style-type: none"><li>• Where corrosion is found, it is important to remove the cause of corrosion. If not possible, the mildest cleaning agent available is to be used, followed by a reversible sealant;</li><li>• Where rust is found, it is to be removed by a Heritage metalworker in accordance with pertinent AS standards. Heritage metalworker is to treat rust throughout with rust inhibitor and a paint equivalent to red oxide paint (red oxide paint contains lead and should not be used); and</li><li>• Allow the heritage architect to carry out intermediate and final inspection of the work as it ensues.</li></ul>
<b>Additional Considerations</b>	<ul style="list-style-type: none"><li>• Regular inspections to be undertaken by structural engineer regarding the structural integrity of the building, and to undertake works necessary to remove or prevent any structural failures.</li></ul>

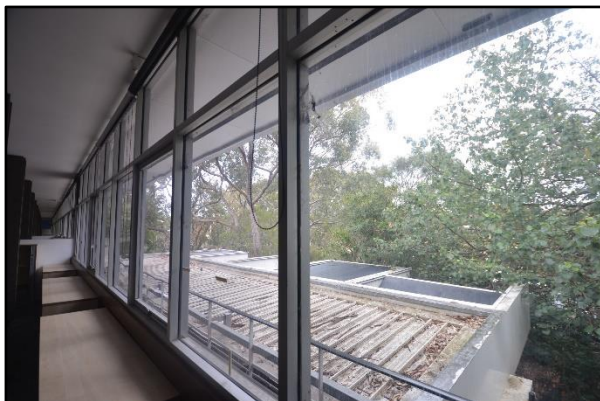
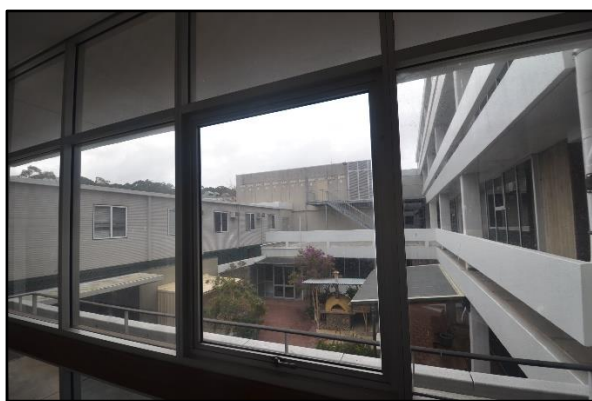
DESCRIPTION	Aluminium framed windows, in addition to a combination of timber and glass doors.				
	Aluminium Window Frames				
SIGNIFICANCE	EXCEPTIONAL	HIGH	MODERATE	LITTLE	INTRUSIVE
CONDITION	VERY GOOD	GOOD	FAIR	POOR	VERY POOR
	Good condition, little signs of deterioration.				
	Internal Timber & Glass Doors				
SIGNIFICANCE	EXCEPTIONAL	HIGH	MODERATE	LITTLE	INTRUSIVE
CONDITION	VERY GOOD	GOOD	FAIR	POOR	VERY POOR
	Good condition.				
VISUAL SURVEY

Figure 164. Close-up view to interior of aluminium framed windows in Building 6, western elevation.			Figure 165. Close-up view to interior of aluminium framed windows in Building 6, eastern elevation.

Figure 166. View to the interior of Building 6 office space, with internal glass partitions.					
ELEMENT	CONSERVATION ACTION				
General Recommendations	<ul style="list-style-type: none"><li>• Retain original metal elements;</li><li>• Only missing or unsound elements are to be formed, or recast and replaced;</li><li>• Maintain protective coatings on ferrous metals;</li></ul>

<ul style="list-style-type: none"><li>• Do not alter the colour, texture, tone or patina of a metal through inappropriate cleanings. It is important to note that all metal cleaners are abrasive to a degree; and</li><li>• Allow the heritage architect to carry out intermediate and final inspection of the work as it ensues.</li></ul>
--	--

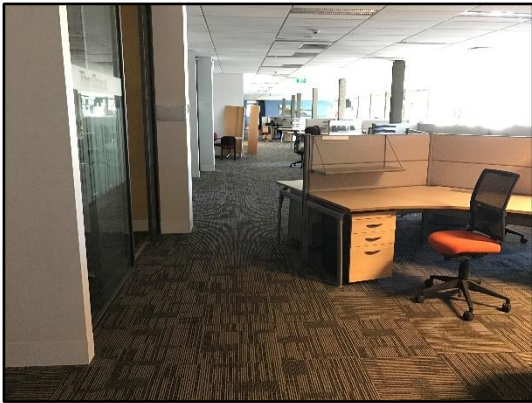
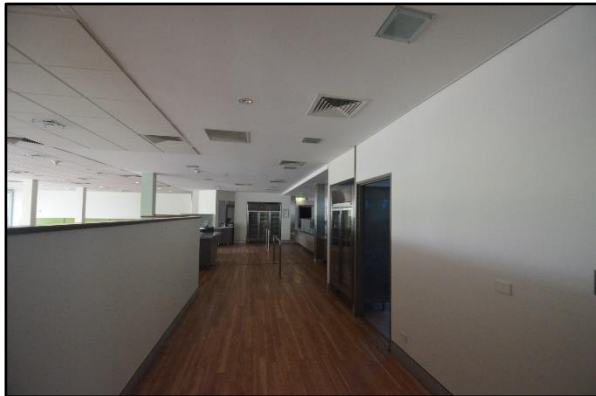
DESCRIPTION	Concrete floor structure, with flooring finishes comprising carpeting, tiles and floating floorboards. Likely introduced during the internal renovations undertaken in 2006.				
SIGNIFICANCE	EXCEPTIONAL	HIGH	MODERATE	LITTLE	INTRUSUVE
CONDITION	VERY GOOD	GOOD	FAIR	POOR	VERY POOR
	Good condition, general signs of wear and tear.				
VISUAL SURVEY

Figure 167. View to the interior of Building 6 first floor, carpet throughout.			Figure 168. View to the interior of Building 6 ground floor, note the floating floorboards.		
ELEMENT	CONSERVATION ACTION				
General Recommendations	<ul style="list-style-type: none"><li>• Retain the original floor structure and conserve in situ;</li><li>• Check structural stability of floor structure in consultation with a registered structural engineer. Allow to replace elements as directed by the structural engineer;</li><li>• Limit repairs only to members which are structurally unsound or dangerous;</li><li>• Where damage to fabric is small (less than 5mm), infill is not necessary;</li><li>• Intrusive flooring may be removed and replaced with a sympathetic flooring;</li><li>• Where flooring is to be replaced, the advice of a Heritage Architect is to be obtained before the commencement of works;</li><li>• Where tiling has been damaged, it is to be repaired; and</li><li>• Allow the heritage architect to carry out intermediate and final inspection of the work as it ensues.</li></ul>

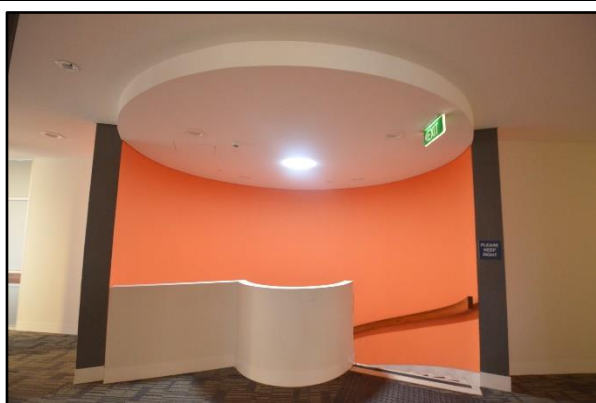
DESCRIPTION	Internal circular stair, comprising of terrazzo and timber handrails.				
SIGNIFICANCE	EXCEPTIONAL	HIGH	MODERATE	LITTLE	INTRUSIVE
CONDITION	VERY GOOD	GOOD	FAIR	POOR	VERY POOR
	Good condition, general signs of wear and tear.				
VISUAL SURVEY

Figure 169. View overlooking the internal circular terrazzo stair within Building 6.			Figure 170. View overlooking the internal circular terrazzo stair within Building 6.

Figure 171. View to the internal stair, close-up of the terrazzo and timber handrail.			Figure 172. View towards the internal stair from the ground floor and timber panelling.		
ELEMENT		CONSERVATION ACTION			
General Recommendations		<ul style="list-style-type: none"><li>• Original staircases and their original balusters and handrails are to be retained and conserved;</li><li>• New carpet runner may be installed on the stairs after submission to appointed heritage architect for approval prior to its installation; and</li><li>• New carpet installed on staircase to be 450mm away from stair edge on the balustrade side; and</li><li>• Non-original timber or concrete staircases, including balusters and handrails may be removed and replaced with a period appropriate staircase.</li></ul>			
		<ul style="list-style-type: none"><li>• Conserve and retain terrazzo elements and make good where necessary;</li></ul>

<b>Terrazzo</b>	<ul style="list-style-type: none"> <li>• Remove any vegetation if found. Mortar joints where vegetation is found should be repointed so as to reduce the risk of further growth;</li> <li>• Where terrazzo is damaged and is in need of repair, it is to be repaired by a mason with experience in heritage masonry;</li> <li>• All surfaces are to be free of loose material or any contaminants before the commencement of works;</li> <li>• Chips and holes to terrazzo are to be filled with UV stable, white epoxy with pigment added to match as close as possible with the Portland cement. Existing holes are to be filled with similar aggregates that match the stone in colour. The hole is to be filled above the finished floor level to allow for the epoxy to be grinded down flat when hardened;</li> <li>• Where terrazzo is to be cleaned, vacuum and sweep the terrazzo to remove loose grit from the surface. Scrub a small area using a light solution of stone cleaner suitable for terrazzo. Terrazzo should be cleaned using a soft brush or broom to work the solution into the pores of the tile and grout. Continue to complete small areas until the entire surface has been scrubbed. The solution is to be left to soak for several minutes, then scrub again. When the solution has lifted out the dirt, remove the liquid and dirt using an old towel or clean, dry mop. Pour clean water over the surface to rinse. Use a clean cloth or mop to soak up any water, do not leave the surface to dry naturally;</li> <li>• Unpainted elements are not to be painted; and</li> <li>• Allow the heritage architect to carry out intermediate and final inspection of the work as it ensues.</li> </ul>

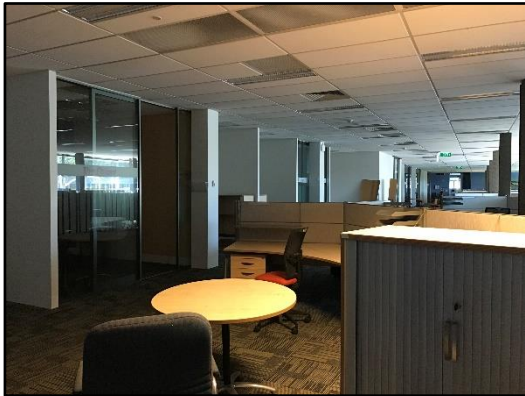
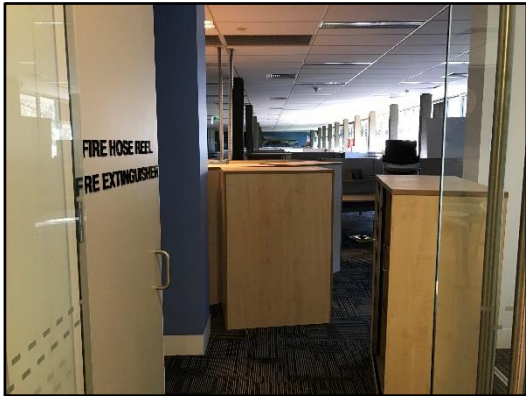
DESCRIPTION	Lighting comprises of fluorescent light fixtures.				
SIGNIFICANCE	EXCEPTIONAL	HIGH	MODERATE	LITTLE	INTRUSIVE
CONDITION	VERY GOOD	GOOD	FAIR	POOR	VERY POOR
	Good condition, general signs of wear and tear.				
VISUAL SURVEY

Figure 173. View to the interior of Building 6.			Figure 174. View to the interior of the offices within Building 6.		
ELEMENT	CONSERVATION ACTION				
General Recommendations	<ul style="list-style-type: none"><li>Fitting of new electrical installations should have regard for the historic fabric of the place and avoid unnecessary damage. Careful planning is needed to avoid the unsightly exposed runs of cabling, internally and externally. No chasing into walls will be allowed. All new services are to be wall-mounted and not chased into the historic fabric; and</li><li>Allow the heritage architect to carry out intermediate and final inspection of the work as it ensues.</li></ul>

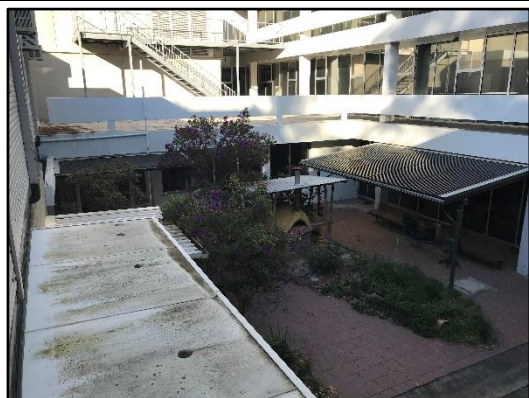
<b>DESCRIPTION</b>	Internal courtyard situated between Buildings 01, 02, 06, 44 & 07. Although the space has been reduced in scale, it became a common open space for employees with the installation of timber benches and a pizza oven.				
<b>SIGNIFICANCE</b>	EXCEPTIONAL	<b>HIGH</b>	MODERATE	LITTLE	INTRUSIVE
<b>CONDITION</b>	VERY GOOD	GOOD	<b>FAIR</b>	POOR	VERY POOR
	Fair condition despite the vacancy of the site.

**Figure 175.** Overlooking the internal courtyard, view from Building 06, facing east.

ELEMENT	CONSERVATION ACTION
<b>General Recommendations</b>	<ul style="list-style-type: none"> <li>Retain an internal courtyard space. Although alterations may be made to the existing scale and form, maintaining open space for employees within the site is imperative and respects the heritage significance of the complex;</li> </ul>

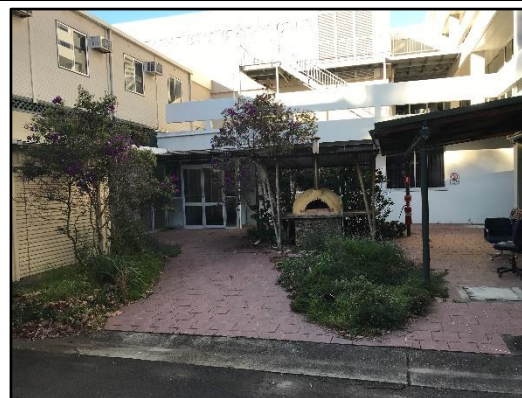
**Figure 176.** View to the internal courtyard, facing north-east.

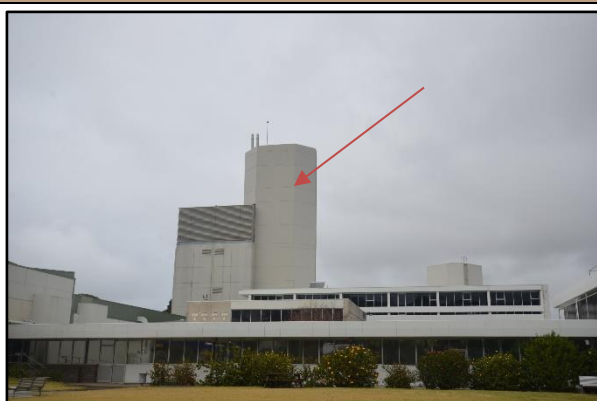
<b>DESCRIPTION</b>	The hexagonal tower of Building 11 comprises a steel structure, with concrete walls and a concrete flooring system.				
<b>SIGNIFICANCE</b>	EXCEPTIONAL	<b>HIGH</b>	MODERATE	LITTLE	INTRUSIVE
<b>CONDITION</b>	VERY GOOD	GOOD	<b>FAIR</b>	POOR	VERY POOR
	Fair condition.

**Figure 178.** View to Building 11, indicated by the red arrow, from within the subject site.

ELEMENT	CONSERVATION ACTION
<b>General Recommendations</b>	<ul style="list-style-type: none"> <li>Retain existing hexagonal tower;</li> <li>Potential to adaptively re-use the base of the tower to be guided by heritage architect, following structural report by engineer to outline the detailing for maintaining the structural integrity of the tower;</li> </ul>

<ul style="list-style-type: none"><li>• Engage a lighting consultant, to provide an appropriate lighting scheme for the tower, to enhance the prominence and landmark qualities of the tower;</li><li>• Waterproofing of tower to be undertaken in conjunction with relevant improvement works following a close inspection of the structure;</li><li>• Inspection to be undertaken regarding existing structure, to ensure no signs of cracking or movement;</li><li>• Structural engineer to provide guidelines for regular maintenance of the tower following demolition and construction works within the site, including a cyclical maintenance schedule; and</li><li>• Ensure the tower is incorporated into the implementation of the comprehensive interpretation strategy developed for the site. May include reinstating a logo on the tower.</li></ul>
--	---

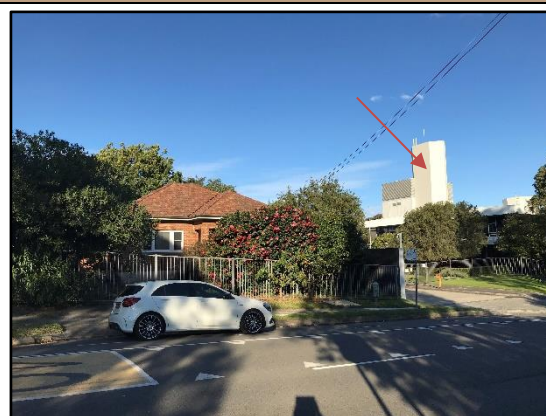
**Figure 179.** View towards the subject site, from Inman Road, facing east.
