Hazardous Materials Survey

64-70 King Georges Road & 280-300 Lakemba
Street, Wiley Park NSW

Report No: E25377.E10_Rev0

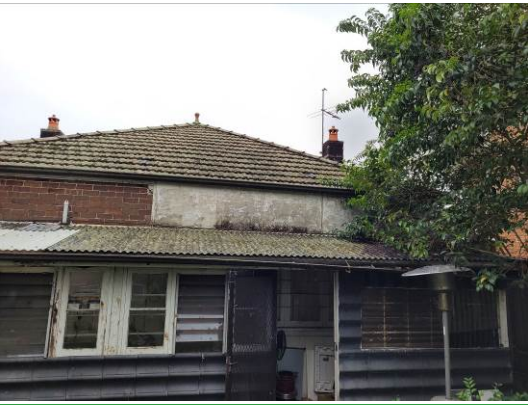
External, rear extension, infill panels	Asbestos cement sheeting (assumed)	Non-friable	Visual Inspection similar to Asb05	-	5m ²	Good-fair Regular	Priority 4 – Negligible Risk Level	Remove prior to demolition works

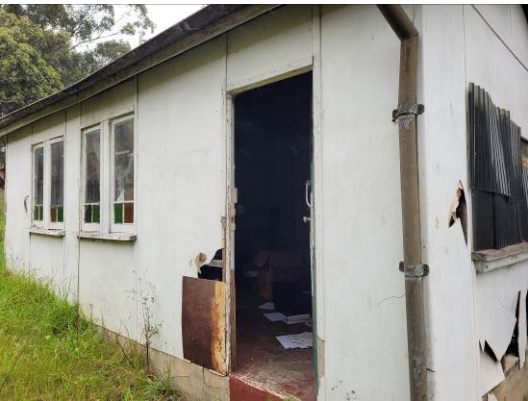
External, garage, edge capping	Asbestos cement sheeting	Non-friable	Asb06	Amosite & Chrysotile Asbestos Detected	1m ²	Good-fair Regular	Priority 4 – Negligible Risk Level	Remove prior to demolition works

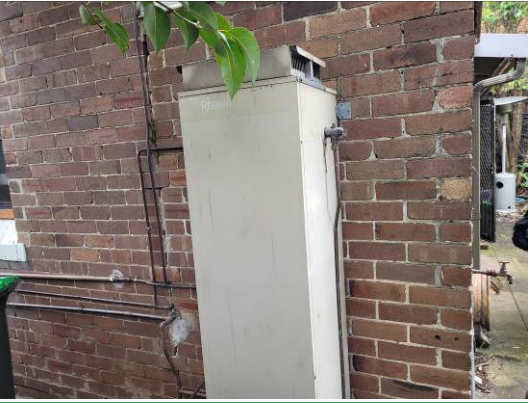
External, rear western wall	SMF Insulation	Non-friable	Visual Inspection	-	1x hot water unit	Good Maintenance Only	Priority 4: Negligible Risk Level	Remove prior to demolition works

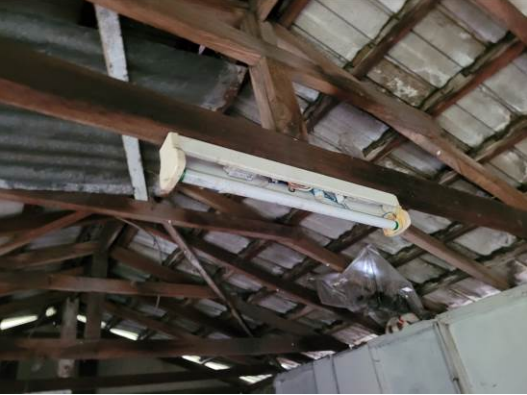
Internal, garage, ceiling	PCB containing single tubed fluorescent light fitting(assumed)	N/A	Visual Inspection	-	1 unit	Good Maintenance Only	Priority 4: Negligible Risk Level	Remove prior to demolition works

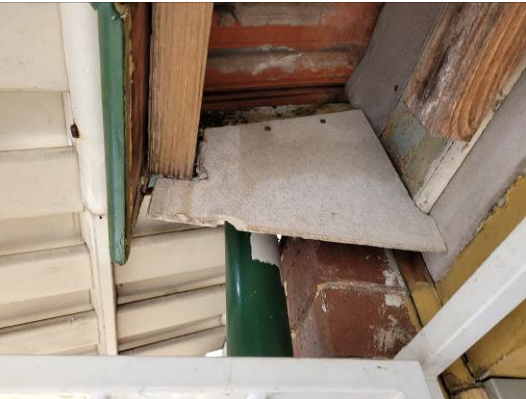
External, main building, eave ends	Asbestos cement sheeting	Non-friable	Asb08	Amosite & Chrysotile Asbestos Detected Organic Fibres Detected	<1m ²	Good Regular	Priority 4 – Negligible Risk Level	Remove prior to demolition works

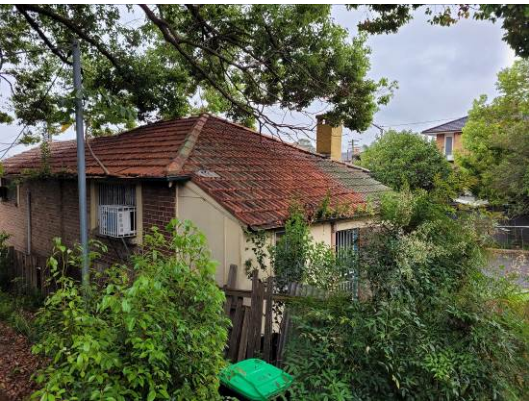
External, rear extension walls	Asbestos cement sheeting (assumed)	Non-friable	Visual Inspection similar to Asb05	-	10m ²	Good Regular	Priority 4 – Negligible Risk Level	Remove prior to demolition works

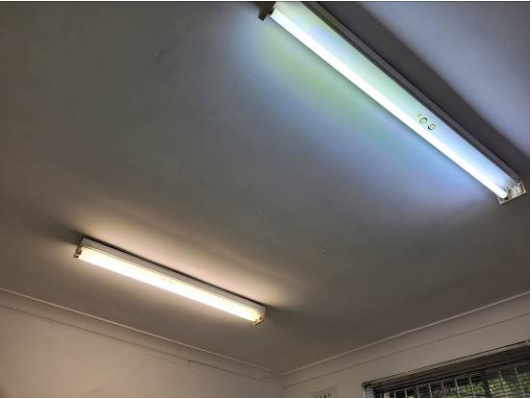
Hazardous Materials Register 64-70 King Georges Road & 280-300 Lakemba Street, Wiley Park NSW									
Internal, rear extension, laundry walls and ceiling	Fibre cement sheeting	N/A	Asb11	No Asbestos Detected Organic Fibres Detected	N/A	N/A	N/A	N/A	
SMF									
Internal and external, throughout	No synthetic mineral fibres were identified	N/A	Visual inspection	N/A	N/A	N/A	N/A	N/A	
Paints									
Internal, front storage room	Light blue paint	N/A	Pb03	0.015% w/w	Throughout	N/A	N/A	N/A	
PCBs									
Internal, ceiling	PCB containing single tube fluorescent light fittings (assumed)	N/A	Visual Inspection	-	Throughout	Good Maintenance Only	Priority 4 - Negligible Risk Level	Remove prior to demolition works

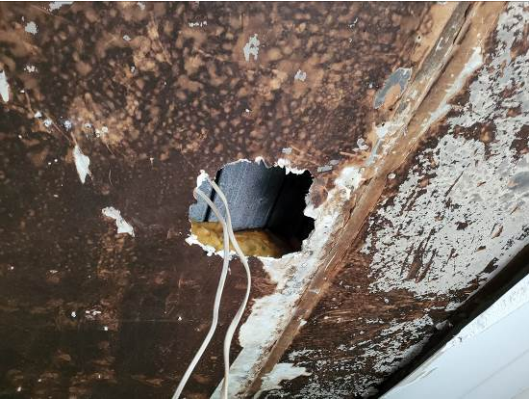
Location	Material Type	Friability	Sample	Analysis Result:	Quantity	Condition and Accessibility	Priority	Recommendations/ Comments	Photograph of material
288a Lakemba Street									
Asbestos									
No asbestos containing materials were identified	N/A	N/A	N/A	N/A	N/A	N/A	N/A	N/A	
SMF									
Internal, ceiling cavity	SMF Insulation	Non-friable	Visual Inspection	-	Throughout	Good Maintenance Only	Priority 4: Negligible Risk Level	Remove prior to demolition works

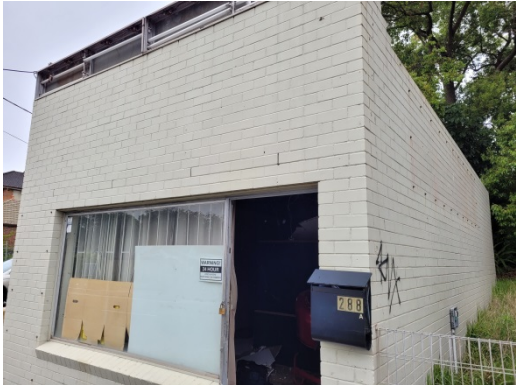
Paints									
No lead based paints were identified	N/A	N/A	N/A	N/A	N/A	N/A	N/A	N/A	
PCBs									
External, upper wall,	PCB containing single & double tube fluorescent light fittings (assumed)	N/A	Visual inspection	-	approx. 7 units	Good	Good Maintenance Only	Priority 4 - Negligible Risk Level

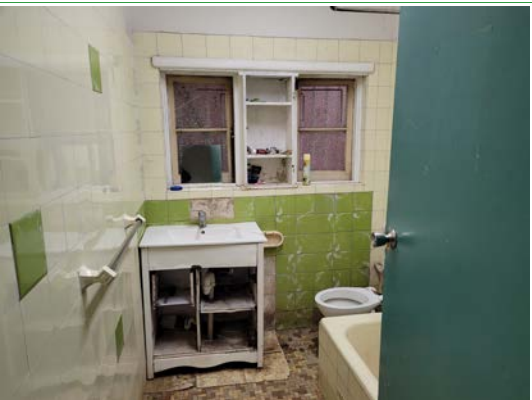
Internal, bathroom, beneath sink, flooring	Asbestos vinyl floor tiles	Non-friable	Asb20	Chrysotile Asbestos Detected	0.5m ²	Good-fair Maintenance only	Priority 4 – Negligible Risk Level	Remove prior to demolition works

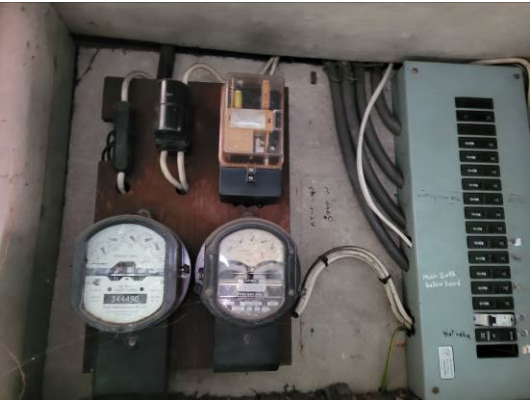
External, western wall, electrical unit lining	Asbestos cement sheeting (assumed)	Non-friable	Visual Inspection	-	1m ²	Good Maintenance only	Priority 4 – Negligible Risk Level	Remove prior to demolition works

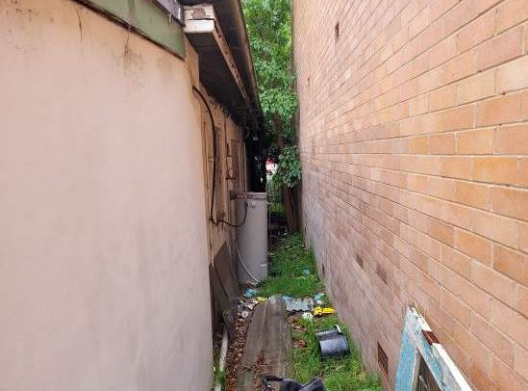
External, western wall	SMF Insulation	Non-friable	Visual Inspection	-	1x hot water unit	Good Maintenance Only	Priority 4: Negligible Risk Level	Remove prior to demolition works

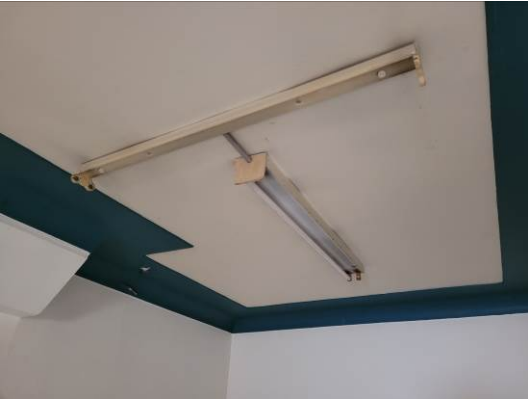
Internal, ceiling	PCB containing single & double tube fluorescent light fittings (assumed)	NA	Visual Inspection	-	Throughout	Good Maintenance Only	Priority 4 - Negligible Risk Level	Remove prior to demolition works

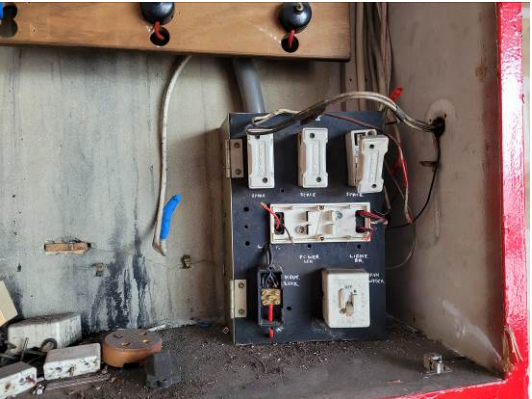
Blazin Grillz – Internal, dining area, electrical unit	Asbestos backing board (assumed)	Non-friable	Visual Inspection	-	1x unit	Good Maintenance only	Priority 4 – Negligible Risk Level	Remove prior to demolition works

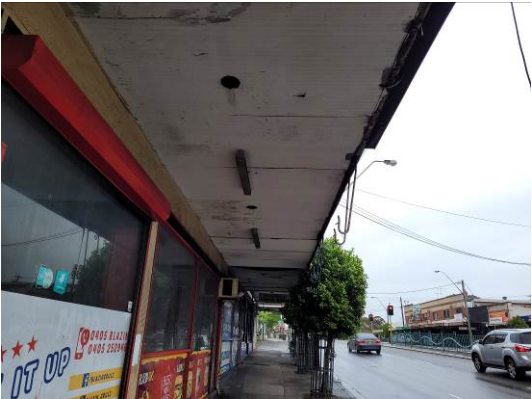
External – awnings across building	Asbestos cement sheeting (assumed)	Non-friable	Visual Inspection	-	40m ²	Good Maintenance only	Priority 4 – Negligible Risk Level	Remove prior to demolition works

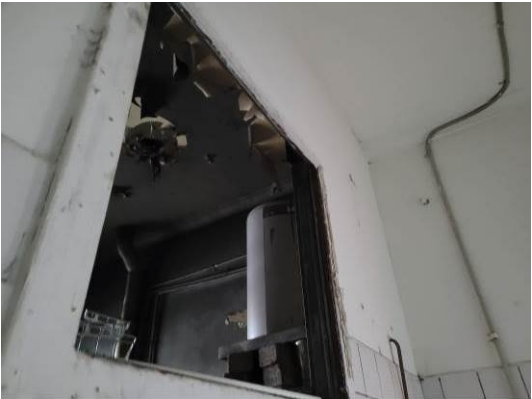
Hadda House – Internal, dining area, infill panels	Fibre cement sheeting	N/A	Asb28	No Asbestos Detected Organic Fibres Detected	N/A	N/A	N/A	N/A	
SMF									
Blazin Grillz– Internal, void above fridge room	SMF Insulation	Non-friable	Visual Inspection	-	1x hot water unit	Good Maintenance Only	Priority 4: Negligible Risk Level	Remove prior to demolition works

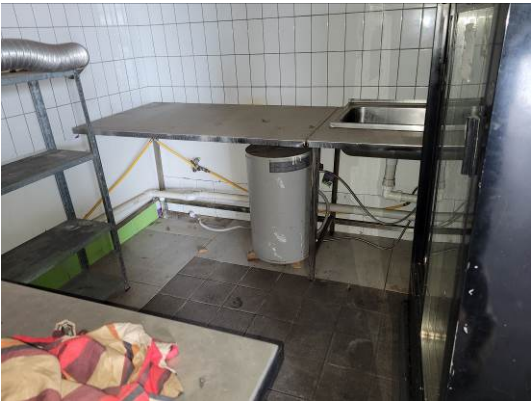
Hadda House – Internal, kitchen area	SMF Insulation	Non-friable	Visual Inspection	-	1x hot water unit	Good Maintenance Only	Priority 4: Negligible Risk Level	Remove prior to demolition works

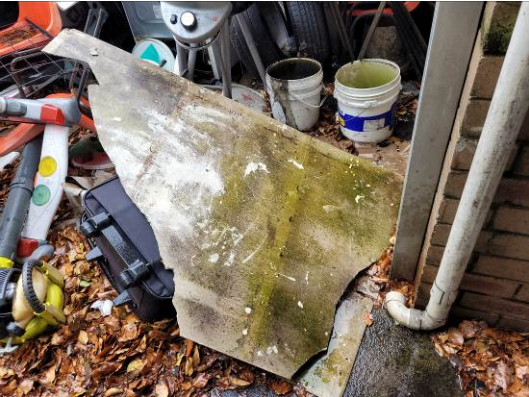
JJs Newsagency – Electrical Unit	Asbestos backing board (assumed)	Unknown	Inaccessible	N/A	Not determined	Unknown Maintenance only	Unknown	Unable to be identified at time of investigation When areas are accessible, confirm status of hazardous materials.	
White Heaven Turkish Cuisine – Electrical Unit	Asbestos backing board (assumed)	Unknown	Inaccessible	N/A	Not determined	Unknown Maintenance only	Unknown	Unable to be identified at time of investigation When areas are accessible, confirm status of hazardous materials.	
Asbestos									
White Heaven Turkish Cuisine – External, rear yard, loose panelling	Asbestos cement sheeting	Non-friable	Asb27	Chrysotile Asbestos Detected Organic Fibres Detected	<1m ²	Fair Maintenance only	Priority 4 - Negligible Risk Level	Remove prior to demolition works

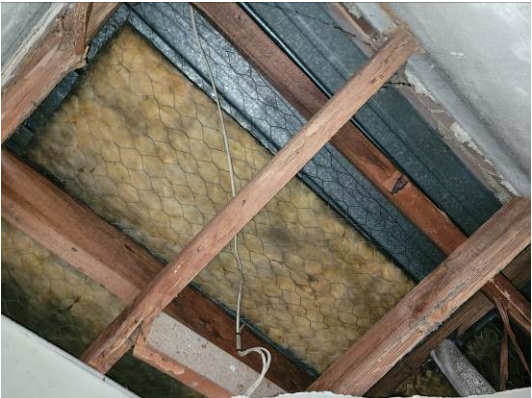
SMF									
White Heaven Turkish Cuisine – Internal, rear laundry, ceiling	SMF Insulation	Non-friable	Visual Inspection	-	Throughout	Good Maintenance Only	Priority 4: Negligible Risk Level	Remove prior to demolition works

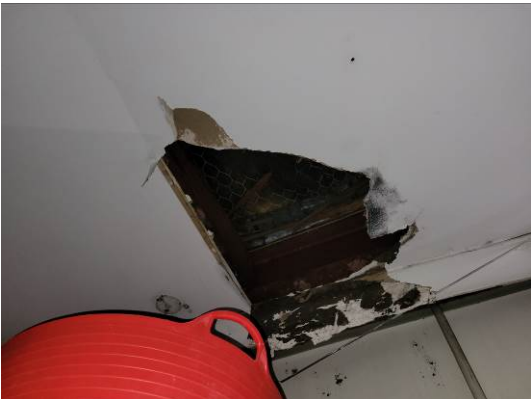
JJs Newsagency – Internal roof cavity	SMF Insulation	Non-friable	Visual Inspection	-	Throughout	Good Maintenance Only	Priority 4: Negligible Risk Level	Remove prior to demolition works

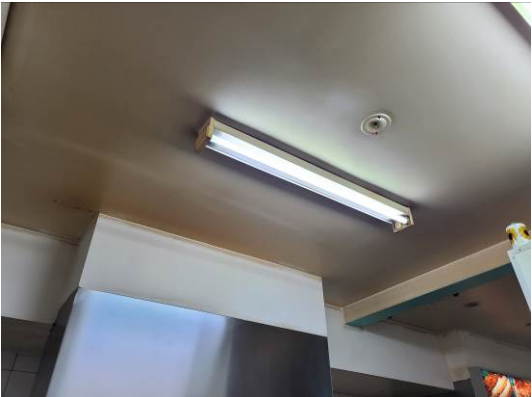
Paints									
No lead based paints were identified									
PCBs									
White Heaven Turkish Cuisine – Internal, ceiling	PCB containing single tube fluorescent light fittings (assumed)	N/A	Visual Inspection	-	Throughout	Good Maintenance Only	Priority 4 - Negligible Risk Level	Remove prior to demolition works

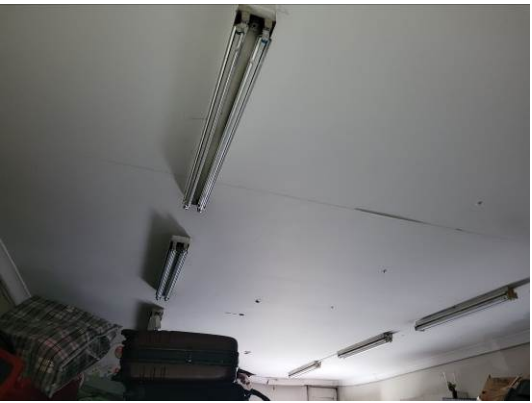
JJs Newsagency – Internal, ceiling	PCB containing single tube fluorescent light fittings (assumed)	N/A	Visual Inspection	-	Throughout	Good Maintenance Only	Priority 4 - Negligible Risk Level	Remove prior to demolition works

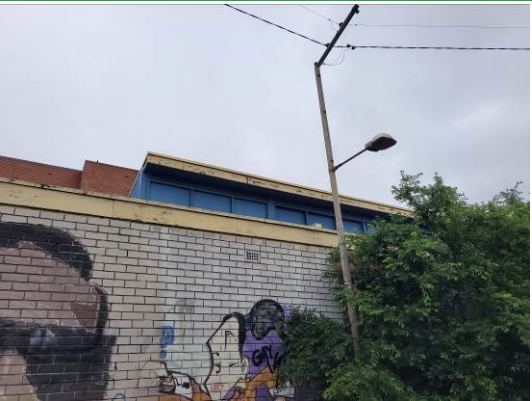
External, eaves	Asbestos cement sheeting (assumed)	Non-friable	Visual Inspection	-	10m ²	Good-fair Maintenance only	Priority 4 – Negligible Risk Level	Remove prior to demolition works

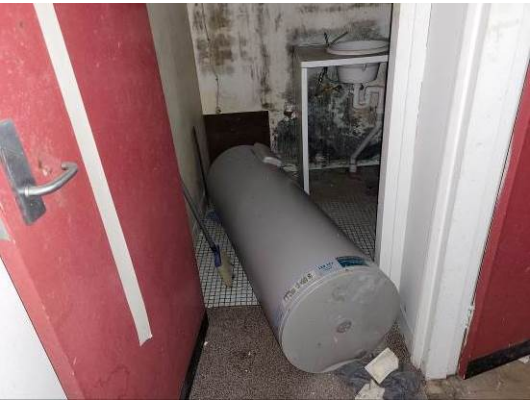
Internal, bathroom	SMF Insulation	N/A	Visual inspection	-	1x hot water unit	Good Maintenance Only	Priority 4: Negligible Risk Level	Remove prior to demolition works

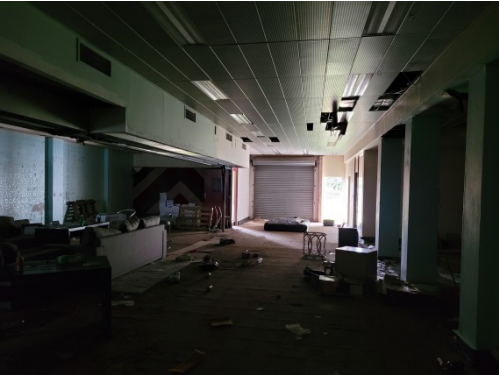
Internal, ceiling	PCB containing single tube fluorescent light fittings (assumed)	N/A	Visual inspection	-	Assumed throughout	Good Maintenance Only	Priority 4: Negligible Risk Level	Remove prior to demolition works
-------------------	---	-----	-------------------	---	--------------------	-----------------------	-----------------------------------	----------------------------------
