# ARBORICULTURAL REPORT & TREE PROTECTION SPECIFICATION

SANCTUARY POINT LIBRARY Paradise Beach Road Lots 944-947 in DP 27857 and Lot 4 in DP 806393 13<sup>th</sup> December 2021 *FINAL* Updated 23 February 2023

Prepared for: Brewster Hjorth Architects

Prepared by: Paul Vezgoff Consulting Arborist ISA, AA Arboriculture Australia Registered Consultant

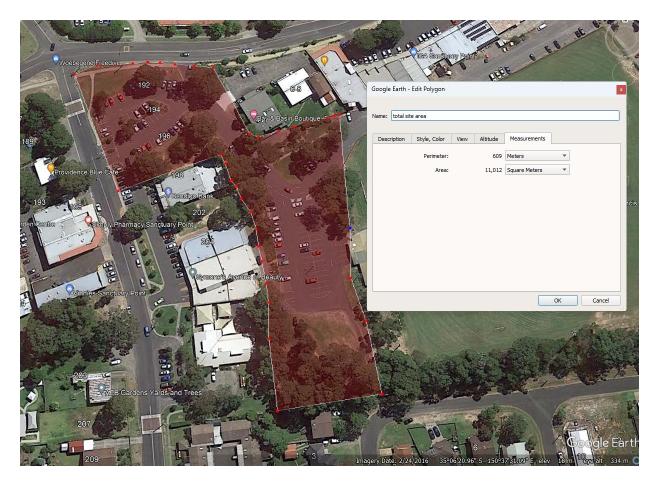
**Diagram 4:** Image showing the total area calculation being approximately 11,012 square metres (Google Earth)

- **3.14** Based on my calculations using Google Earth polygon shape layers the following calculations were made. These calculations are approximate only. The total area for the site is 11,012 square metres (Diagram 4). The total area of canopy cover for the site is approximately 3,930 square metres. The total area of canopy proposed to be removed is 1878.7 square metres (Diagram 5). The remaining canopy cover will be 2052 square metres (Diagram 5). As a percentage, the remaining canopy cover for the site will be 52.2% of the existing vegetation and 47.8% of the site canopy will be removed.

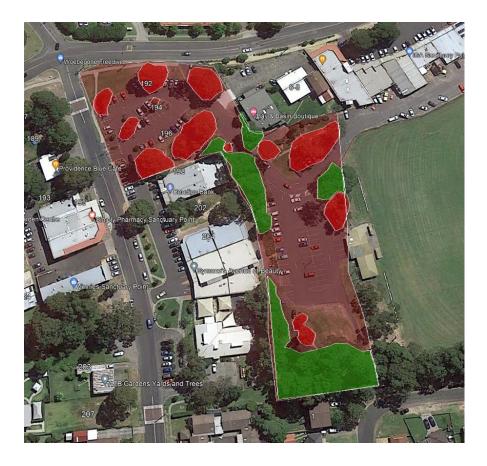
- **Diagram 5:** As a percentage, the remaining canopy cover for the site will be 52.2% of the existing vegetation and 47.8% of the site canopy will be removed.
- 3.15 Based on the updated drawings Trees 53 and 57 will now be retained (Diagram 8 and 9). The northern portion of the TPZ of these trees will have a minor incursion that calculates to 13.2% for Tree 53 and 14% for Tree 57. These incursion are reasonably shallow and as such there will be no detrimental impacts from the new design to Trees 53 and 57.
- **3.16** New incursions are noted for Trees 41 and 43 (Diagrams 6 and 7). These incursions calculate to 14.9% for Tree 41 and 24.9% for Tree 43. Again, these incursions are reasonably shallow but not ideal. Improving the remaining TPZ area below these trees with mulch and soil amelioration will help them cope with these incursions.

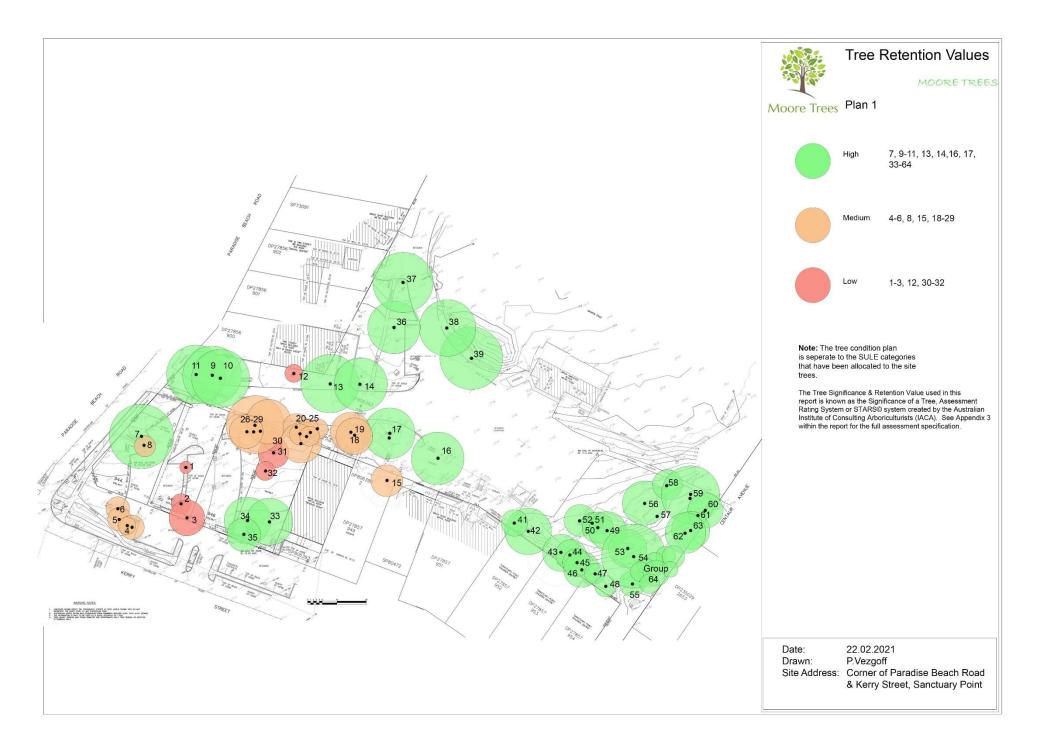
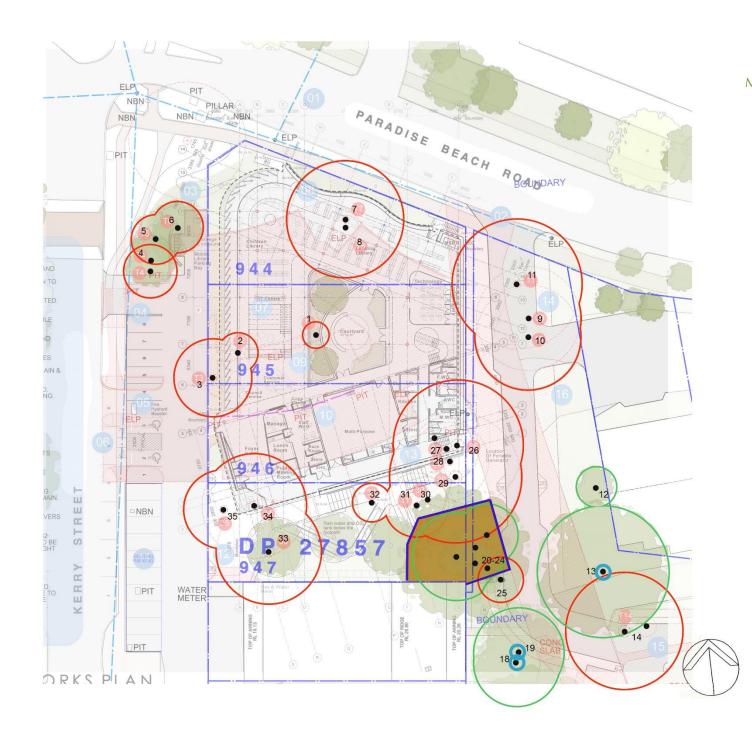
- 4.1 Based on the plans provided Trees to be removed are numbered as 1-11, 14, 25-37, 39, 49-52. All other trees appear possible to retain.
- **4.2** A Tree Protection Plans can be found in Appendix 1 (Plans 2 and 3). This Plan only covers the area of the site where trees require protection. Tree removals and retentions can be seen in Plan 4 (Appendix 1).

Mulching. Area recommended for mulching. Prior to any demoition or construction work mulch shall be applied to a depth of 100mm to this area for the duration of the construction period. Once construction is complete the mulch shall be reduced to a depth of no greater than 70mm.

Trunk protection. Lengths of timber (75mm x 50mm x 2000) shall be fastened to the trunk or overhead branches that are greater than 80mm in diameter. These timbers are to be fastened with hoop iron strapping and not fixed directly onto the trunk of the tree.
