TREE ASSESSMENT REPORT

**MR COLIN KRAMER & MRS SANDRA KRAMER
DIP. ARBORICULTURE
DIP. ENVIRONMENTAL SUSTAINABILITY
LOCAL TREE CARE
22 KOTHES LANE
BARANDUDA VIC 3691**

**JOSS CONSTRUCTION
ATT: MR MARTIN REID
DEVELOPMENT MANAGER JOSS GROUP
206 EAST STREET
ALBURY NSW 2640**

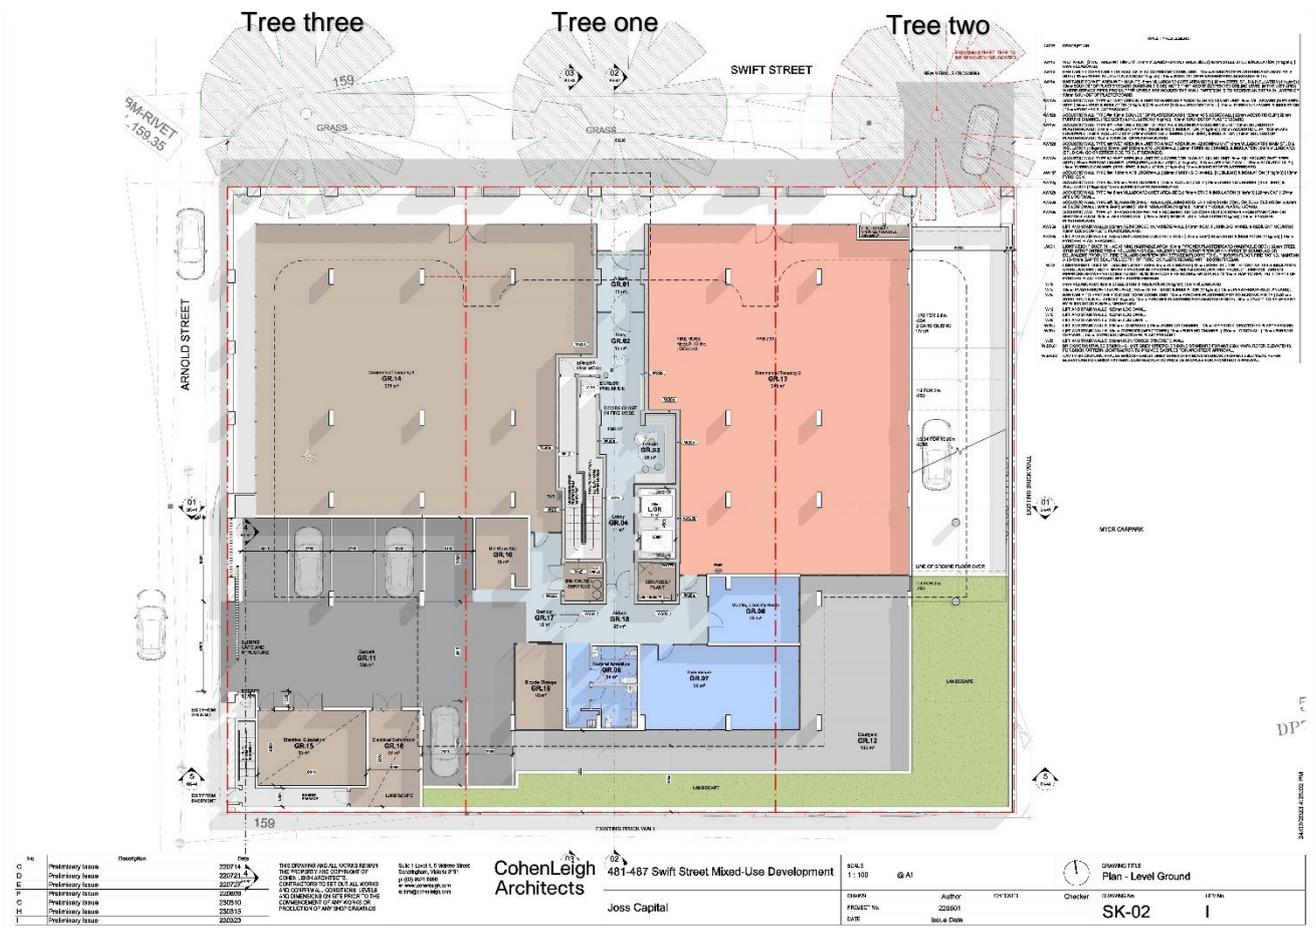
Proposed development: 481-487 Swift Street, Albury

- From our review of the specifications provided, a new building with a basement carpark is designated to be installed approximately 4.4 metres from the trunk, this would equate to an encroachment of 14.4% of the TPZ.
