# Construction Impact Report

Assessment of trees adjacent to 257 Crawford Street,  
Queanbeyan

**Homewood Consulting Pty Ltd**

17 September 2019

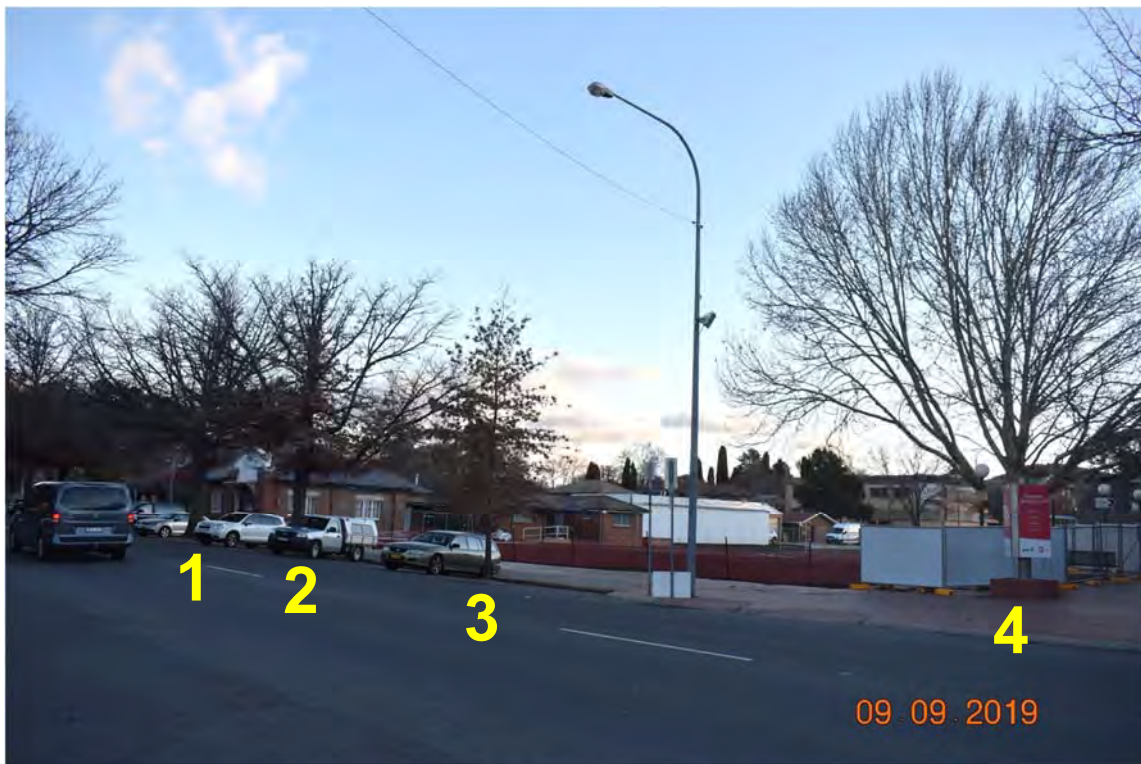
Figure 1: Subject site and existing trees

Three of the assessed trees are located within planting pits between parking bays and are part of a consistent avenue along Crawford Street. The pits are quite large (roughly the size of one parking bay) and are topped with compacted granitic sand.

The remaining tree is located on the adjacent parcel (253 Crawford St- Queanbeyan Bicentennial Hall), but is very near (~2.5m) to the shared property boundary with the subject site and the former library. The majority of the tree's root zone is covered by brick paving which forms a pedestrian thoroughfare between Crawford Street and the Queanbeyan Performing Arts Centre/Public Parking to the rear of the site.

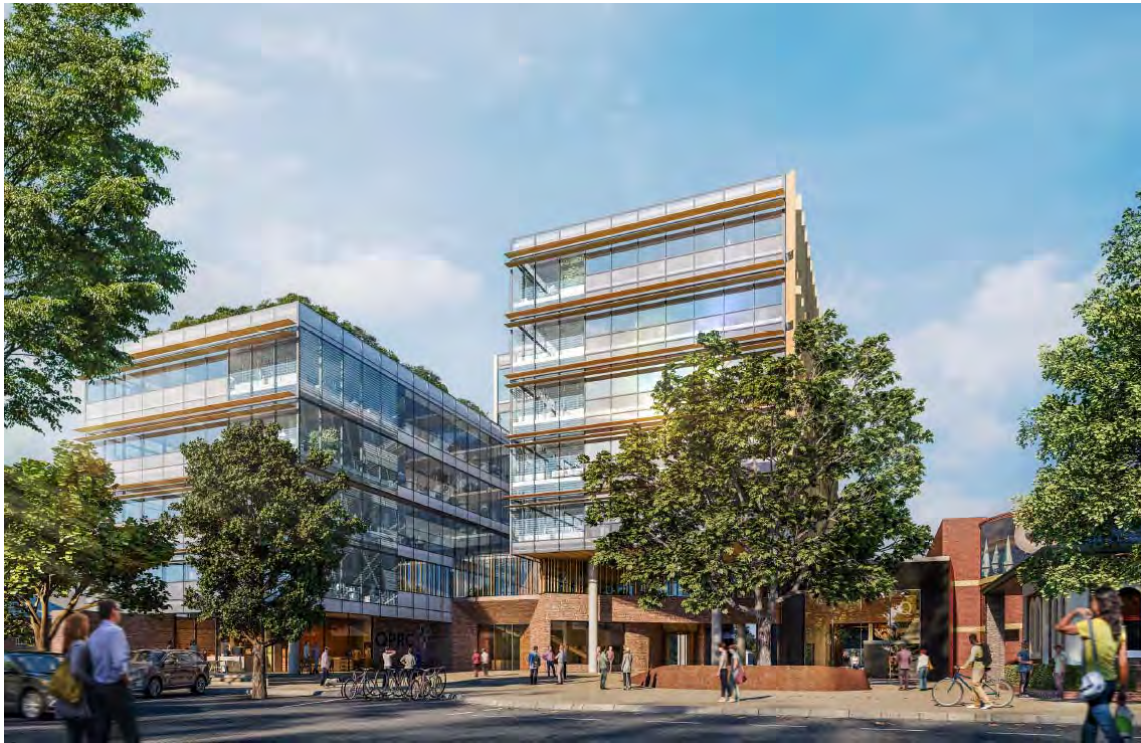
Figure 2: The proposed QPRC HOSH and subject trees (foreground)

The QPRC HOSH project has involved demolition of the existing building on site and construction of a new Council office and customer service building (Figure 2). The proposed building will include basement carparking, a rear civic square and entry forecourt.

Paving, landscaping and minor roadworks associated with the entry forecourt area are the major design features within the vicinity of the trees.
