# *Ulmus procera* (English Elm) adjacent to the CIVITAS Stage 3 development site

## Arborist Report

May 2024,  
Ref 24/475A.

# *Ulmus procera* (English Elm) adjacent to the CIVITAS Stage 3 Development Site – corner of Murray and Morgan Streets, Wagga Wagga.

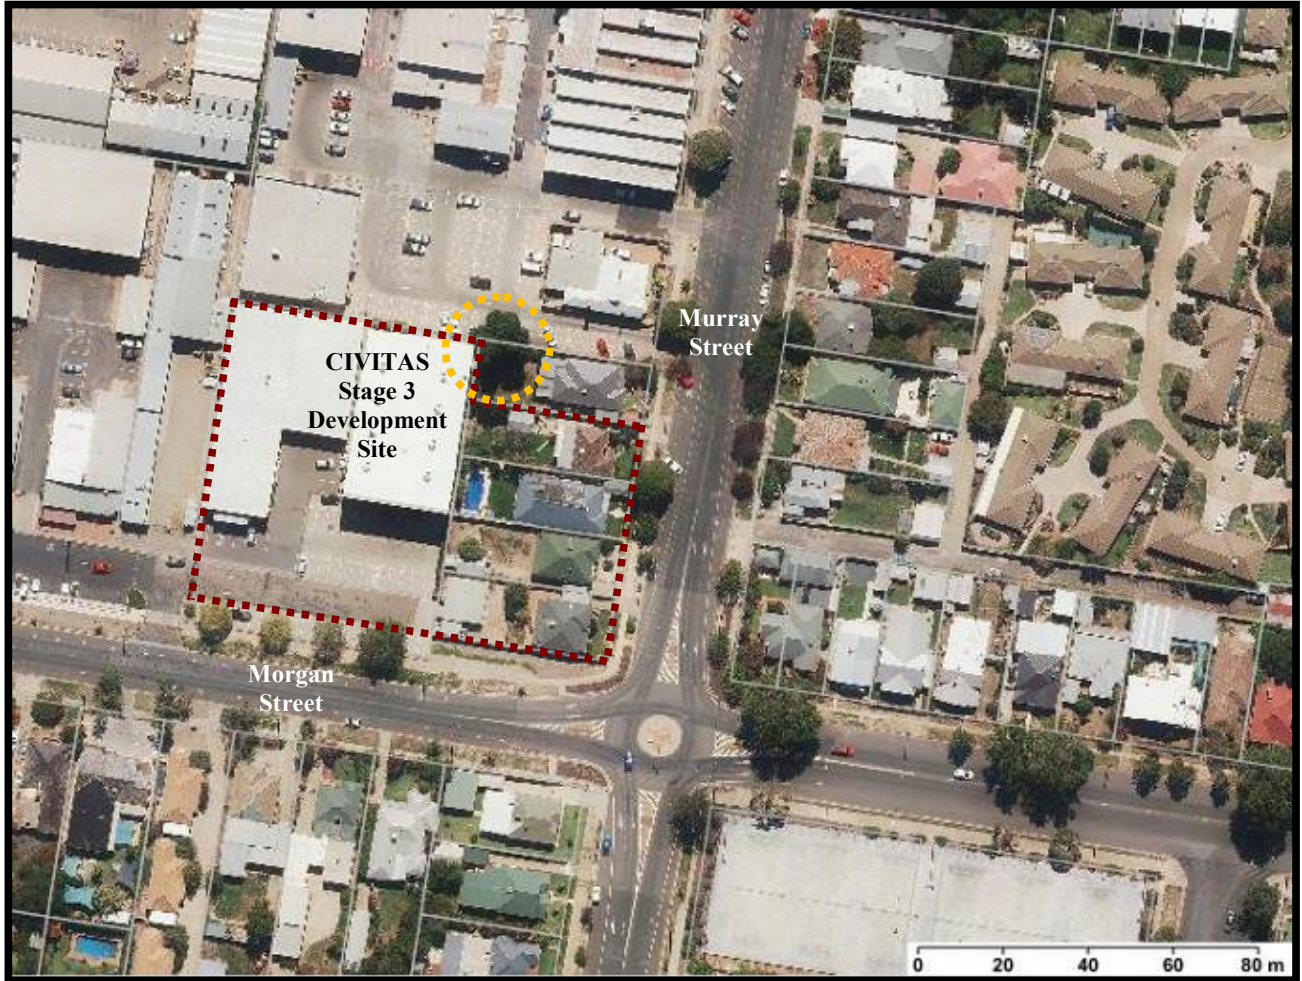
**Exhibit 1** – Locality Plan; CIVITAS Stage 3, with the canopy of the subject tree highlighted (in **Yellow**).

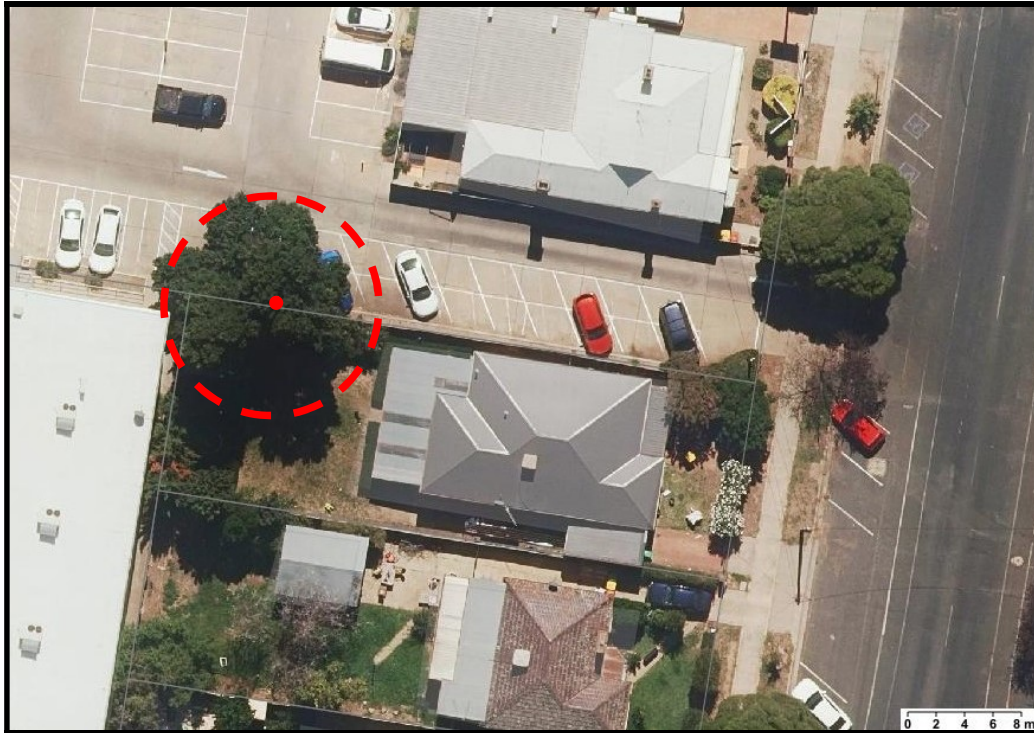
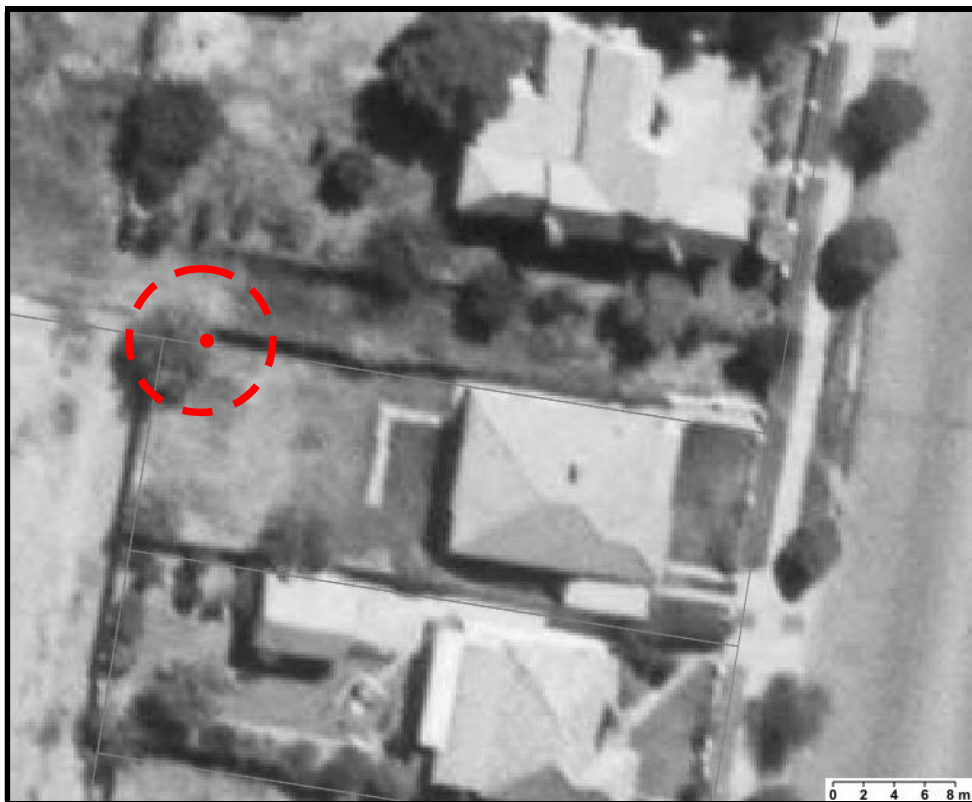
**Exhibit 3** – Contrasting aerial photographs, dated 2020 (**Upper** image) and 1971 (**Lower** image), showing the position of the subject tree. Source; <https://maps.wagga.nsw.gov.au/intramaps90>
