DA Structural Report

Malthouse 3

The Maltings, Mittagong

Colliers International / 6 February 2024

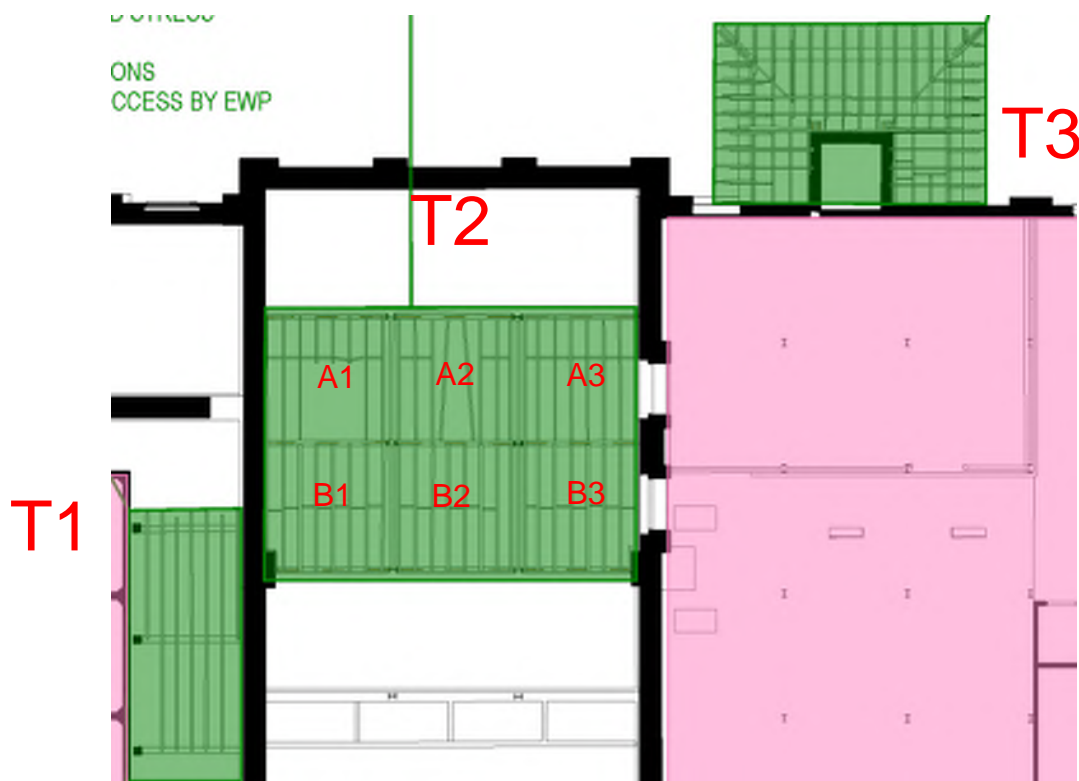
Figure 3. Layout of Level 1 T1, T2 and T3

T2 was divided into 6 sections A1-3 and B1-3. The joists at T2 are Oregon, 220x75mm at spans of 3450mm and 270x60mm at spans of 3500mm. The joists show signs of significant degradation due to extended exposure to the elements. Significant staining and rot observed especially at bearers. All joists at T2 are out of grade.

At T3 the all the timber members are Oregon. The rafters are 125x50mm Oregon, with pine bolted on as it has been previously repaired. The beams are 125x50mm. All the timber members have been exposed to the elements for an extended time and show significant decay. All members at T3 are out of grade.

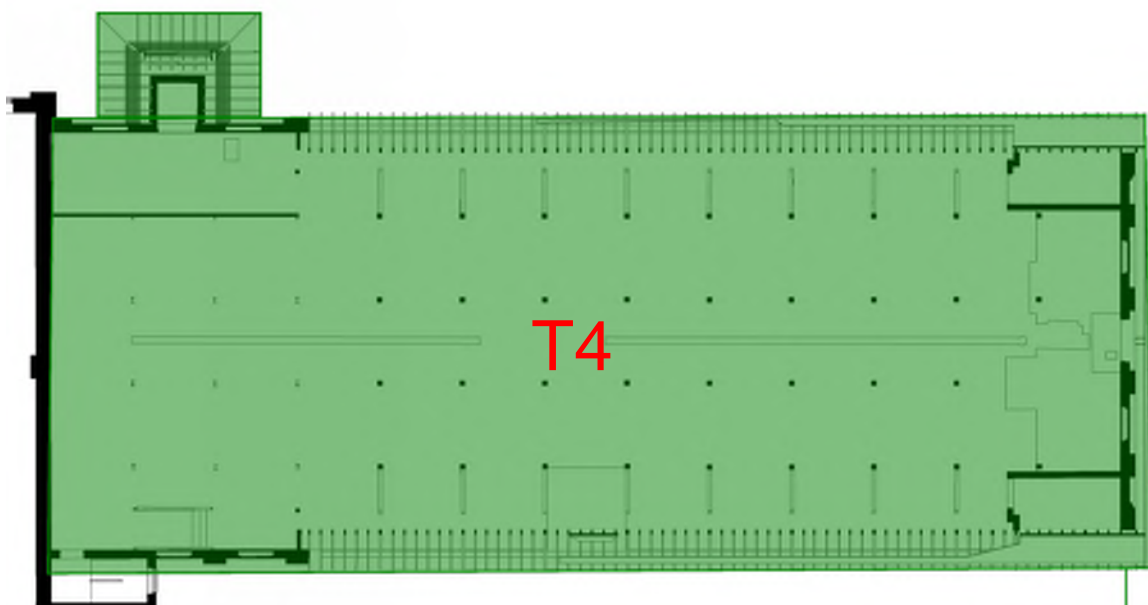
Figure 5. Layout of Level 2 T4

The joists on Level 2 T4 are Oregon 290x75mm at 3380mm spans. All the joists show some level of water damage ranging from staining to rot. Some members are sound when probed but show significant weather damage throughout (moss and severe staining). Damage usually most severe at bearers. Where visible top of joists showed more degradation than the bottom of the joists. Rot was visible due to extended exposure to water in perpetually inundated areas, such as between floorboard and on bearers. Due to extended exposure to elements all joists are deemed out of grade.

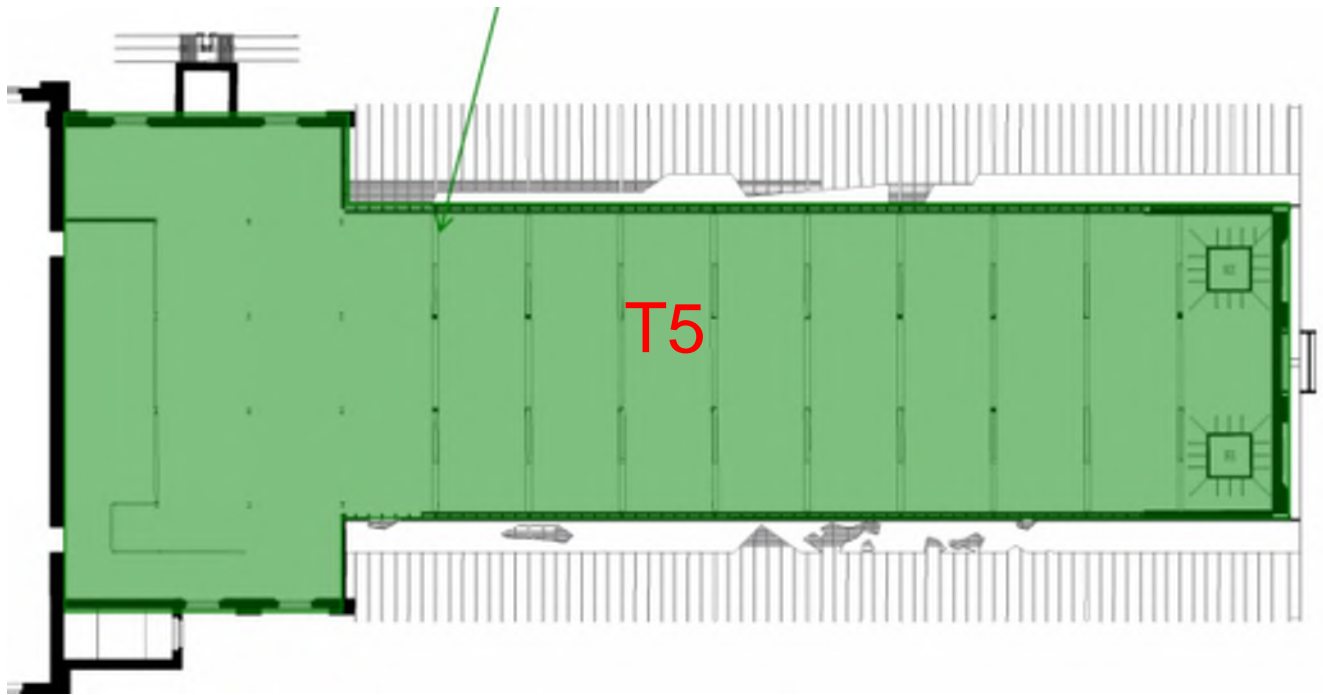
Figure 7. Layout of Level 3 T5

The timber members on level 3 are Oregon. The posts are 200x200mm. Bottom chord is 250x250mm. Purlins are 200x105mm. Beams are 300x200mm. Rafters are 120x50mm. The posts are missing inclined struts which caused the water to pool in these areas. Due to this pooling severe rot has been found in the bottom of these posts, with all of them showing at least 10mm section loss but most being more severe in the indents where the struts have been removed from, with some probing 50mm or more section loss. At Spot 14 a post is completely missing. Bottom chord shows significant water damage and rot in sections, at least 10mm section loss. Several chords have horizontal checks running through them. Purlins, beams and rafters all show significant water damage due to extended exposure to the weather. At least 10mm section loss in most members. All timber members are out of grade due to the severity weather exposure throughout the structure,

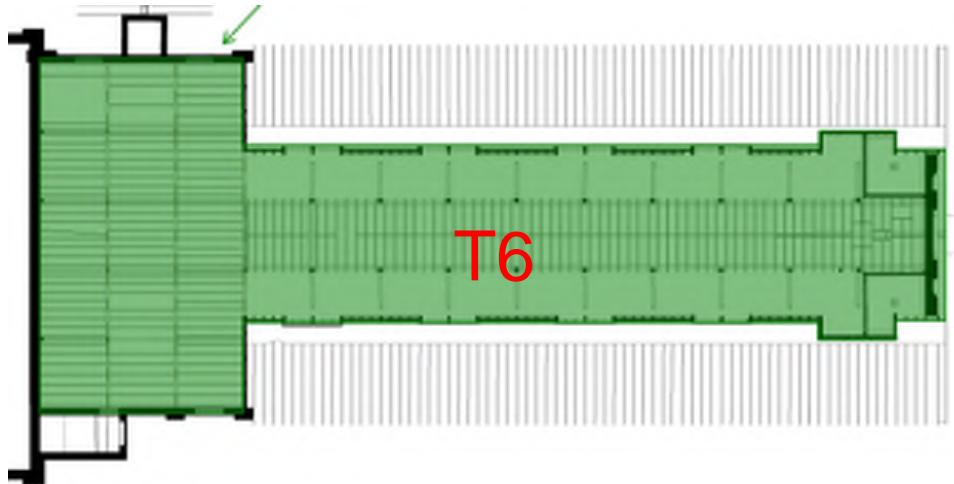
Figure 9. Layout of Level 4 T6

The timber members on level 4 and 5 are Oregon. The top chord is 250x200mm. Joists are 250x50mm. The top chords show significant water damage and some vertical fractures. The joists showed water damage including rot as well as general decay due to extended exposure to the elements. The decay is most severe around where bolts have been installed through the timber members as well as where two timber members are adjoined or connected. The members at T6 are all considered to be out of grade.

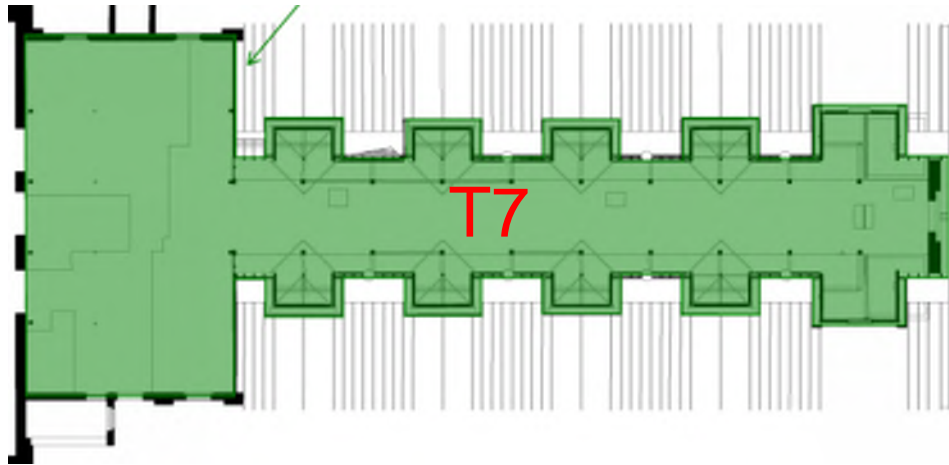
Figure 10. Layout of Level 5 T7

Level 5 was unable to be inspected up close due to unsafe or unsound access to the higher levels (rotted floorboards, no rails etc). The roof was missing or patchy at best throughout the structure. The inspection from level 4 showed that most members were exposed to the elements for an extended time as weather degradation such as rot and moss was visible. All members at T7 are considered out of grade.

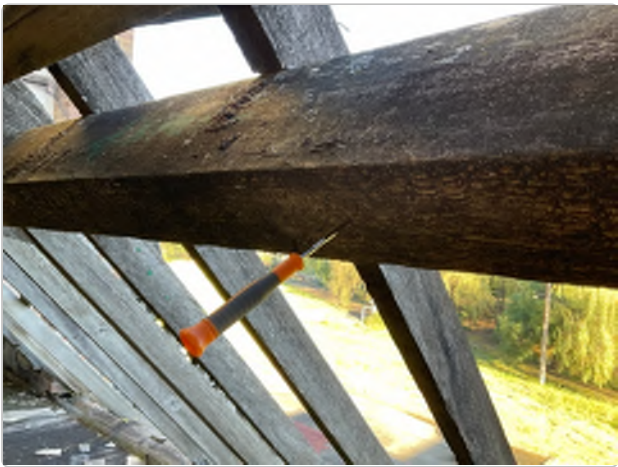
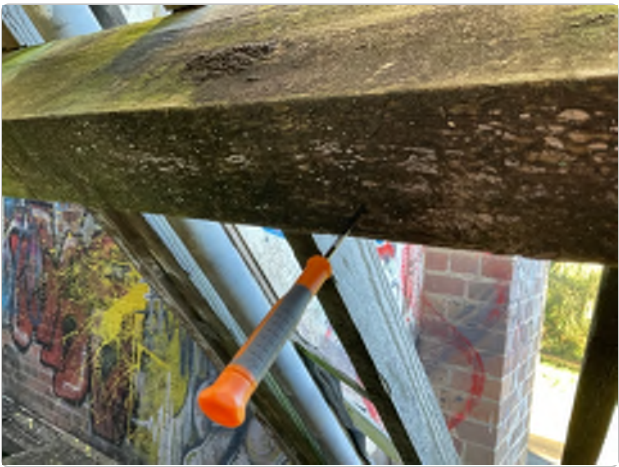
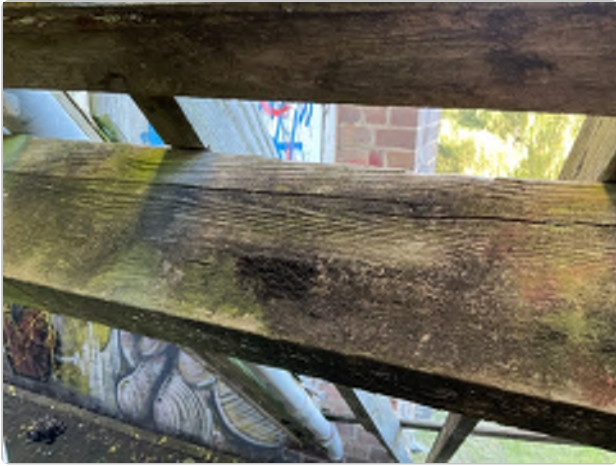
Spot 16 [↗](#)

REMARKS
Size: 200x105mm
All purlins severe water damage and degradation due to exposure to elements
When probed at least 10mm section loss

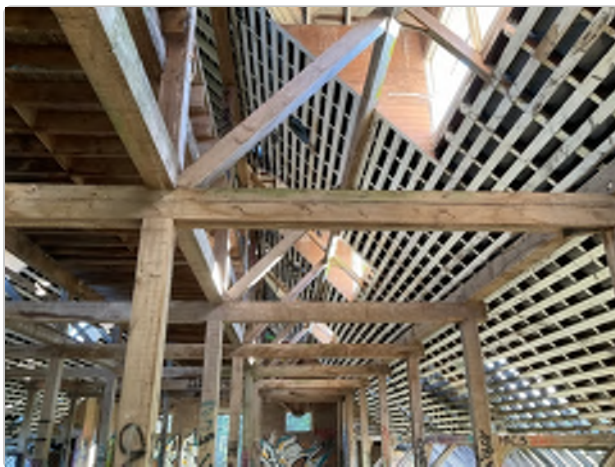
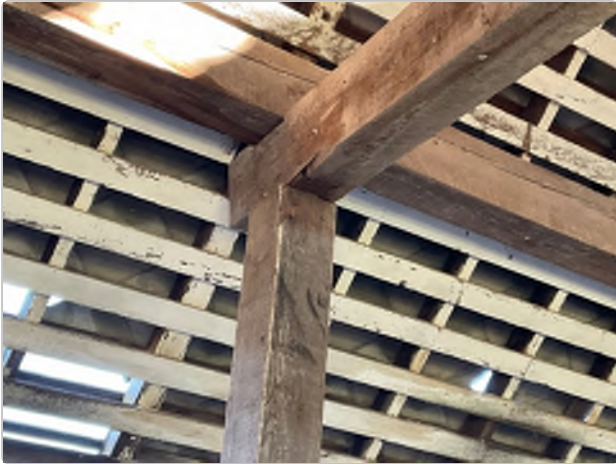
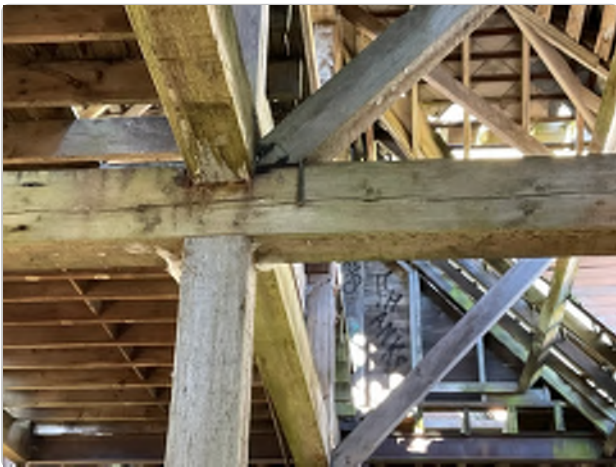
Spot 15 [↗](#)

All beams show signs of rot or water damage due to exposure to the elements
Severe checks through middle of chord

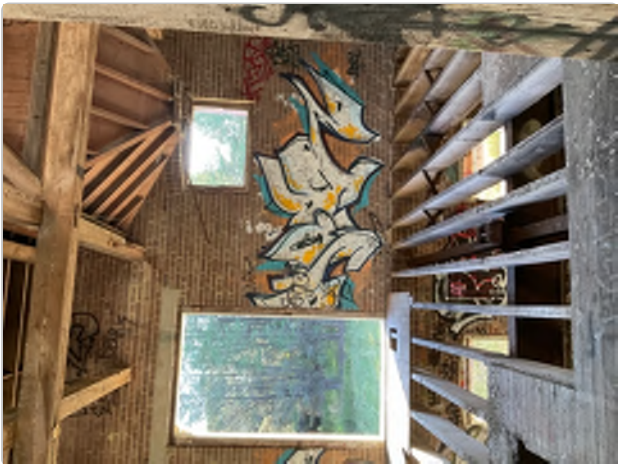
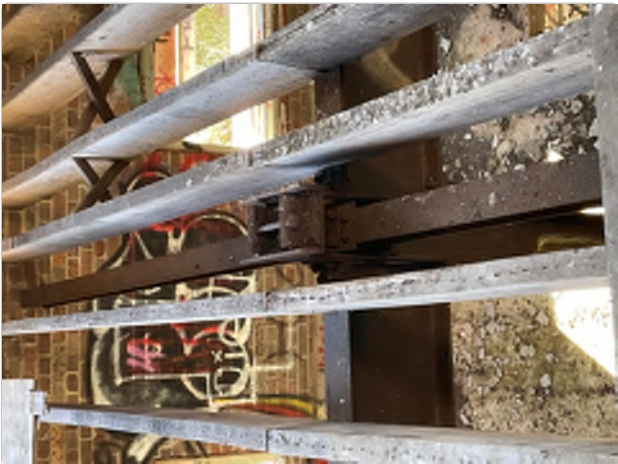
Spot 14 [↗](#)

REMARKS
Missing post

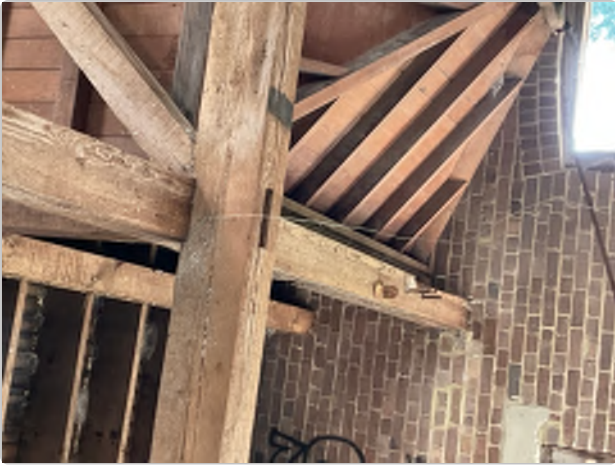
Spot 13 [↗](#)

Posts show significant deterioration due to extended exposure to elements

Inclined struts removed in the past led to complete rot in indented sections

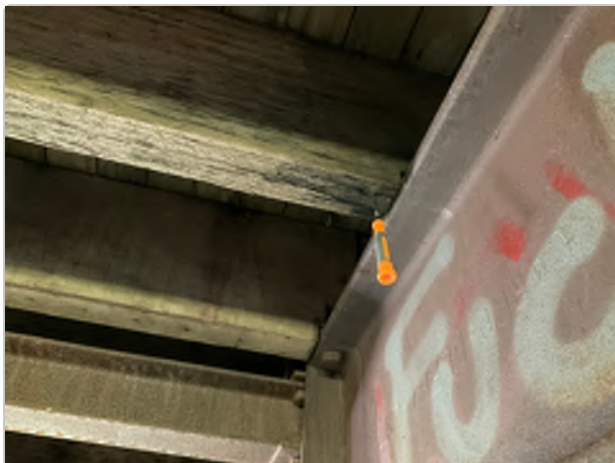
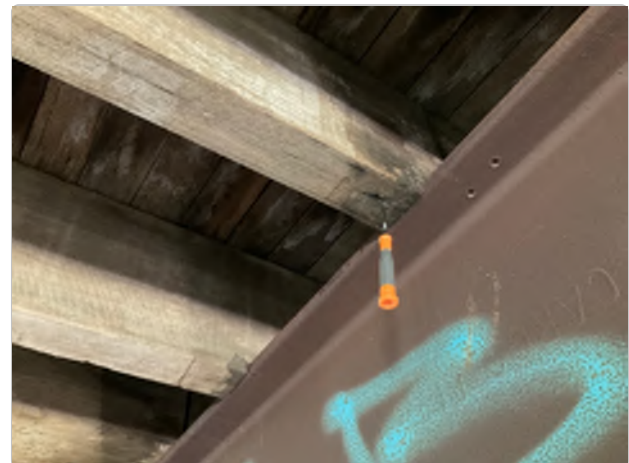
Spot 12 [↗](#)

All the joists show some to significant water damage and/or rot. Timber members have been exposed to the elements for an extensive amount of time due to barely intact roof

Top of joists unable to be inspected in most places but viewed from bottom show signs of water damage or rot

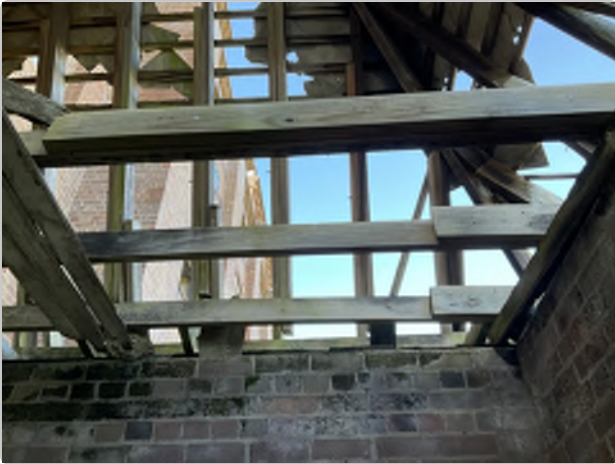
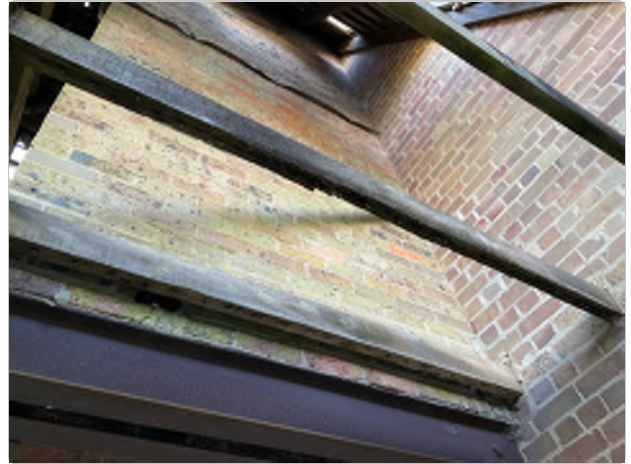
Spot 10

REMARKS
Oregon and pine has been previously repaired
Size 125x50mm
Weather exposed
Rot and water damage

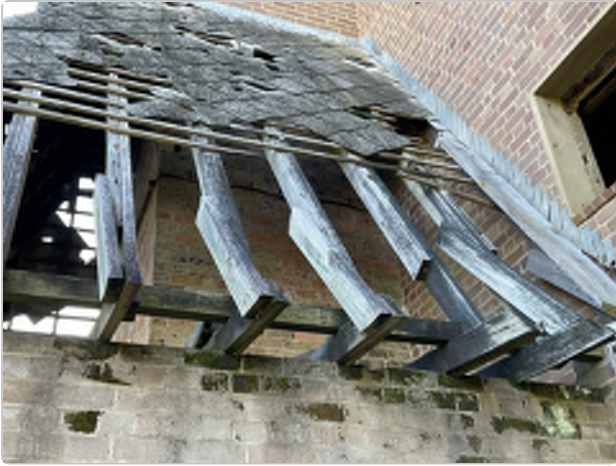
Spot 9 [🔗](#)

REMARKS
Waterlogged bearers
Exposed to elements
Fracture in member 5
End splits

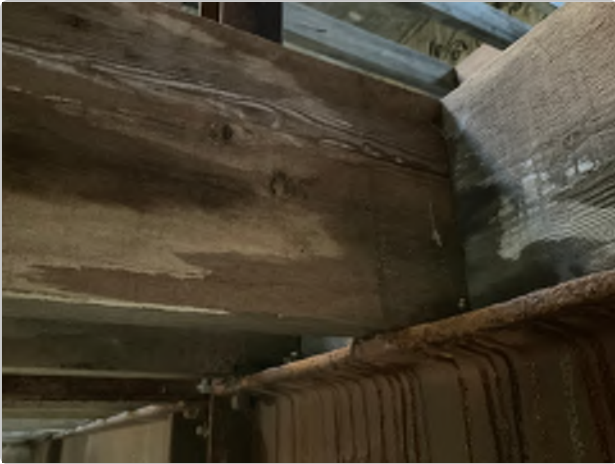
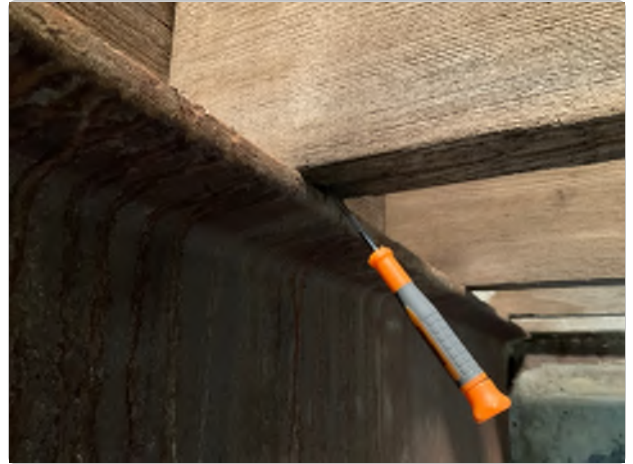
Spot 8

REMARKS
Rot and water damage
Exposed to elements

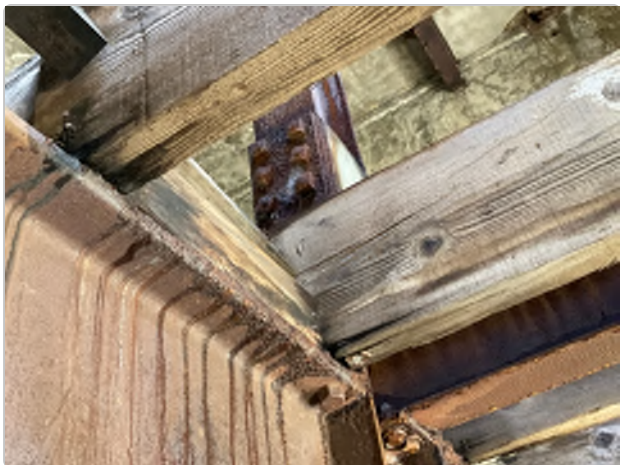
Spot 7 [🔗](#)

REMARKS
Size 270x60
Span 3500
Exposed to elements
Rot and water damage especially at bearers

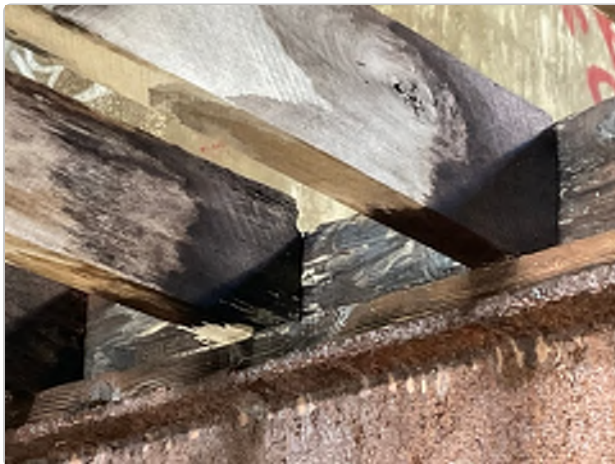
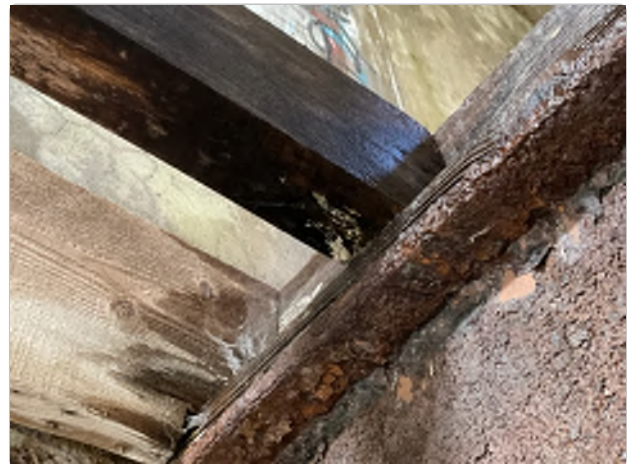
Spot 6 [📄](#)

REMARKS
Exposed to elements
Signs of rot and water damage

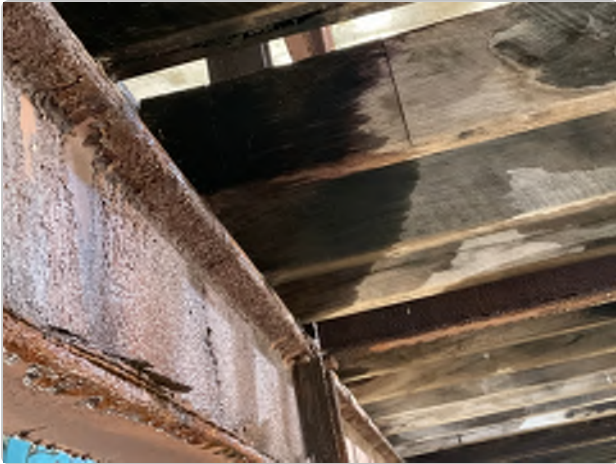
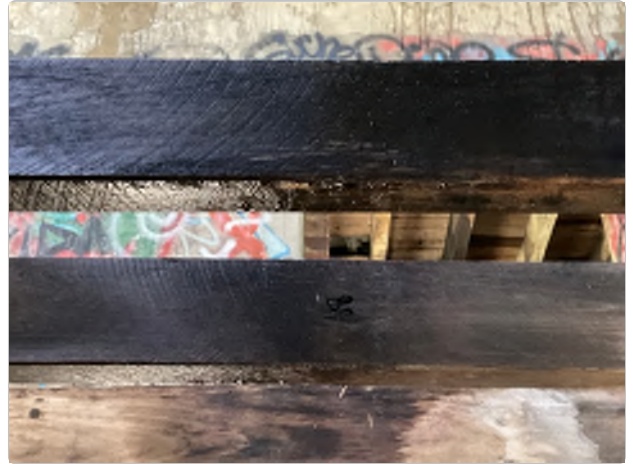
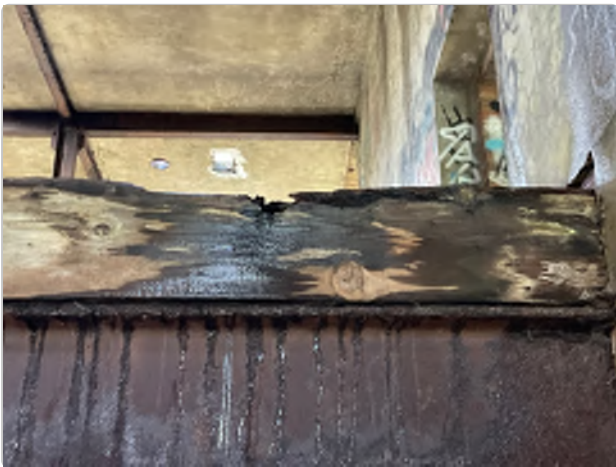
Spot 5

REMARKS
Joists are exposed to elements
Bearers show signs of water damage and rot

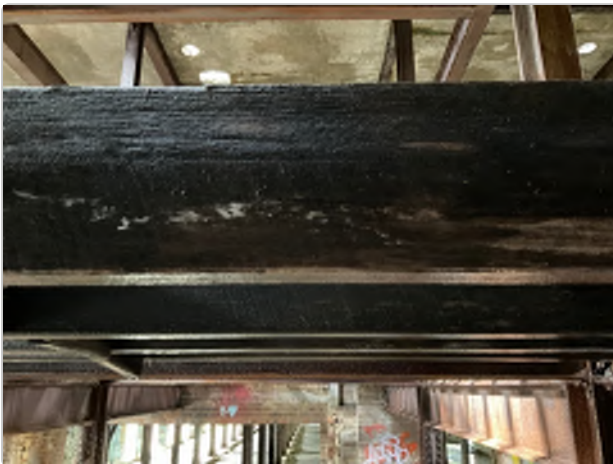
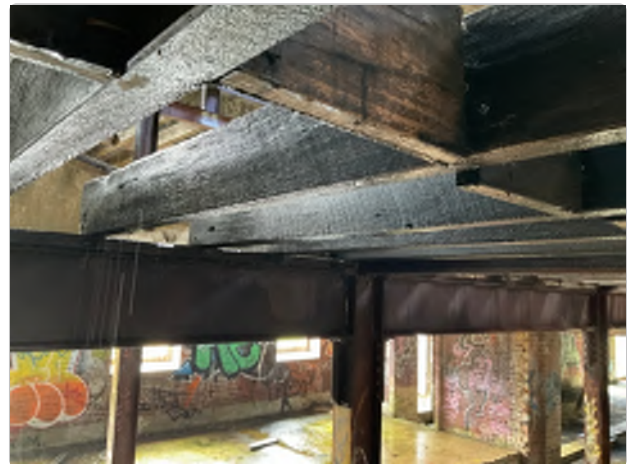
Spot 4 [🔗](#)

REMARKS
Oregon
Size 220x75mm
Span 3450mm
Weather exposed
Rot

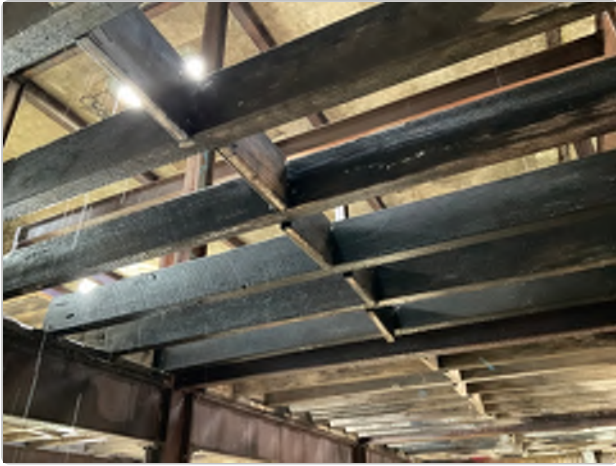
Spot 3 [📍](#)

REMARKS
Size 205x75mm
Span 3500mm
All members exposed to elements. Rot

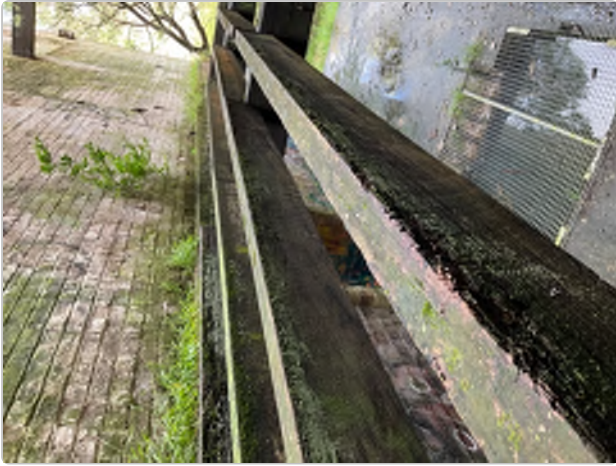
Spot 2 [🔗](#)

Rot at bearing location

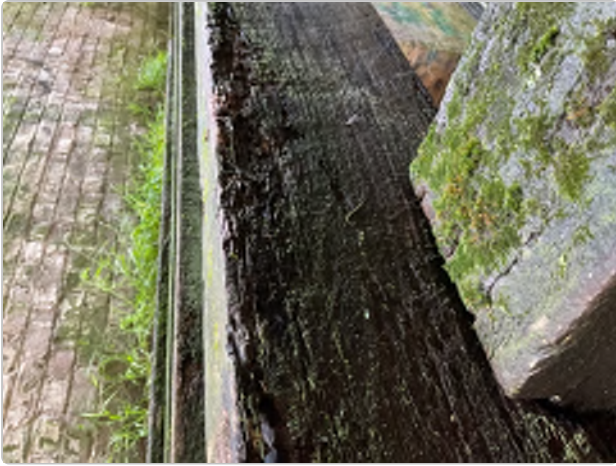
Spot 1

All posts (Upper and Lower) have been exposed to the elements. Severe rot at the ground connection of all the columns. Section loss of at least 50mm all round
