REPORT TO
AUSTRALIAN EXECUTIVE APARTMENTS PTY LTD

ON
GEOTECHNICAL ASSESSMENT

FOR
PROPOSED REDEVELOPMENT
OF ROBERTSON HOTEL

AT
1 FOUNTAINDALE ROAD, ROBERTSON, NSW

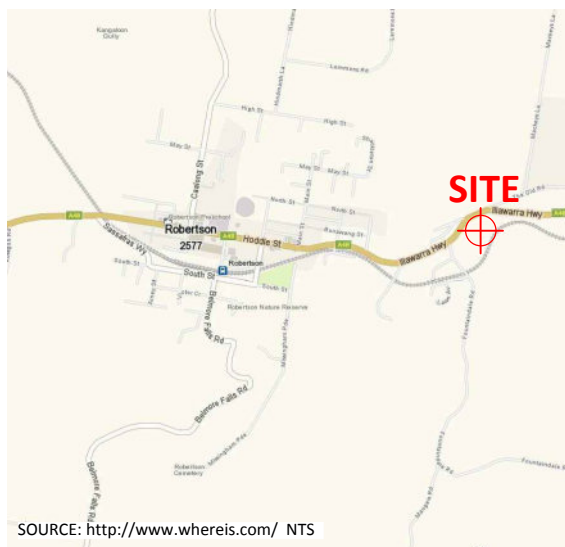
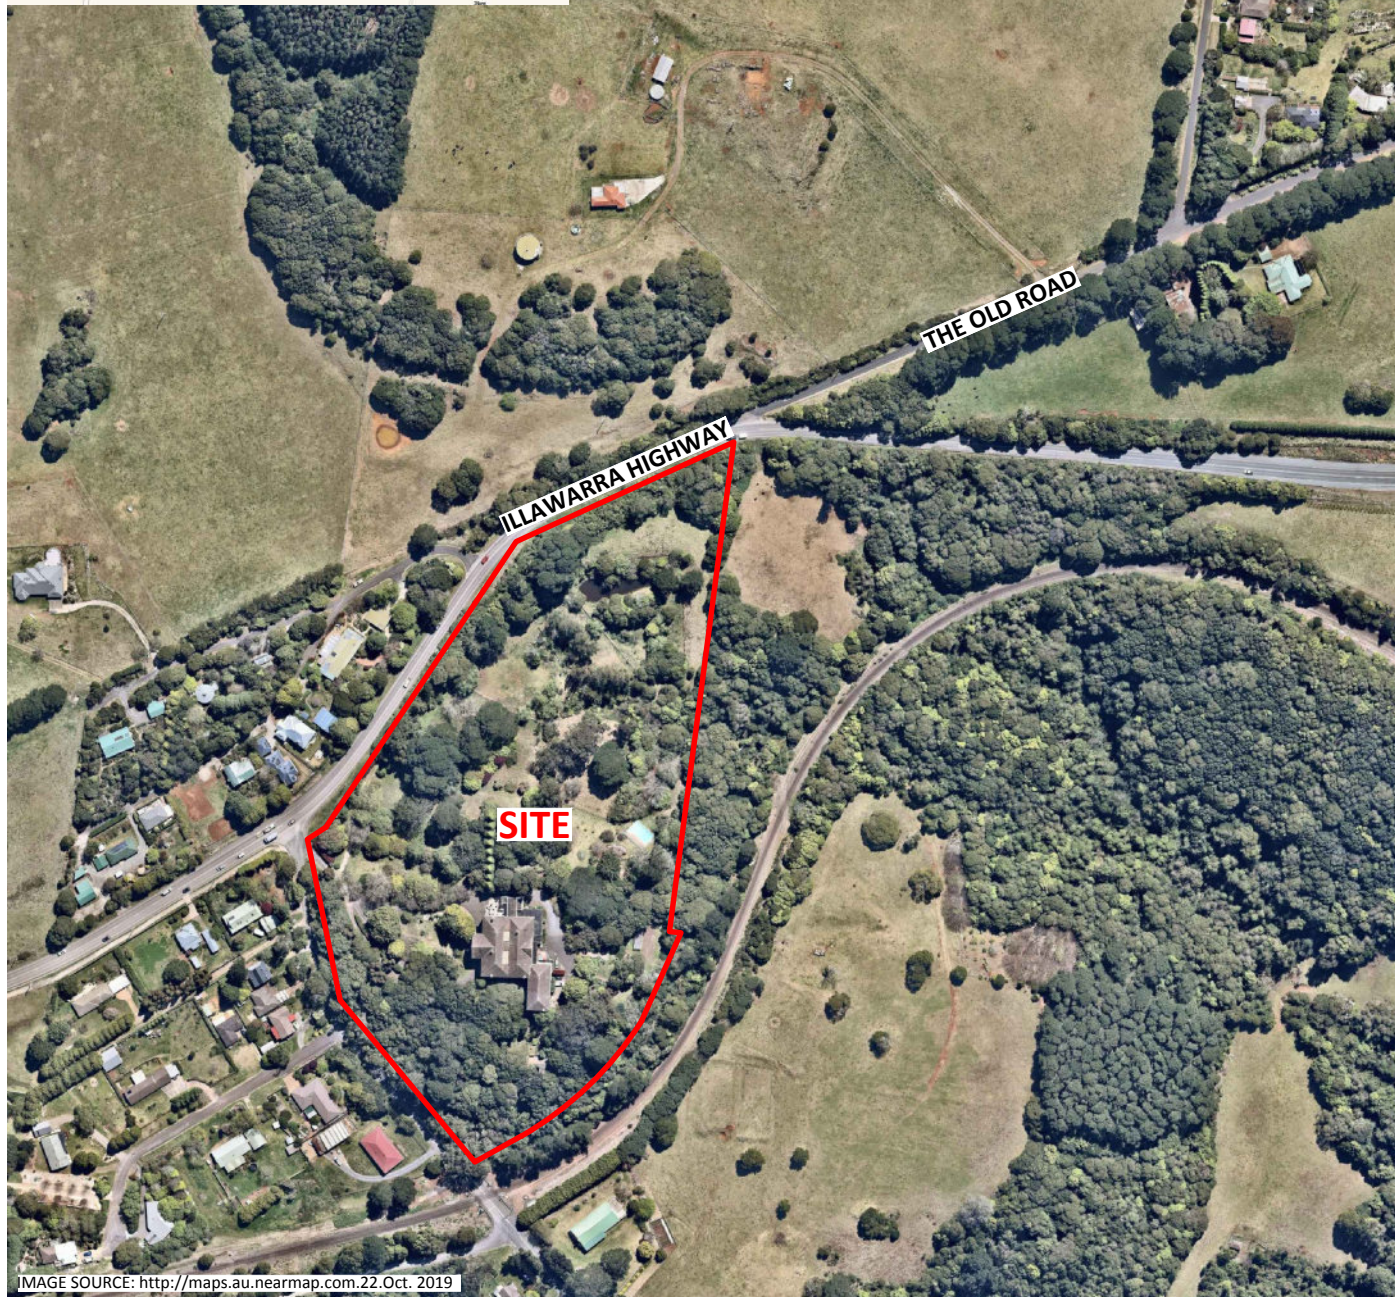
Title: GEOTECHNICAL SITE PLAN	
		Location: 1 FOUNTAINDALE ROAD ROBERTSON, NSW	
Report No: 32853PH		Figure: 2	
This plan should be read in conjunction with the JK Geotechnics report.

The attached Figure 2 presents a geotechnical site plan showing the principal geotechnical features present at the site. Figure 2 is based on a survey plan prepared by CEH Consulting Pty Ltd (Drawing No. A1-D218228-Contours, dated 27 July 2018). Additional features on Figure 2 have been measured by hand held clinometer and tape measure techniques and hence are only approximate. Figure 3 presents an explanation of the geotechnical mapping symbols used in Figure 2.

We recommend that the summary of observations which follow be read in conjunction with the attached Figure 2. The blue circled numbers on Figure 2, refer to specific features and are referred to in the text below.
