EROSION CONTROL PLAN

Jumping Creek QUEANBEYAN

Version 3

29 January 2019

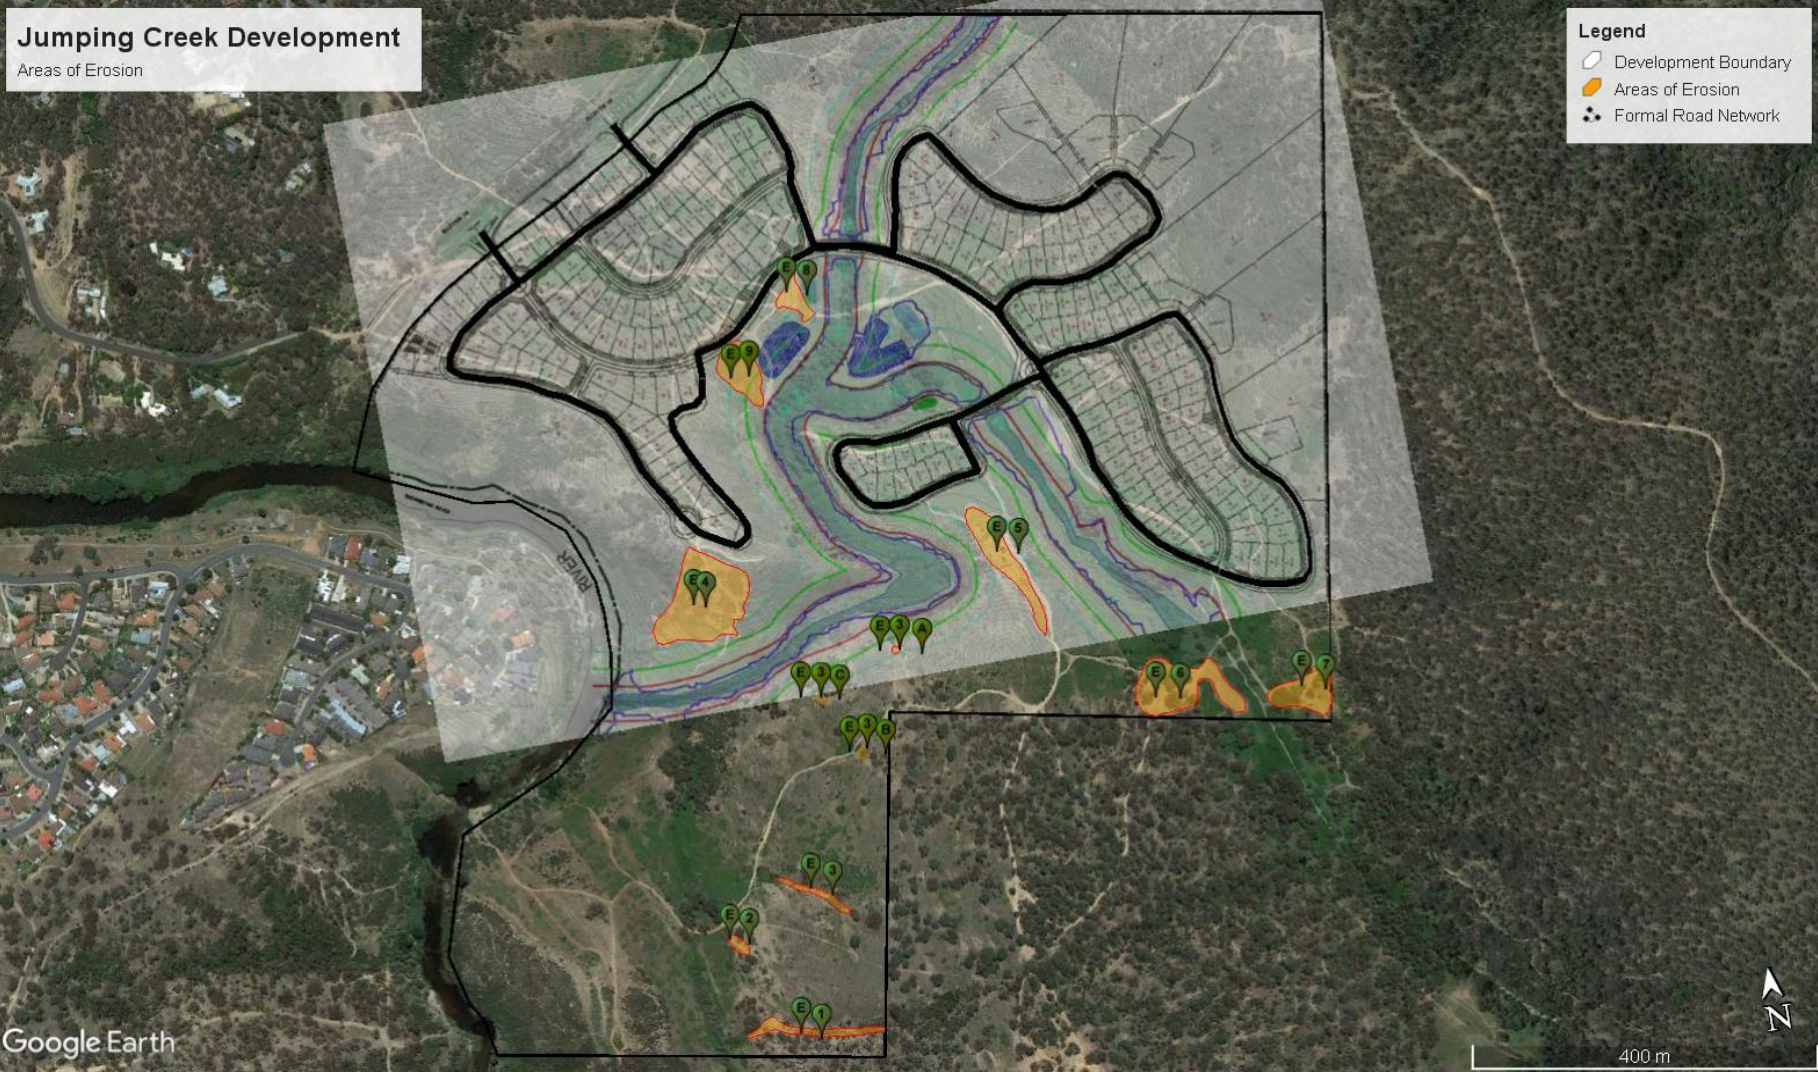
Figure 1: Areas of Erosion

There are 12 areas of erosion identified across the development site that lay outside the area to be developed for housing or associated infrastructure, refer **Figure 1**. Six of these areas are erosion generated by rainfall run-off and associated with minor drainage depressions, refer sites E1, E2, E3, E3A, E3B & E3C. One site is related to historical mining operations on the site (E9), and another is the product of quarrying on the site (E5). The remaining five sites (E4, E6-E9) are the result of uncontrolled access to the site and the impact of four-wheel drive and other vehicular traffic on the site.

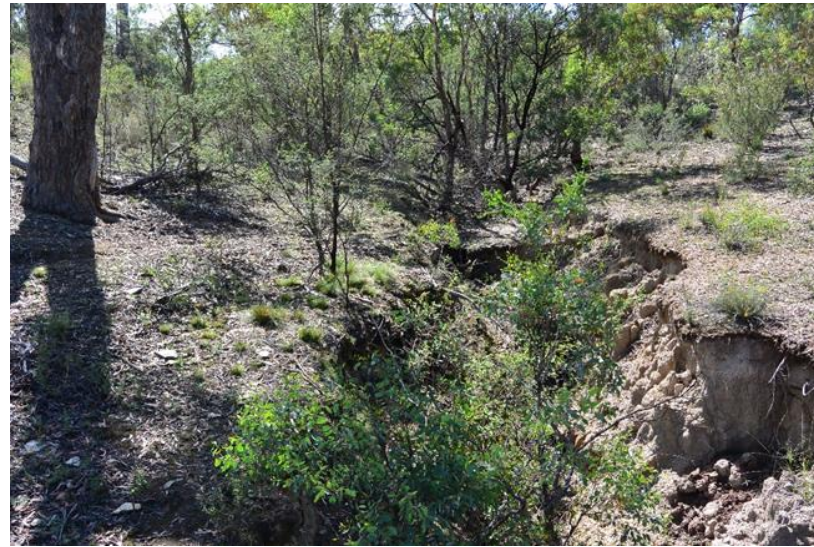
DSC 3809: Extensive native vegetation in the riparian zone

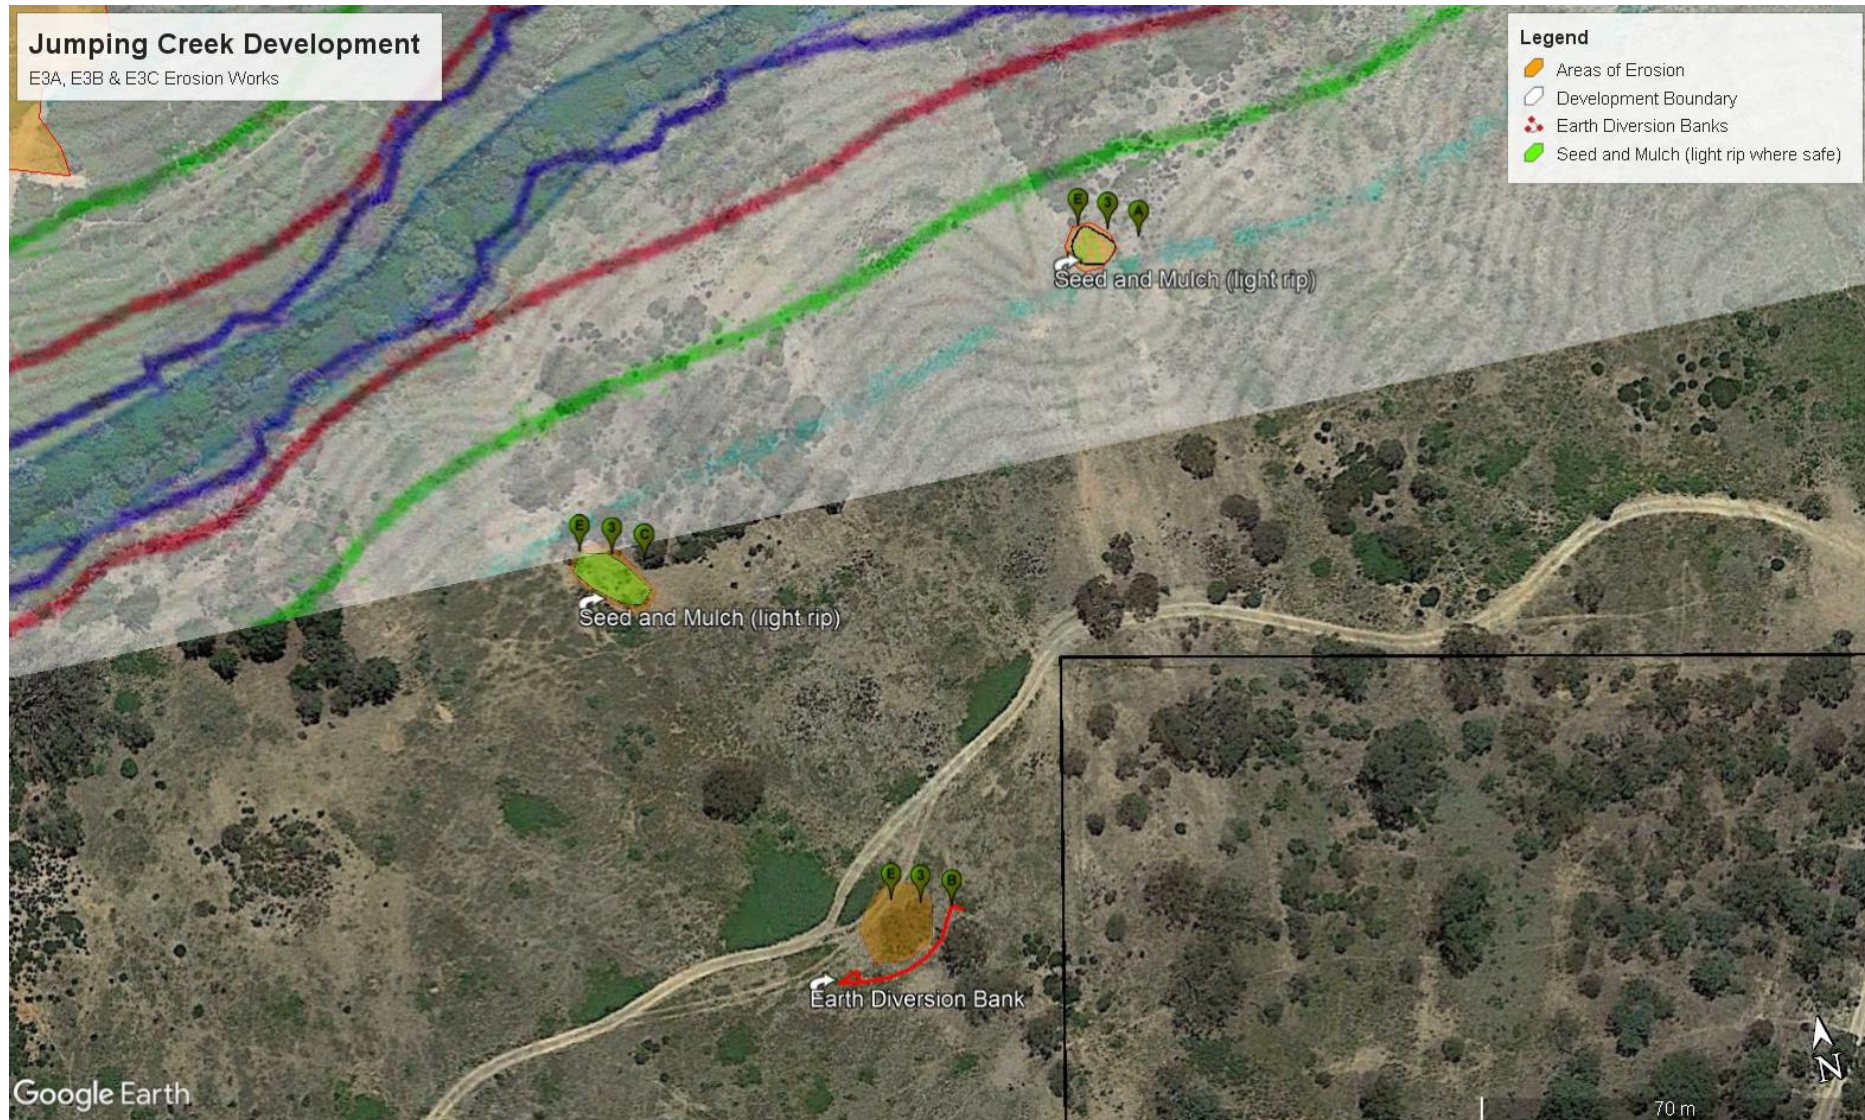
Figure 5: E3A, E3B & E3C Erosion Works

E3A, B & C – Erosion Areas				
SITE REF & LOCATION Lat/Long	DESCRIPTION	STATUS Active (Severe, Moderate, Minor) or Stable	REMEDATION PRIORITY High/Medium/Low	REMEDATION OPTION
E3A Lat -35.376405 Lon 149.254887	Small area of gully erosion in minor drainage depression

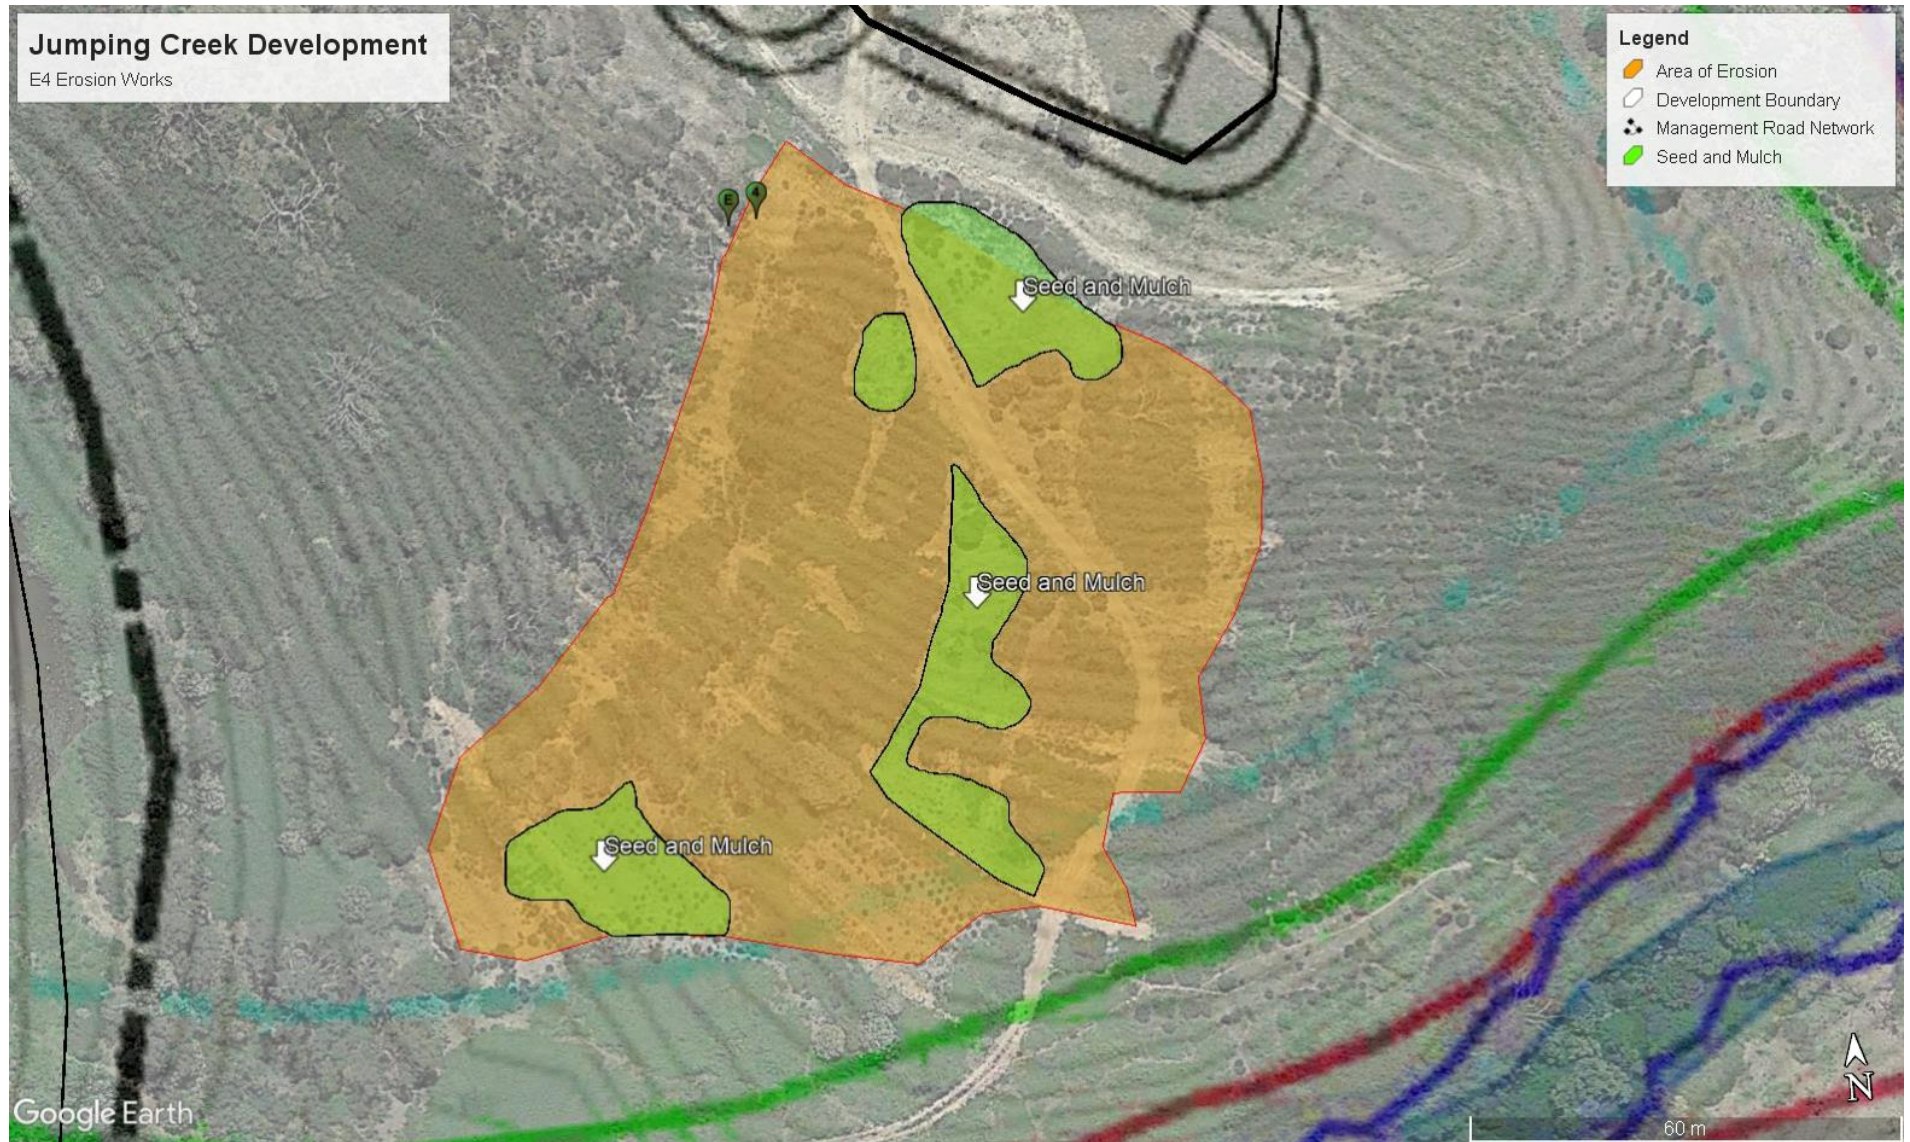
Figure 6: E4 Erosion Works

E4 – Erosion Area				
SITE REF & LOCATION Lat/Long	DESCRIPTION	STATUS Active (Severe, Moderate, Minor) or Stable	REMEDATION PRIORITY High/Medium/Low	REMEDICATION OPTION
E4 Lat -°35.376043 Lon °149.251654	Extensive area of steep slope with historical erosion and soil erosion earthworks in place. Erosion created by four-wheel driving tracks up and down the steep slopes.	Small localised areas of active erosion however mostly stable.	Medium (due to high erosion risk and damage to expensive erosion control infrastructure if minor maintenance is not undertaken.	Maintain existing erosion control infrastructure by cleaning sediment out of channels and building up freeboard (height) of banks where these have been degraded. Fill areas of minor rill erosion with loose rock and topsoil. Seed and mulch bare areas to reduce sheet and rill erosion
<div style="display: flex; justify-content: space-around; align-items: flex-end;"> <div style="text-align: center;">

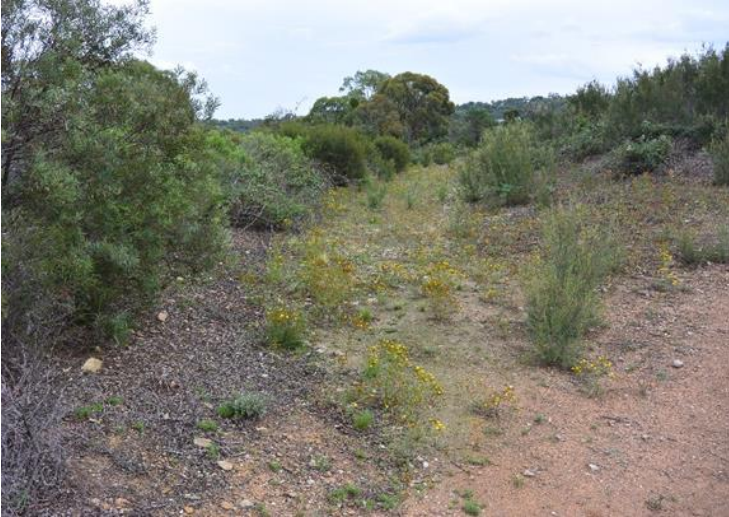
<p>DSC 3766: Well vegetated erosion control earthworks</p> </div> <div style="text-align: center;">

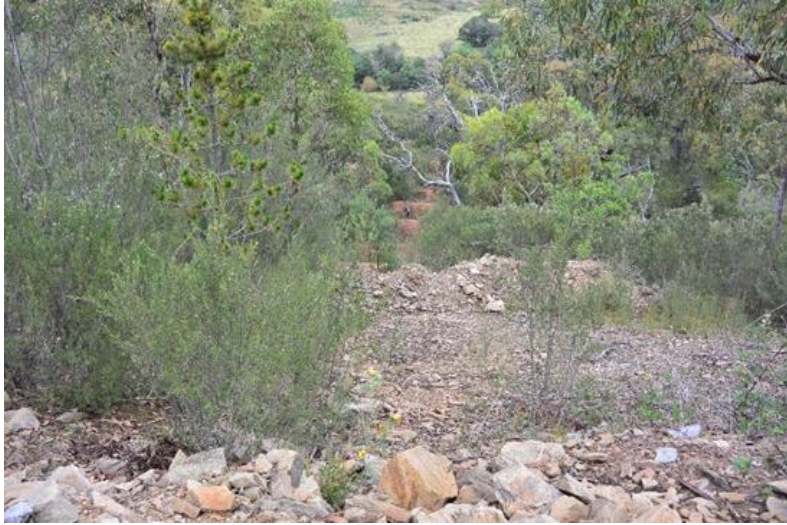
<p>DSC 3767: Erosion control earthworks</p> </div> </div>

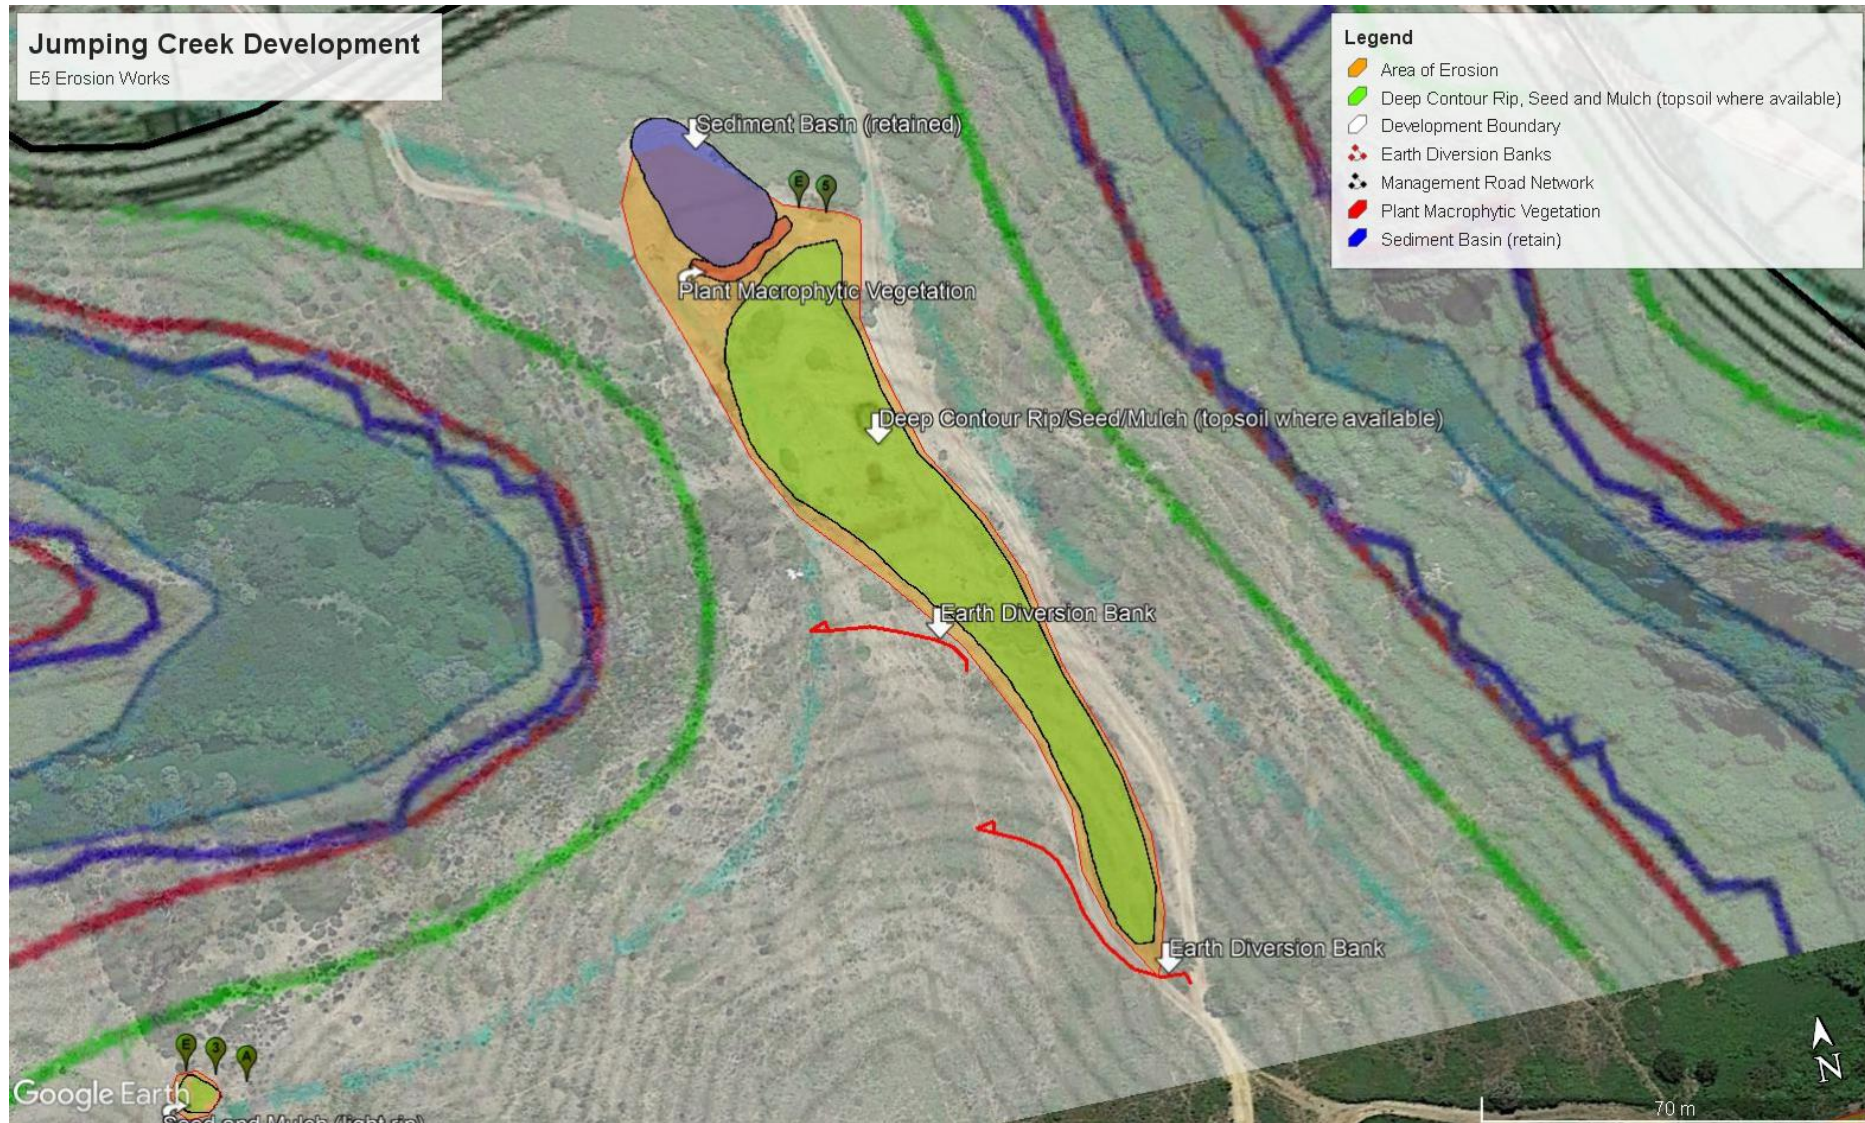
Figure 7: E5 Erosion Works

E5 – Erosion Area				
SITE REF & LOCATION Lat/Long	DESCRIPTION	STATUS Active (Severe, Moderate, Minor) or Stable	REMEDATION PRIORITY High/Medium/Low	REMEDATION OPTION
E5 Lat -35.375649° Lon 149.256613°	Gravel quarry with erosion emanating from the large area of bare subsoil and degraded bedrock material.	Moderately active sheet and rill erosion across most of the site	Medium (site drains internally to a small sediment basin reducing immediate impact on nearby watercourse)	Construct small earth diversion banks upslope of the gravel quarry to divert clean runoff away from the site and reduce erosion potential. Deep rip the bed of the quarry on the contour to reduce runoff and retain sediment. Where available topsoil the base of the quarry to promote revegetation. Seed and mulch the area with suitable groundcover and shrub species, refer Vegetation Management Plan. Retain the sediment detention basin and enhance the filtering capacity by planting macrophytes in the shallow backwater of the storage.

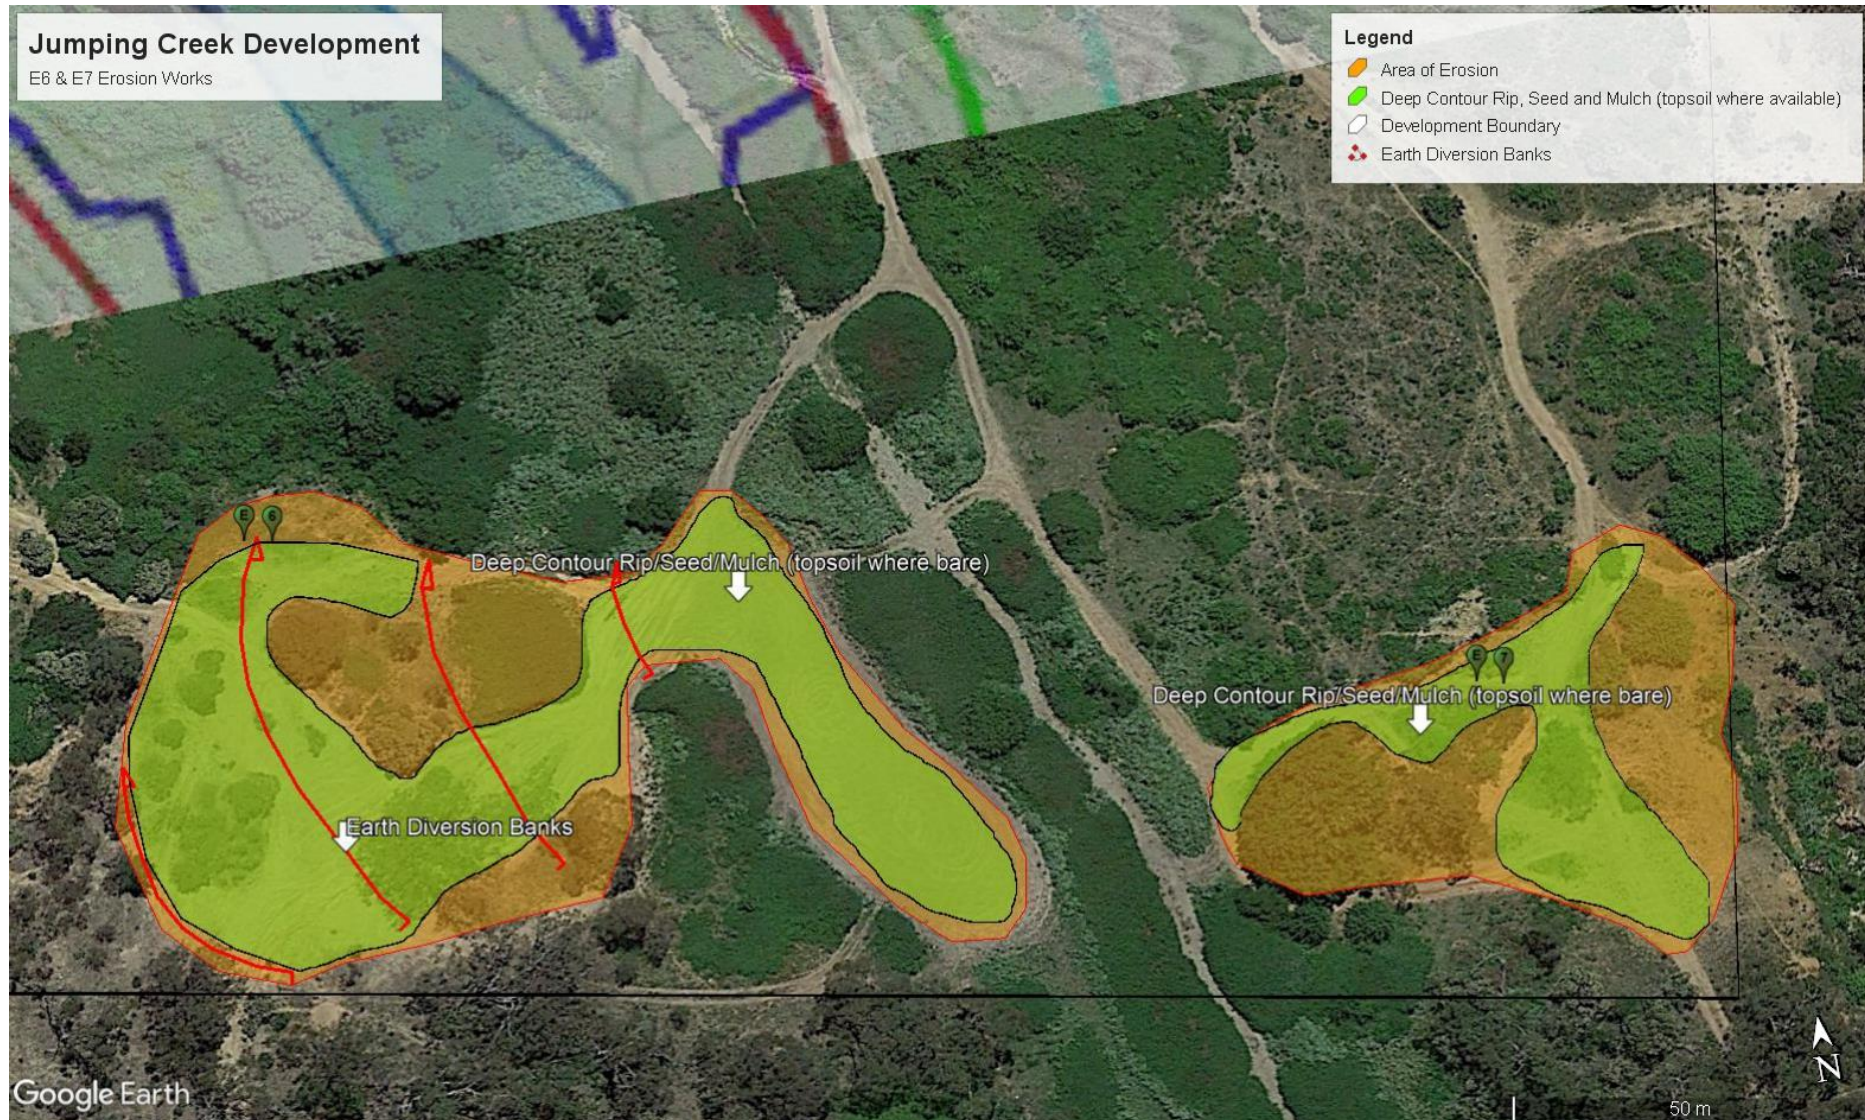
Figure 8: E6 & E7 Erosion Works

E6 – Erosion Area				
SITE REF & LOCATION Lat/Long	DESCRIPTION	STATUS Active (Severe, Moderate, Minor) or Stable	REMEDICATION PRIORITY High/Medium/Low	REMEDICATION OPTION
E6 Lat -35.376894° Lon 149.258879°	Extensive area of sheet and rill erosion formed by the concentration of track and trails and vehicle traffic on steep slopes. Includes an extensive area of bare creek flats below flood level	Active moderate to severe erosion.

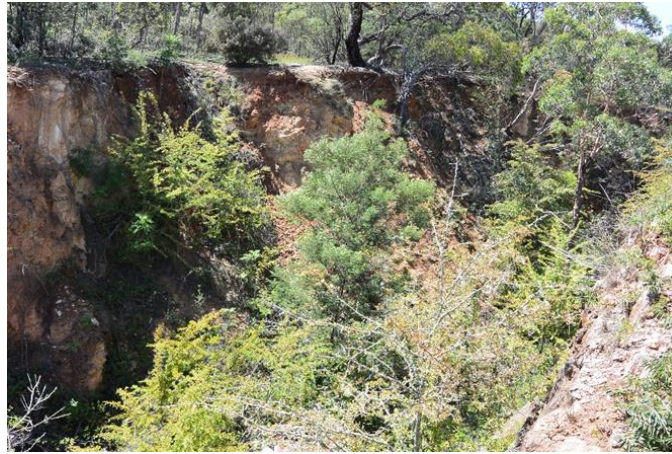
DSC 3834: Mine/quarry site adjacent to the eastern boundary

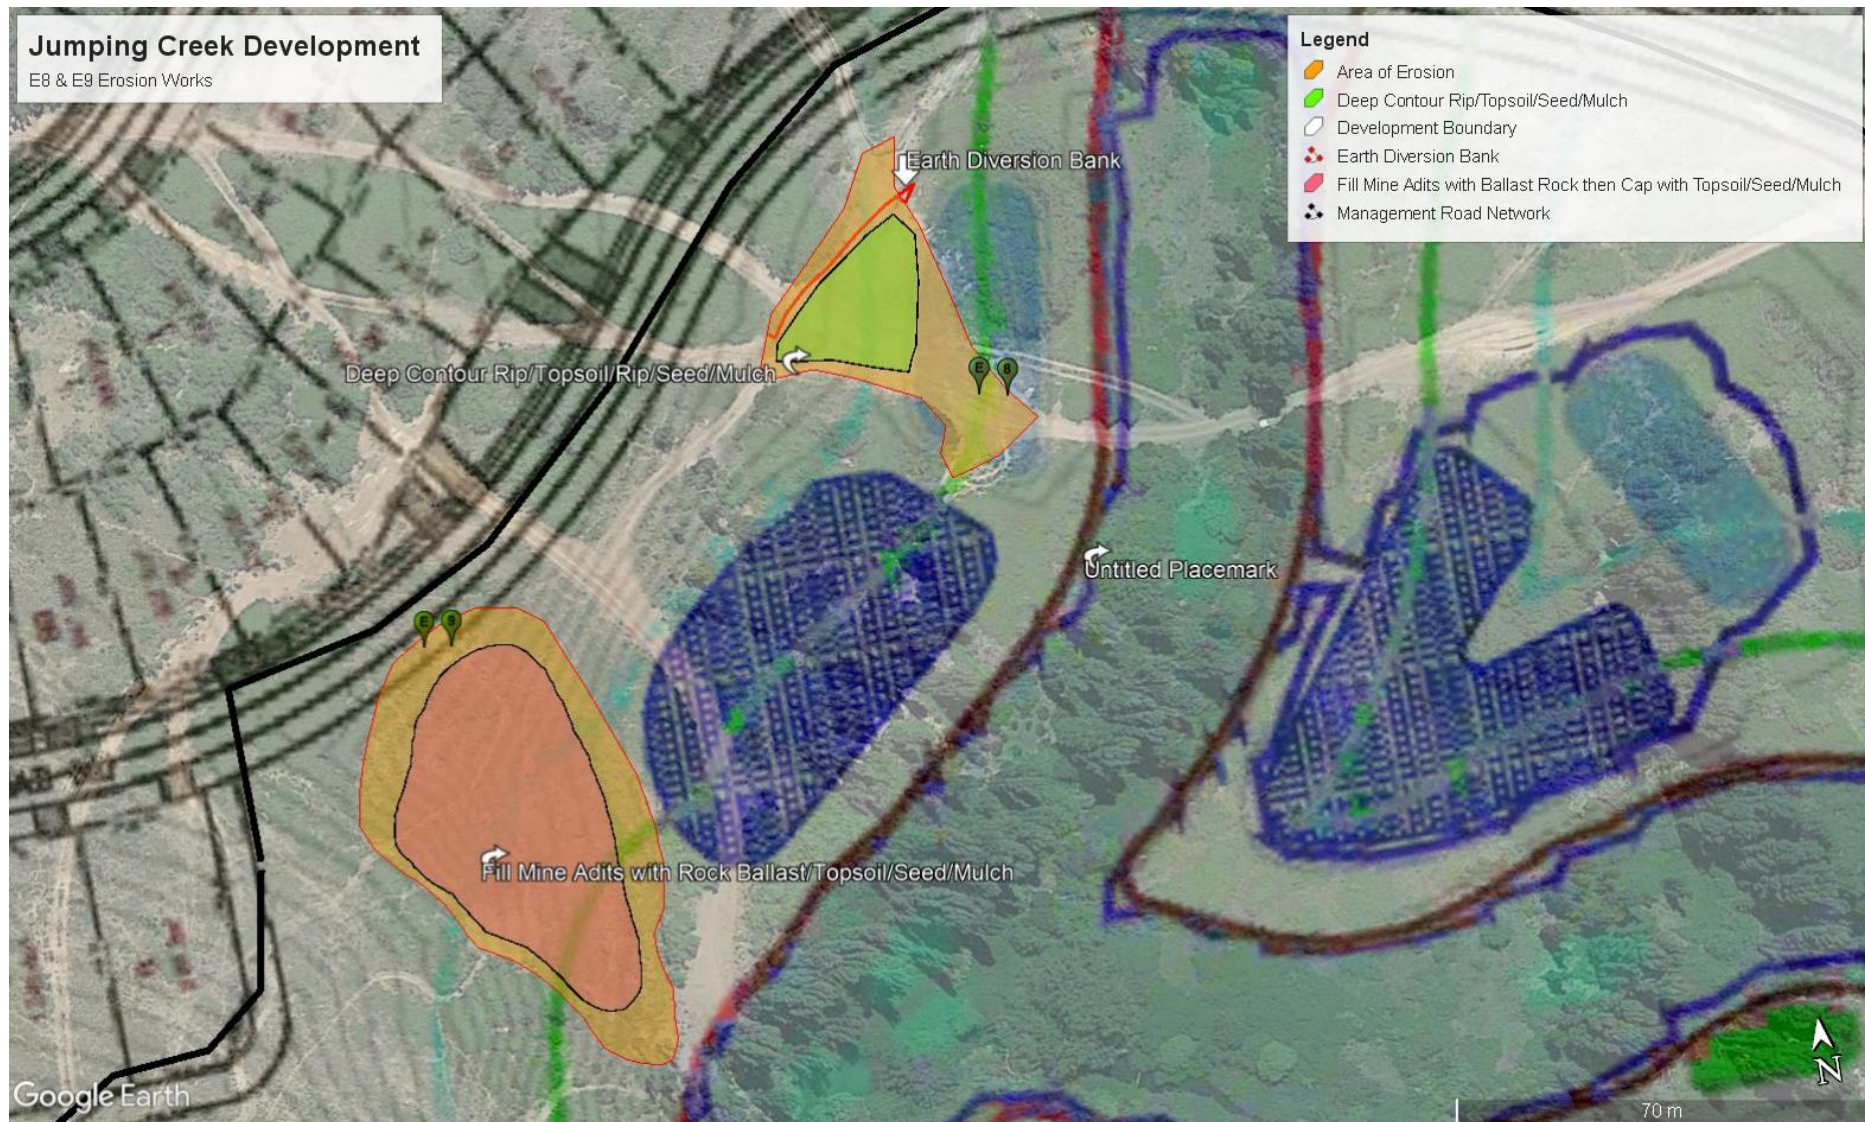
Figure 11: E8 & E9 Erosion Works

Lat -35.375432° Lon 149.252395°	Historical mine site with small areas of bare ground and various mine adits. Largely vegetated however still presents a safety hazard	Stable (minor erosion risk but active safety risk)
