**336-344 Edward Street
Wagga Wagga NSW**

**Hazardous Materials
Assessment and
Register**

June 2020

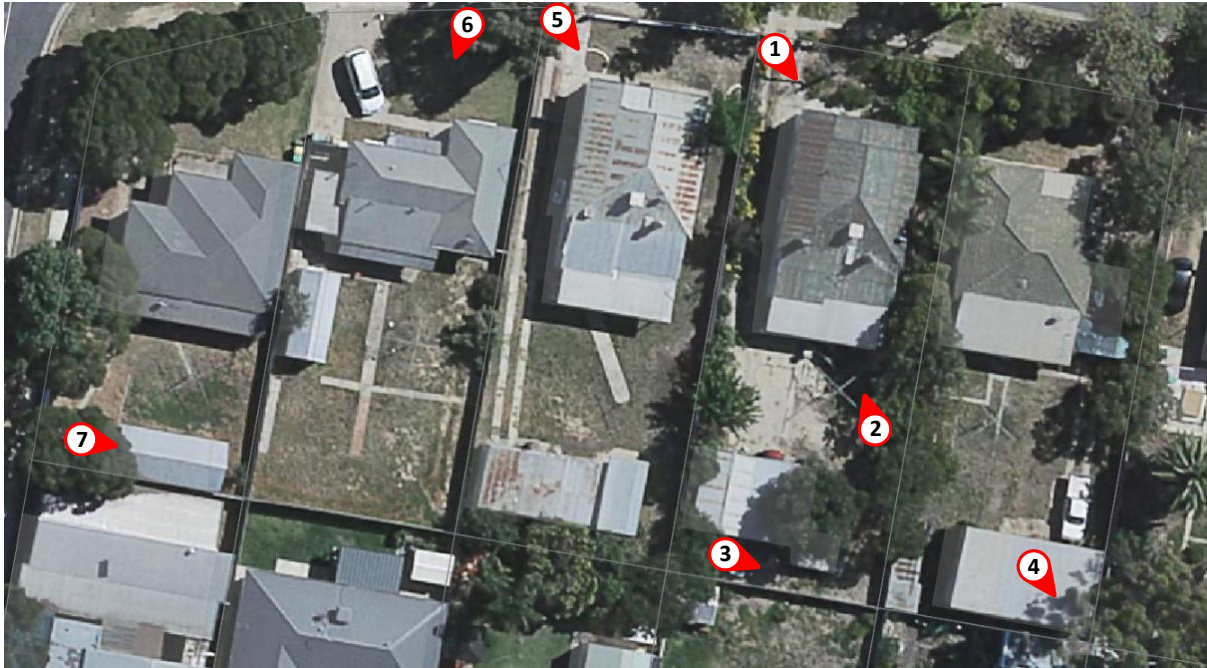
- All driveways entered their respective properties via Edward Street except for 344 which enters via Cullen Road.
- **336 Edward Street** is a brick veneer house with a ceramic tile and corrugated iron roof. A large back shed is built from timber and steel framing and clad with corrugated iron (**Photograph 4**). A smaller shed built of like material was used as a firewood store. All structures were in a reasonable condition with no indication of any contamination, ie. Hazardous building materials, chemical storage, fuel and oil staining, automotive works, etc.

- **338 Edward Street** is a timber framed house clad with potential ACM cladding on the exterior walls and corrugated iron on the roof (**Photograph 1 & 2**), eaves on the house are also suspect as ACM. ACM cladding was in a reasonably good condition with no indication of damage and contamination risk. Paint to the house was in a reasonable to poor condition and suspect for lead, some small flakes of paint were observed around the house on nearby soil and concrete surfaces to the east and west side of the house (within 2m), but these were not significant. Two sheds of like construction to 336 Edward Street are evident in the backyard atop a concrete slab. Two small fragments (~60mm x 30cm x 7mm) of ACM material were identified in the back yard behind the sheds. The ACM, although broken, was in a reasonably well bonded condition (**Photograph 3**).

- **340 Edward Street** is a timber framed house clad with potential ACM on the exterior walls and eaves in good condition, corrugated iron clad the roof (**Photograph 5**). Paint to the house seemed relatively new (<10 years old), and in a good condition. Paint was deemed to be a low risk for lead based on age. No flakes or debris from previous paint systems were noted around the house. Two sheds of like construction to 336 are evident in the backyard.

- **342 Edward Street** is a timber framed house with potential ACM to the eaves, corrugated iron clad the roof and timber clad the external walls (**Photograph 6**). One shed of like construction to 336 is evident in the backyard. Paint to the house seemed relatively new (<10 years old), and in a good condition. Paint was deemed to be a low risk for lead based on age. No flakes or debris from previous paint systems were noted around the house. The internal cladding of the house is also assessed as potential ACM from the brief walkthrough undertaken.

- **344 Edward Street** is a brick veneer house with a corrugated iron roof. One large shed of previously discussed construction (i.e. timber/steel frame and corrugated iron cladding) stood in the backyard and has potential ACM gable ends (**Photograph 7**). ACM, although broken in one corner of a sheet, was observed to be in a good condition.
- Some paint flakes were noted on nearby (<2m) soil and concrete surfaces to the east and west side of 338 Edward Street, but were not significant. All other houses did not have paint flakes or ACM fragments on surrounding soil surfaces.
- There was no disturbed vegetation.
- There were no unusual odours or discoloured ground surfaces.
- There was no piles of waste, rubbish or soil across any of the addresses.

1. 338 Edward Street, external cladding likely ACM
2. 338 Edward Street, external cladding likely ACM
3. 338 Edward Street, 1 of 2 small ACM fragments behind back shed
4. Internal construction of 336 Edward Street rear shed
5. 340 Edward Street, external cladding likely ACM
6. 342 Edward Street, eaves likely to contain ACM
7. 344 Edward Street, gable ends to garage are made of ACM
