Report on  
Geotechnical Investigation

Proposed Residential Subdivision  
32 Lovelle Street and 141 Yarrowa Road,  
Moss Vale

Prepared for  
Prime Moss Vale Pty Ltd

Project 40494.03  
April 2020

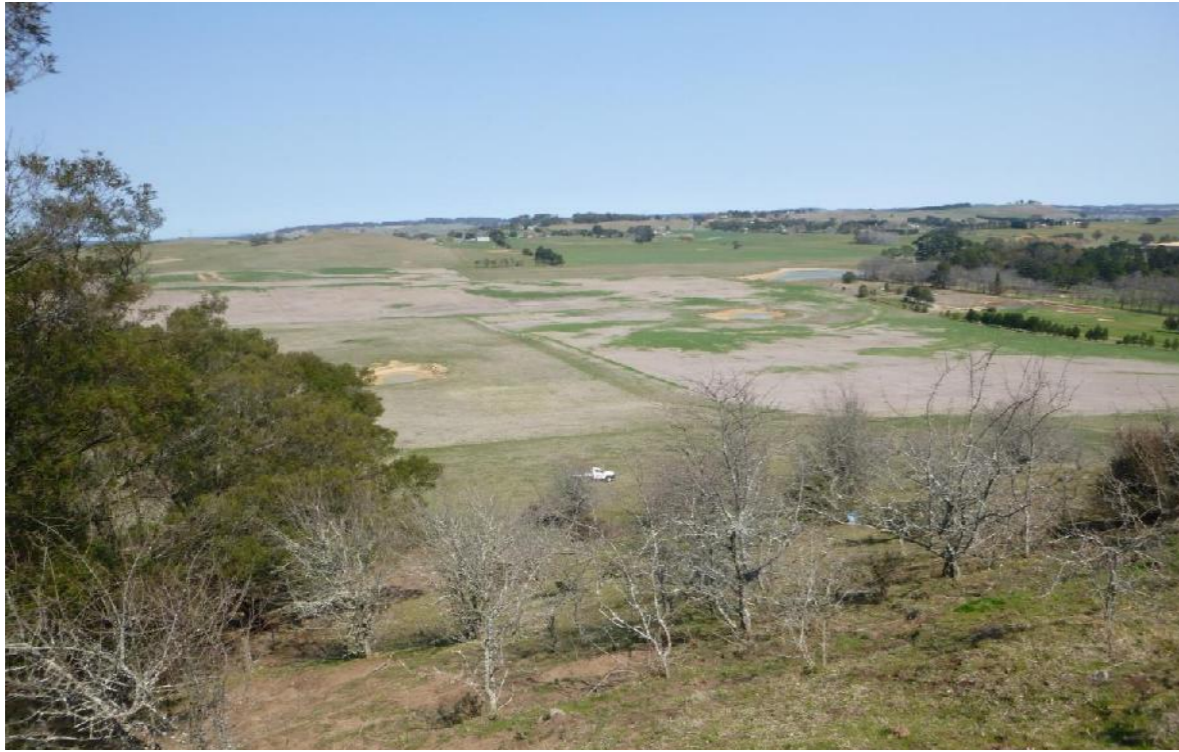
Photo 1: View looking south across the central part of the site from the very steep hillside in the northern part of the site.

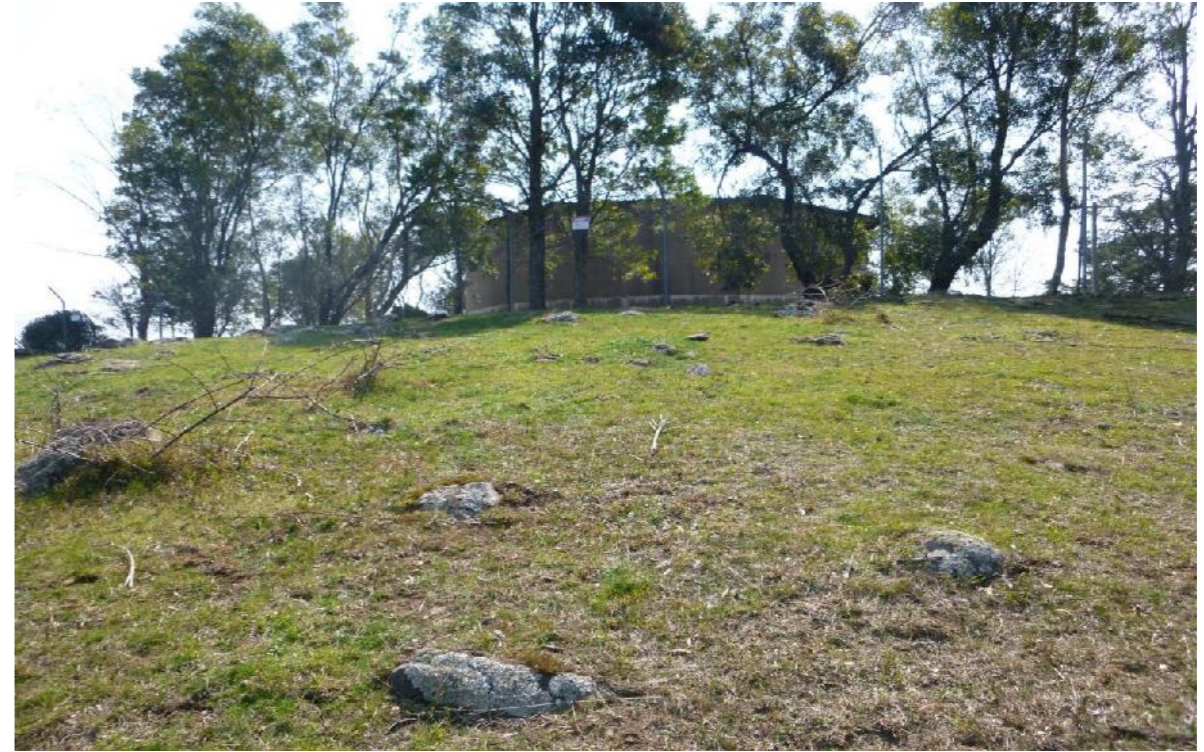
Photo 2: View looking north at the smaller of the two water reservoirs at the top of the hill adjacent to the northern part of the site.
