TREE SURVEY & REPORT

40-46 EVAN ST & 96-98 LETHBRIDGE ST

PENRITH

05/08/19
Ref. # 2042

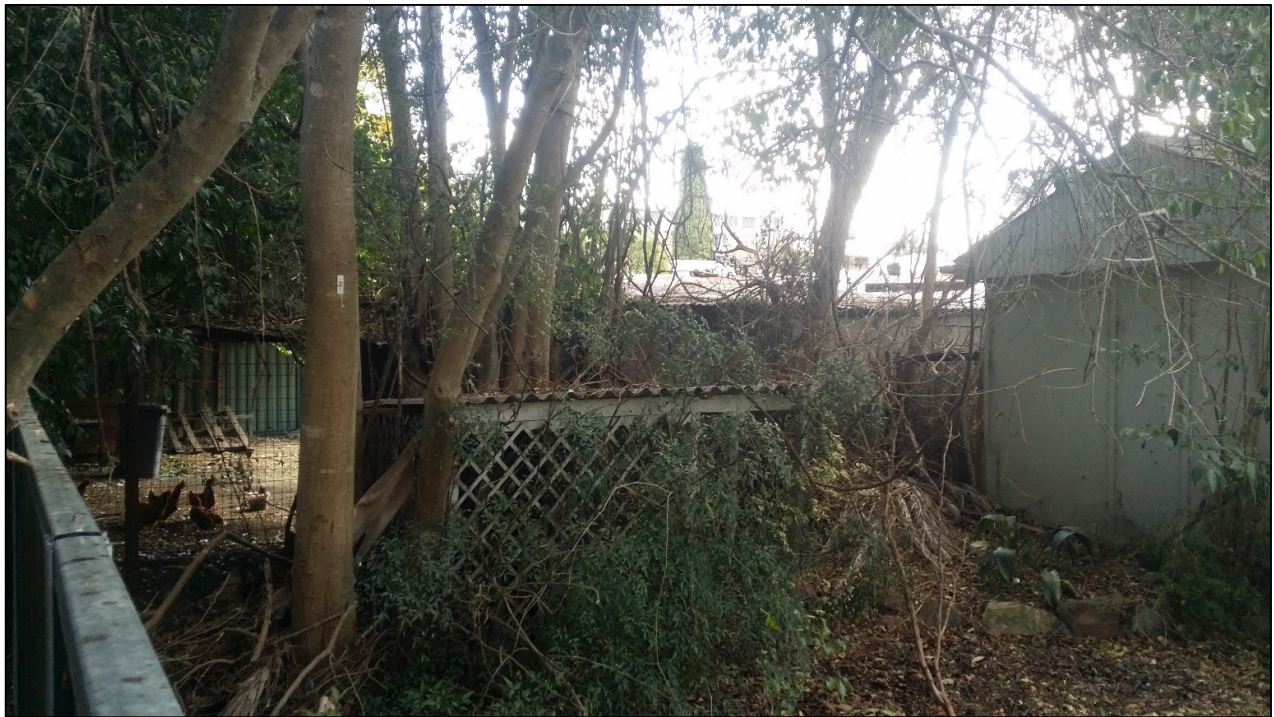
Plate 1 – showing tree No's 2 – 6 (Privets)

- This species is a ‘weed of National Concern in the Sydney Region – harmful to human health and the environment, and is listed as an exempt in Penrith DCP 2014 (see Plate 1).
- These trees should be removed

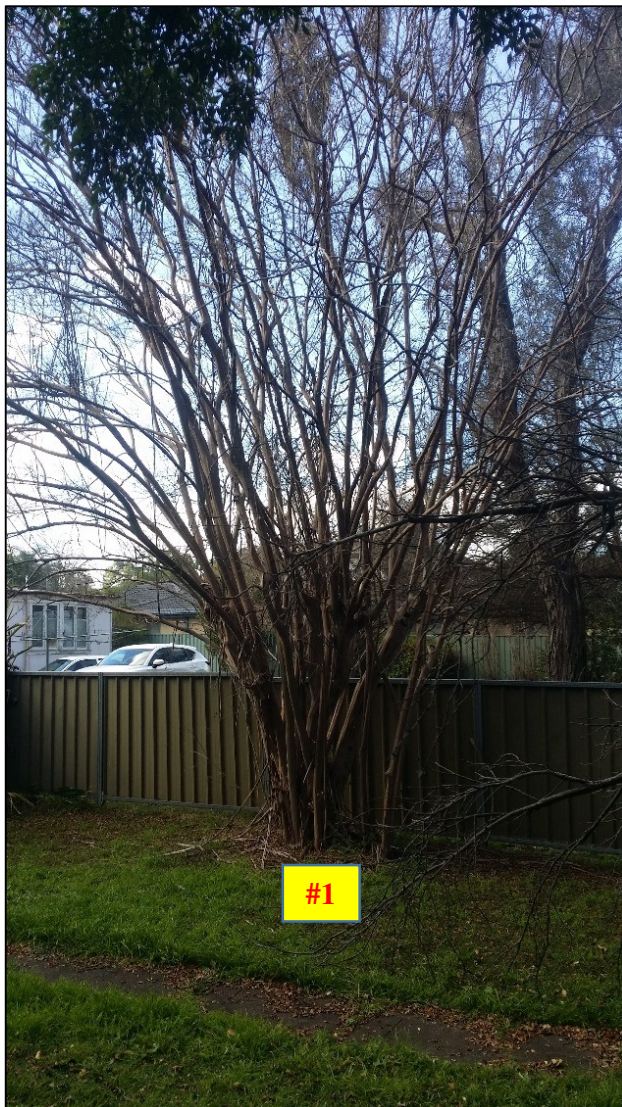
Plate 4 – showing tree No. 1

- Health & Vitality:** Average – this is a deciduous species and was dormant at the time of the inspection. However, an examination of the previous seasons of extension growth indicates that it’s generally healthy and growing vigorously, with no visible symptoms of decline (see Plate 4).
- Tree Form:** – it has formed multiple stems from the rootcrown and these combine to form a codominant canopy that is 7m in height, with a crown spread of 10x10m.
- Structural Condition:** Average, retainable in the long term

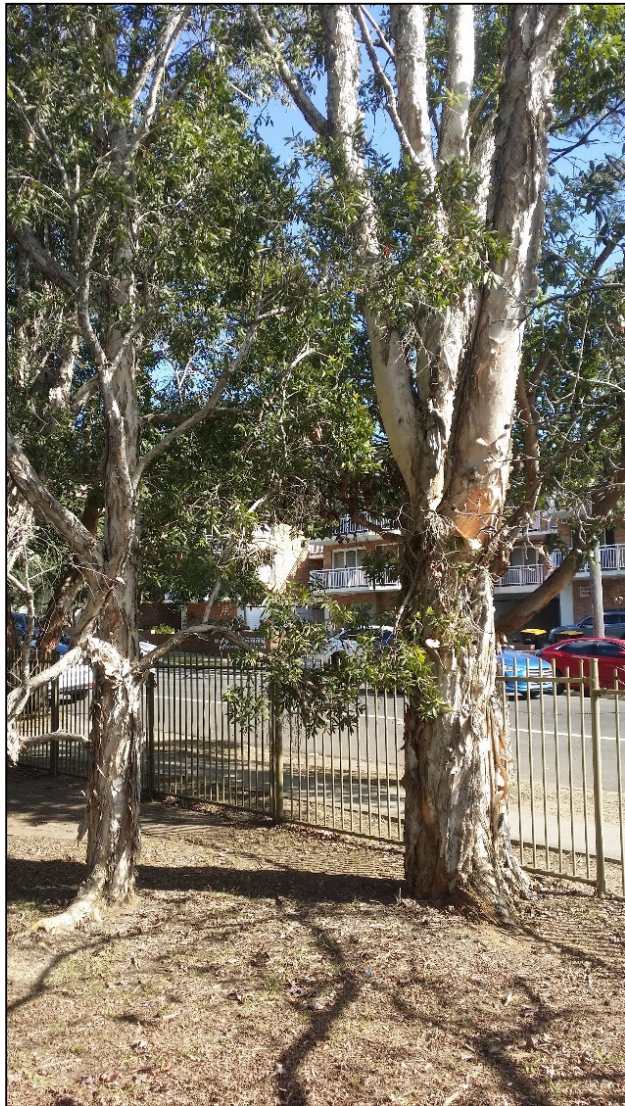
Plate 13 – showing tree No's 26 & 27

- a. **Health & Vitality:** Average – the foliage of these trees appear to be generally healthy and growing vigorously, with no visible symptoms of decline (see Plate 13).
- b. **Tree Form:** These trees formed single stems with DBH's of 300 & 450mm and a codominant, asymmetrical canopy that is 17m in height, with a crown spread of 9x8m.
- c. **Structural Condition:** Average, retainable in the long term

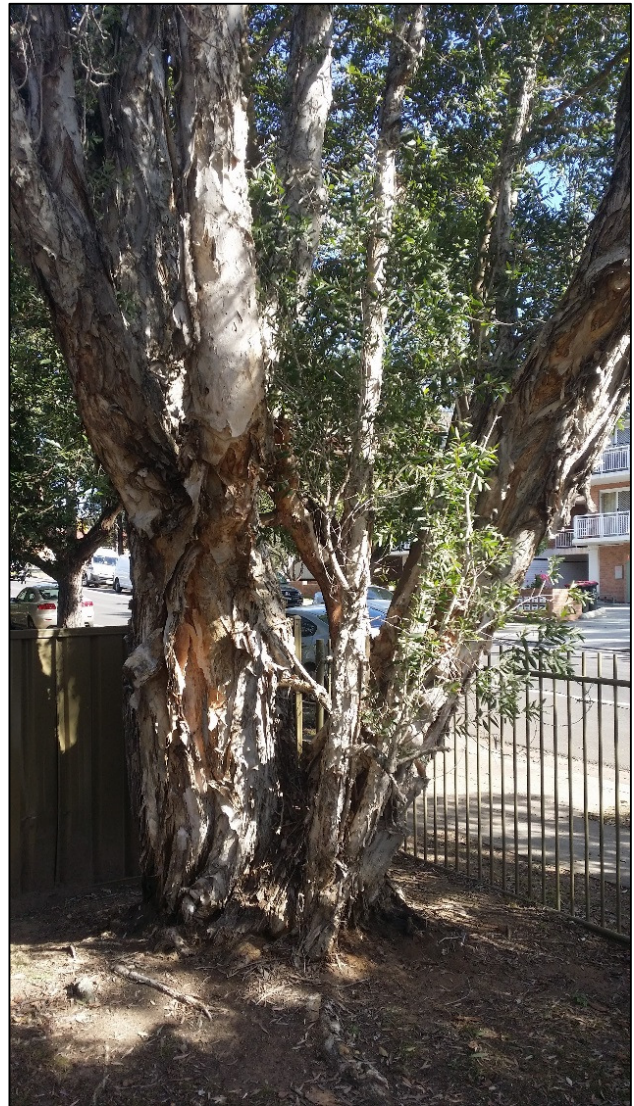
Plate 14 – showing tree No. 28

- a. **Health & Vitality:** Average – the foliage of these trees appear to be generally healthy and growing vigorously, with no visible symptoms of decline (see Plate 14).
- b. **Tree Form:** This tree has formed four codominant stems with DBH's 400 and a codominant canopy that is 15.5m in height, with a crown spread of 11x9m.
- c. **Structural Condition:** Average, retainable in the long term

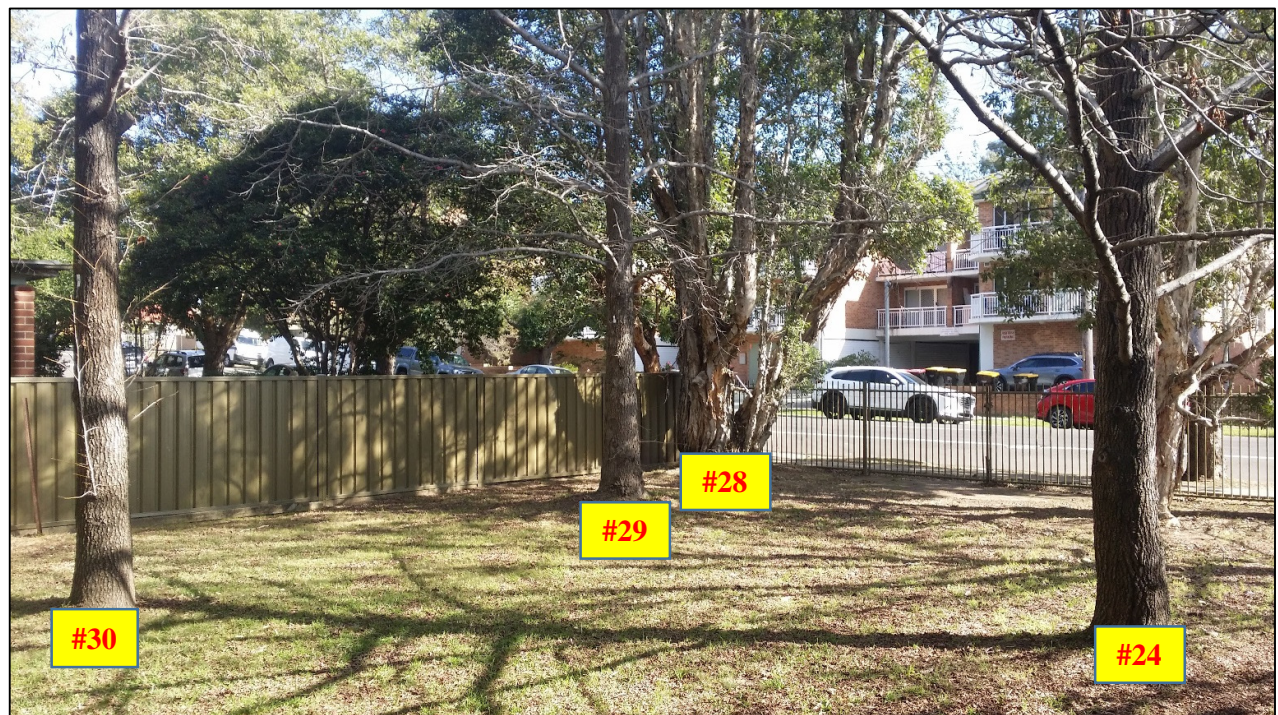
Plate 15 – showing tree No's 24, 28, 29 & 30

- a. **Health & Vitality:** Average – the foliage of these trees appears to be generally healthy and growing vigorously, with no visible symptoms of decline (see Plate 15).
- b. **Tree Form:** These trees have formed single stems with DBH's of 300 & 400mm and codominant canopies that are approximately 12m in height, with a crown spreads of 10x10m.
- c. **Structural Condition:** Average, retainable in the long term

- a. **Health & Vitality:** Average – the foliage of these trees appears to be generally healthy and growing vigorously, with no visible symptoms of decline (see Plates 15 & 16).
- b. **Tree Form:** These trees have formed a single stem with DBH of 300mm and codominant canopies that are 15m in height, with a crown spreads of 10x10m.
- c. **Structural Condition:** Average, retainable in the long term

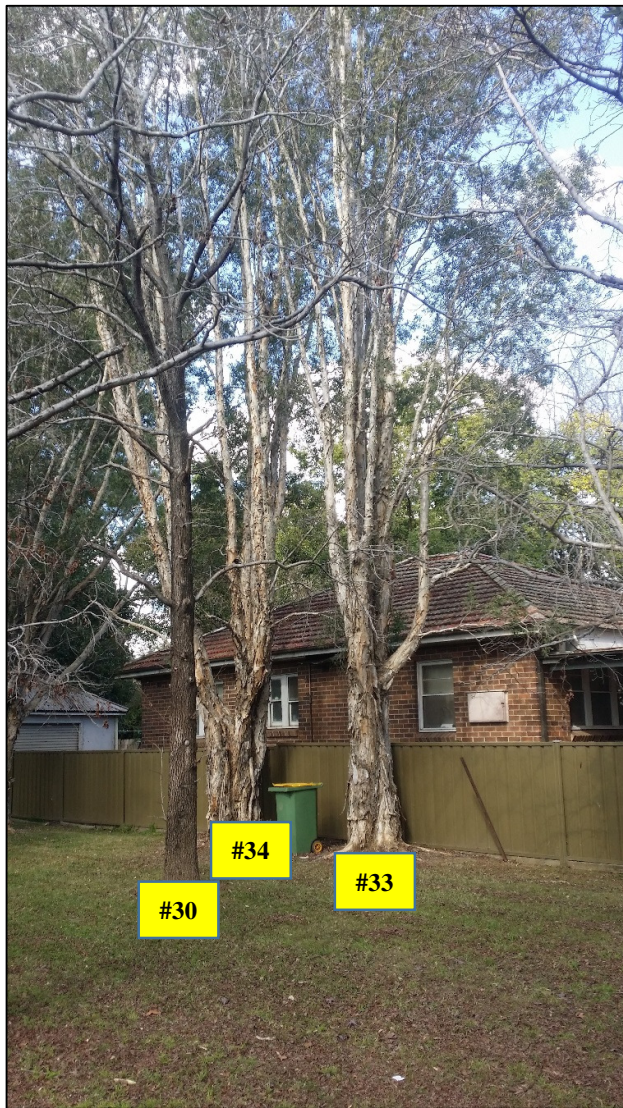
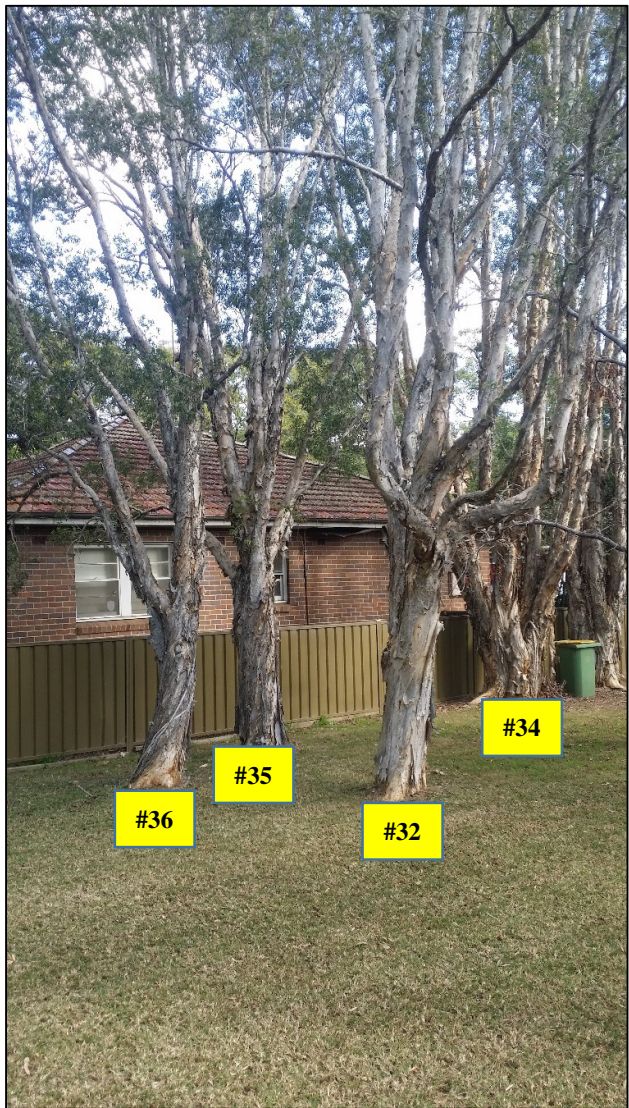
Plates 16 & 17 – showing the codominant stands of tree (No's 33 & 34) and tree (No's 32, 35 & 36)

- a. **Health & Vitality:** Average – the foliage of these trees appear to be generally healthy and growing vigorously, with no visible symptoms of decline (see Plate 16).
- b. **Tree Form:** They have has formed stems with DBH's of 300 & 400mm and a codominant canopy that is 19m in height, with a crown spread of 10x12m.
- c. **Structural Condition:** Average, retainable in the long term

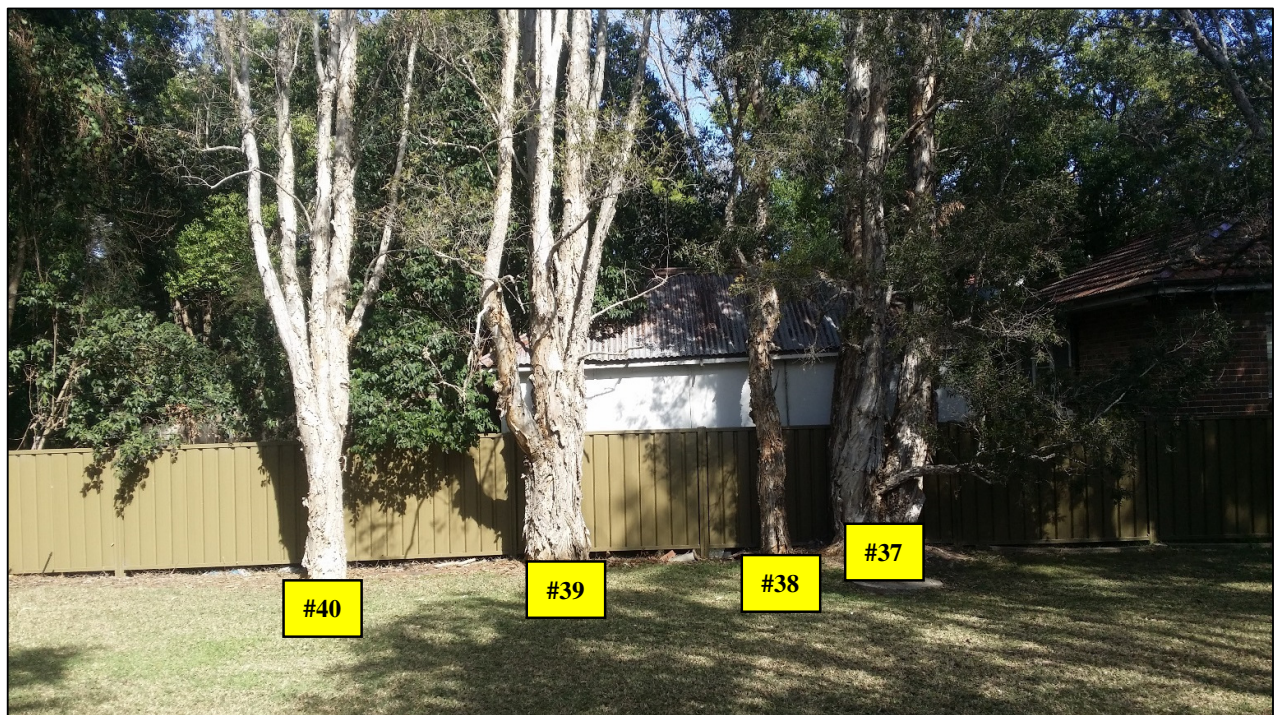
Plate 18 – showing codominant stand of tree No's 37 - 40

- a. **Health & Vitality:** Average– the foliage of these trees appear to be generally healthy and growing vigorously, with no visible symptoms of decline (see Plate 18).
- b. **Tree Form:** They have formed stems with DBH.s of 220 - 550mm and a codominant, asymmetrical canopy towards the north that is 19m in height, with a crown spread of 11x17m.
- c. **Structural Condition:** Average, retainable in the long term

- a. **Health & Vitality: Average** – the foliage of this tree appears to be generally healthy and growing vigorously, with no visible symptoms of decline (see Plate 18).
- b. **Tree Form:** This tree has formed a single stem with DBH of 400mm and a codominant canopy that is 22m in height, with a crown spread of 15x11m.
- c. **Structural Condition:** Average, retainable in the long term

- a. **Health & Vitality:** Average – the foliage of this tree appears to be generally healthy and growing vigorously, with no visible symptoms of decline (see Plate 18).
- b. **Tree Form:** This tree has formed a single stem with DBH of 250mm and a codominant canopy that is 21m in height, with a crown spread of 9x8m.
- c. **Structural Condition:** Poor – tall thin form with a very high trunk diameter to tree height ration

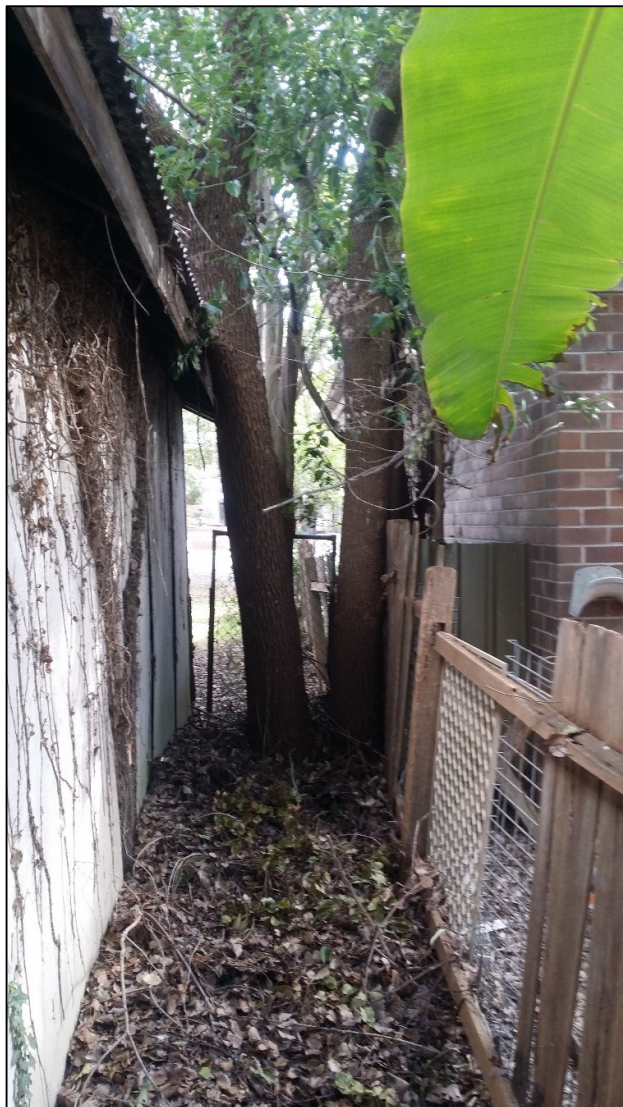
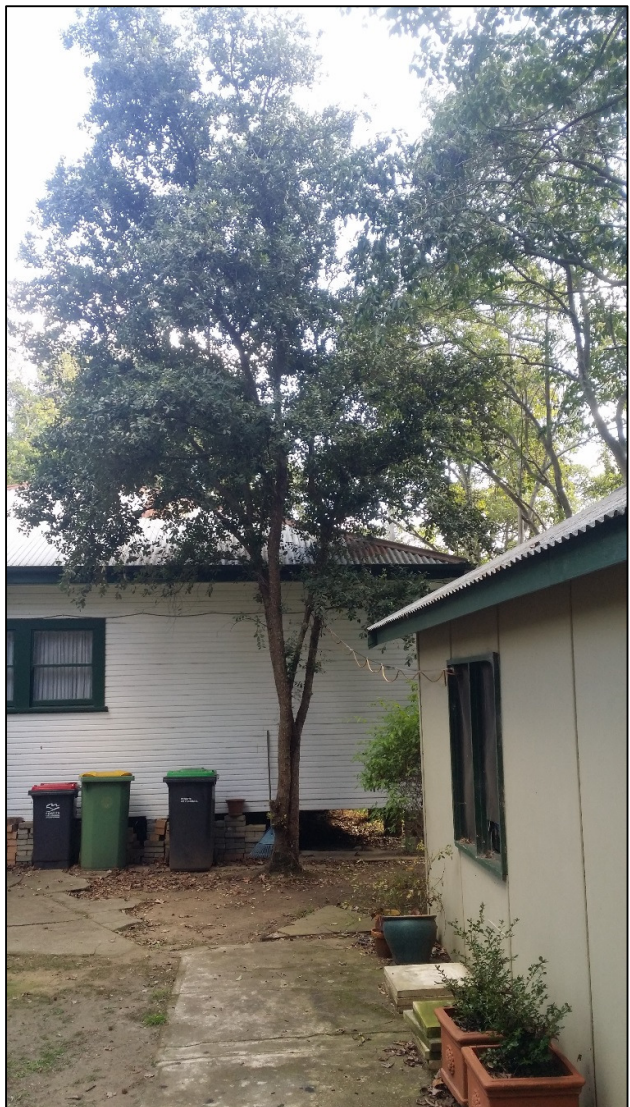
- a. **Health & Vitality:** Average – the foliage of these tree appears to be generally healthy and growing vigorously, with no visible symptoms of decline (see Plates 46 & 47).
- b. **Tree Form:** They form a codominant row of street trees that is 13m in height, with average crown spread of 6x6m.
- c. **Structural Condition:** Average – retainable in the long term

Plate 46 – showing tree No. 107

Plate 47 – showing tree No. 108
