Arboriculture Impact Assessment

**35 - 47 Stennett Road, Ingleburn
Stage 3, Warehouse Development**

Date: 24 March 2022
Reference: 20221869
Revision: 3

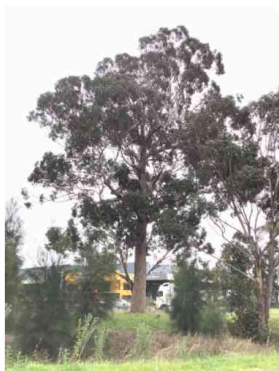
- 6.4.1 Tree No. 5 *Eucalyptus moluccana* (Grey Box)
 - 6.4.1.1 This indigenous tree is located on site and is protected by council. The tree is mature in age with a dominant trunk and is in fair health with average (3) crown condition and fair structural condition. The tree has a minor level of previously failed branches and a nest was sighted in the in upper canopy. This tree has a 'TreeAZ' rating of 'A2' and an estimated life expectancy of 40+yrs.

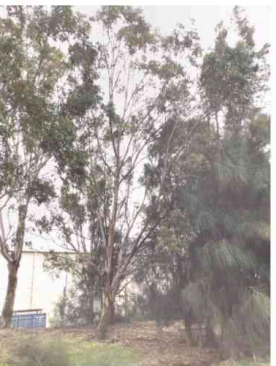
**29**

- 6.3.1 **Tree Wounds:** Trees No. 29, 57, 60 and 65 have varying types of wounds, both on the trunk, within canopies and wounds from the pruning of large branches. Bark protects the cambial layer that transports food. Damage and exposure to this layer will disrupt the flow and cause the cells to die. Fungal and mirco-organism infections can cause decay or canker formation.
