SWCPP DEFERRAL RECOMMENDED ACTION - DATED 1st DECEMBER 2024
RESPONSE TO TfNSW CONSULTANTS 2024 REPORTS – HERITAGE 21

PART A – CONSERVATION ARCHITECT RESPONSE TO HERITAGE 21 REPORT DATED 29TH FEBRUARY 2024

PART B1 – CONSERVATION ARCHITECT ILLUSTRATION OF A METHODOLOGY FOR A ‘FULSOME ANALYSIS OF FABRIC’

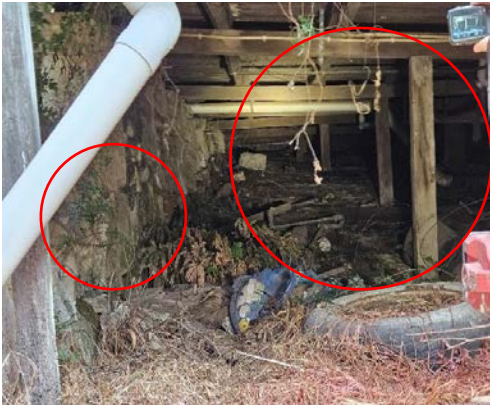
<p>Extract from Heritage 21 Report Figure 21 <i>Figure 21. Deteriorated and termite eaten foundations to the front verandah.</i></p>

<p>Note : The Heritage 21 report states that ‘many of the timber stumps are termite affected’ but the only image of termite damaged timber is Figure 21 above. The caption states that the image is of “termite eaten</p>	<p>Timber stump construction is common across Australia since first settlement in the early 1800s and it is equally common in Australia for houses to be “restumped”. <i>Canstar</i>, the well-respected organisation that markets itself on its ‘fact-checking process’ has researched restumping of residences https://www.canstar.com.au/home-loans/restumping-cost/</p> <p>Canstar’s analysis concluded that “According to tradie listings website <i>HIREtrades</i>, fully restumping a small to average-sized home with one to three bedrooms could set homeowners back around \$10,000 to \$25,000, or potentially more depending on the specifics of the job. Trade website <i>HiPages</i> estimates that restumping a house could cost anywhere between \$5,000 and \$20,000”.</p> <p>There are many building firms regularly undertaking restumping of residences and although the costs may vary depending on site specific factors the costs are not substantial.</p> <p>Allambie could be restumped to make good the deteriorated posts in a straightforward manner. It is not a complex building task. The Heritage 21 provides no indication of the extent of the deterioration of the stumps without a detailed inspection. Therefore the conclusions arrived at in the Heritage 21 report may not be correct or accurate without a fulsome inspection and analysis of the fabric.</p>

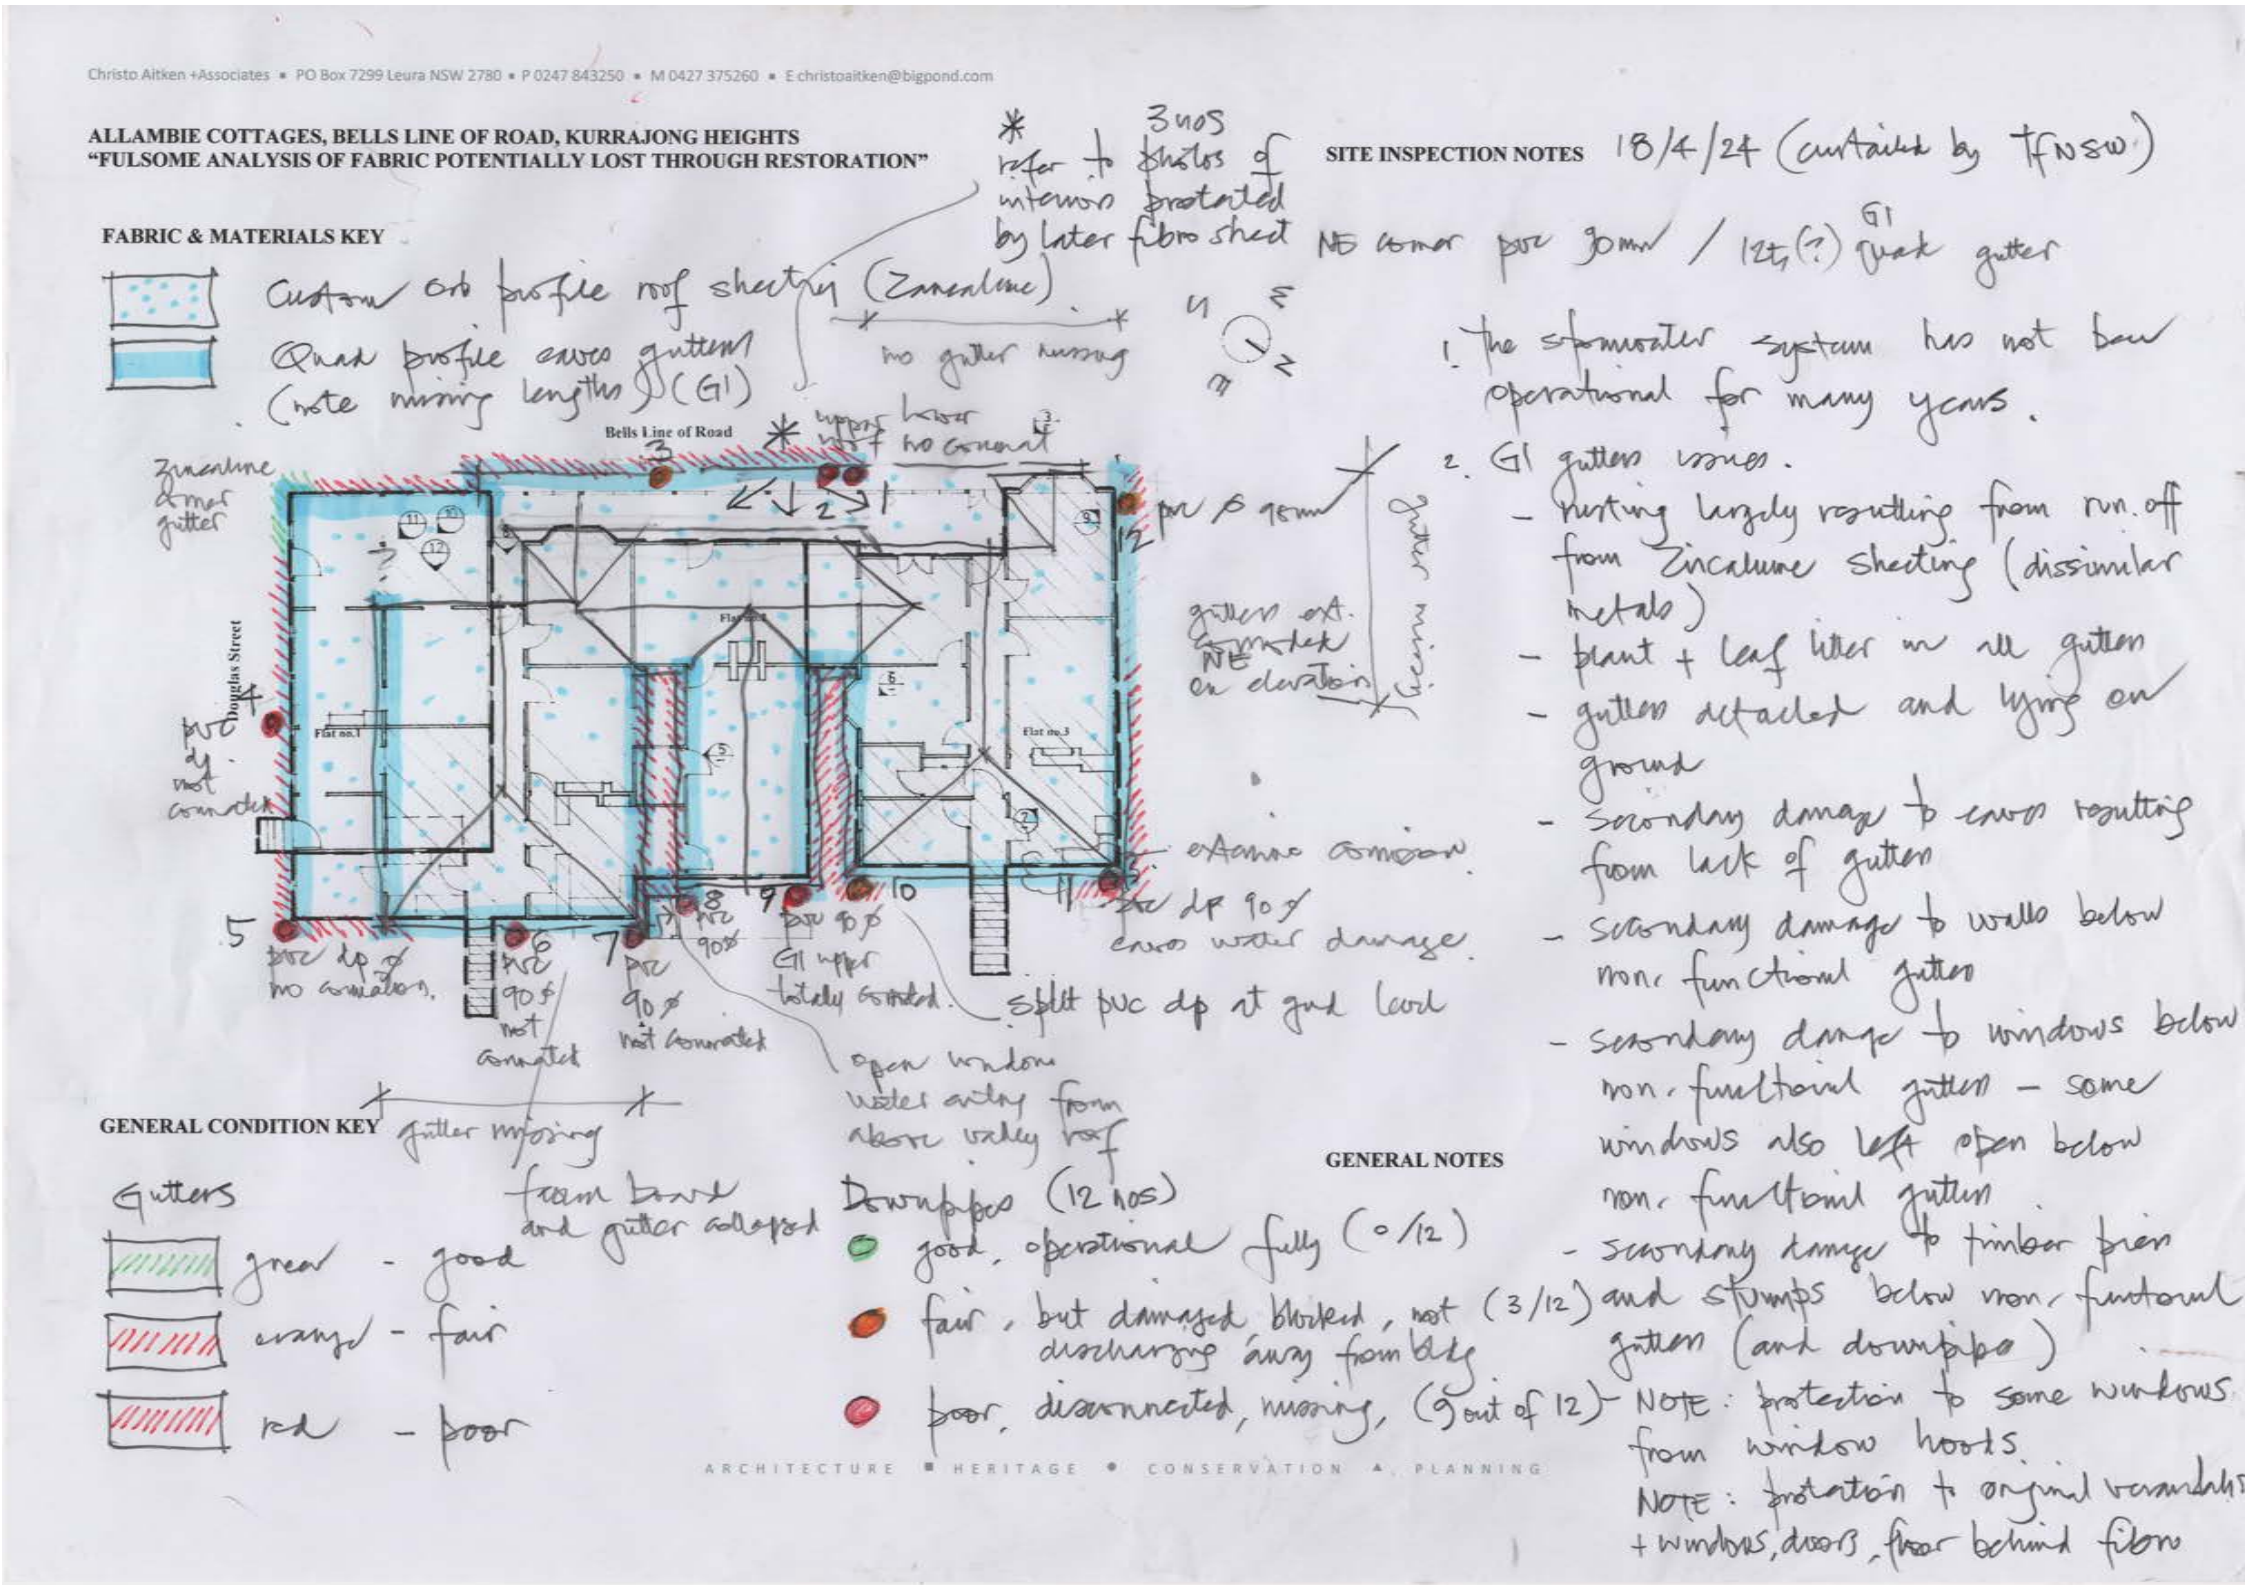
FRONT ELEVATION DP1 Non-Functional	FRONT ELEVATION DP2 Non-Functional	FRONT ELEVATION DP3 Non-Functional	FRONT ELEVATION DP4 Non-Functional	SIDE ELEVATION DP5 Non-Functional	REAR ELEVATION DP6 Non-Functional	REAR ELEVATION DP7 Non-Functional	REAR ELEVATION DP8 Non-Functional	REAR ELEVATION DP9 Non-Functional	REAR ELEVATION DP10 Non-Functional	SIDE ELEVATION DP11 Non-Functional	SIDE ELEVATION DP12 Non-Functional
DP – Disconnected Related Gutter - Collapsed	DP – Blocked Related Gutter - Blocked	DP – Blocked and Cracked Related Gutter – Blocked	DP – Disconnected and Cracked Related Gutter - Collapsed	DP – Disconnected Related Gutter - Collapsed	DP – Disconnected and previously discharging under Allambie floorspace Related Gutter - Collapsed	DP – Disconnected and likely cracked Related Gutter - Collapsed	DP – Connected to fully corroded gutter Related Gutter – Corroded and Discharging into open window below	DP – Corroded early GI downpipe connected to PVC downpipe apparently discharging under Allambie floor space Related Gutter - Corroded	DP – Connected to fully corroded GI gutter and PVC downpipe damaged at ground level Related Gutter - Corroded	DP – Disconnected from fully corroded GI gutter Related Gutter – Corroded and discharging into open window below.	DP – Connected to corroded and collapsing GI gutter. Base of PVC downpipe missing cover and likely to be discharging into Allambie sub floor space Related Gutter – Blocked, corroded and collapsing

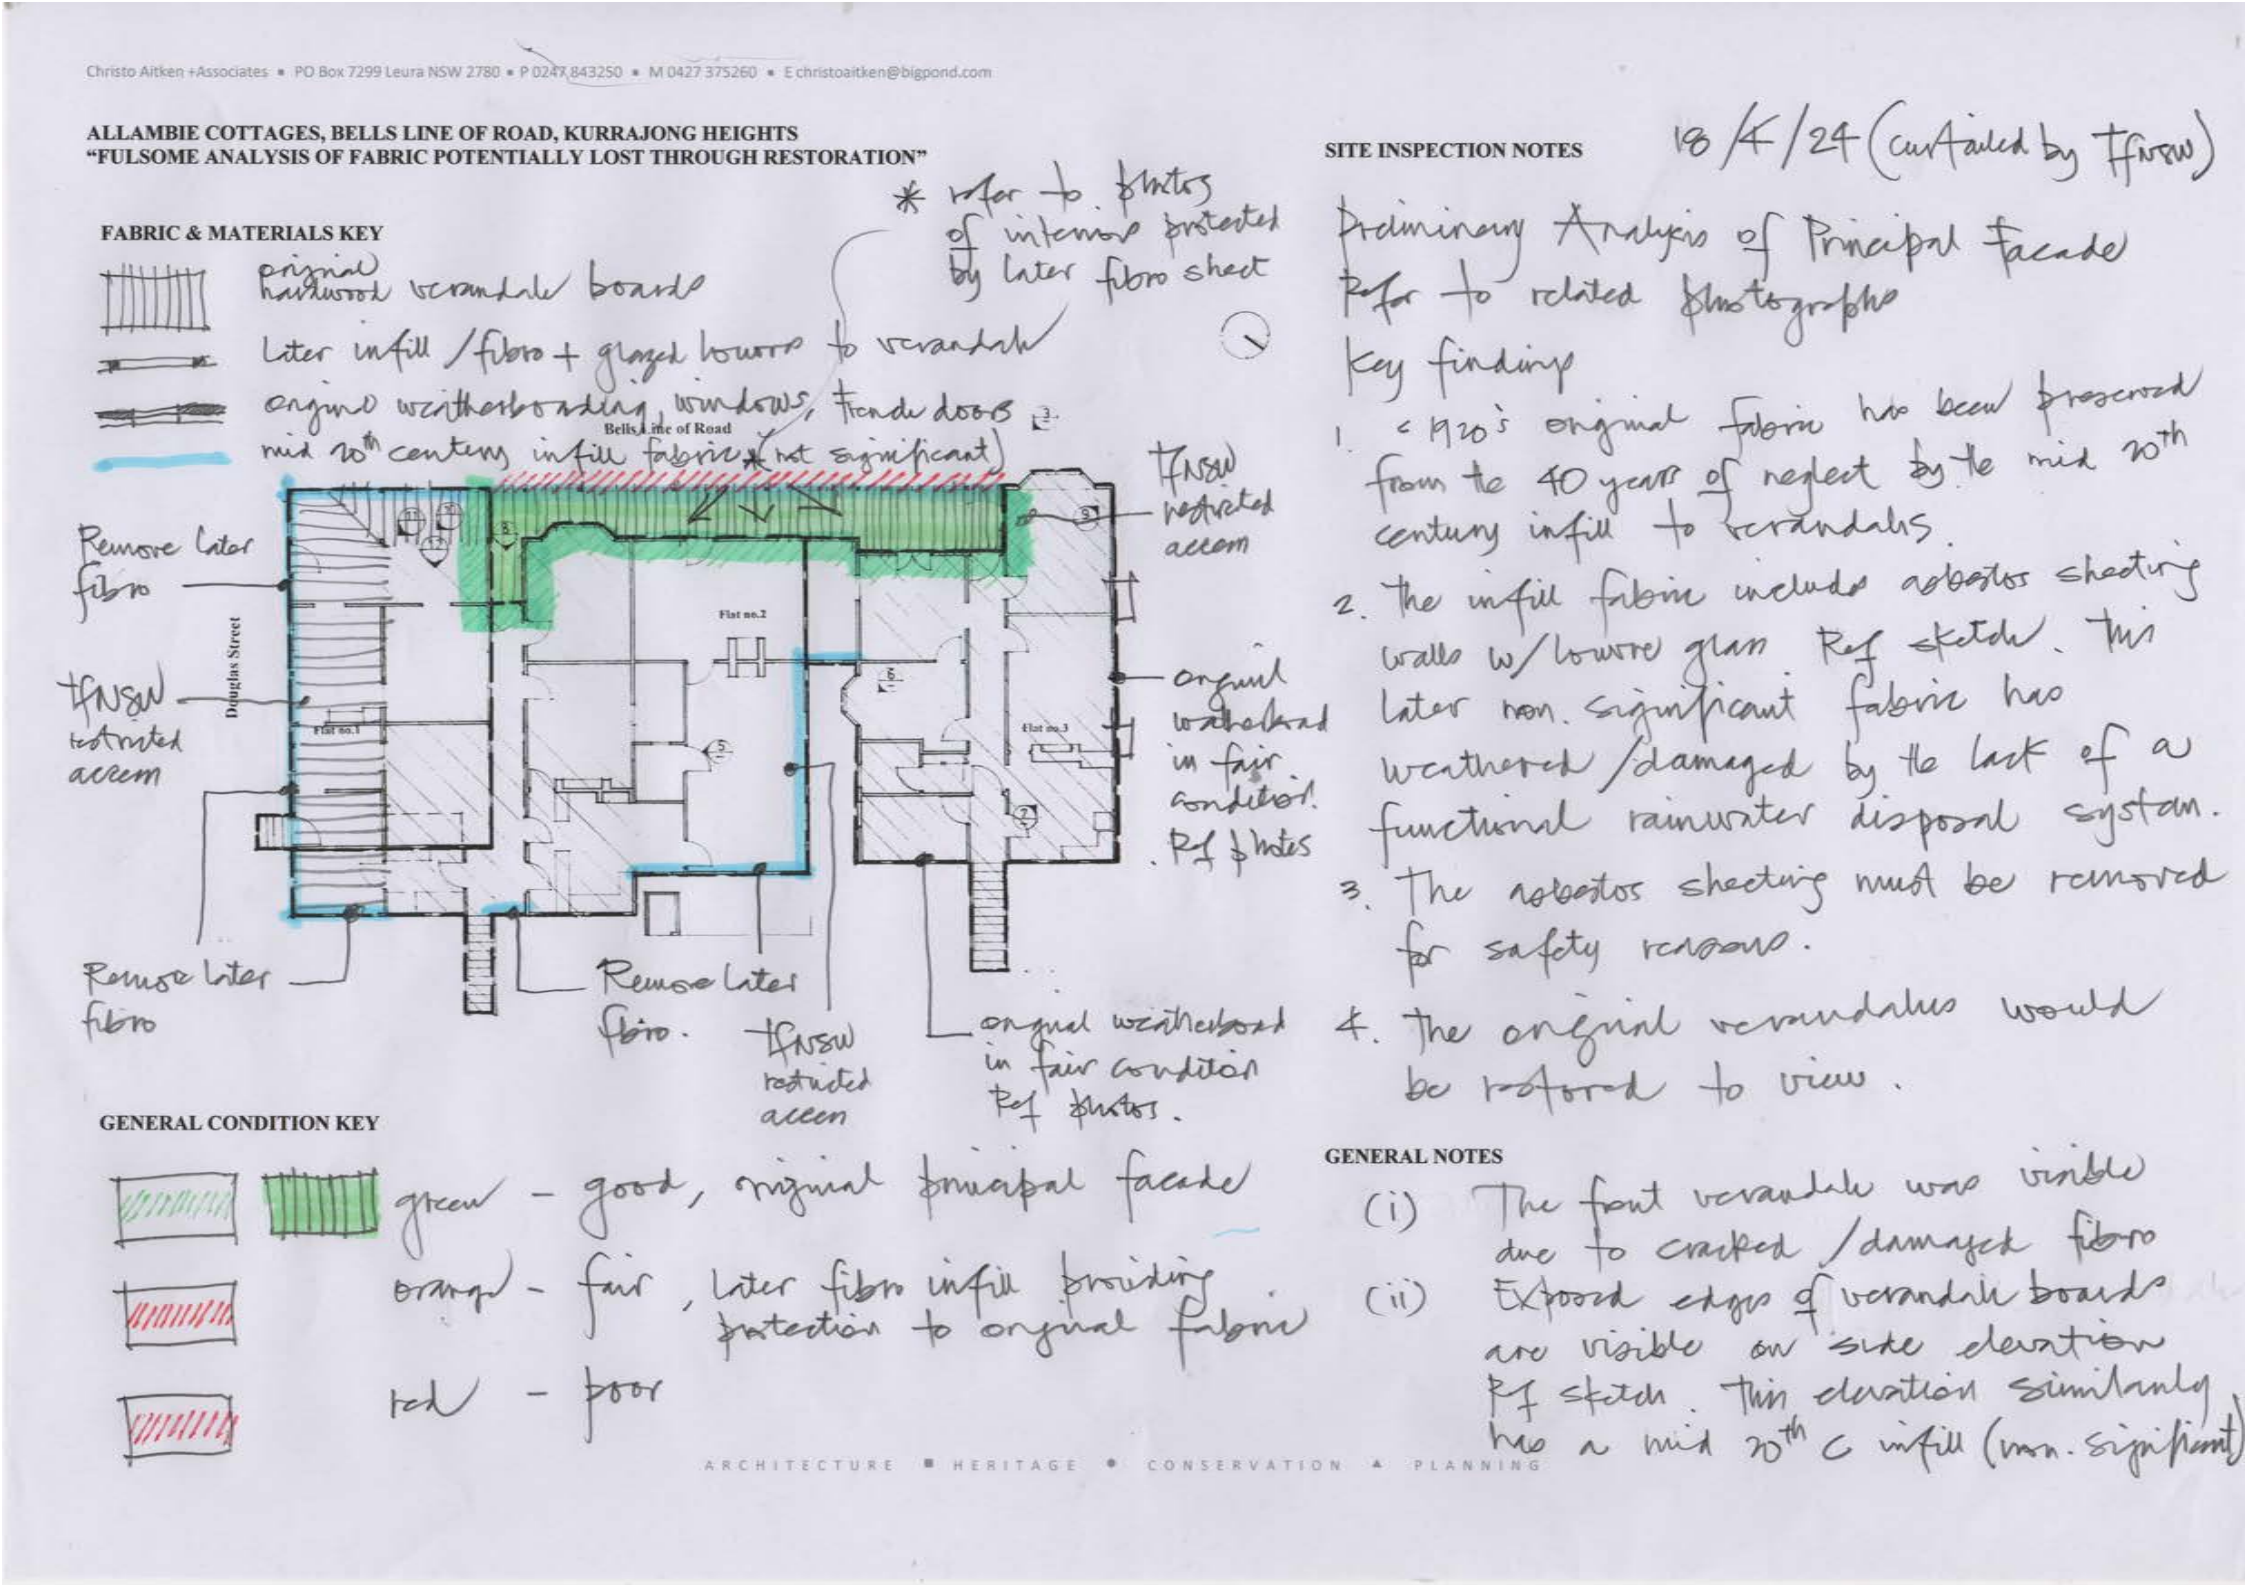
ONSITE PHOTOGRAPHIC ANALYSIS – INFILLED VERANDAHS

The more significant early 20th Century interiors preserved and protected by the later asbestos sheeting - viewed through cracked fibrous asbestos sheeting (TfNSW restricted access to inspect these areas)
