Arborist Impact
Assessment

Opal Specialist Aged Care
C/o Matthew O'Sullivan

5-7 Floribunda Avenue
Glenmore Park

24th June 2019

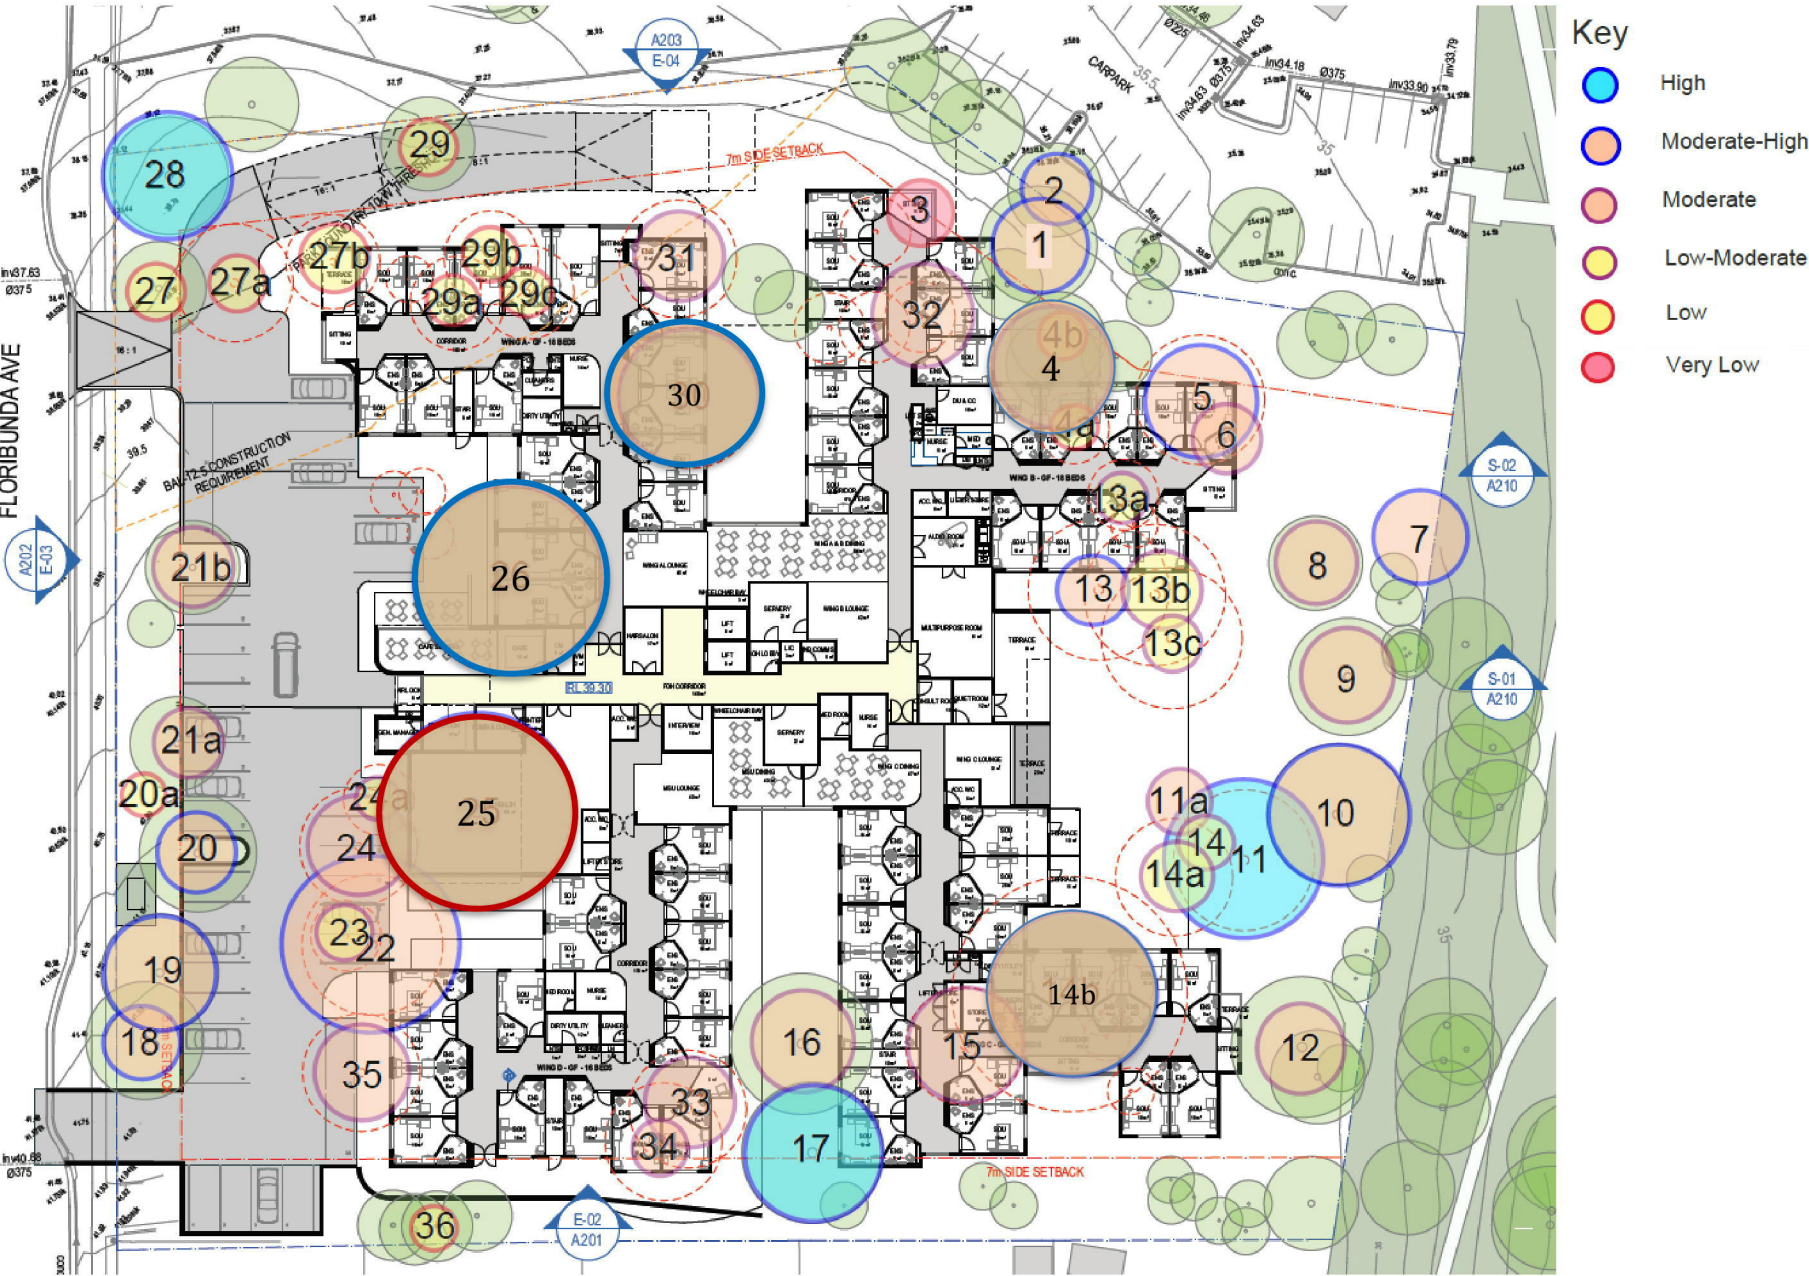
10.1 TREE RETENTION MAP

11.1 Fifty-two (52) trees within the proposed area of development have been assessed. No High value trees will be removed from this proposal. High value trees will be retained for this site.
