# FIRE SAFETY UPGRADE STRATEGY REPORT

220 Bentinck Street, BATHURST NSW 2795

| <b>Client:</b> | St Stanislaus College |
| <b>Reference:</b> | 23175 |

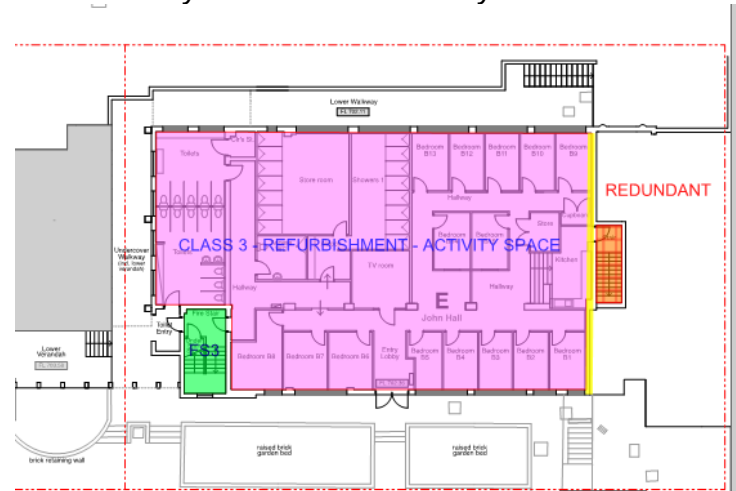
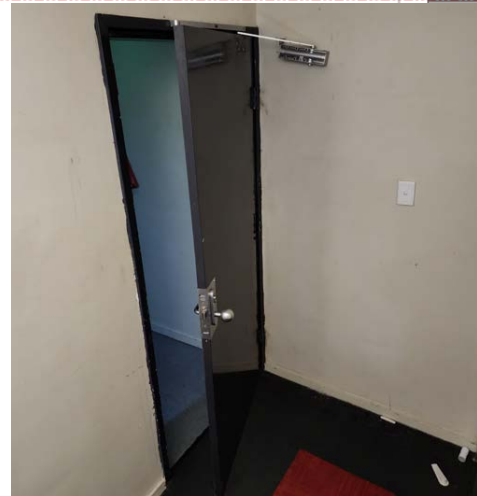
The existing masonry wall located at the bottom of the redundant stairway contains a doorway.

It is recommended the existing doorway located at the bottom of the redundant stairway be blocked up to achieve an FRL of at least 90/90/90.

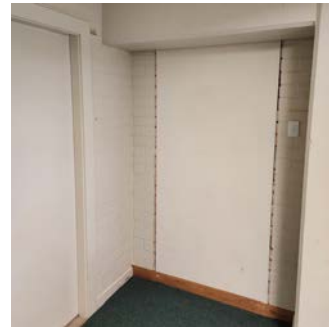
The wall located between the Class 9b classroom and floor area to be demolished contains an opening (possibly an old doorway) in the masonry construction that does not appear to be of fire-resisting construction. Refer to the photograph below.

It is recommended the infill material be removed and the opening be upgraded to achieve an FRL of at least 90/90/90.

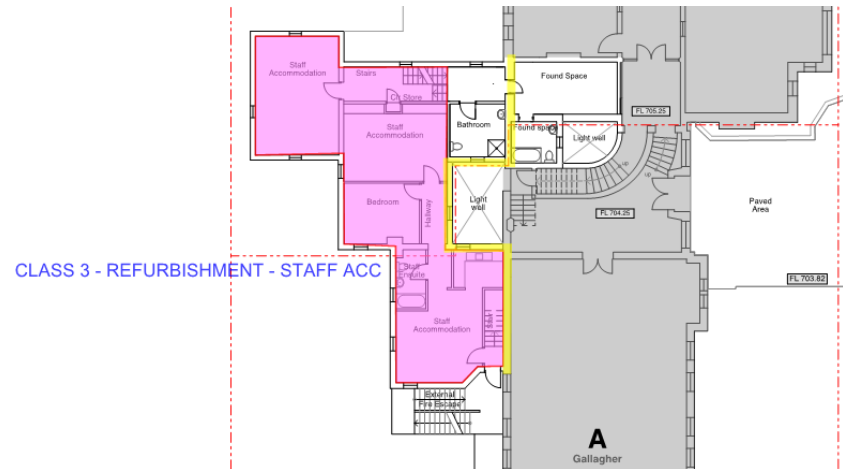
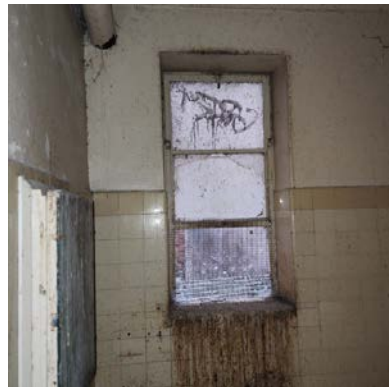
**Bounding construction - Upper Ground Storey – Block A**

During the site inspection, it was observed a double masonry wall had been constructed in the location marked up in yellow (possibly a previous part of an external wall).

It is recommended the doorway between the hallway and the found space be blocked up and discussions occur with the Certifier – Fire Safety regarding the feasibility of a Performance Solution for drenchers to be provided to the windows located in the light well.

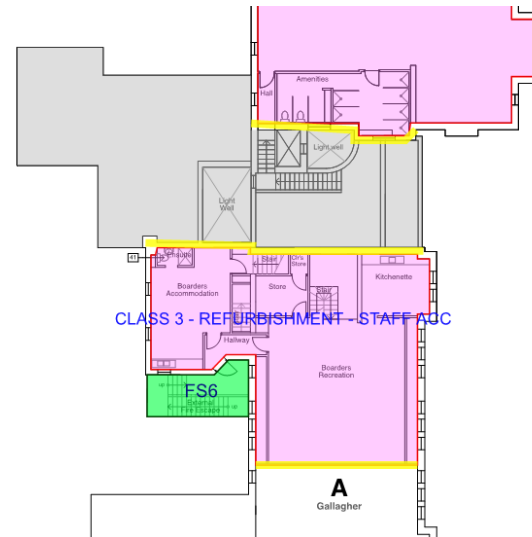
The Second Storey in Block A is a mezzanine styled storey that is proposed to be used for the purpose of staff accommodation. The southern wall is lightweight construction with windows, exposed to the proposed First Storey below.

It is recommended the walls highlighted in yellow are provided as bounding construction to the Class 3 parts. Whilst outside the scope of upgrades, bounding construction is also required to be provided at the top of the proposed stairway to the Second Storey of Block A. The required wall is not highlighted on the plan above.

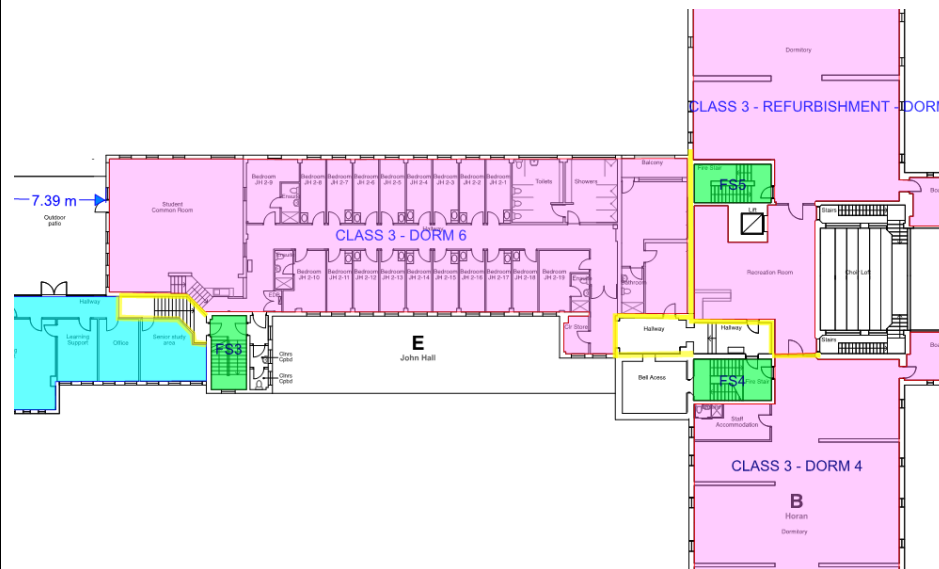
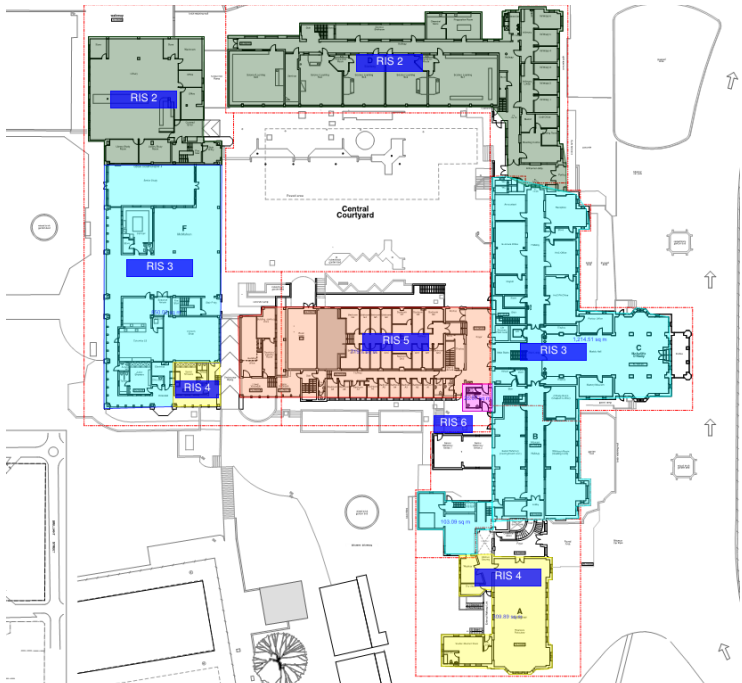
**Bounding construction - Second Storey – Block B, C and E**

The wall adjacent to the light blue part of Block F is proposed to be bounding construction for a public corridor. However, it is also indicatively proposed to be a fire wall with a FRL of 120/120/120. Refer to the comments in C3D8 of this report. The fire wall has the higher FRL and the wall is required to achieve a FRL of 120/120/120.

It is recommended the walls highlighted in yellow be provided as bounding construction to the Class 3 parts of the building and the proposed public corridors associated with the Class 3 parts.

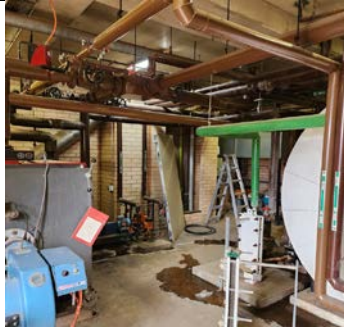
| C3D13<br>[C2.12] | Separation of equipment | During the site inspection, a boiler was observed in the basement of Block F. The boiler room was enclosed by masonry construction (concrete slab and brick walls). The existing concrete slab and masonry walls appear to be modern construction and are assumed to achieve an FRL of 120/120/120, although no destructive testing was conducted. | <b>No Upgrade</b> |

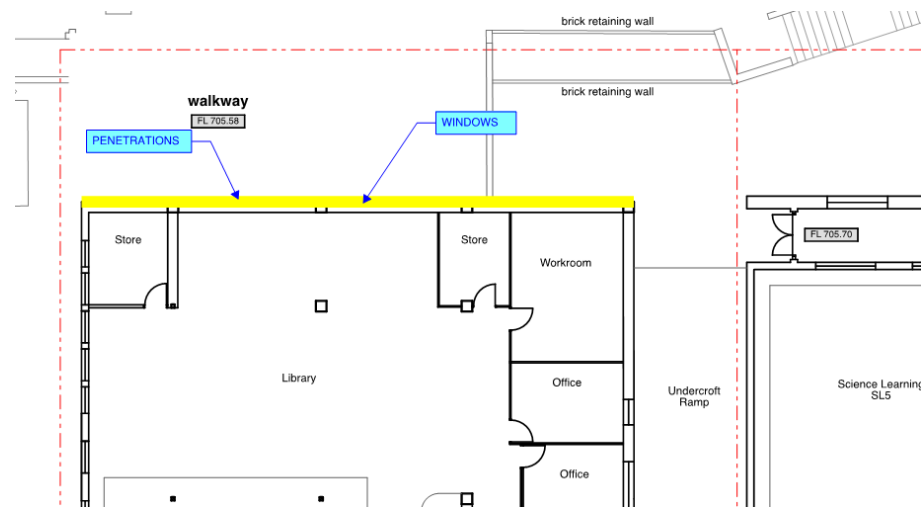
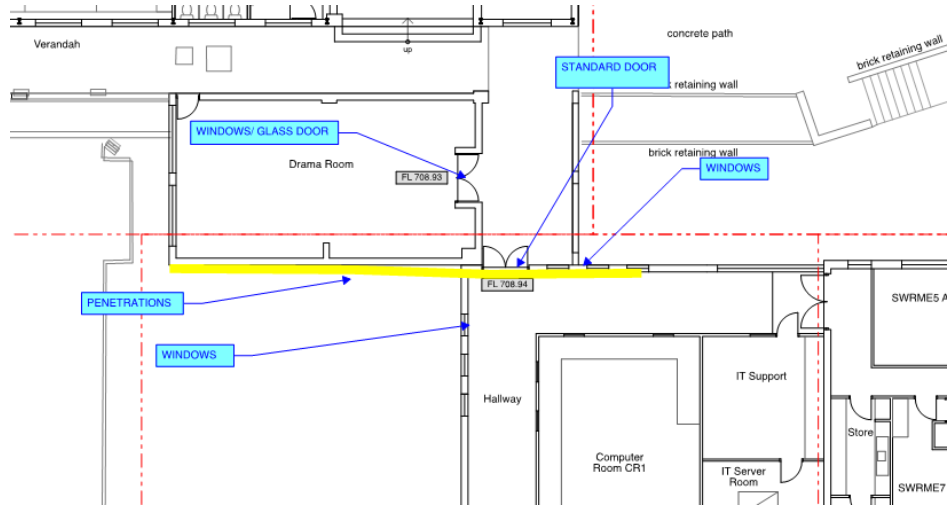
| | | <p>The external wall contains multiple unprotected penetrations, windows and non-fire-resisting doors, which is contrary to C4D3.</p> <p>It is recommended the configuration of the external walls and the openings be reviewed in a holistic manner by a Certifier – Fire Safety. It is recommended the external walls and openings be upgraded to comply with the Performance Requirements of the BCA via a Performance Solution prepared by a Certifier – Fire Safety.</p> | |

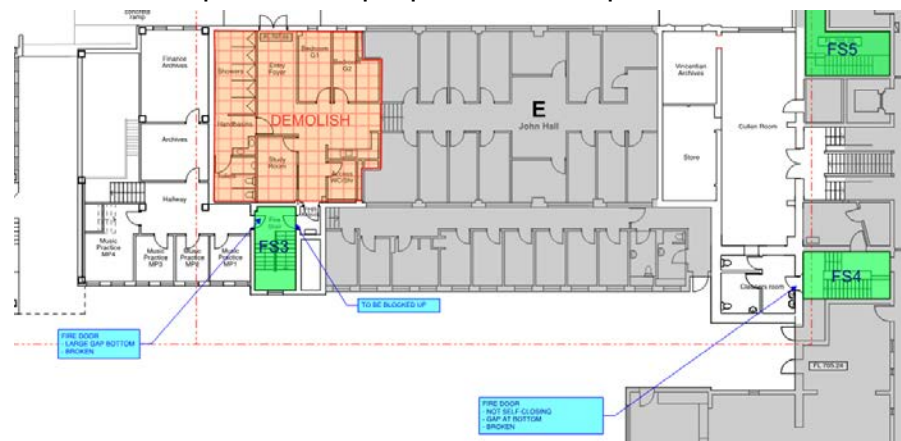
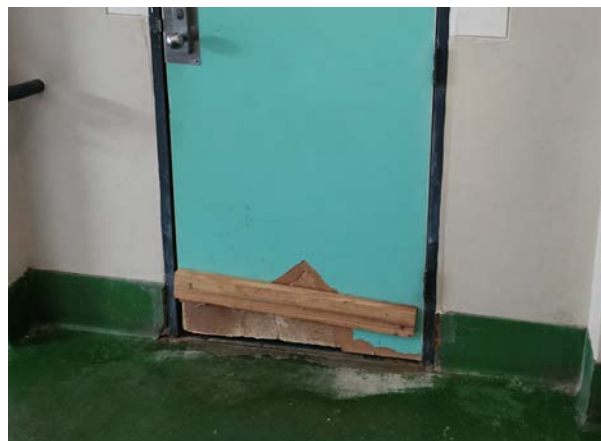
### Upper Ground Storey – Fire stair 3 and 4

The fire doors in fire stairs 3 and 4 are damaged and contain excessive gaps. The entry into fire stair 3 (eastern side) is to be filled in as part of the proposed development.

It is recommended the damaged and untagged fire-doors to fire stairs 3 and 4 be removed and replaced with new -/60/30 fire doors to comply with C4D9. The entry into fire stair 3 (eastern side) be filled in with masonry construction to achieve a FRL of at least 120/120/120 to comply with Specification 5.

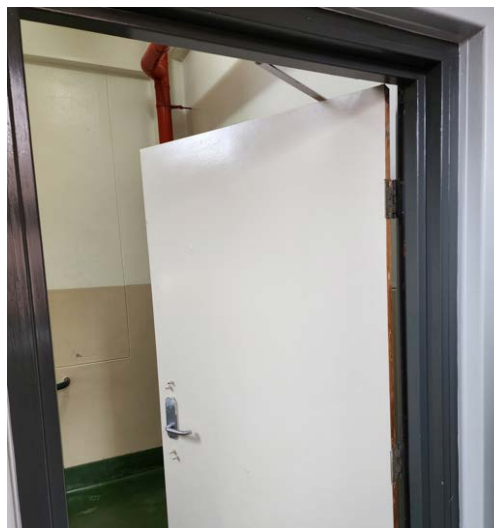
### First Storey – fire stair 3, 4 and 5

The fire doors in fire stairs 3, 4 5 are not self-closing or not tagged as fire doors.

It is recommended the damaged and untagged fire-doors to fire stairs 3, 4 and 5 be removed and replaced with new -/60/30 fire doors to comply with C4D9.

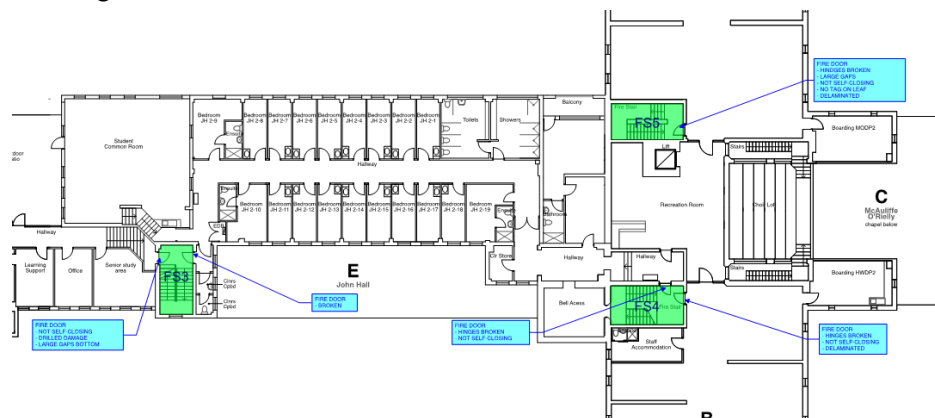
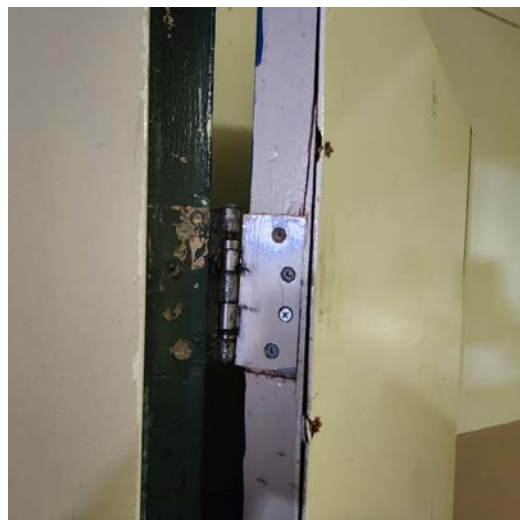
### Second Storey – Fire stair 3, 4 and 5

The fire doors in fire stairs 3, 4 and 5 are not self-closing, not tagged as fire doors, contain excessive gaps or are significantly damaged/ broken.

It is recommended the damaged and untagged fire-doors to fire stairs 3, 4 and 5 be removed and replaced with new -/60/30 fire doors to comply with C4D9.

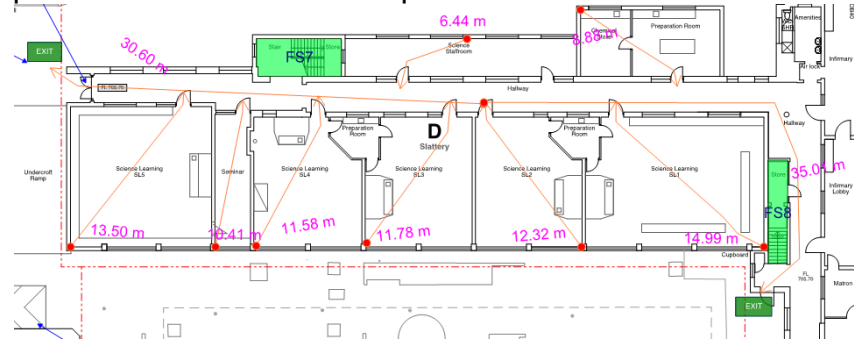
### Block D – Ground Storey

The travel distance from the existing Science Learning SL2 room to an exit is approximately 43 m, which exceeds 40 m and is contrary to D2D5(3)(a). It is also noted the travel distance in Science Learning SL1 will exceed 40 m as a result of the proposed external circulation space.

It is recommended the extended travel distances to an exit be upgraded to comply with the Performance Requirements of the BCA via a Performance Solution prepared by a Certifier – Fire Safety.

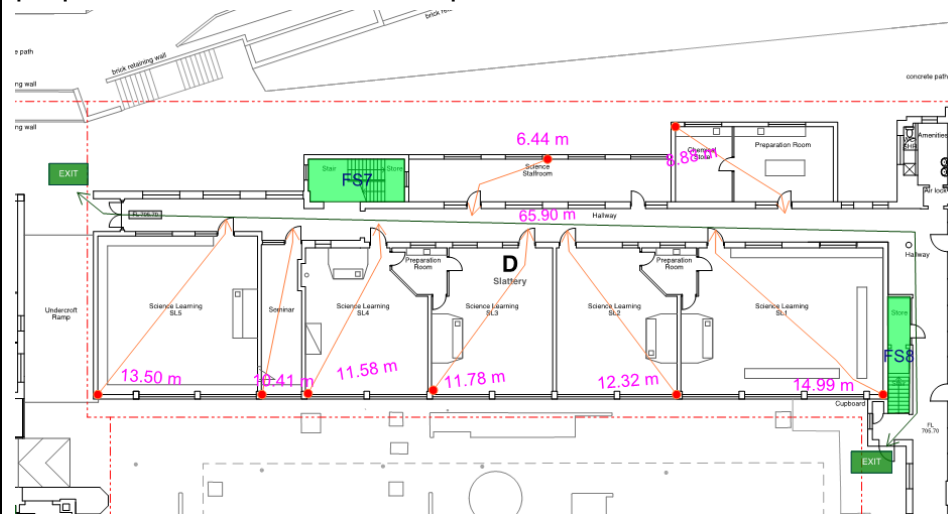
The distance between the existing alternative exits (measured through the point of choice) is approximately 66 m, which exceeds 60 m and is contrary to D2D6(c)(iii). It is also noted the travel distance will be extended to approximately 77 m as a result of the proposed external circulation space.

It is recommended the alternative distance between alternative exits be upgraded to comply with the Performance Requirements of the BCA via a Performance Solution prepared by a Certifier – Fire Safety.

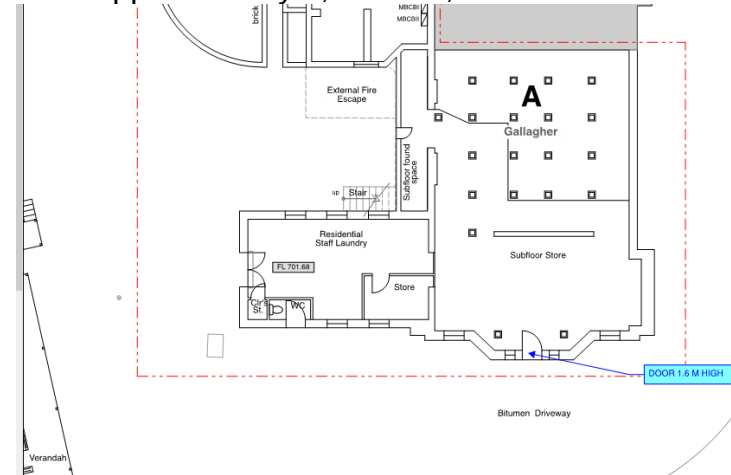
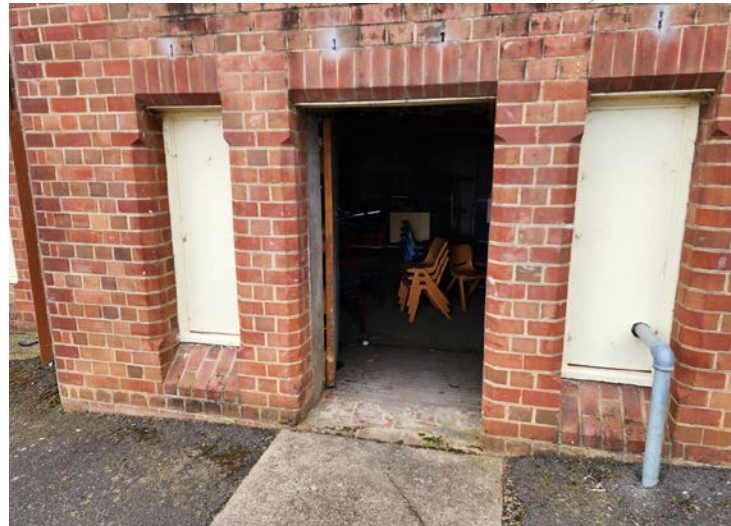
Block A – Basement

The existing unobstructed height of the doorway to the subfloor store is approximately 1,600 mm, which is less than 1,980 mm.

It is recommended no upgrades occur to the existing external doorway due to the heritage value of the external walls and the infrequent use of the subfloor space.

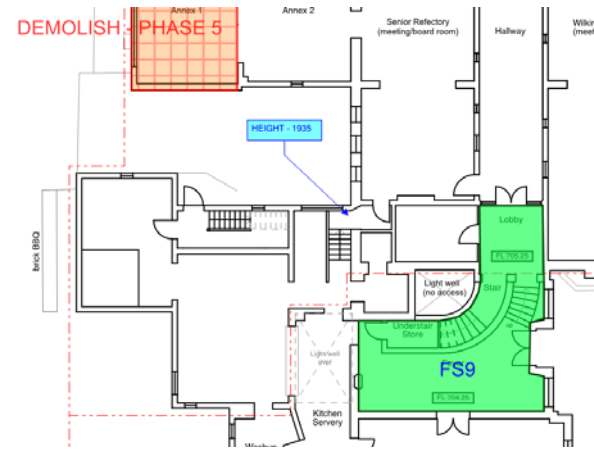
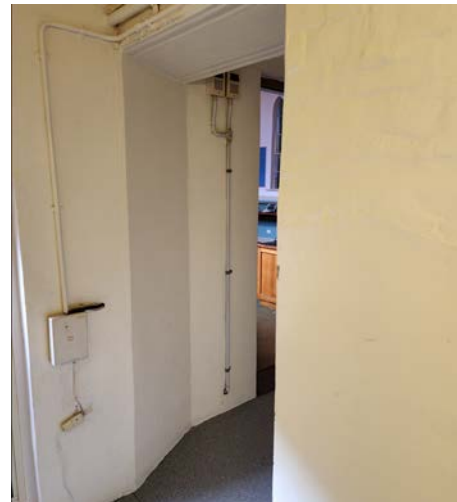
**Block A – Ground Storey (Internal)**

The existing internal pathway located between the senior refectory and kitchen area has an unobstructed height of 1,935 mm, in lieu of 2 m, which is contrary to D2D7.

It is recommended the reduced egress height be upgraded to comply with the Performance Requirements of the BCA via a Performance Solution prepared by a Certifier – Fire Safety.

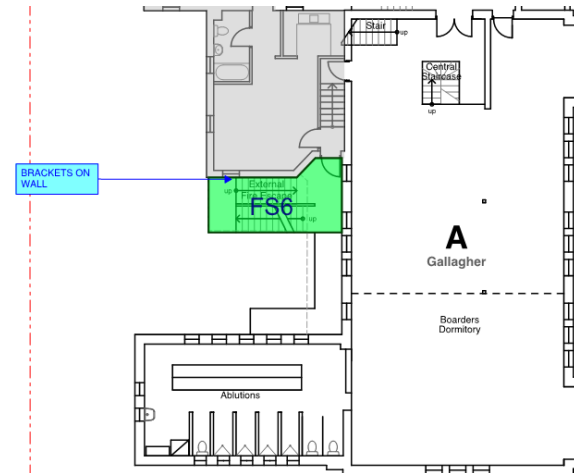
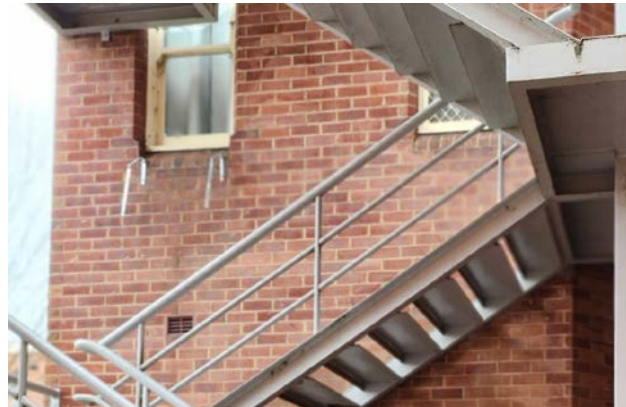
**Block A – First Storey – Fire Stair 6**

The path of travel on fire stair 6 neat the mid-landing on the First Storey is obstructed by two brackets attached to the external wall of the building. The brackets are located within 2 m (measured vertically above the stairway) and obstruct the height of the stairway, which is contrary to D2D7.

It is recommended the existing brackets attached to the external wall of the building (under the window) on the First Storey be removed to comply with D2D7.

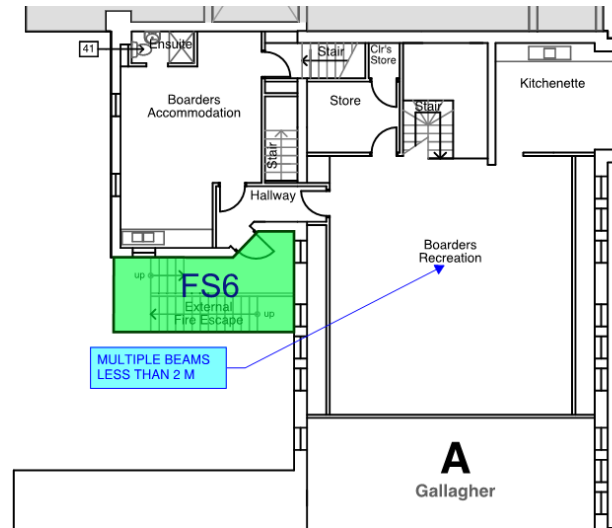
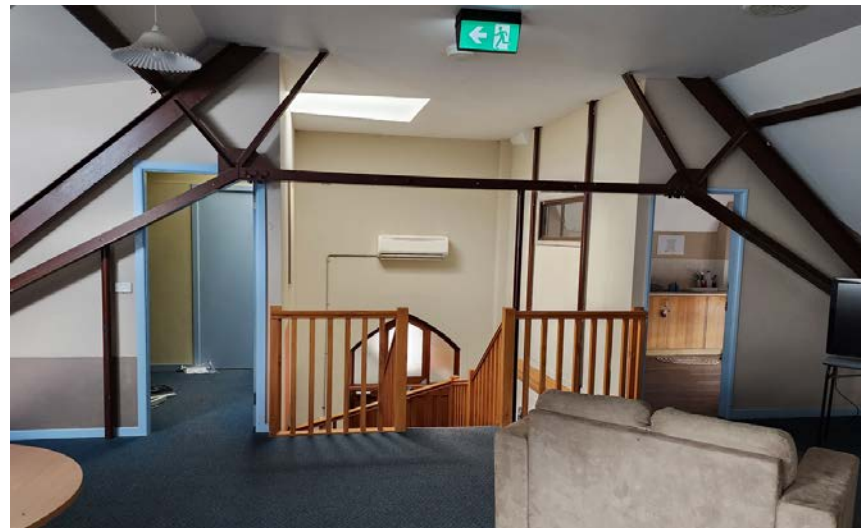
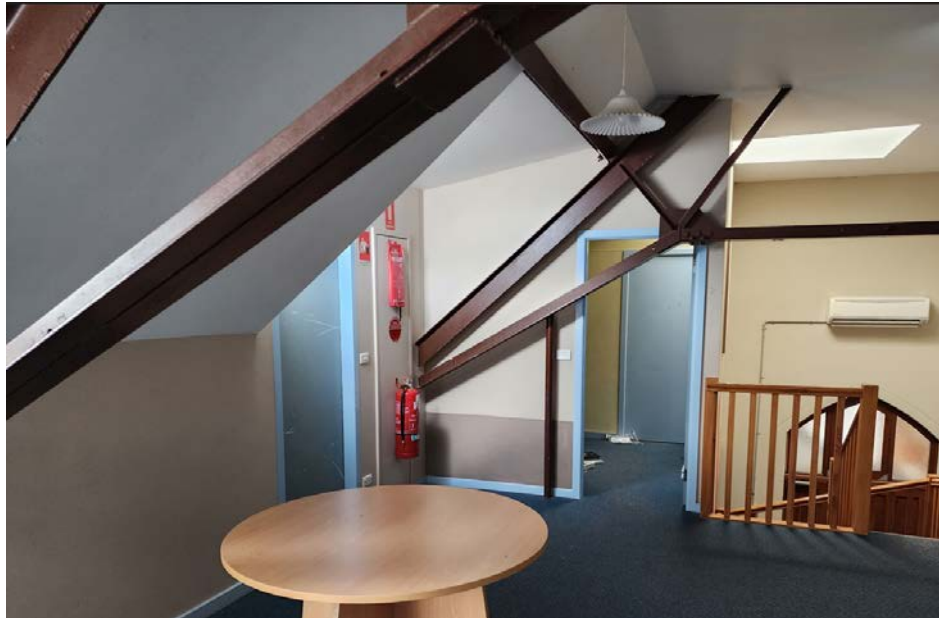
Block A – Second Storey – Boarders Recreation

The existing boarder's recreation space located on the Second Storey of Block A contains multiple metal beams that are located within 2 m of the finished floor, which is contrary to D2D7.

It is recommended discussions occur with the structural engineer to confirm if the existing steel beams can be removed and/ or altered to at least 2 m above the finished floor.

It is recommended the reduced egress height be upgraded to comply with the Performance Requirements of the BCA via a Performance Solution prepared by a Certifier – Fire Safety.

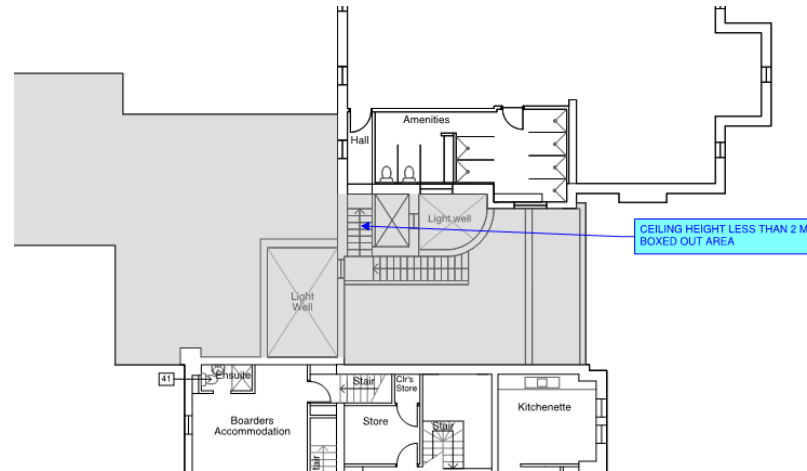
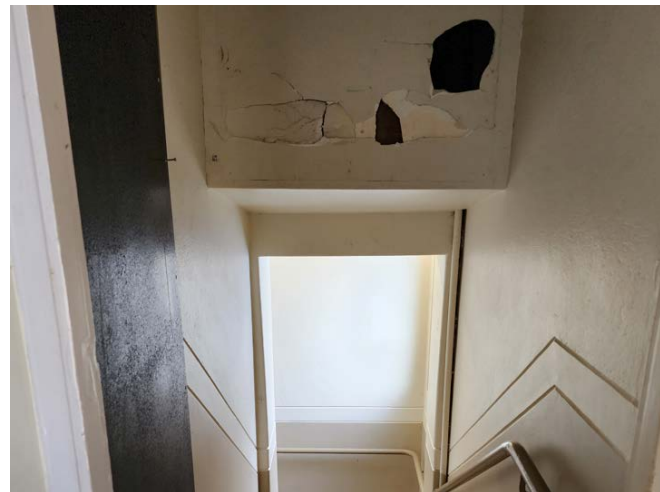
**Block A – Second Storey – Fire Stair 9**

The unobstructed height above the top flight of fire stair 9 located on the Secondary Storey is less than 2 m, which is contrary to D2D7.

It is recommended the non-required and damaged plasterboard box be removed to ensure the unobstructed height on the stairway is at least 2 m to comply with D2D7.

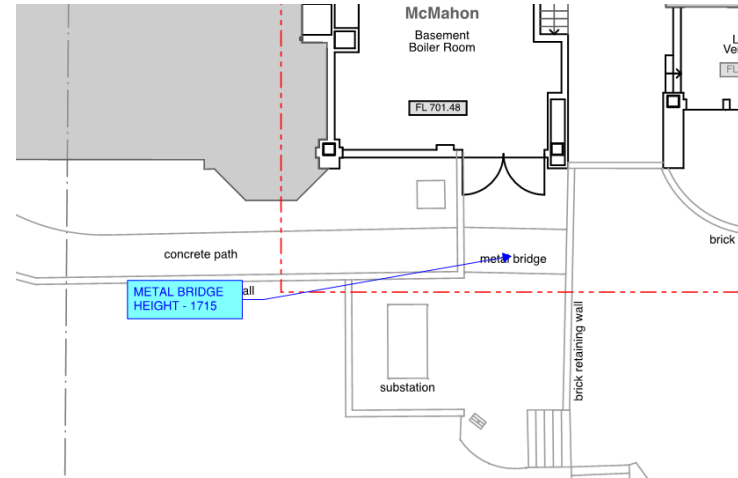
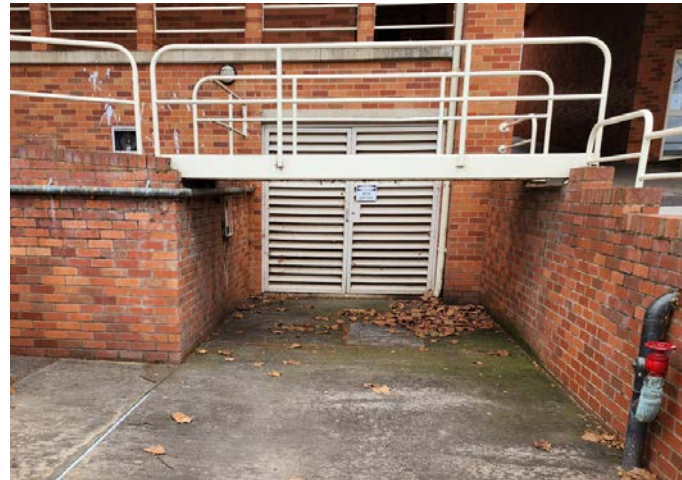
**Block F – External Bridge – Boiler Room**

The unobstructed height under the metal bridge near the boiler room is 1,715 mm, in lieu of 2 m, which is contrary to D2D7.

It is recommended the existing unobstructed height under the bridge not be upgraded as the boiler room is used infrequently, the bridge is external to the building and the boiler room is only intended to be used by trained professionals.

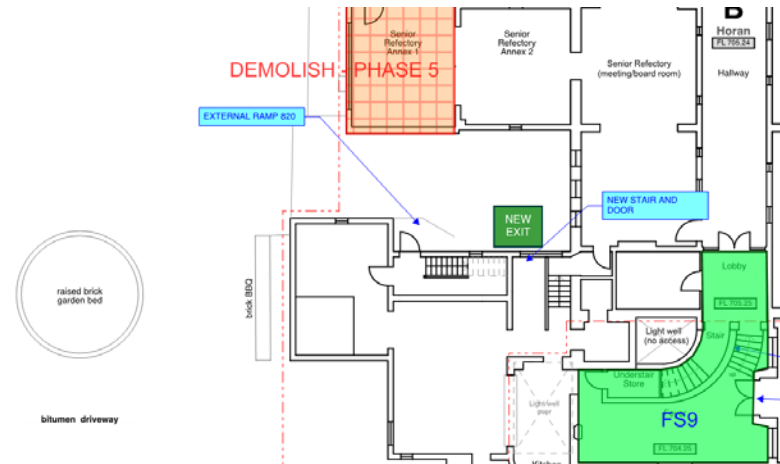
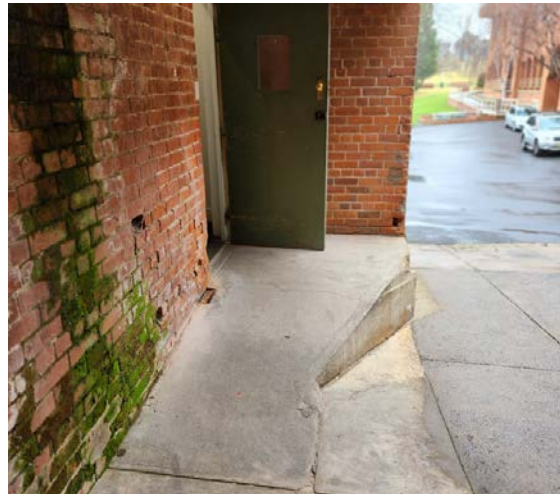
Block A – Ground Storey (External)

The existing external ramp located at the rear of the kitchen on the Ground Storey has an unobstructed width of 820 mm.

It is recommended the ramp not be upgraded as a new stairway, door and exit is proposed to be installed in an adjacent location and the existing ramp will not be serving as a part of a required exit.

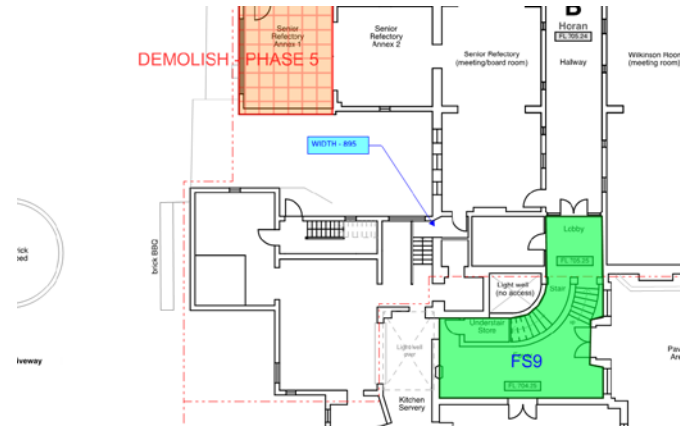
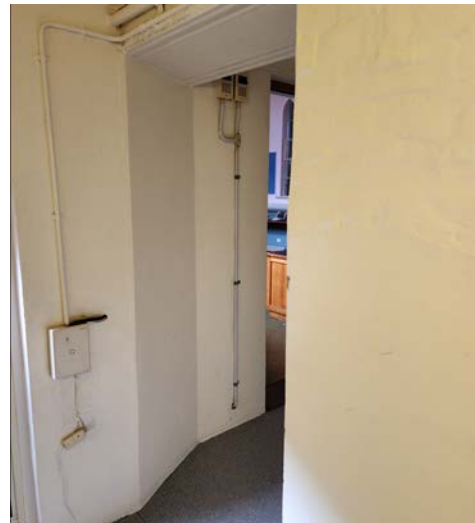
**Block A – Ground Storey (Internal)**

The existing internal pathway located between the senior refectory and kitchen area has an unobstructed width of 895 mm, in lieu of 1 m, which is contrary to D2D8(1)(a).

It is recommended the reduced egress width be upgraded to comply with the Performance Requirements of the BCA via a Performance Solution prepared by a Certifier – Fire Safety.

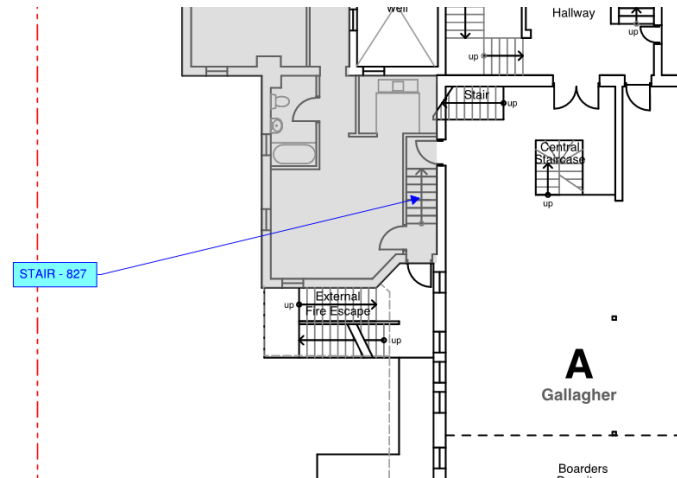
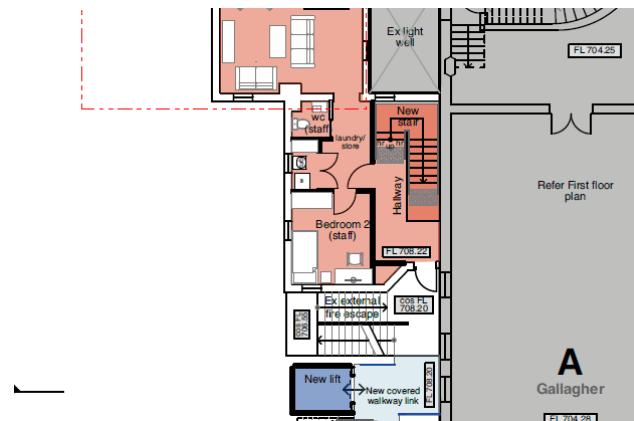
**Block A – Upper Ground Storey – Stairway**

The existing stairway located in the Upper Ground Storey of Block A has an unobstructed width of 827 mm, in lieu of 1 m, which is contrary to D2D8(1)(a).

No upgrade works are recommended as the existing stairway is proposed to be demolished and reconstructed as part of the refurbishment works.

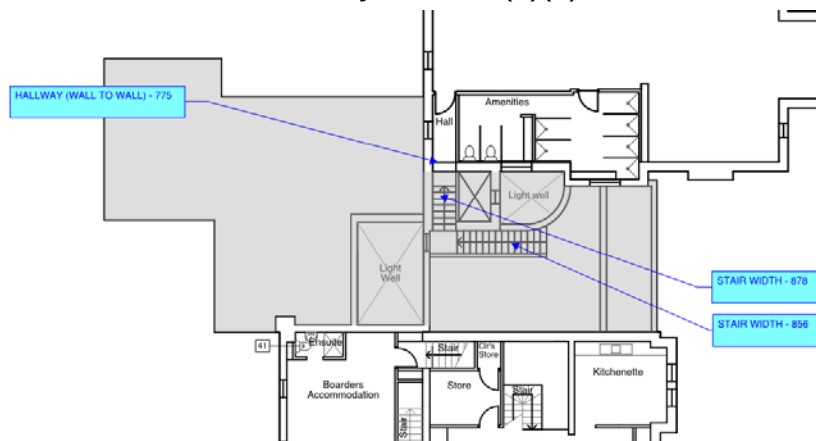
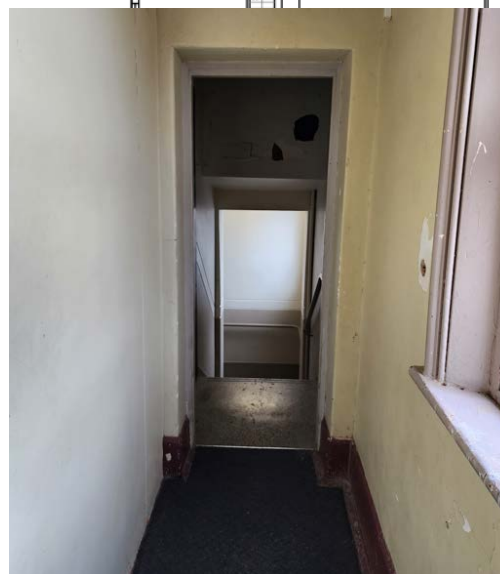
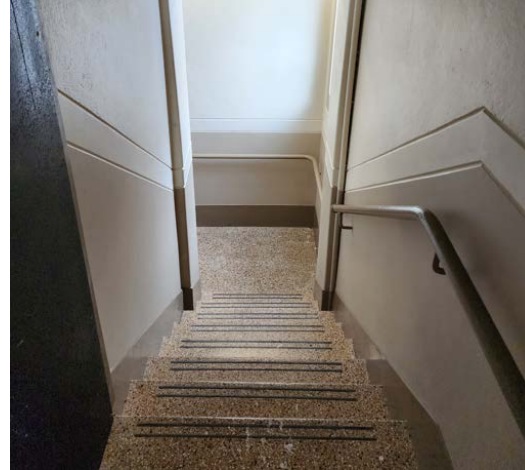
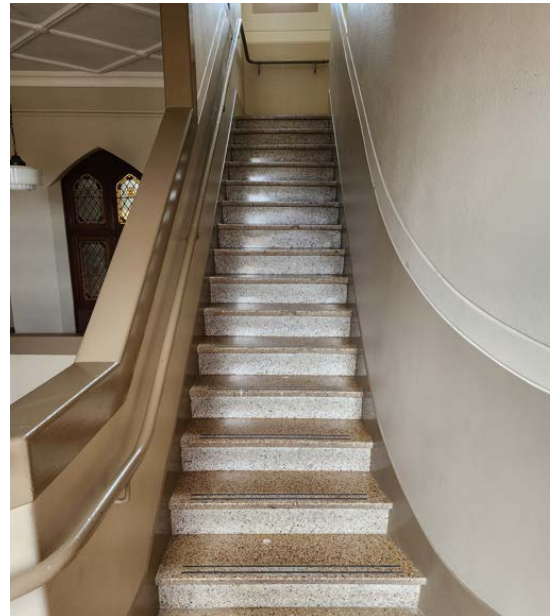
The two flights of stairs serving the Second Storey in fire stair 9 has an unobstructed width vary between 878 mm and 856 mm, in lieu of 1 m, which is contrary to D2D8(1)(a). The associated hallway located at the top of the stairway has a width of 775 mm, in lieu of 1 m, which is contrary to D2D8(1)(a).

It is recommended the reduced egress width be upgraded to comply with the Performance Requirements of the BCA via a Performance Solution prepared by a Certifier – Fire Safety.

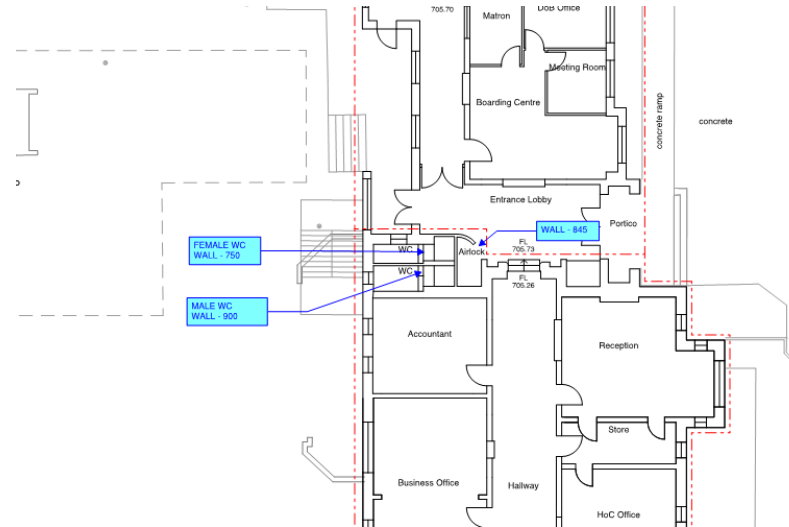
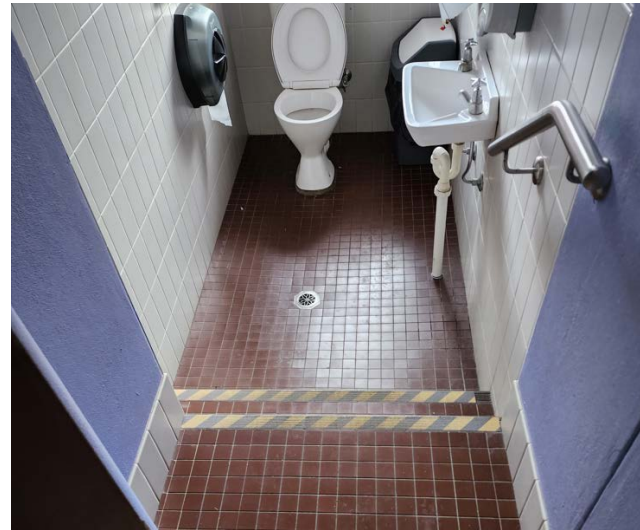
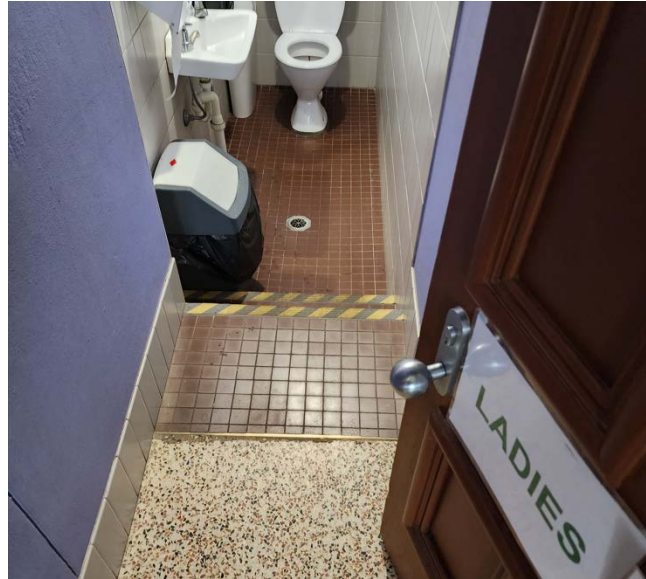
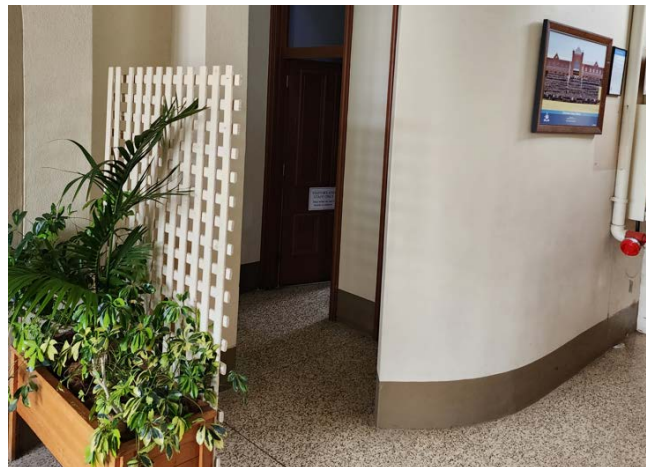
### Block D – Sanitary Compartments

The unobstructed egress width from the sanitary facilities on the Ground Storey of Block D vary between 760 mm and 845 mm, in lieu of 1 m, which is contrary to D2D8(1)(a).

It is recommended the reduced egress width be upgraded to comply with the Performance Requirements of the BCA via a Performance Solution prepared by a Certifier – Fire Safety.

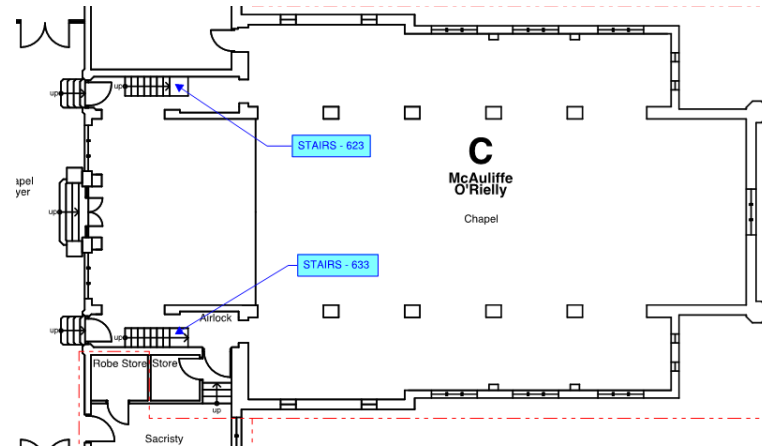
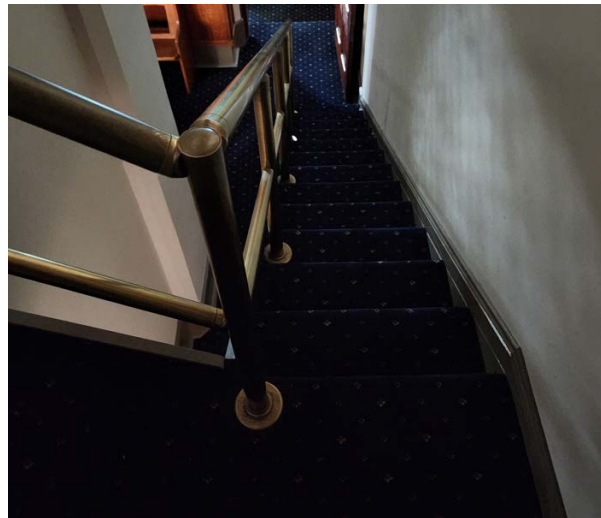
**Block C – Second Storey – Choir Loft**

The unobstructed egress width on the stairways from the choir loft on the Second Storey is 623 mm and 633 mm, in lieu of 1 m, which is contrary to D2D8(1)(a).

It is recommended the reduced egress width be upgraded to comply with the Performance Requirements of the BCA via a Performance Solution prepared by a Certifier – Fire Safety.

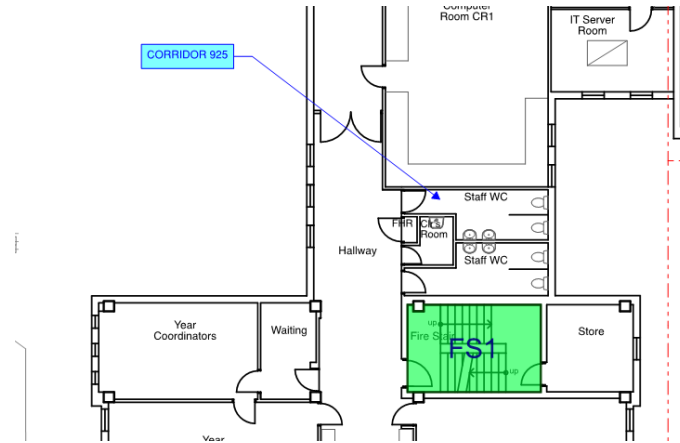
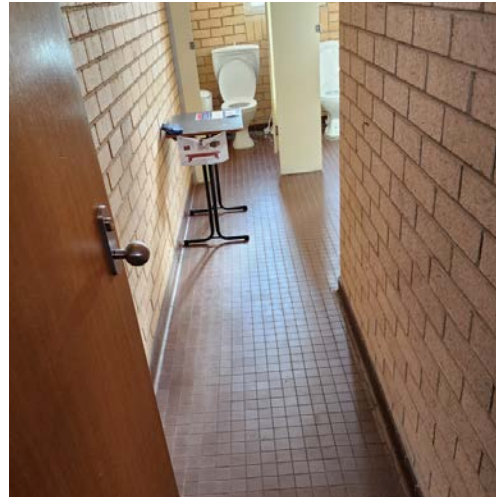
**Block F – First Storey – Staff WC**

The unobstructed egress width in the hallway from the staff WC on the Ground Storey of Block F is 925 mm, in lieu of 1 m, which is contrary to D2D8(1)(a).

It is recommended the reduced egress width be upgraded to comply with the Performance Requirements of the BCA via a Performance Solution prepared by a Certifier – Fire Safety.

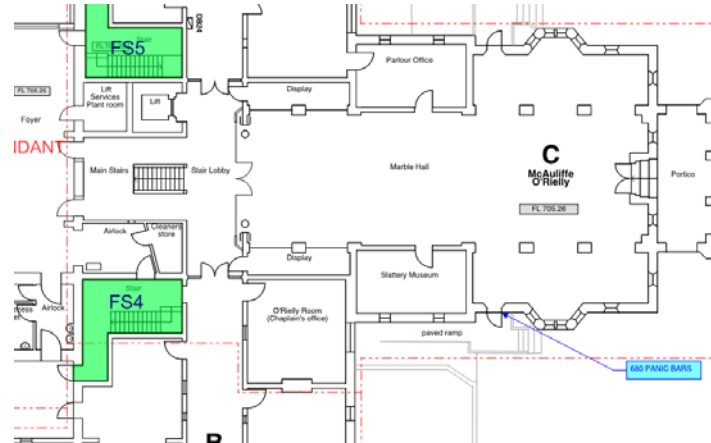
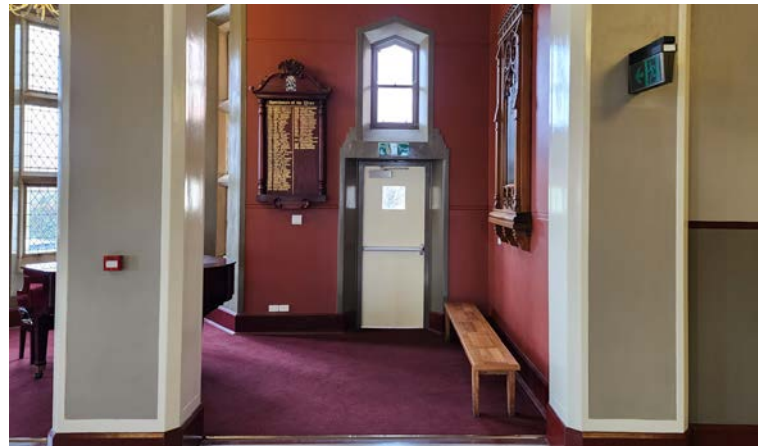
The existing external doorway in the southern wall of the marble hall has been setup as an exit. The doorway has an unobstructed width of 680 mm, in lieu of 750 mm, which is contrary to NSW D2D9(f).

It is recommended the existing door not be used as an exit as it is not required by the BCA. It is recommended the existing exit signage be removed.

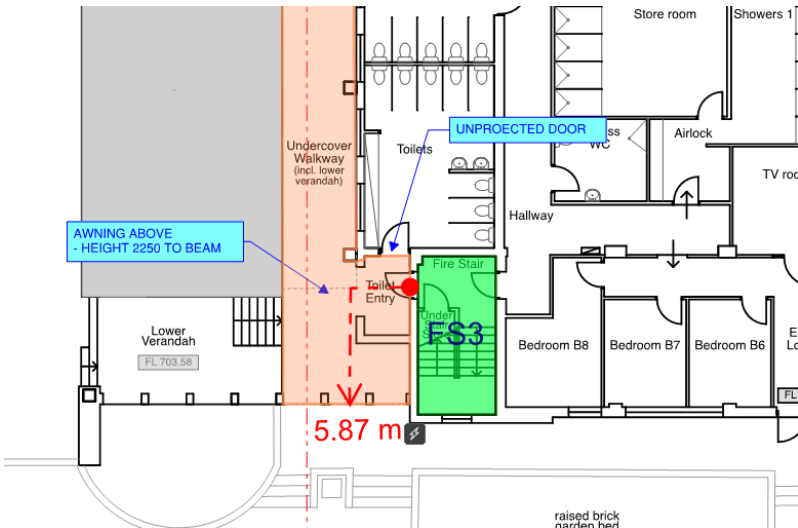
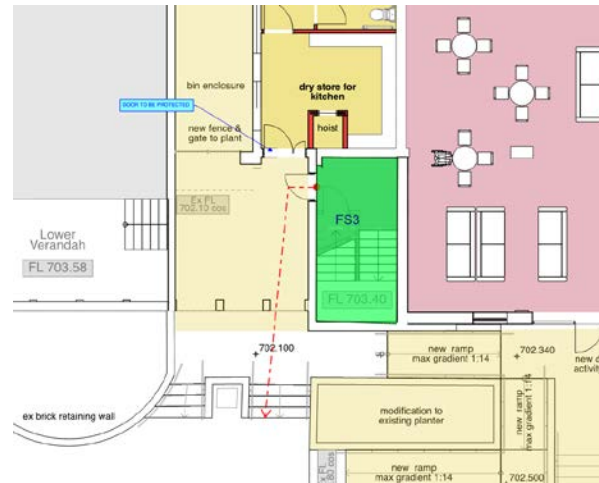
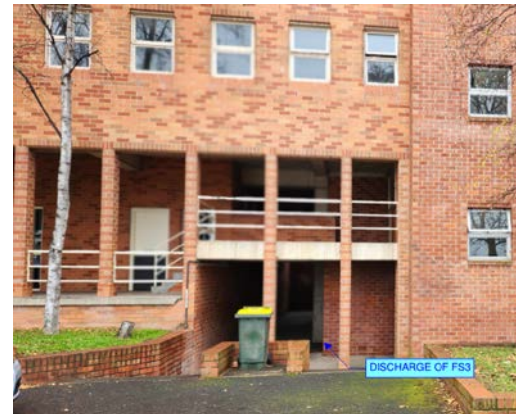
| <p>D2D12<br/>[D1.7]</p> | <p>Travel via fire-isolated exits</p> | <p><u>Fire Stair 3 – Ground Storey - Discharge</u><br/>Fire stair 3 currently has two points of discharge, being the Ground Storey and Basement. This is proposed to be rectified as part of the proposed development and the only point of discharge will be at the basement (lowest level). No further upgrade is recommended.</p> <p><u>Fire Stair 3 – Basement - Discharge</u><br/>The marked up floor plan shows the existing configuration for egress from fire stair 3. The discharge location is not open for at least 1/3 of the perimeter and does not have an unobstructed clear height throughout of at least 3 m.</p> <p>Additionally, the existing door to the toilets is not a self-closing fire door that achieves an FRL of at least -/60/30.</p> <p>The following marked up floor plan shows the proposed configuration. The discharge location is not open for at least 1/3 of the perimeter and does not have an unobstructed clear height throughout of at least 3 m, which is contrary to D2D12(c).</p> | <p><b>No Upgrade</b></p> <p><b>Upgrade Recommended/<br/>Performance Solution</b></p> |

It is recommended the discharge location (into the awning) of fire stair 3 be upgraded to comply with the Performance Requirements of the BCA via a Performance Solution prepared by a Certifier – Fire Safety.

It is also recommended the proposed door to the dry store for the kitchen achieve is a self-closing fire door that achieves an FRL of at least -/60-30 to comply with D2D12(3).

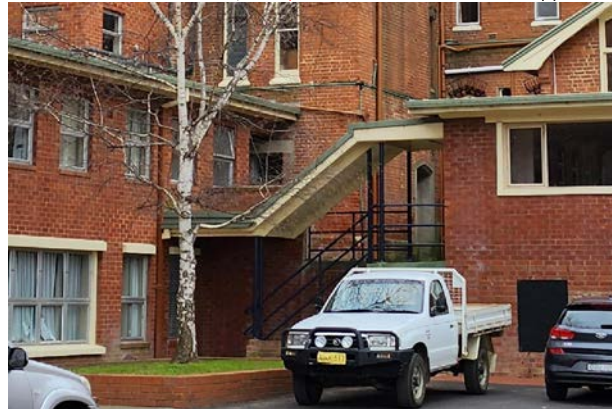
### Fire stair 3 and 4 – Additional External Stairs

Fire stair 3 and 4 discharge to a level that requires the occupants to use an additional external non-fire-isolated flight of stairs to reach the level of open space, which is contrary to D2D12(2).

It is also recommended the use of additional external stairway by occupants of fire stair 3 and 4 be upgraded to comply with the Performance Requirements of the BCA via a Performance Solution prepared by a Certifier – Fire Safety.

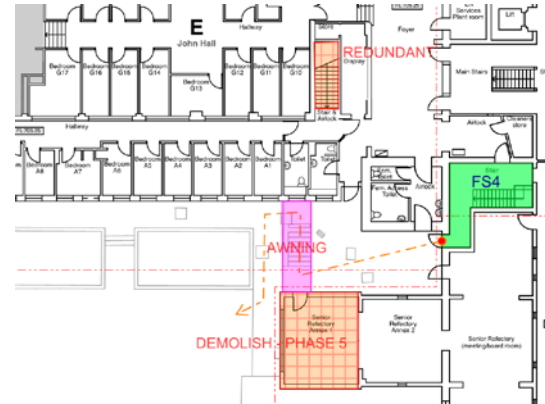
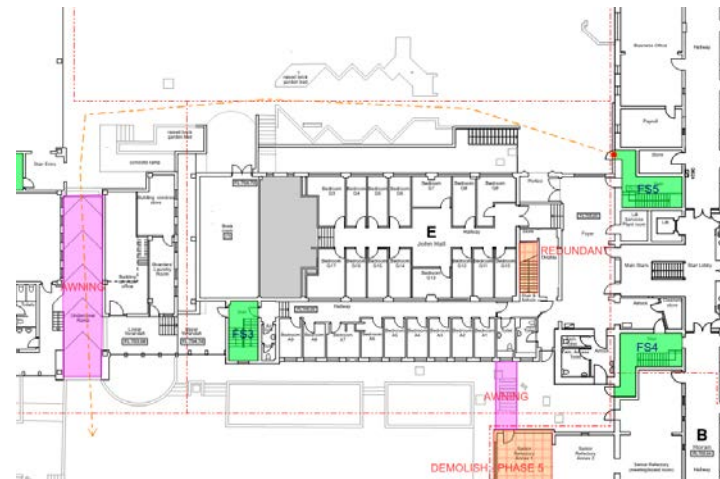
### Fire Stair 4 and 5 – Travel Under Awnings

Occupants discharging from fire stair 4 and 5 are required to pass under external awnings before reaching the road, which is contrary to D2D12(2). The awnings are highlighted in purple on the plans below.

It is recommended occupants passing under the awnings be upgraded to comply with the Performance Requirements of the BCA via a Performance Solution prepared by a Certifier – Fire Safety.
