# FIRE SAFETY UPGRADE STRATEGY REPORT

220 Bentinck Street, BATHURST NSW 2795

| <b>Client:</b> | St Stanislaus College |
| <b>Reference:</b> | 23175 |

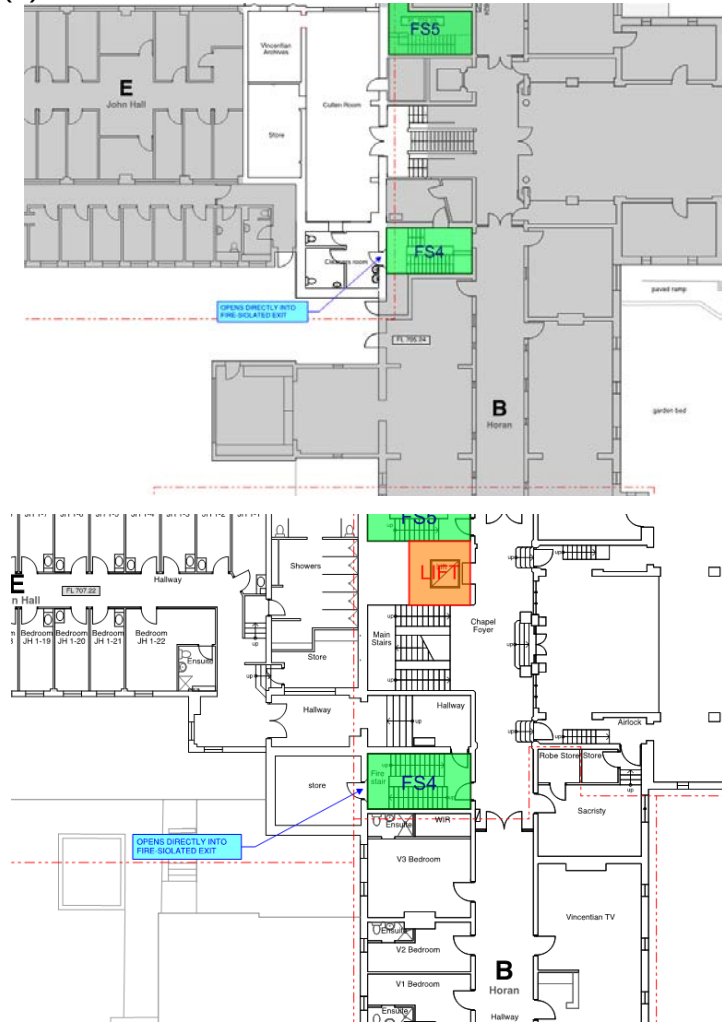
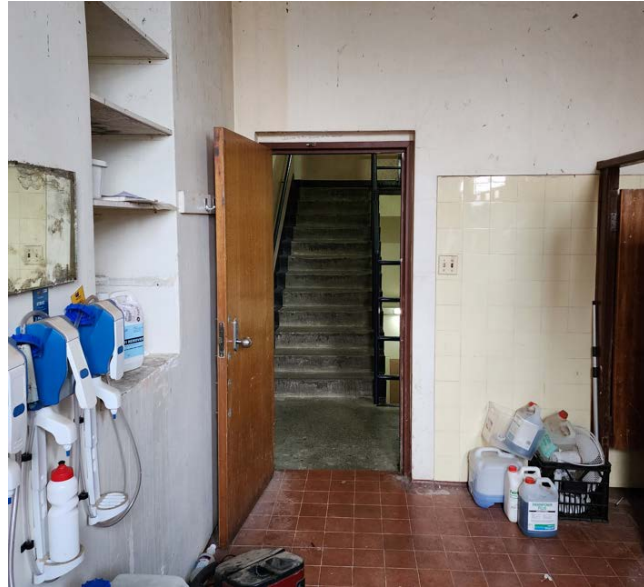
Fire Stair 4 – Rooms opening into the exit

Fire stair 4 contains store rooms that are accessed via doorways located on the mid-landings of the fire-isolated exit. The doorways open directly into the fire-isolated exits, which is contrary to D2D12(1).

It is recommended the rooms opening directly into the fire-isolated exits be upgraded to comply with the Performance Requirements of the BCA via a Performance Solution prepared by a Certifier – Fire Safety.

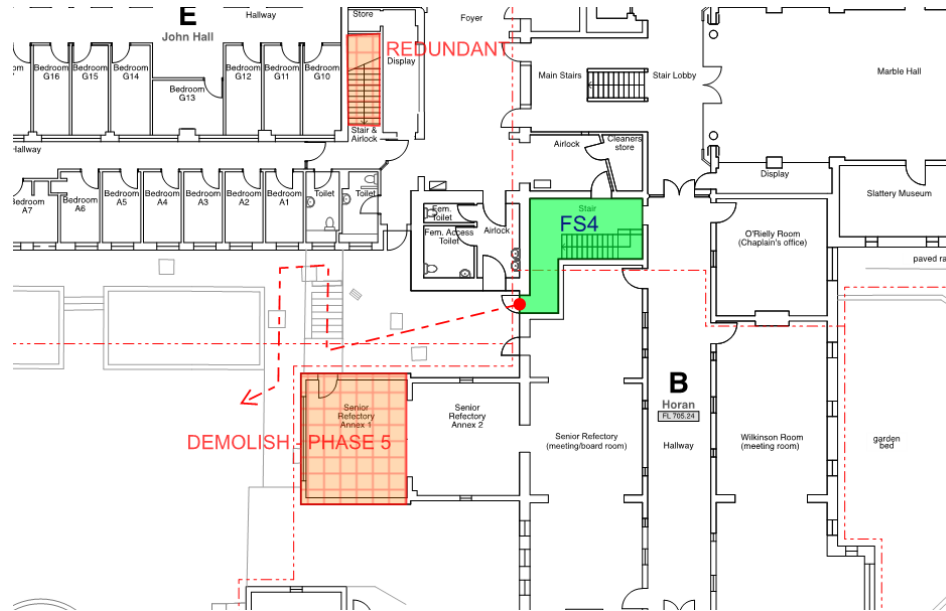
#### Fire Stair 4 – Protection

Fire stair 4 discharges into a courtyard that contains multiple unprotected openings. The openings are located within 6 m (measured at right angles) and less than 3 m above the path of travel. The marked up floor plan shows the discharge location and path of travel to the open space.

The Senior Refectory is proposed to be demolished in Phase 5 and no upgrades are recommended to this part of the building.

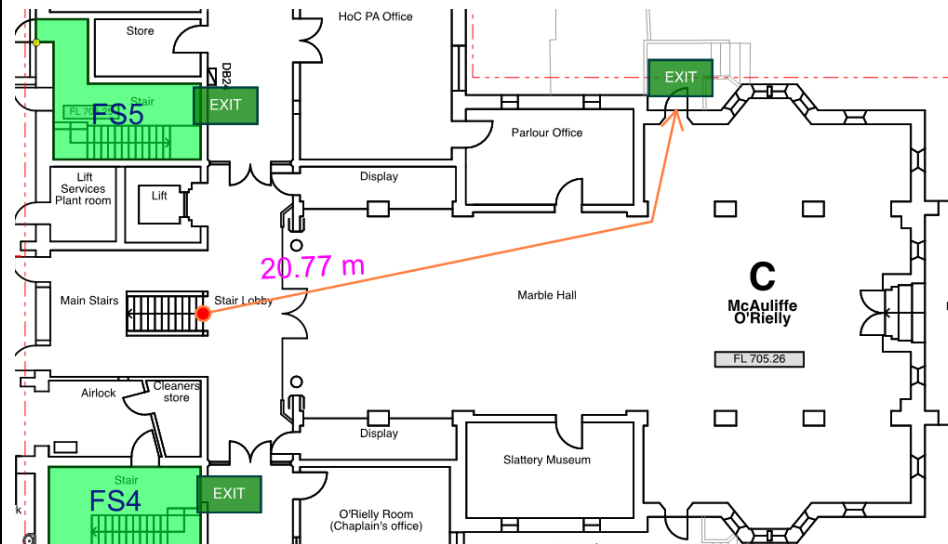
The main stairs serve as a required exit from the First Storey Chapel (due to the required minimum egress width). The non-fire-isolated stairway discharges into part of the building that is not only used for pedestrian movement and is located more than 20 m from the exit to the road/ open space, which is contrary to D2D12(2)(b).

It is recommended the discharge location of the main stairs (non-fire-isolated stairs) be upgraded to comply with the Performance Requirements of the BCA via a Performance Solution prepared by a Certifier – Fire Safety.

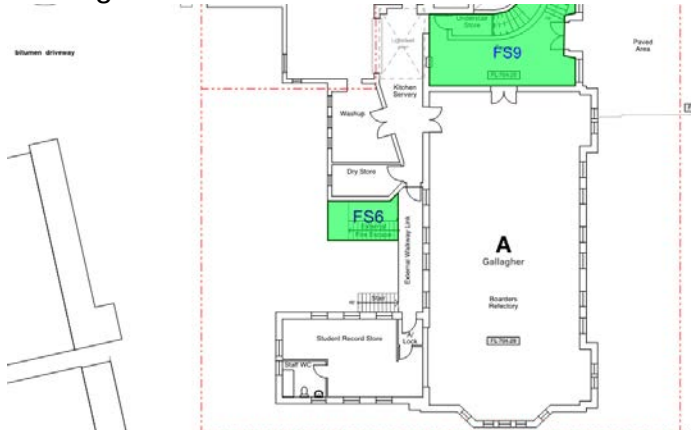
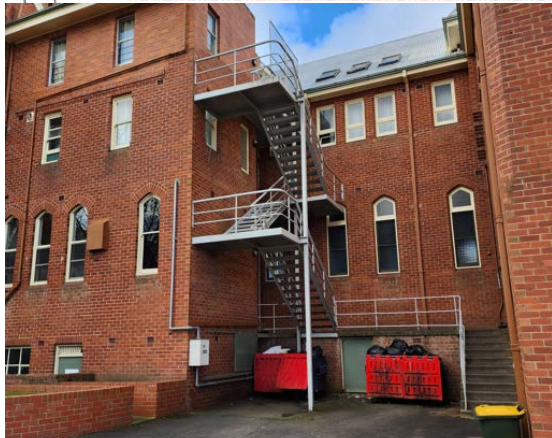
| <p>D2D13<br/>[D1.8]</p> | <p>External stairways or ramps in lieu of fire-isolated exits</p> | <p><u>Block A - Fire Stair 6 - General</u></p> <p>The existing building includes an external non-fire-isolated stairway serving as a required exit. The stairway is located in Block A and identified as fire stair 6.</p> <p>The stairway is constructed of a steel frame between the Second Storey and Ground Storey. The stairway then continues from the Ground Storey along a concrete pathway and down a masonry stairway to the ground.</p> | <p><b>Noted</b></p> |

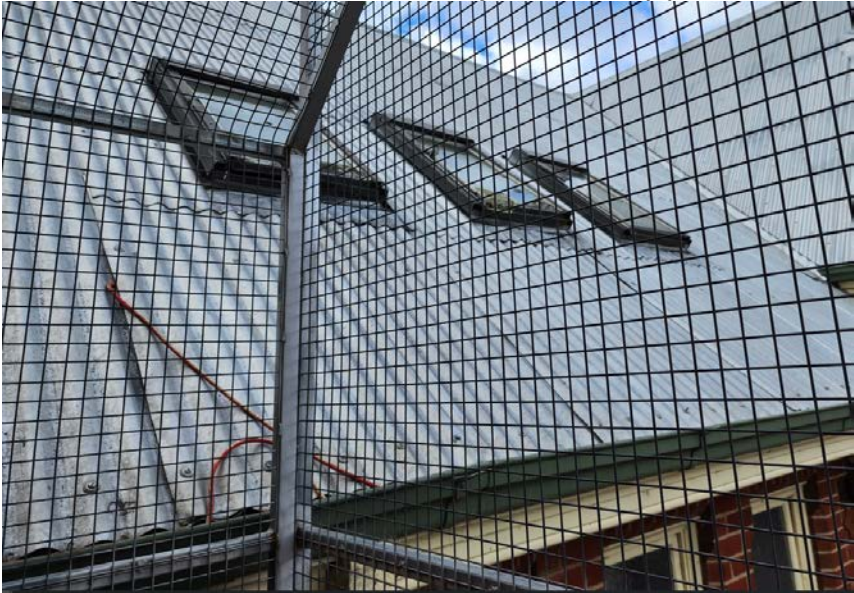
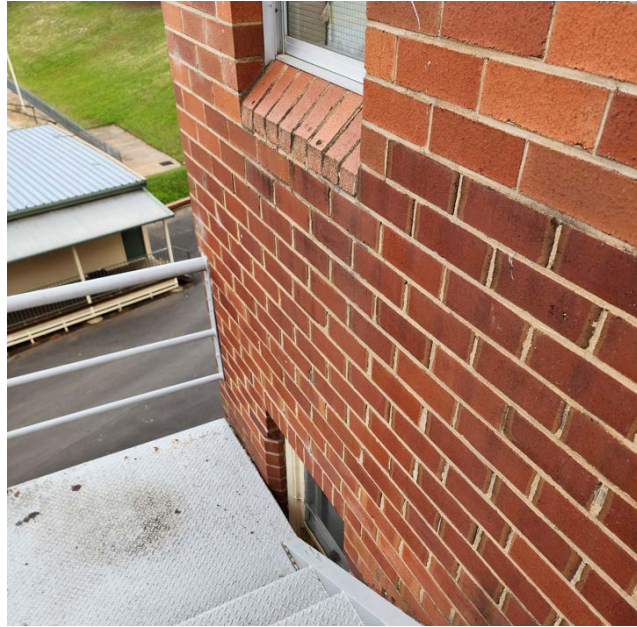
| | | <p><u>Exposure - walls</u><br/>The stairway is located within 6 m of, and exposed to, parts of the external walls of the building it serves. The external walls are of masonry construction and likely to achieve a FRL of at least 60/60/60.</p> <p>It is recommended no upgrade occur to the existing masonry external walls of the building that are located within 6 m of fire stair 6.</p> <p><u>Exposure - roof</u><br/>The corrugated roof and skylights are unlikely to achieve a FRL of at least 60/60/60, which is contrary to D2D13(3).</p> <p>It is recommended the existing roof and skylights be upgraded to comply with the Performance Requirements of the BCA via a Performance Solution prepared by a Certifier – Fire Safety. This is likely to rely upon the proposed sprinkler system.</p> | <p><b>No Upgrade</b></p> <p><b>Performance Solution</b></p> |

It is recommended the openings located more than 3 m, but less than 6 m from the stairway and pathway be fixed shut and protected with internal wall-wetting sprinklers to comply with D2D13(3).

It is recommended the existing window openings located within 3 m be upgraded to comply with the Performance Requirements of the BCA via a Performance Solution prepared by a Certifier – Fire Safety. This is likely to rely upon the proposed sprinkler system and possibly radiant heat shields or internal wall wetting sprinklers.

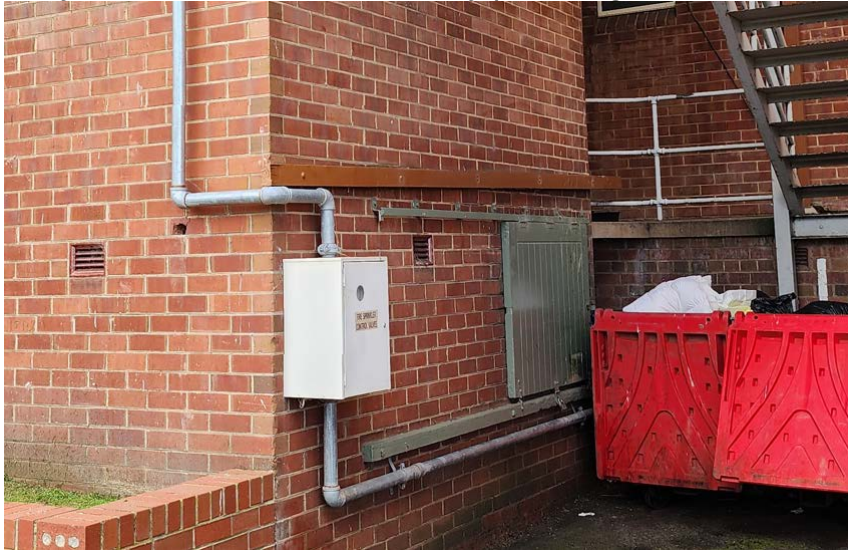
| | | <p><u>Exposure – opening</u></p> <p>The external wall of the basement contains an opening protected by a timber sliding door that is exposed to the stairway and pathway. The timber door is currently painted green.</p> <p>It is recommended the existing opening be blocked up with masonry construction to achieve a FRL of at least 60/60/60.</p> | <p><b>Upgrade<br/>Recommended</b></p> |

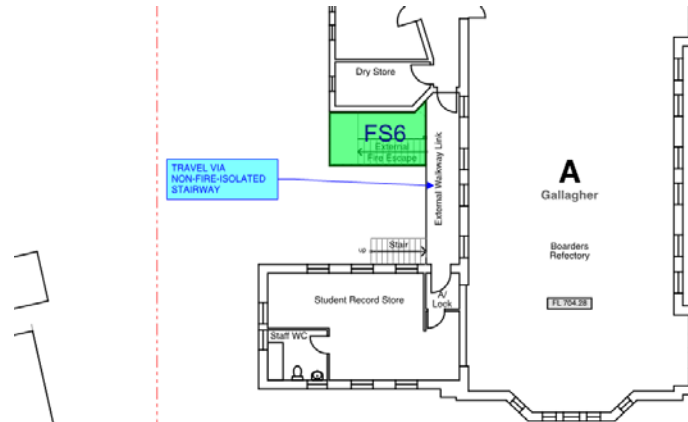
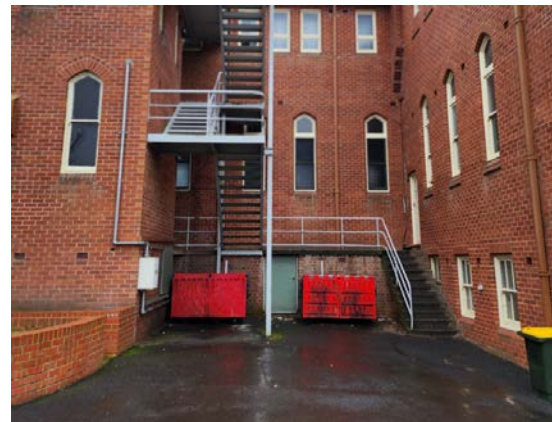
**Block A – Ground Storey – Fire Stair 6**

The existing external stairway (fire stair 6) contains a walkway that join the two stairs together at the Ground Storey. The stairway does not provide a continuous means of travel by its own flights and landings to the level at which egress to a road or open space is provided, which is contrary to D2D14(1).

It is recommended the existing non-fire-isolated stairway be upgraded to comply with the Performance Requirements of the BCA via a Performance Solution prepared by a Certifier – Fire Safety.

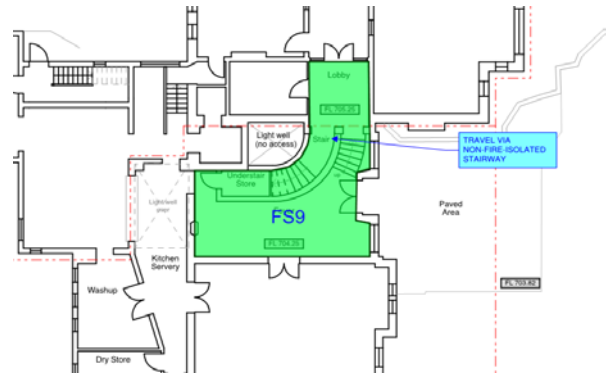
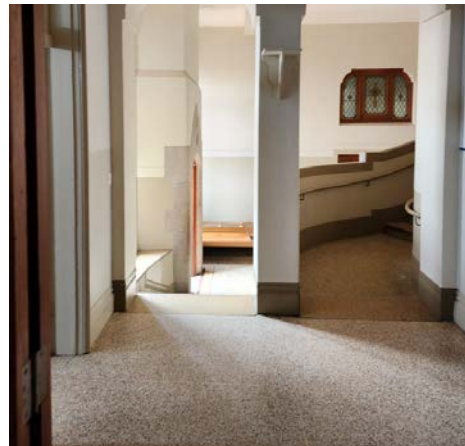
**Block A – Ground Storey/ First Storey – Fire Stair 9**

The existing internal stairway (fire stair 9) contains multiple pathways that join the flights of stairs together. The pathways are not landings. The stairway does not provide a continuous means of travel by its own flights and landings to the level at which egress to a road or open space is provided, which is contrary to D2D14(1).

It is recommended the existing non-fire-isolated stairway be upgraded to comply with the Performance Requirements of the BCA via a Performance Solution prepared by a Certifier – Fire Safety.

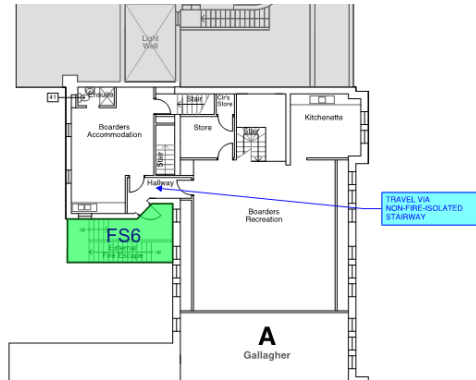
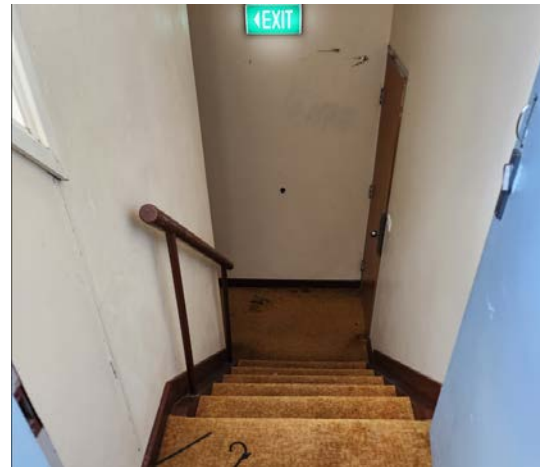
**Block A – Second Storey – Boarders Recreation**

The existing internal stairway serving the boarders recreation room in Block A on the Second Storey does not provide a continuous means of travel by its own flights and landings to the level at which egress to a road or open space is provided, which is contrary to D2D14(1).

It is recommended the existing non-fire-isolated stairway be upgraded to comply with the Performance Requirements of the BCA via a Performance Solution prepared by a Certifier – Fire Safety.

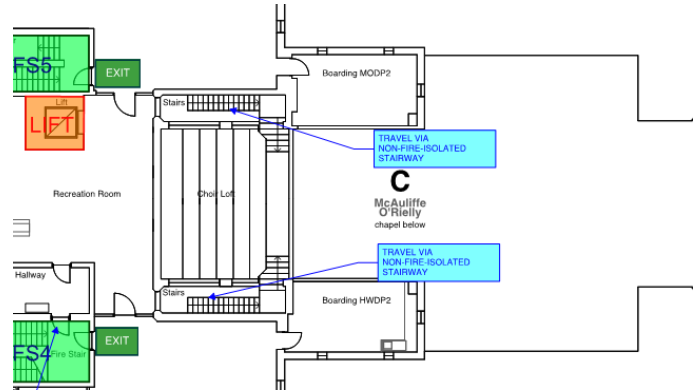
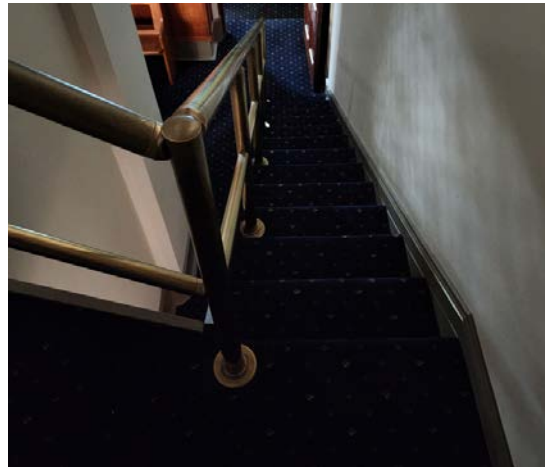
### Block C – Second Storey – Choir Loft

The existing stairways serving the choir loft on the Second Storey of Block C do not provide a continuous means of travel by its own flights and landings to the level at which egress to a road or open space is provided, which is contrary to D2D14(1).

It is recommended the existing non-fire-isolated stairways be upgraded to comply with the Performance Requirements of the BCA via a Performance Solution prepared by a Certifier – Fire Safety.

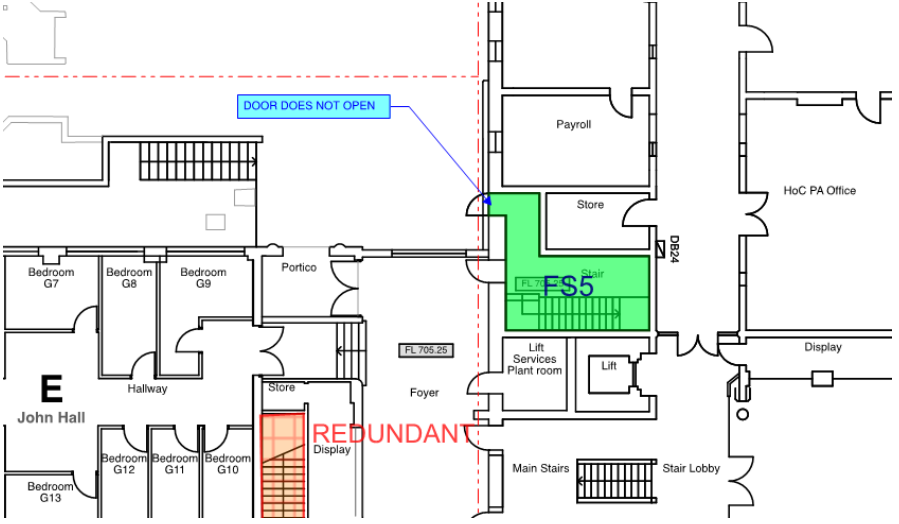
| <p>D2D15<br/>[D1.10]</p> | <p>Discharge from exits</p> | <p><u>Point of discharge</u><br/>The point of discharge (external doorway) located at the ground storey in Block C – Fire Stair 5 was jammed shut and unable to be opened.</p> <p>It is recommended the door be repaired and unblocked so it is operable from within the fire stair to comply with D2D15.</p> <p><u>Ramps</u><br/>Refer to the comments in D3D11 of this report regarding the external pedestrian ramps.</p> | <p><b>Upgrade<br/>Recommended</b></p> <p><b>Noted</b></p> |

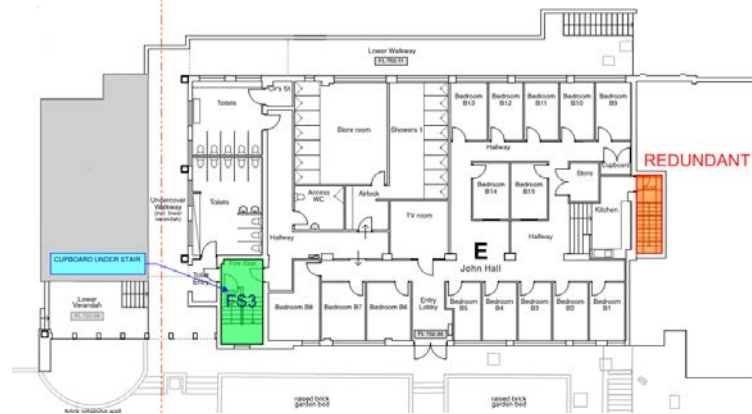
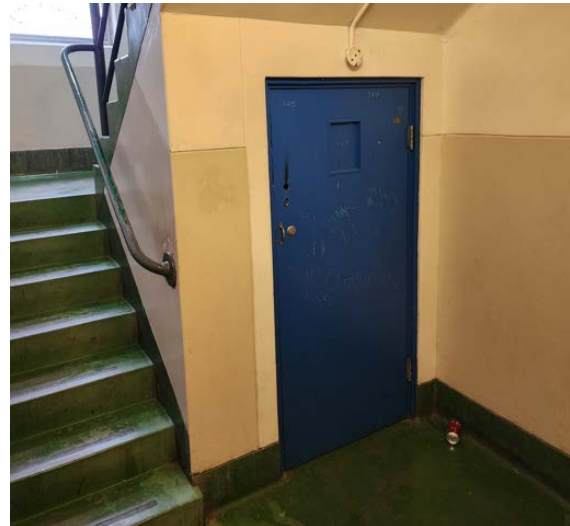
Block E - Basement – Fire Stair 3

The existing building contains multiple spaces under stairs that have been enclosed to form cupboards and the like.

It is recommended the existing cupboard door at the bottom of fire stair 3 be removed so the space is not enclosed to comply with D3D9(1).

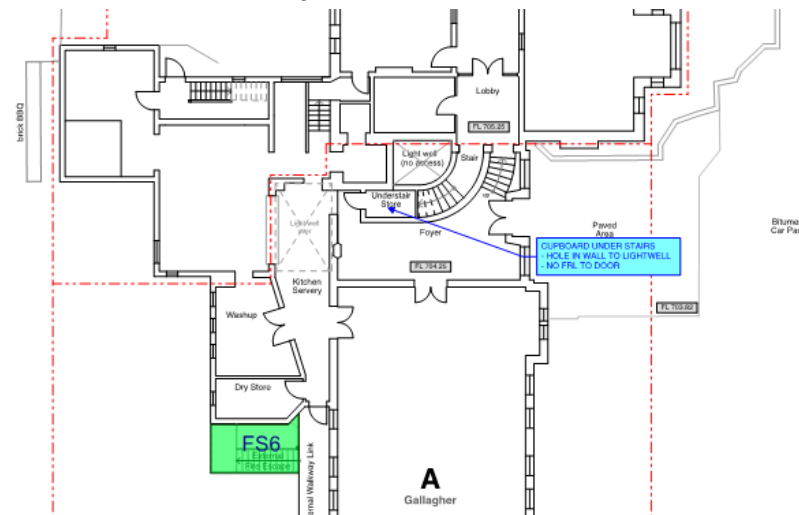
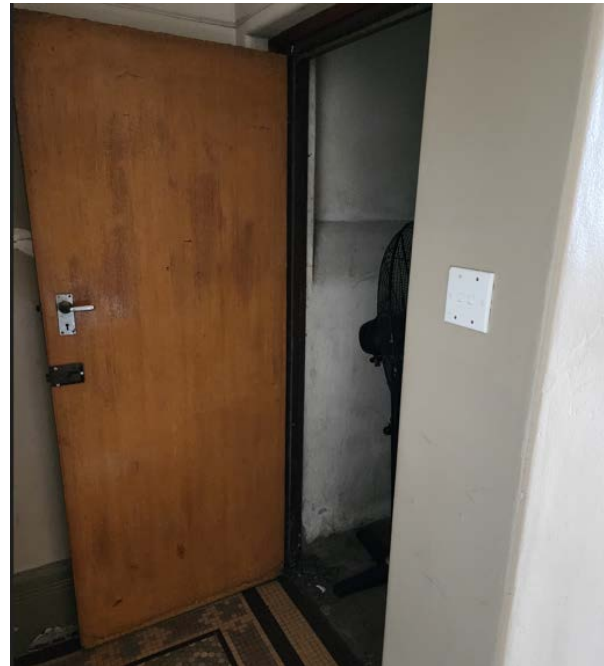
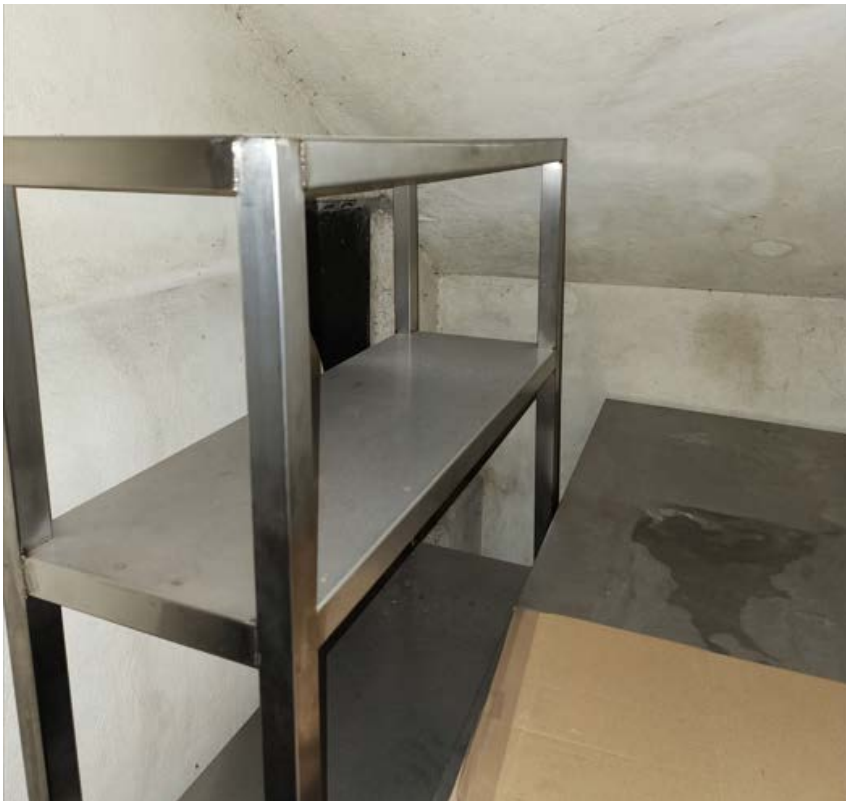
**Block A – Ground Storey – Fire Stair 9**

**Upgrade  
Recommended**

| | | <p>It is recommended the existing hole (appears to be opening into the light well) be blocked up to achieve a FRL of at least 60/60/60 and the door under fire stair 9 be replaced with a self-closing - /60/30 fire door to comply with D3D9(2).</p> | |

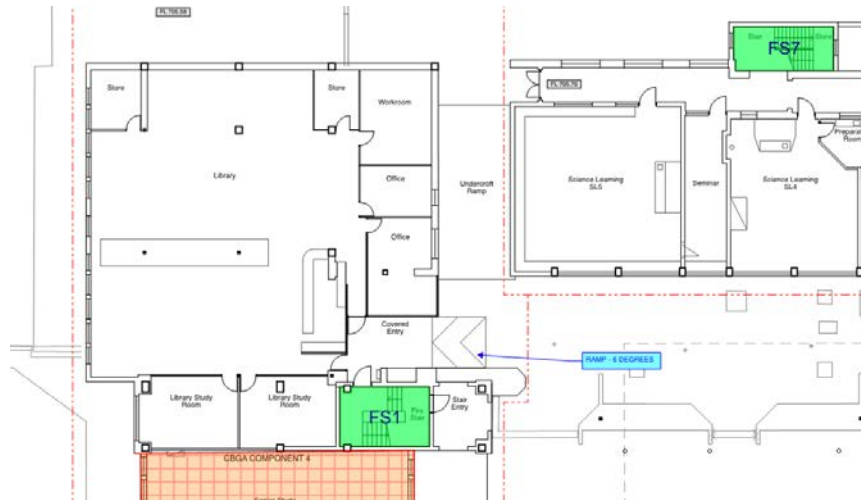
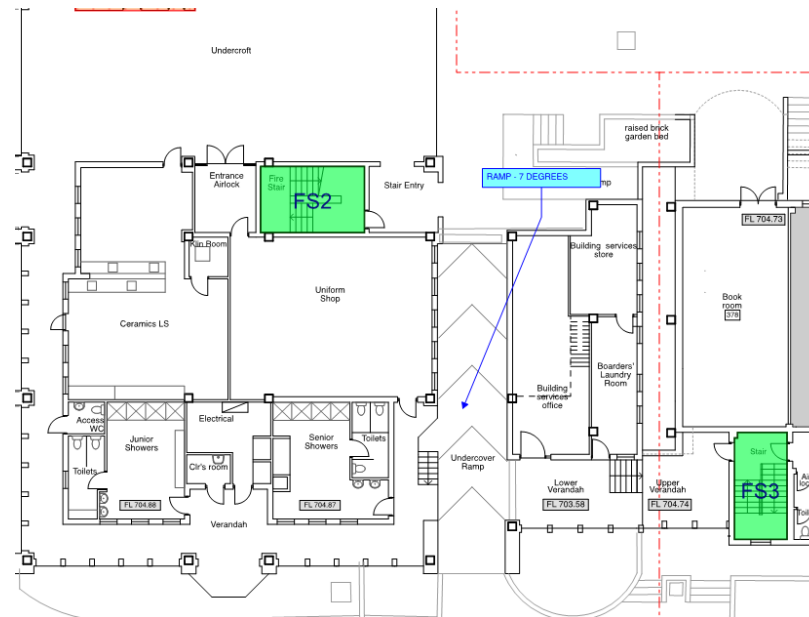
| D3D11<br>[D2.10] | Pedestrian ramps | The existing building contains two ramps located near Block F that form part of the exit. The ramps have a gradient of 6 degrees and 7 degrees, which are not steeper than 1:8. | <b>No Upgrade</b> |

It is recommended the existing ramp are not upgraded.

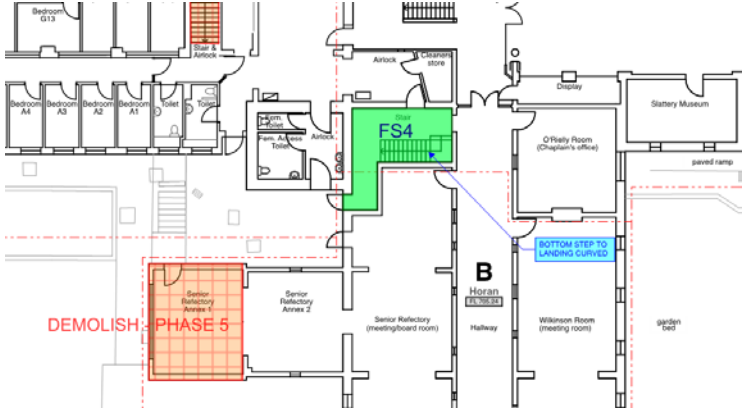
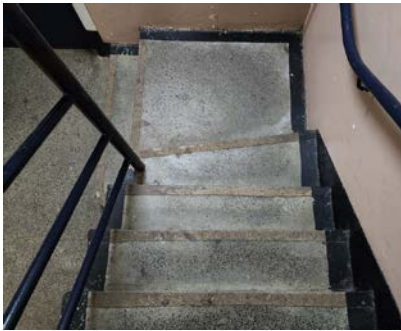
| NSW<br>D3D14<br>[D2.13] | Goings and risers | <p><b>Ground Storey – Fire Stair 4</b></p> <p>The last step (before the quarter landing) in fire stair 4, on the Ground Storey is constructed on an angle, with a going dimension that is not consistent with the other treads in the flight.</p> <p>It is recommended the last step be reconstructed to have a consistent going as the other treads in the flight to comply with NSW D3D14 and Table D3D14.</p> | <b>Upgrade Recommended</b> |

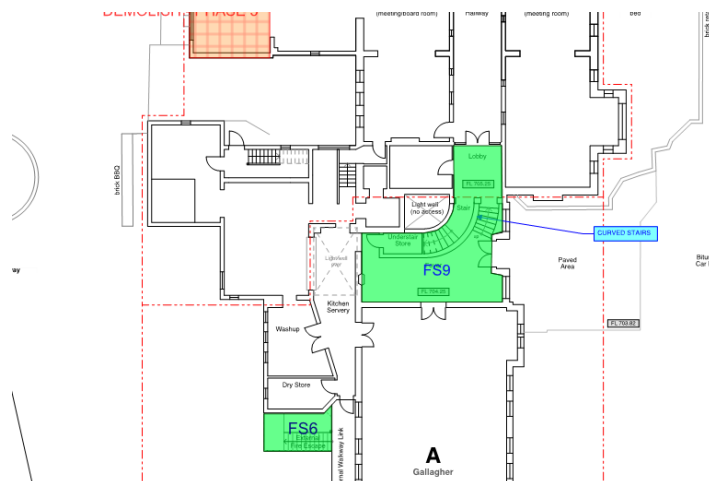
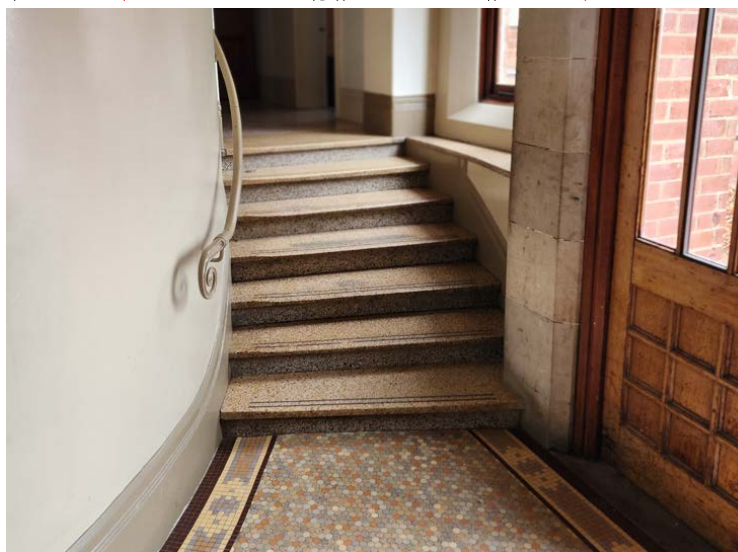
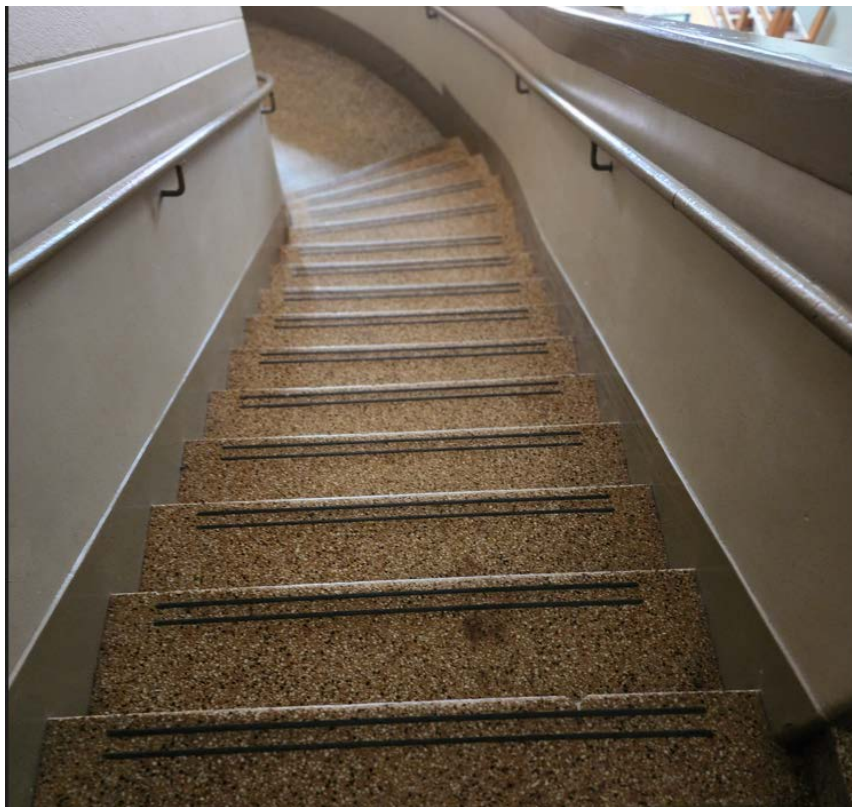
### Ground Storey – Fire Stair 9

Two flights of stairs in fire stair 9, that are located on the Ground Storey, are provided with curved treads that result in the flight having inconsistent going dimensions, which is contrary to NSW D3D14 and Table D3D14.

It is recommended the existing stairway geometry (goings) be upgraded to comply with the Performance Requirements of the BCA via a Performance Solution prepared by a Certifier – Fire Safety.

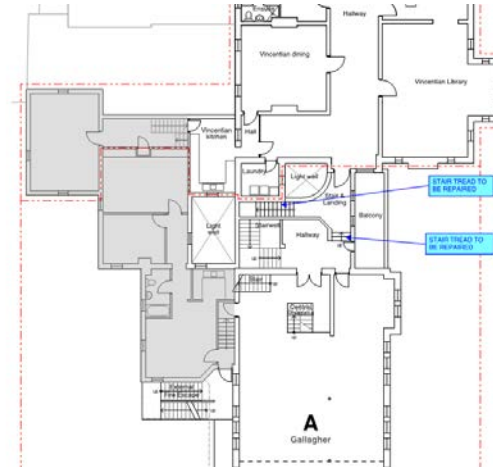
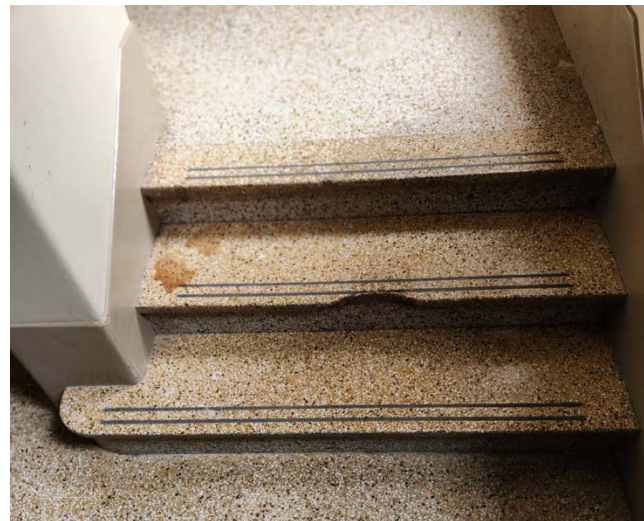
Second Storey – Fire stair 9

Multiple treads in fire stair 9 are broken and therefore not provided with a consistent going dimension, which is contrary to Table D3D14.

It is recommended the stairs be repaired to comply with NSW D3D14.

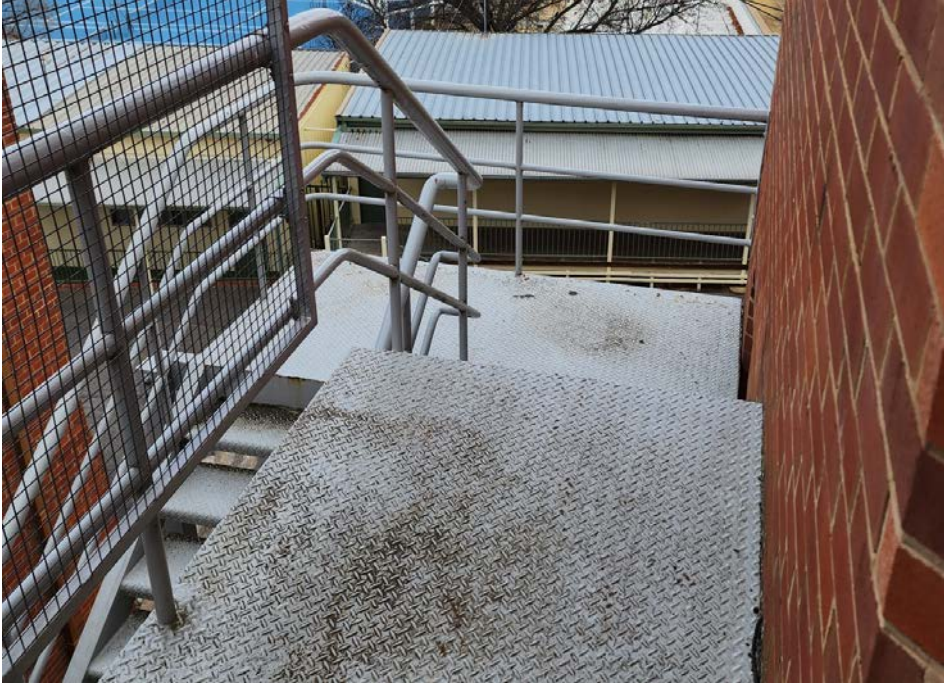
| <p>D3D15<br/>[D2.14]</p> | <p>Landings</p> | <p><u>Dimensions</u><br/>During the site inspection, it was observed all landings were at least 750 mm in length (except for the matters discussed in D3D18 of this report).</p> <p><u>Slip-resistance</u><br/>Multiple external landings were observed to not have a slip-resistant surface or slip-resistant strip at the edge of the landing throughout the building, which is contrary to D3D15(a).</p> <p>It is recommended all landing be provided with a slip-resistant strip at the edge of the landing to comply with D3D15 and Table D3D15.</p> | <p><b>Noted</b></p> <p><b>Upgrade<br/>Recommended</b></p> |

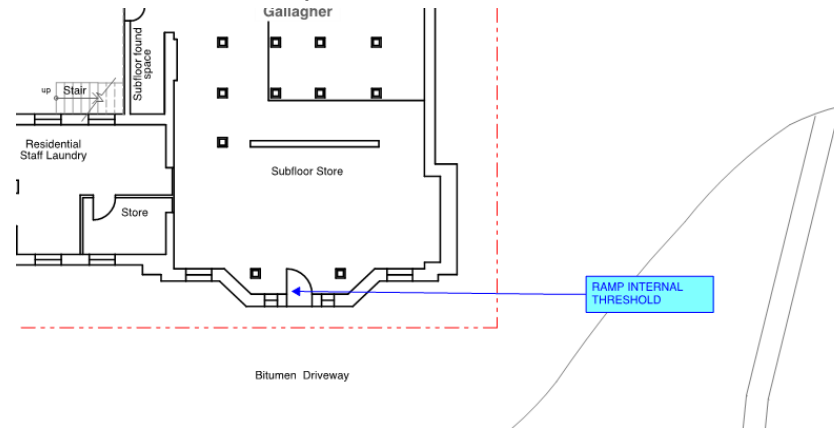
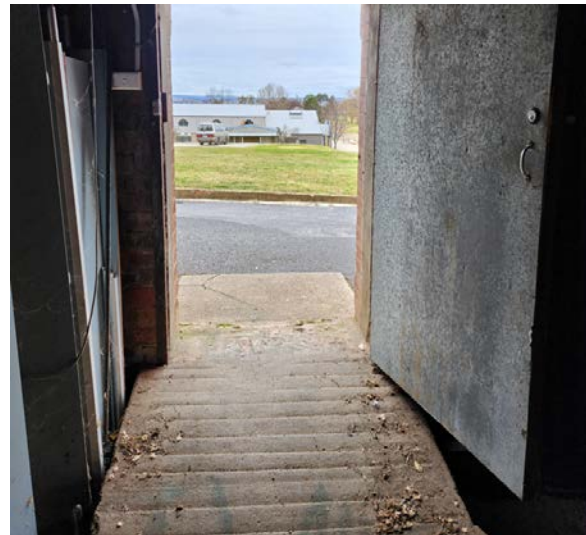
**Block A – Basement – Subfloor Store**

The door providing access to the basement subfloor store contains an internal ramp within the width of door leaf.

It is recommended no upgrades occur to the existing ramp as the subfloor store is used infrequently and is provided with a ramp that has a small landing located immediately inside the doorway.

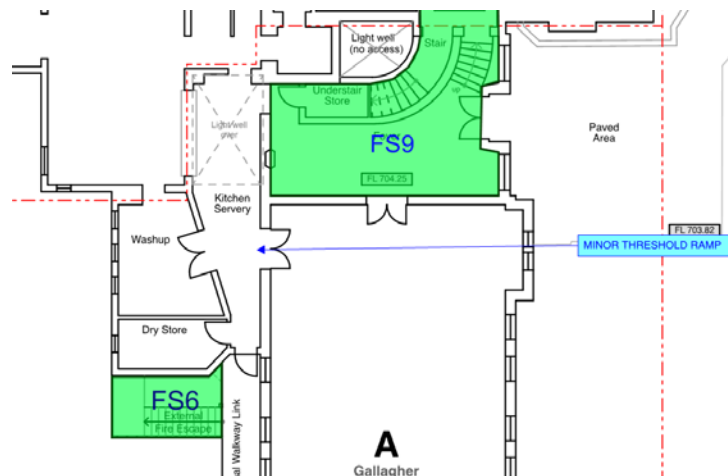
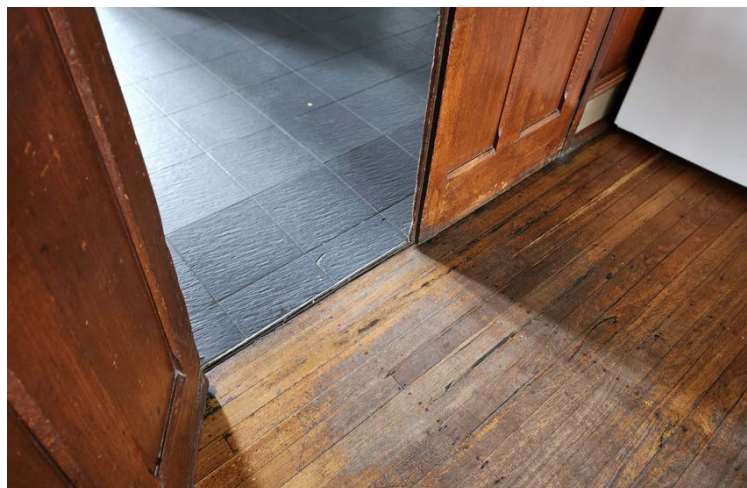
Block A – Ground Storey – Kitchen Servery

The internal door located between the kitchen servery and boarder's refectory contains a minor threshold ramp due to the different floor materials.

The proposed development includes works to the area and results in the finished floor level in both areas both being RL 704.30 to comply with NSW D3D16.

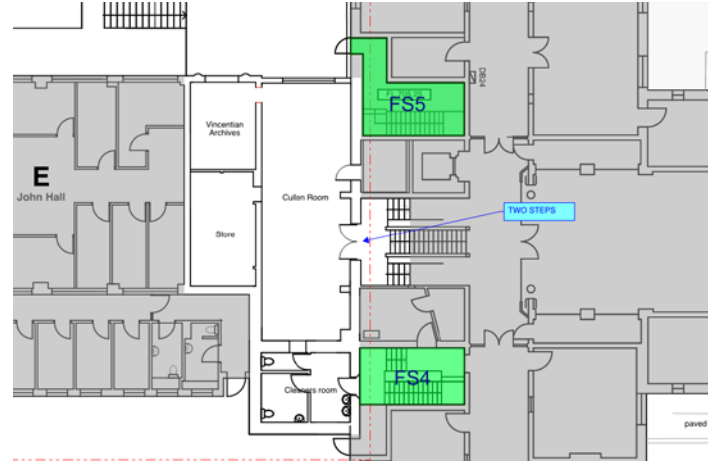
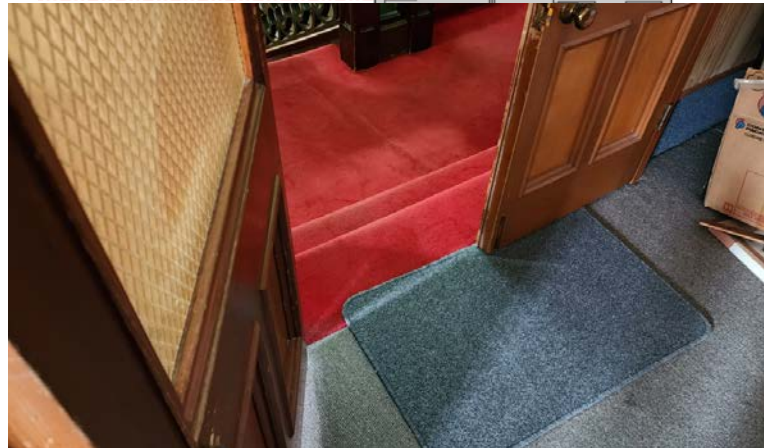
**Block C – Upper Ground Storey – Cullen Room**

The internal door located on the mid-landing of the foyer stairway, into the Cullen room contains two steps within the width of the door leaf.

It is recommended no upgrades occur to the existing stairs or doorway as it forms part of the main stairway. The main stairway and surrounding area is proposed to be retained without modification due to the heritage value and significance.

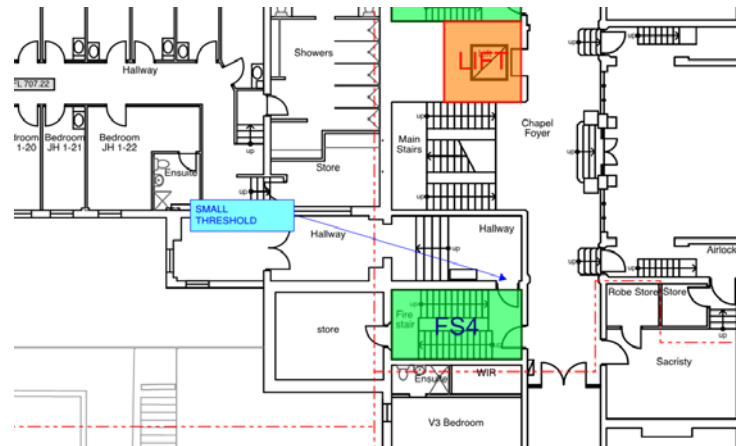
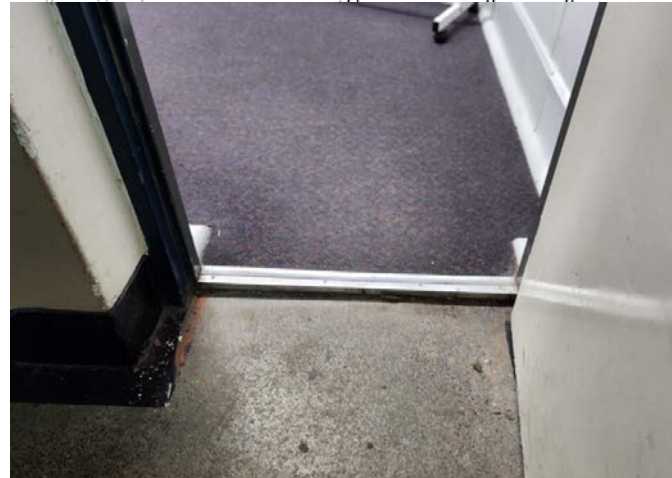
#### Block C – First Storey – Fire Stair 4

The doorway leading into fire stair 4 from the hallway on the First Storey contains a small step into the fire-isolated shaft, which is contrary to NSW D3D16.

It is recommended the step be upgraded with a threshold ramp and Performance Solution to comply with the Performance Requirements of the BCA via a Performance Solution prepared by a Certifier – Fire Safety.

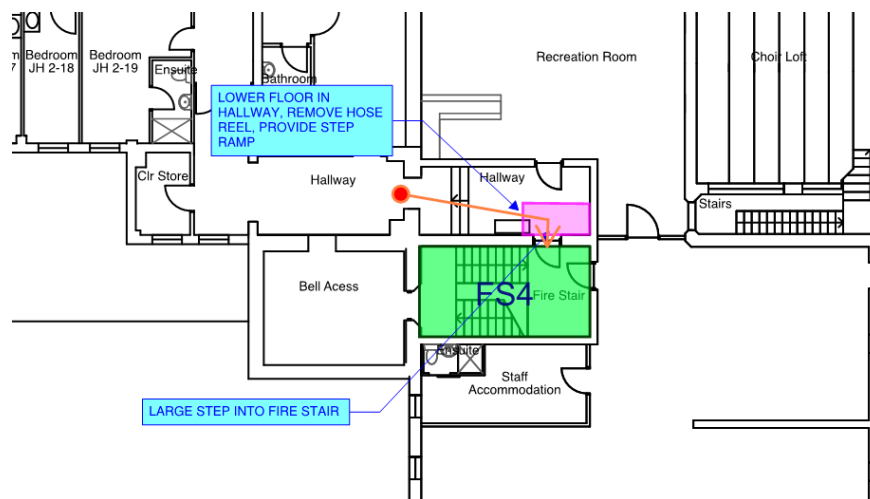
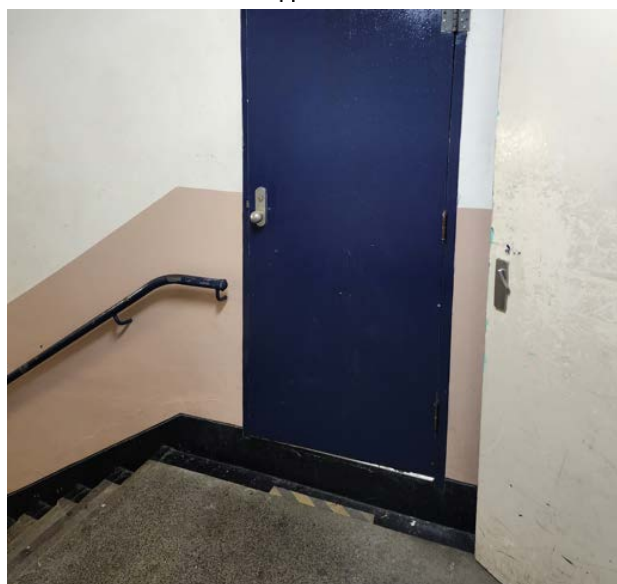
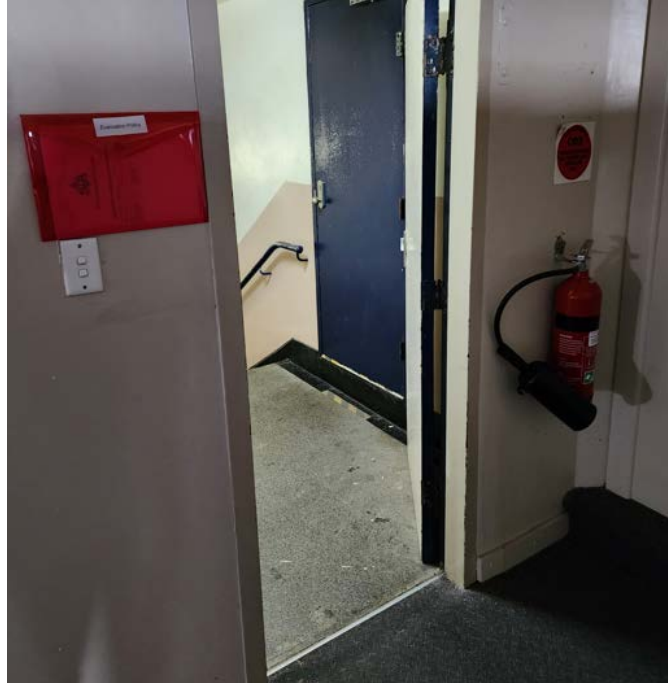
The doorway leading into fire stair 4 on the Second Storey contains a step inside the fire-isolated shaft, which is contrary to NSW D3D16.

It is recommended the finished floor level in the hallway (approximately marked up in purple on the plan above) be lowered by approximately 190 mm to align with the finished floor level inside fire stair 4.

It is also recommended the redundant fire hose reel be removed to make room for construction of a step ramp, as a stairway cannot contain a single riser.

Finally, it is recommended the existing fire door leading into the fire stair be demolished, the opening realigned to new finished floor levels and a new fire door set installed away from the steps to ensure no part of its swing encroaches more than 500 mm into the required width of the landings. Refer to comments in D3D25.

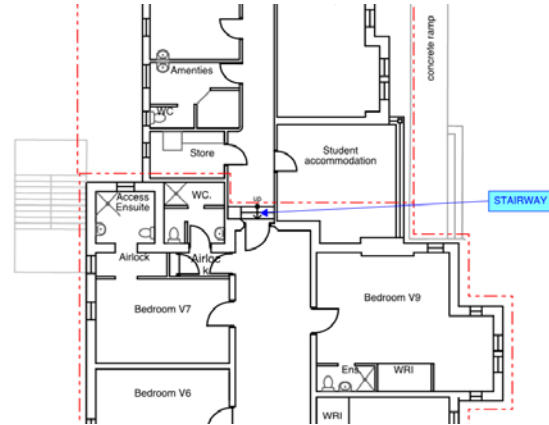
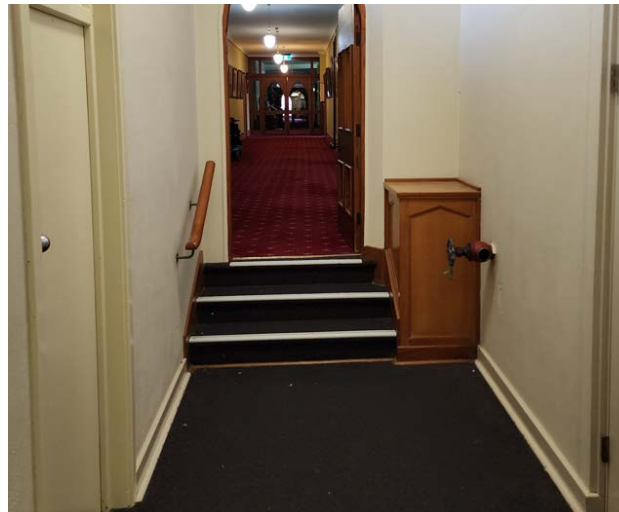
**Block D – First Storey – Hallway**

The stairway located in the hallway on the First Storey of Block D is located adjacent to the doorway. This stairway appears to be located at the historical construction joint between Block C and D.

It is recommended a new landing be constructed in the location of the existing stairway (at RL710.09) and a new stairway be constructed at the end of the landing to comply with NSW D3D19.

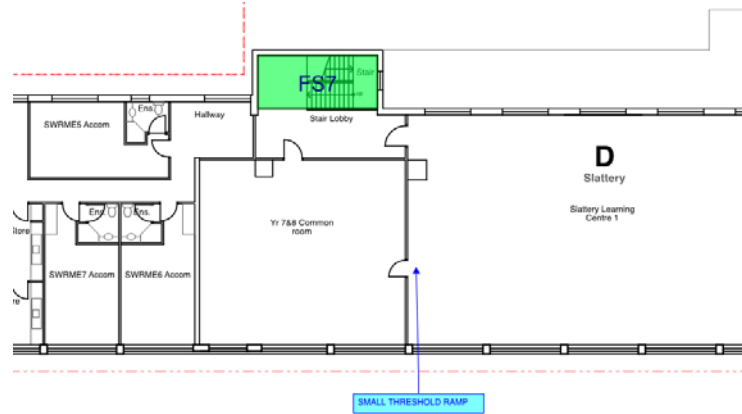
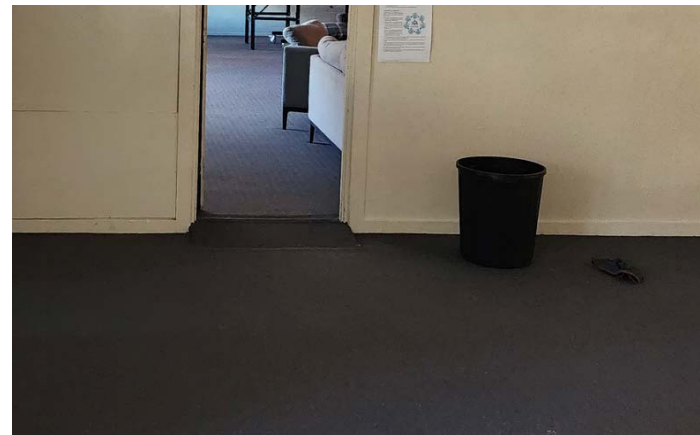
The doorway between the Slattery Learning Centre 1 and Year 7&8 Common Room contains a small threshold ramp adjacent to the door.

It is recommended no upgrades occur to the existing ramp as it is a minor threshold ramp and is not located in a required path of travel to an exit.

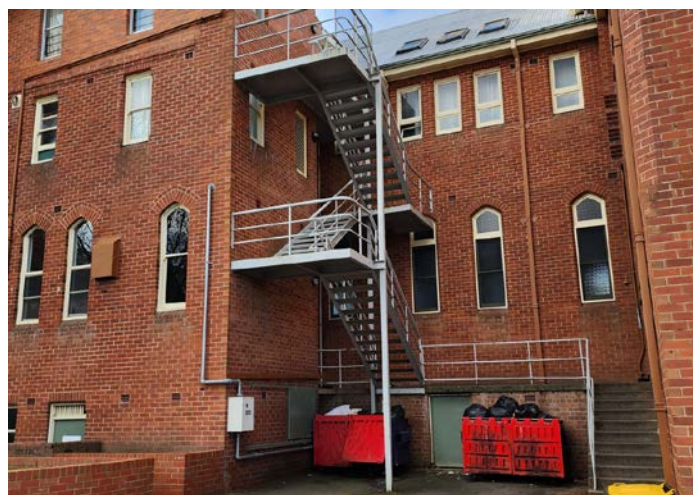
### Block A – Fire Stair 6

The heights of the balustrades to prevent falls located adjacent to fire stair 6 are less than 1 m, which is contrary to NSW D3D18.

It is recommended the existing barriers are replaced and upgraded to comply with NSW D3D18.

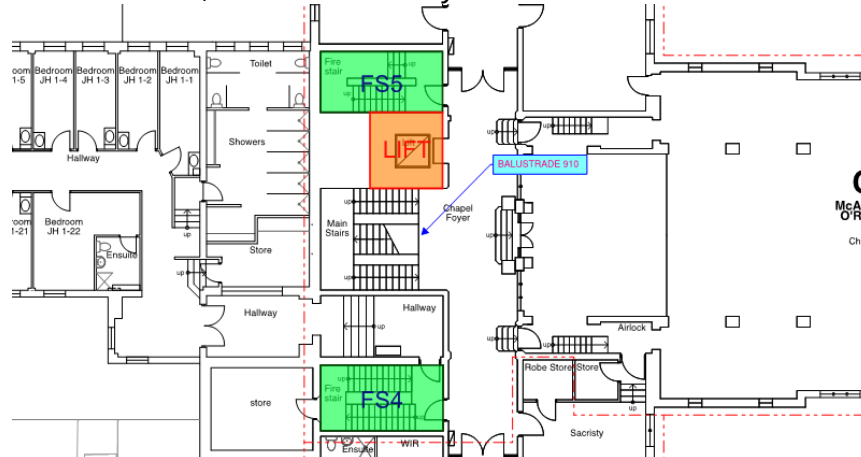
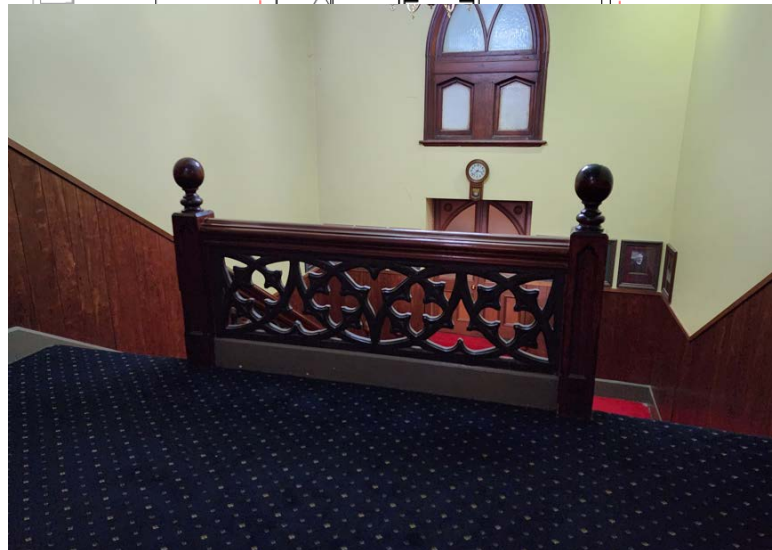
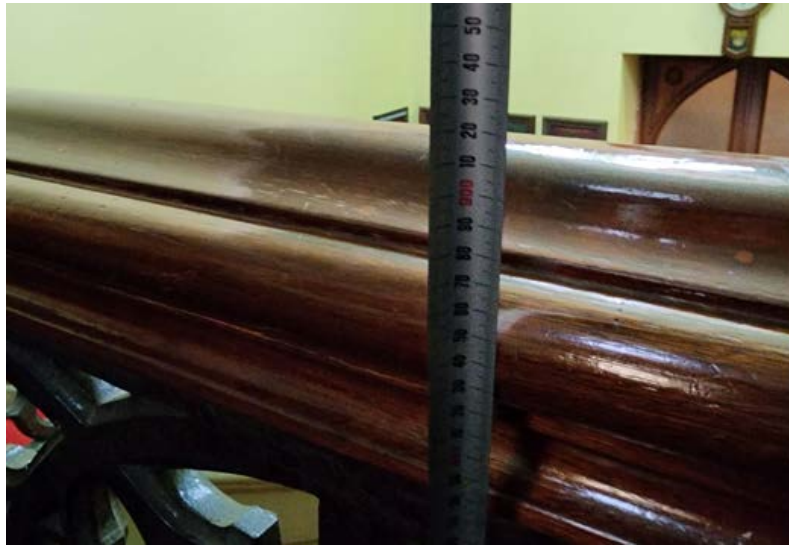
The main stairway has an ornate heritage timber barrier to prevent falls on the First Storey. The height of the barrier is approximately 910 mm and the trafficable surface is more than 1 m above the surface beneath, which is contrary to NSW D3D18.

It is recommended no upgrades occur to the existing barrier to the first storey due to the heritage value and significance of the stairway. The mid-landing is already provided with a barrier on the inside edge (less than 500 mm in length) that has a height of more than 865 mm in accordance with D3D18(1)(b).
