# FIRE SAFETY UPGRADE STRATEGY REPORT

220 Bentinck Street, BATHURST NSW 2795

| <b>Client:</b> | St Stanislaus College |
| <b>Reference:</b> | 23175 |

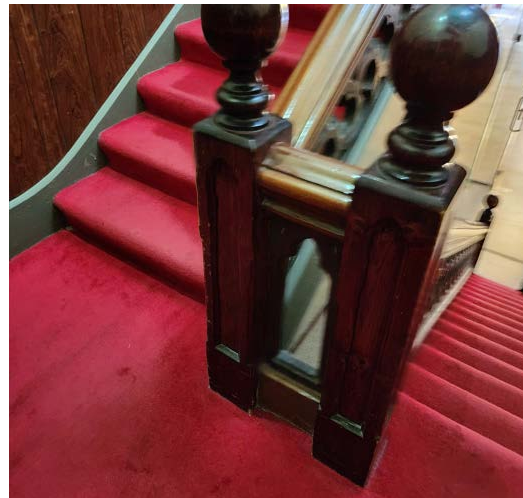
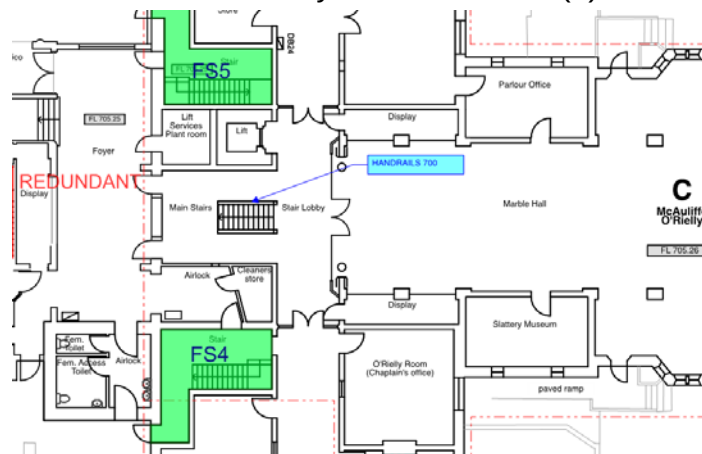
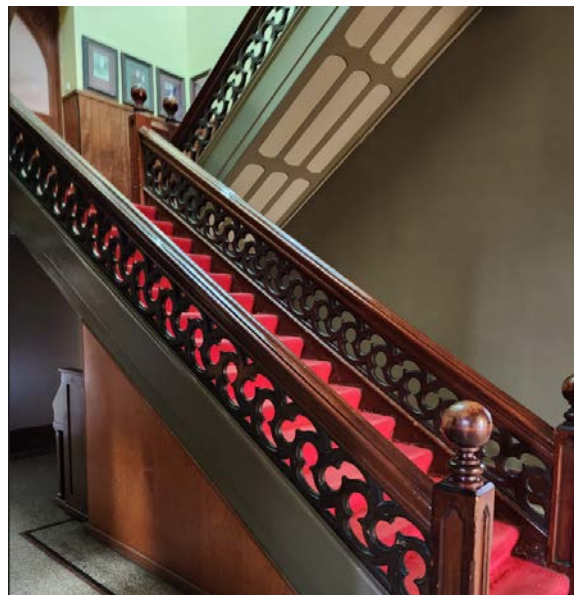
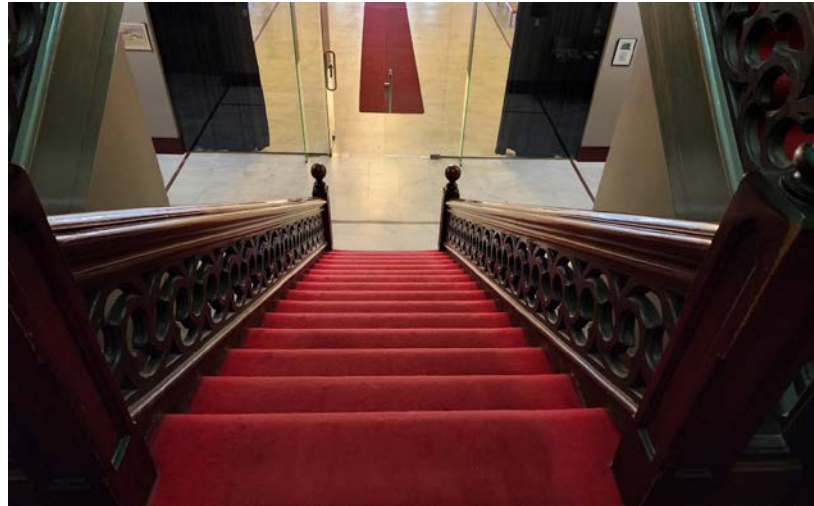
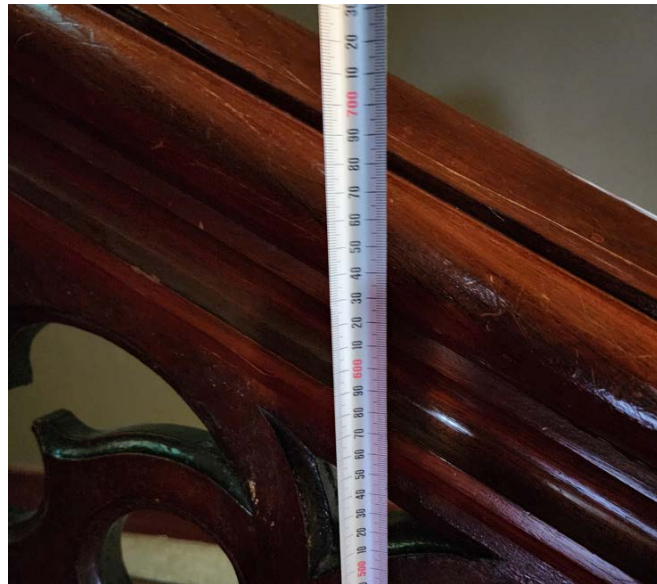
The main stairs, located in the stair lobby are also provided with handrails that have a height of approximately 700 mm, which is less than 865 mm and contrary to NSW D3D18(1).

It is recommended no upgrades occur to the existing stairway due to the heritage value and significance of the stairway.

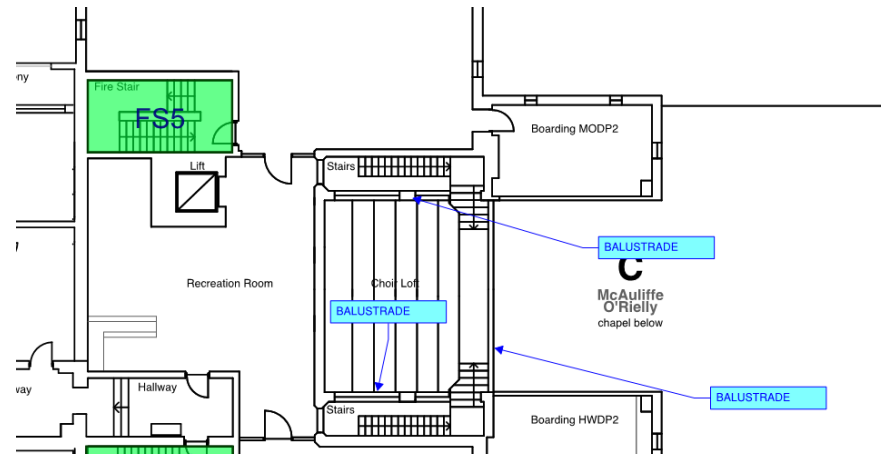
Block C – Second Storey – Choir Loft

The barriers to prevent falls located on the front and sides of the choir loft have a height of less than 1 m.

It is recommended the existing barriers are altered and upgraded to have a height of at least 1 m to comply with NSW D3D18.

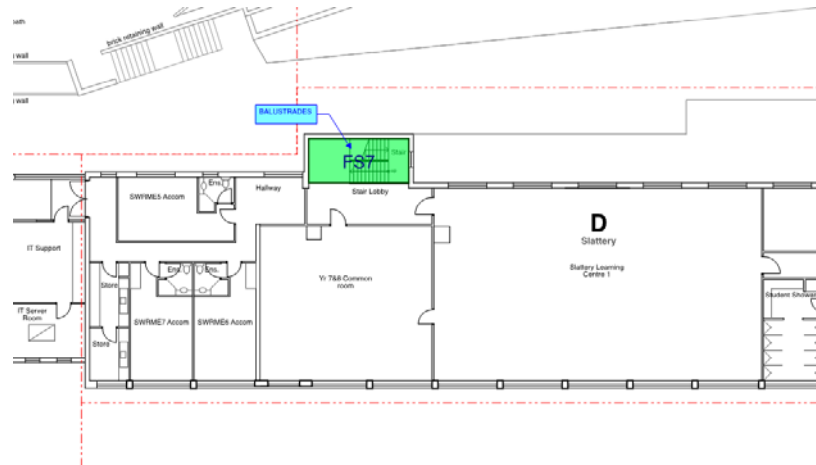
Block D – First Storey – Fire Stair 7

The barriers to prevent falls located on and adjacent to the top of fire stair 7 have a height of approximately 840 mm, which is less than 1 m.

It is recommended the barriers to prevent falls be upgraded and replaced to comply with NSW D3D18.

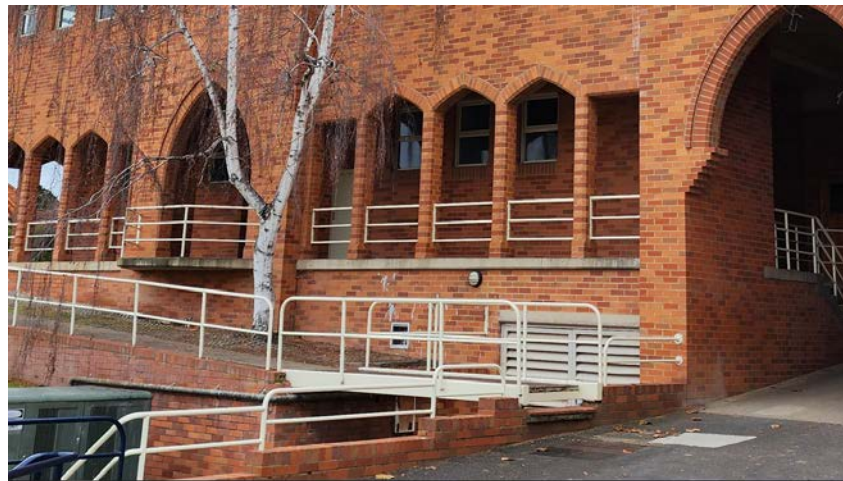
**Block F – Ground Storey - External**

The external verandah located on the Ground Storey of Block F has a trafficable surface that is more than 1 m above the surface beneath and has a balustrade that has a height of less than 1 m.

It is recommended the barrier be replaced and upgraded to comply with NSW D3D18.

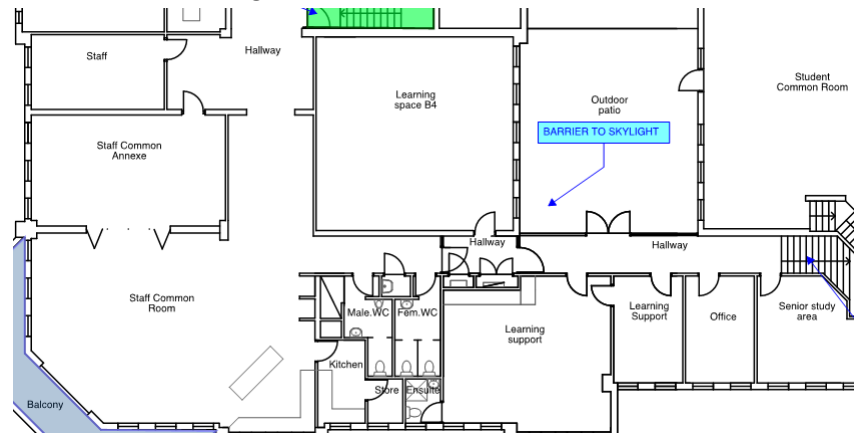
### Block F – Outdoor Patio

The barrier located adjacent to the skylight located in the outdoor patio area has a height of less than 1 m.

It is recommended the barrier be replaced and upgraded to comply with NSW D3D18.

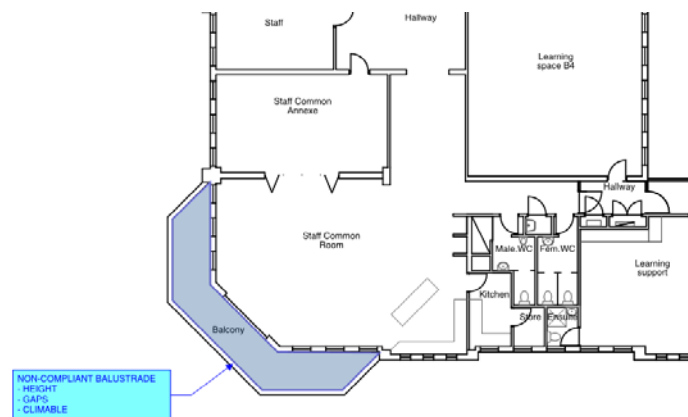
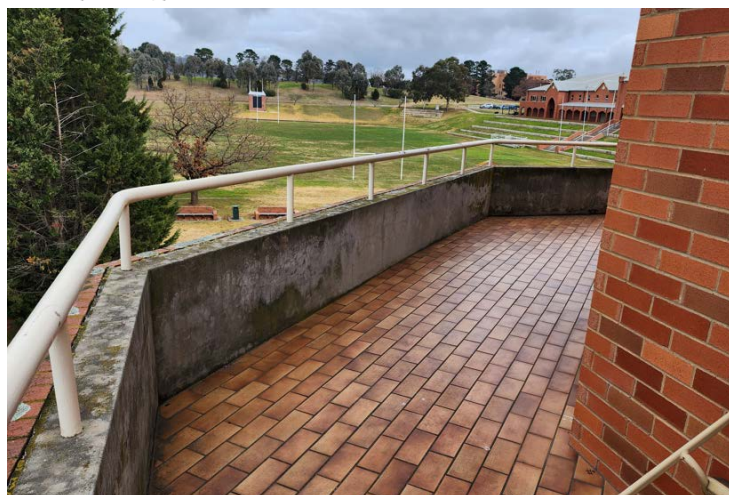
The Second Storey of Block F includes an external balcony that is provided with a barrier to prevent falls that has a height of less than 1 m.

It is recommended the existing barrier be upgraded to comply with NSW D3D18.

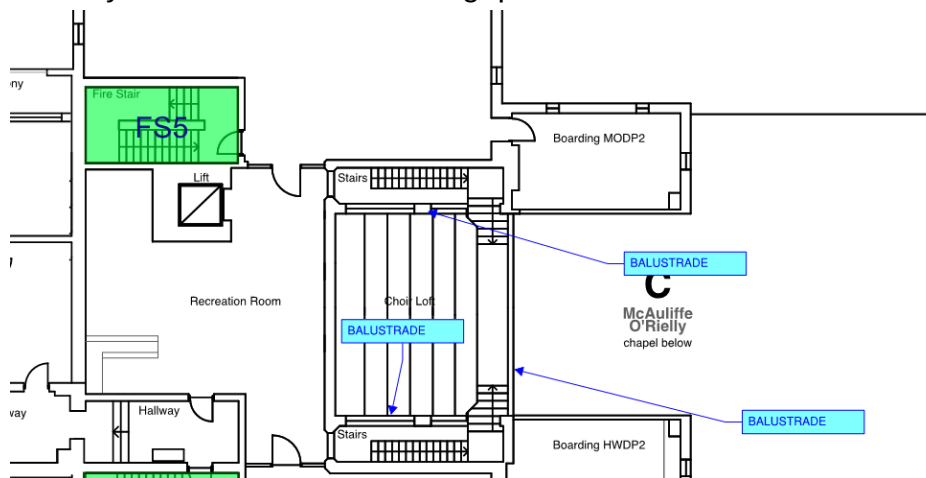
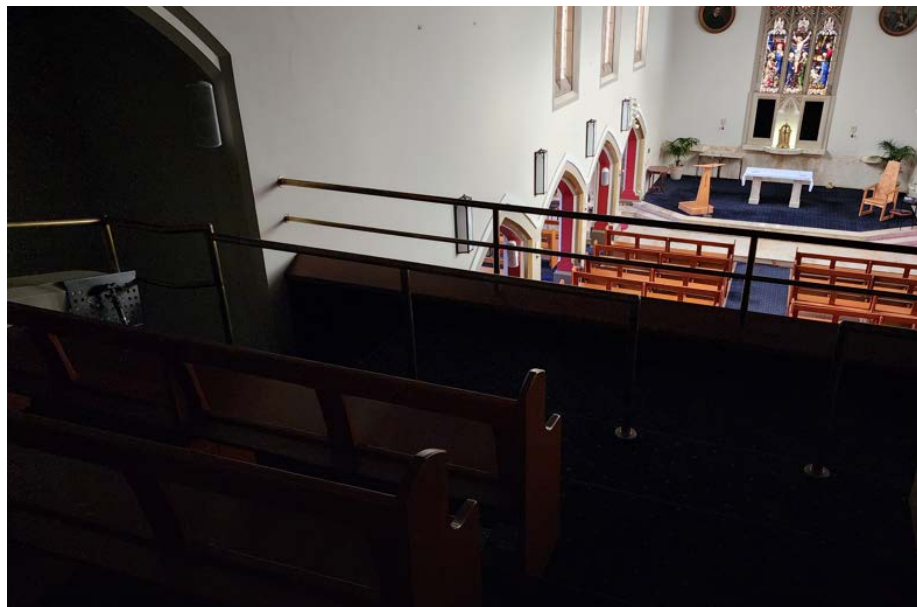
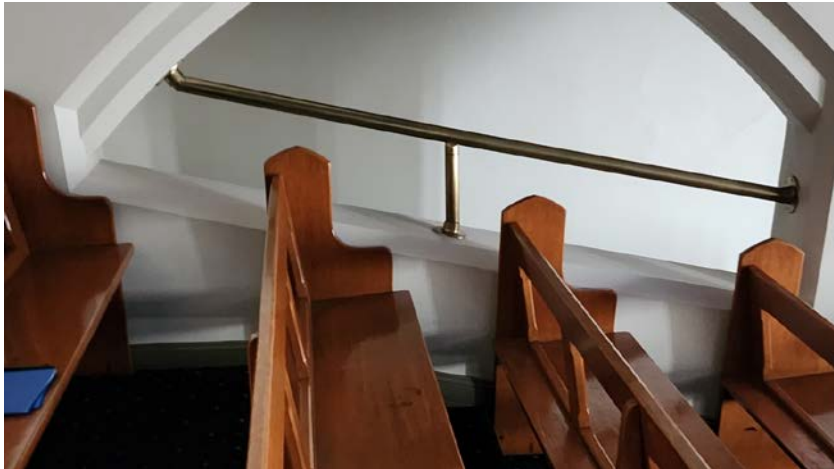
### Block C – Second Storey – Choir Loft

The barriers to prevent falls located along the front, side and stairway of the choir loft contain gaps in excess of 125 mm.

It is recommended the existing barriers to altered and upgraded to comply with D3D19.

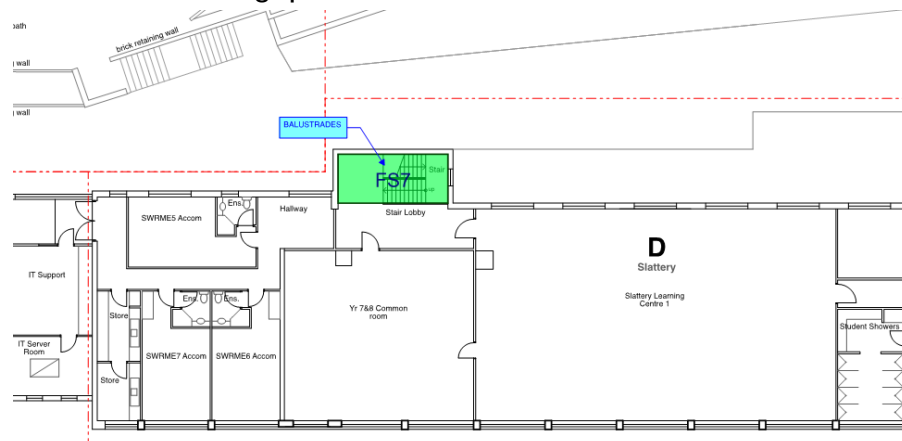
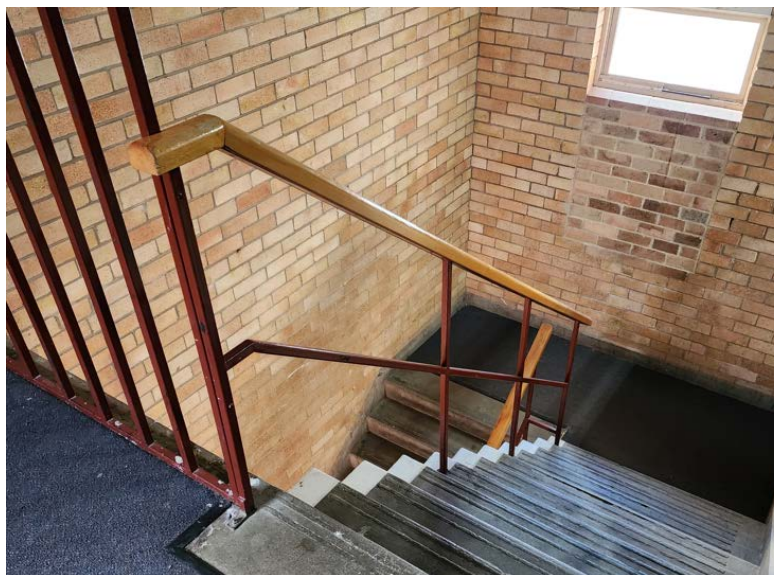
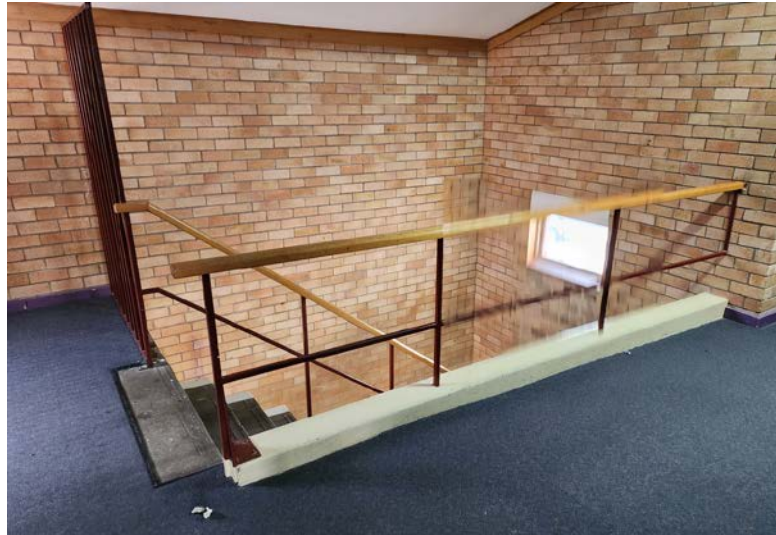
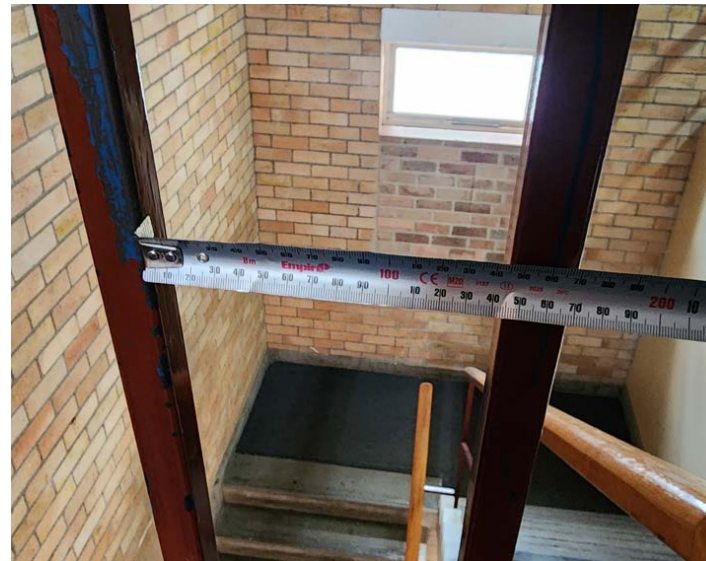
### Block D – First Storey – FS7

The barriers to prevent falls located on and adjacent to the top of fire stair 7 contain gaps that exceed 125 mm.

It is recommended the barriers to prevent falls be upgraded and replaced to comply with D3D19.

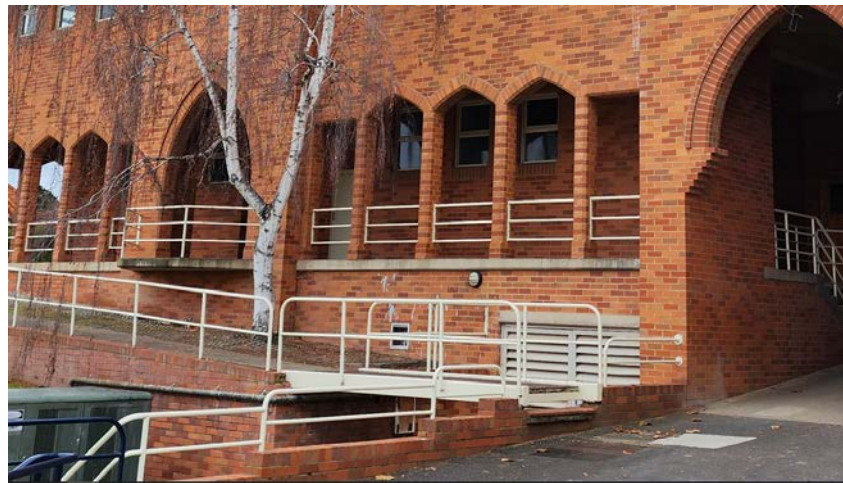
**Block F – Ground Storey - External**

The external verandah and stair located on the Ground Storey of Block F has a trafficable surface that is more than 1 m above the surface beneath with gaps more than 125 mm.

It is recommended the barrier be replaced and upgraded to comply with D3D19.

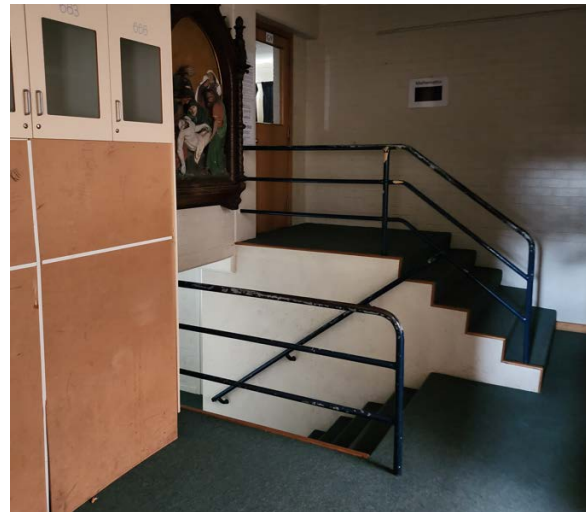
**Block F – First Storey – Internal Stair**

The barrier located adjacent to the internal stair located on the First Storey of Block F contains gaps in excess of 125 mm.

It is recommended the barrier be replaced and upgraded to comply with D3D19.

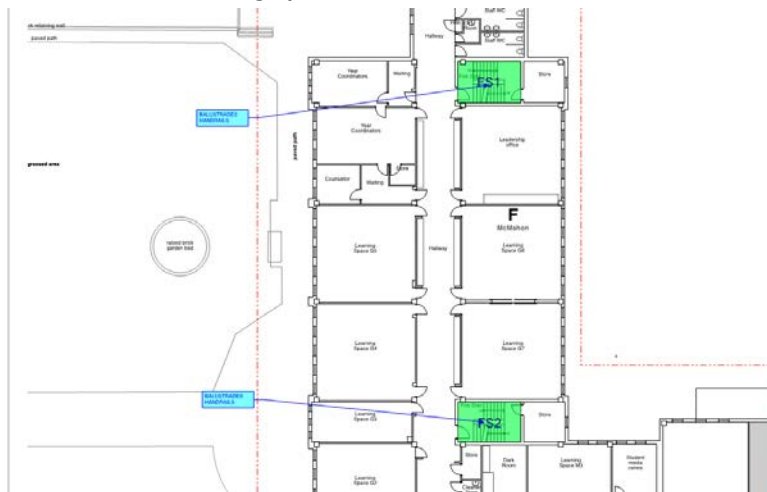
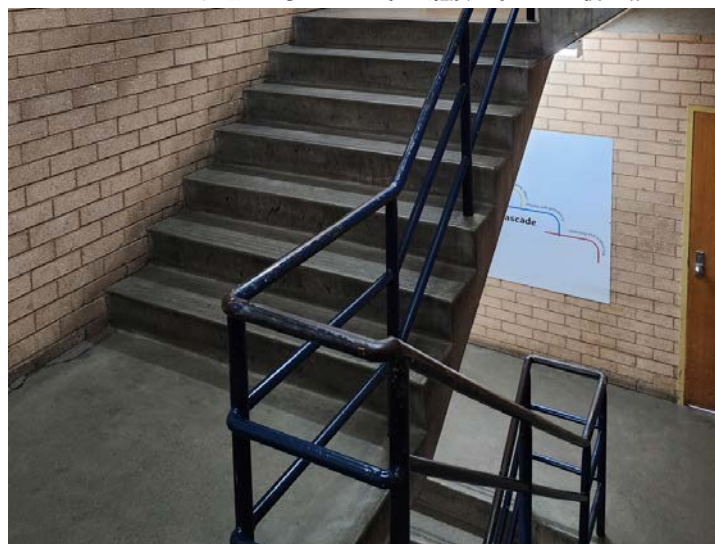
### Block F - Fire Stair 1 and 2

Fire stairs 1 and 2 are not required to be fire-isolated. The barriers to prevent falls contain gaps that exceed 125 mm.

It is recommended the barriers to prevent falls be upgraded and replaced to comply with D3D19.

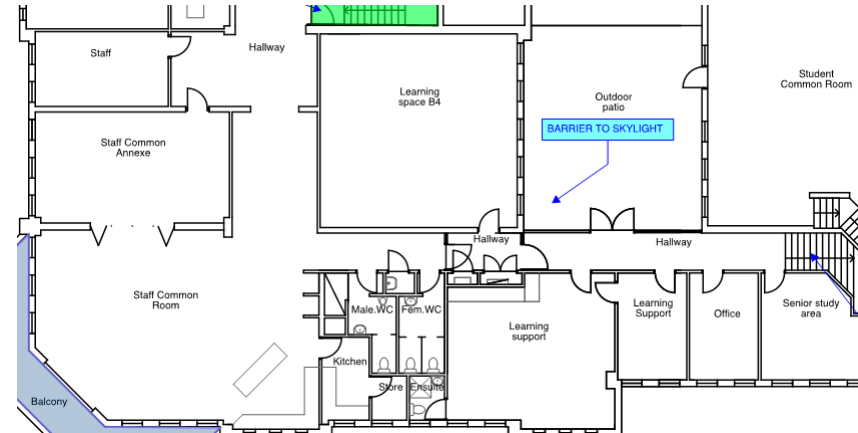
### Block F – Outdoor Patio

The barrier located adjacent to the skylight on the outdoor patio area contains gaps in excess of 125 mm.

It is recommended the barrier be replaced and upgraded to comply with D3D19.

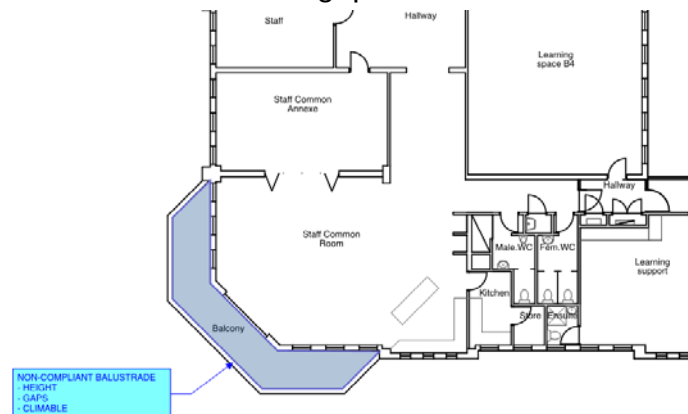
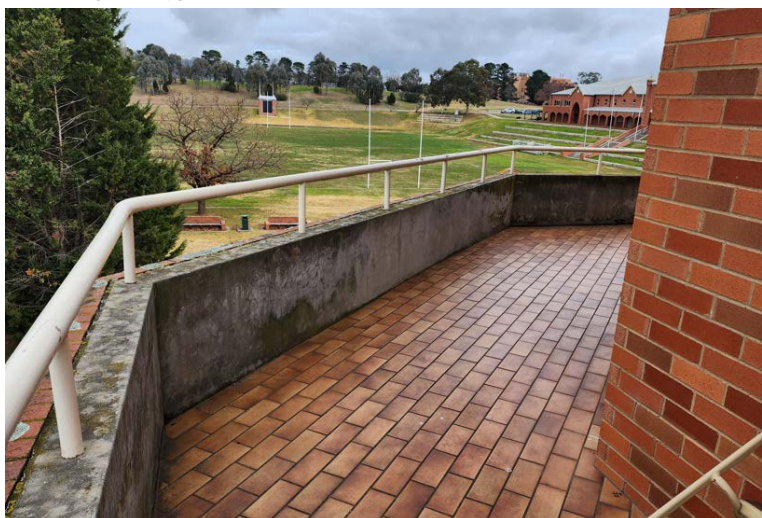
The Second Storey of Block F includes an external balcony that is provided with a barrier that contains gaps in excess of 125 mm.

It is recommended the existing barrier be upgraded to comply with D3D19.

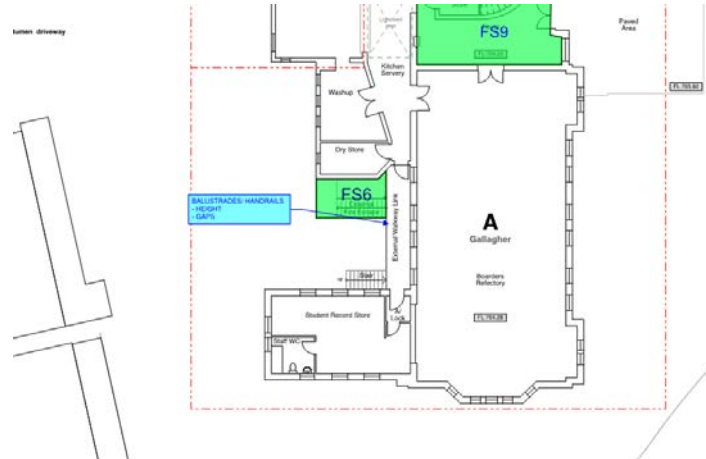
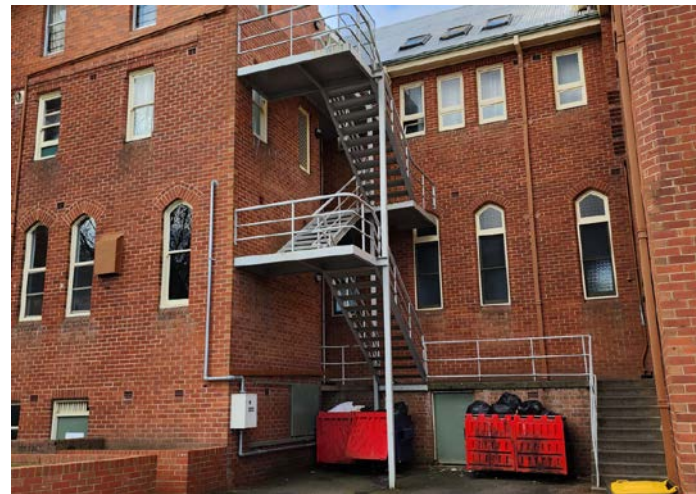
The barriers to prevent falls located adjacent to the top of fire stair 6 are more than 4 m above the surface beneath and include a horizontal surface between 150 mm and 760 mm above the landing that facilitates climbing.

It is recommended the existing barriers are replaced and upgraded to comply with D3D20.

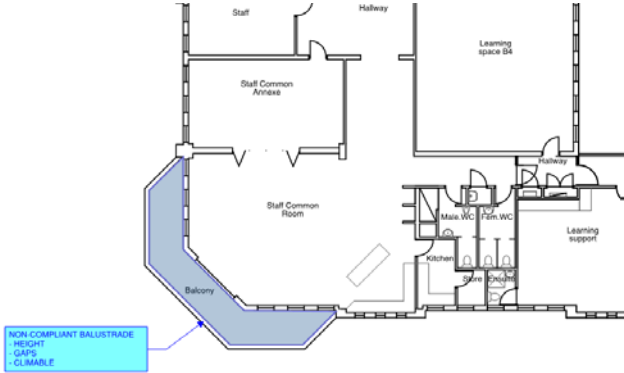
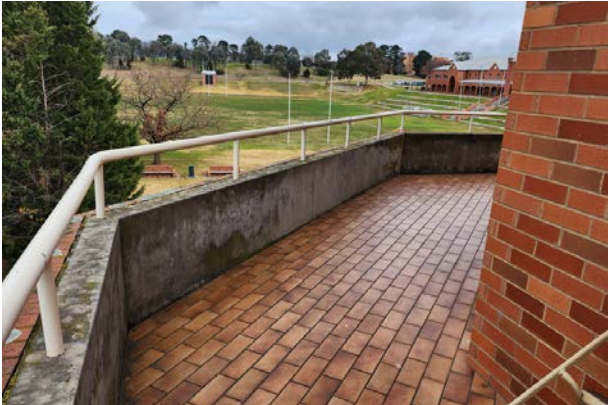
| | | <p><b>Block F – Second Storey Balcony</b></p> <p>The Second Storey of Block F includes an external balcony that is provided with a barrier to prevent falls. The barrier includes a horizontal surface between 150 mm and 760 mm above the floor that facilitates climbing.</p> <p>It is recommended the existing barrier be upgraded to comply with D3D20.</p> | <p><b>Upgrade Recommended</b></p> |

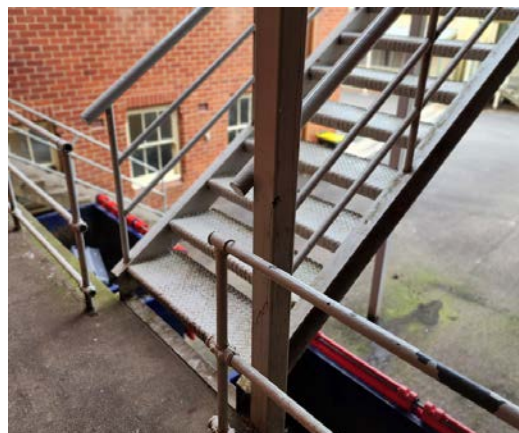
The handrail adjacent to fire stair 6 is provided with a handrail that requires an occupant to break their grip at the landing at the Ground Storey landing.

It is recommended the handrail is replaced and upgraded to comply with D3D22(1)(e).

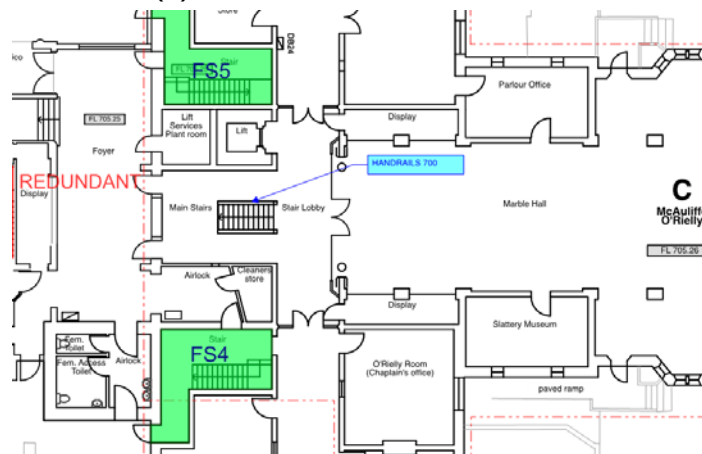
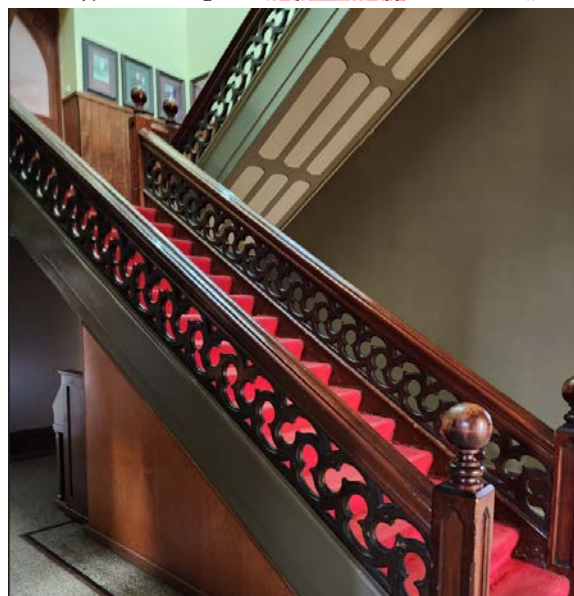
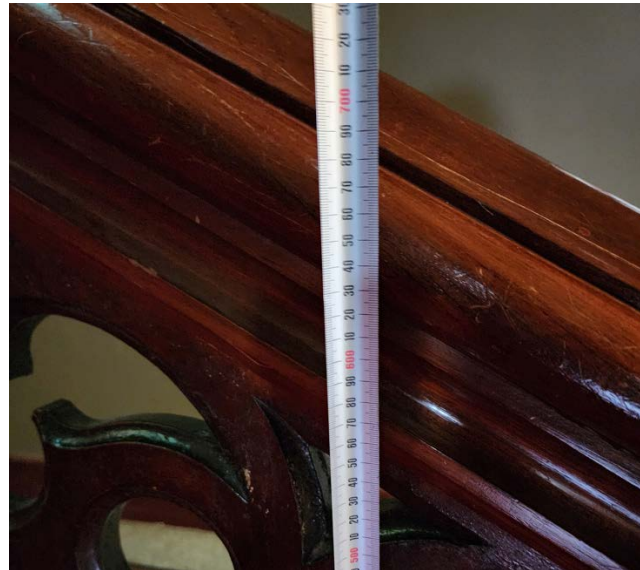
Block C – Ground Storey - Main Stairs

The main stairs, located in the stair lobby are provided with handrails that have a height of approximately 700 mm, which is contrary to D2D22(1).

It is recommended no upgrades occur to the existing stairway due to the heritage value and significance of the stairway.

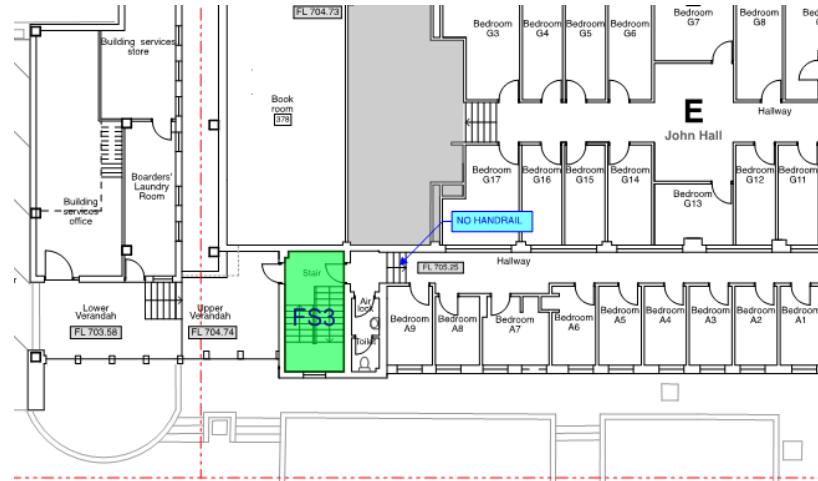
### Block E – Ground Storey

The internal stairway located near fire stair 3 on the Ground Storey of Block F is not provided with a handrail.

It is recommended a handrail be provided in accordance with D3D22.

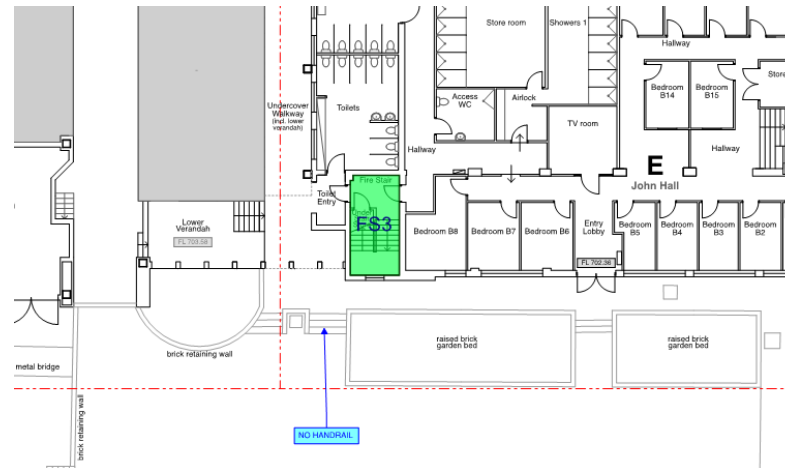
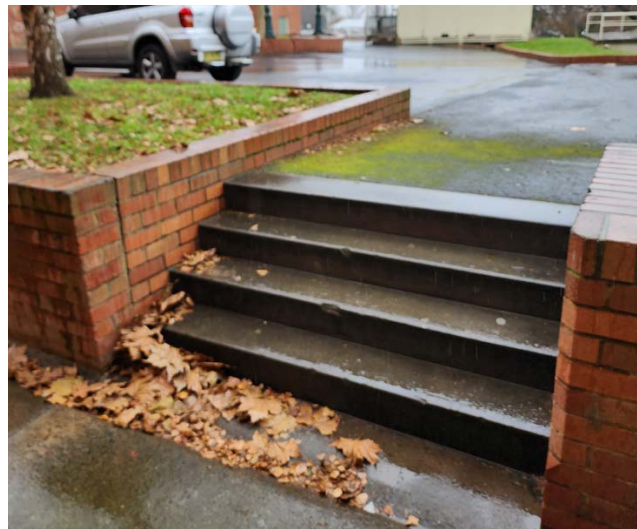
The external stairway located at the basement level (near fire stair 3), that connects fire stair 3 to the road/ open space is not provided with a handrail.

It is recommended a handrail be provided in accordance with D3D22.

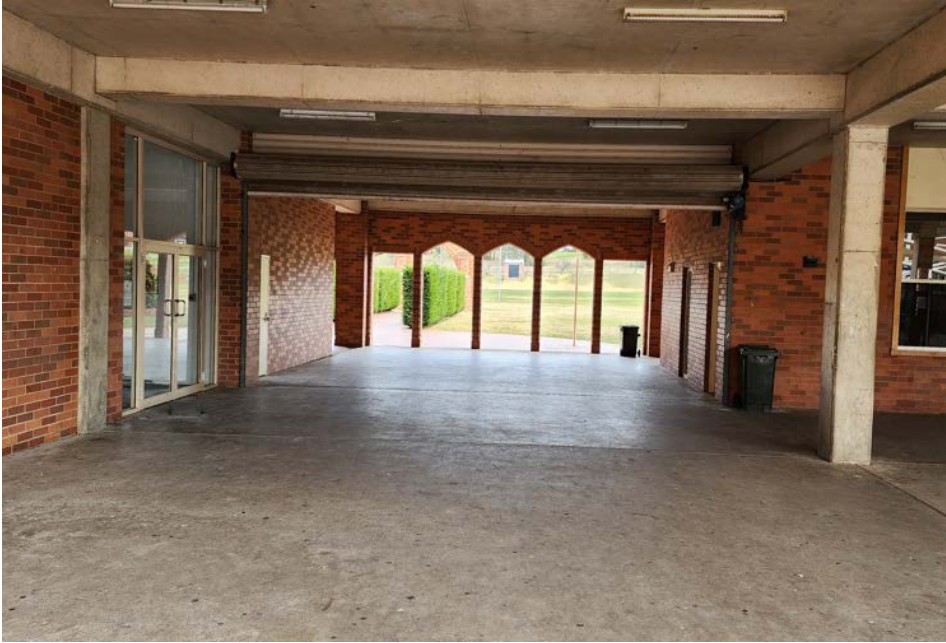
| D3D24<br>[D2.19] | Doorways and doors | <p>The existing building contains a roller-shutter located in the undercroft area on the Ground Storey of Block F.</p> <p>It is recommended no upgrade occur to the roller-shutter as it is proposed to be demolished as part of the development.</p> | <b>No Upgrade</b> |

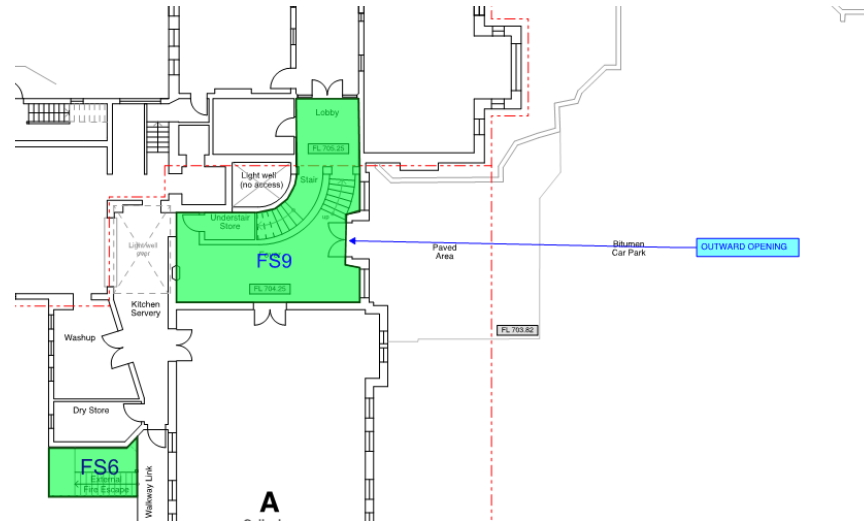
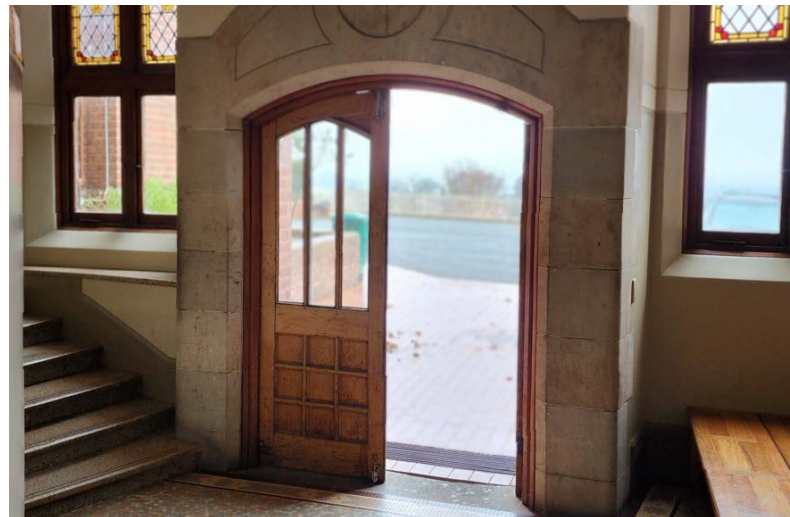
**Block A – Ground Storey – Fire Stair 9**

Although the floor plans show the existing external doorway at the bottom of fire stair 9 swinging inwards, it was observed during the site inspection that the doorway currently swings outwards (in the direction egress).

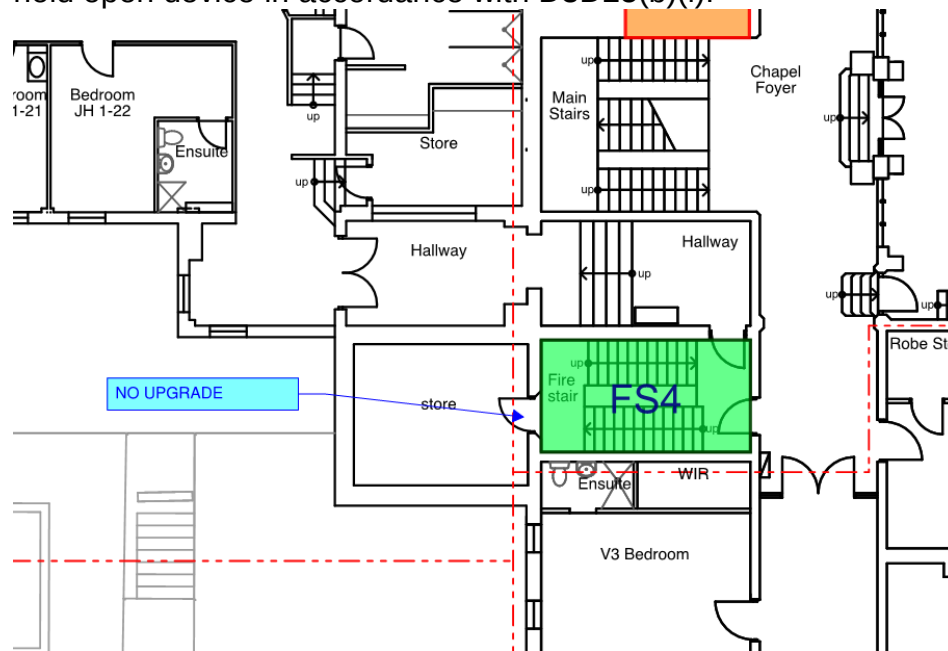
**Block C – Storeroom doors into Fire Stair 4**

The doors from the two rooms located off fire stair 4 serve an area of less than 200 m<sup>2</sup> and are the only means of egress from that part of the building.

The storerooms are not subject to the concession under D3D25(1)(b)(ii) that allows the door to not be provided with a hold-open device. Therefore, the door is required to be provided with a hold open device in accordance with D3D25(b)(i).

As the door is required to be a fire-resisting door, it must be self-closing. However, it is redundant to have a self-closing fire door fitted with a hold-open device. Accordingly, it is recommended the existing doors from the store rooms opening into fire stair 4 (that swings against the direction of egress) not be upgraded or required to be fitted with a hold-open device.

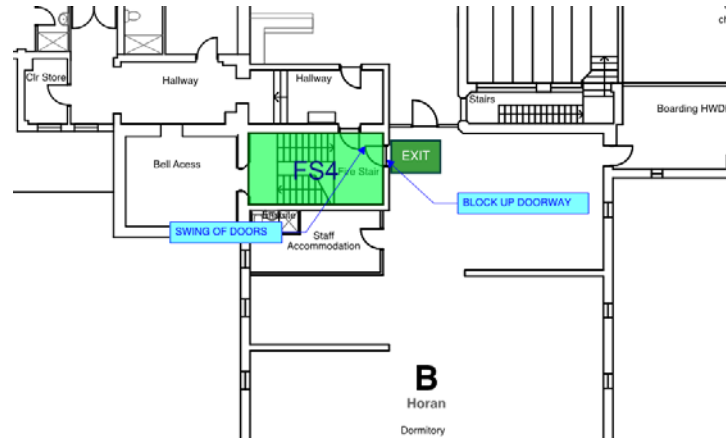
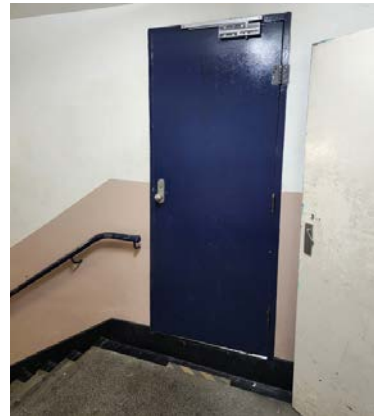
**Block C – First Storey – Fire Stair 4**

Fire stair 4 contains two door doors on the Second Storey that open onto the landing. The doors share a swinging arc and cannot be opened at the same time. Additionally, the swinging door adjacent to the stairway encroaches into the required width of egress by more than 500 mm, which is contrary to D3D25(1)(a).

It is recommended the doorway located adjacent to the stairs be re-located, refer to the comments in NSW D3D16. It is also recommended the additional doorway be blocked up to achieve a FRL of at least 120/120/120.

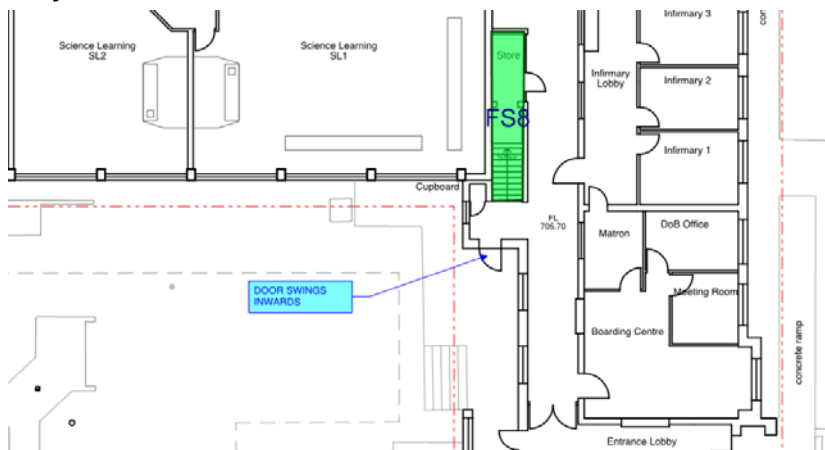
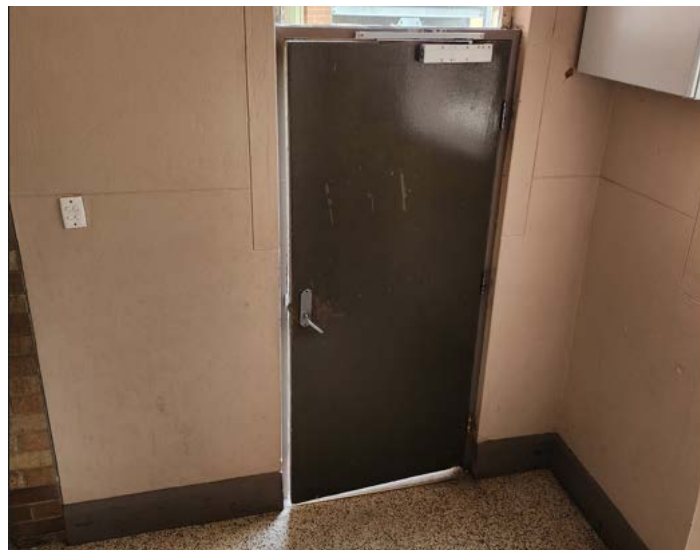
### Block D – Ground Storey – Fire Stair 8

The existing external doorway located at the bottom of fire stair 8 currently swings inwards (against the direction of egress), which is contrary to D3D25.

It is recommended the existing door be rehung to swing in the direction of egress to comply with D3D25.

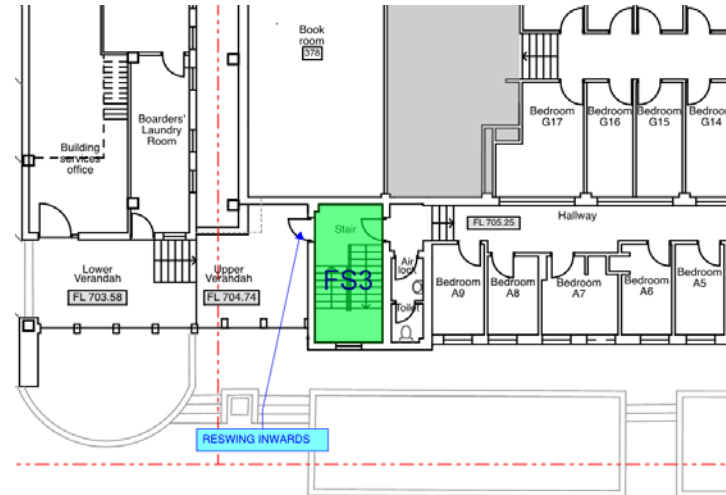
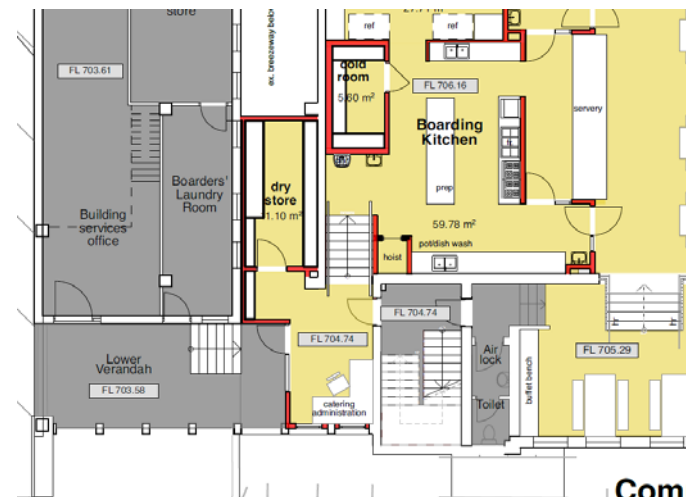
The proposed development includes converting the discharge door on the Ground Storey of fire stair 3 into an entry door.

It is recommended the existing door be replaced and re-hung to swing in the direction of egress (into the fire stair) to comply with D3D25.

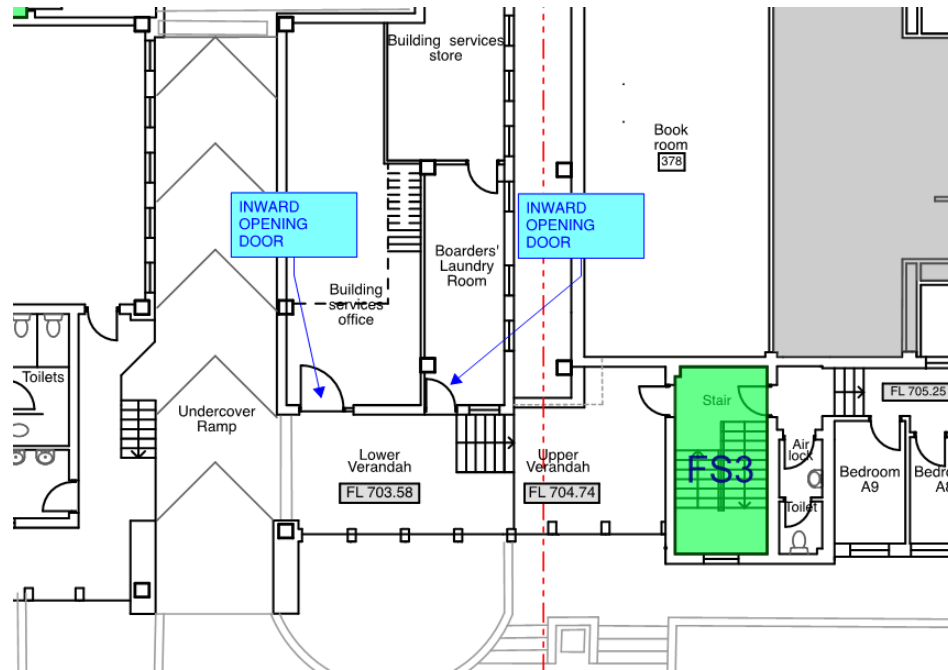
The existing doors in the laundry and building services area both swing against the direction of egress (inwards). Each doorway serves as the only required exit from that part of the building and each room has a floor area of less than 200 m<sup>2</sup>.

It is recommended each inward opening door be fitted with a device for holding it in the open position (eg. magnetic door catch) to comply with D3D25(1)(b)(i).

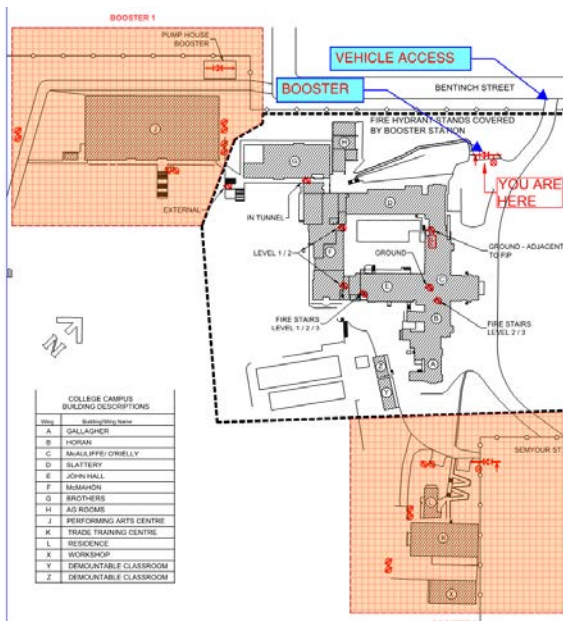
| PART E1: FIRE FIGHTING EQUIPMENT | | | |
|---|---|---|---|
| E1D2<br>[E1.3] | Fire hydrants | <p><u>Existing arrangement</u></p> <p>The site contains three fire hydrant systems, each with an independent fire brigade booster assembly. The building subject to this DA is protected by the fire brigade booster assembly that is located near the main vehicular access from Bentinch Street. The fire brigade booster assembly serves existing internal and external fire hydrants.</p> | Noted |

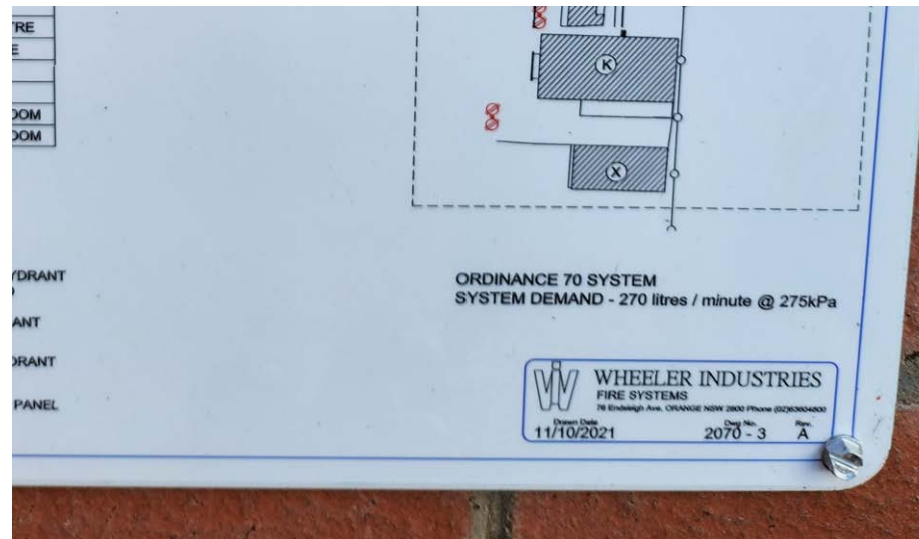
The fire hydrant block plan located near the fire brigade booster assembly indicates the minimum standard of performance for the system is Ordinance 70.

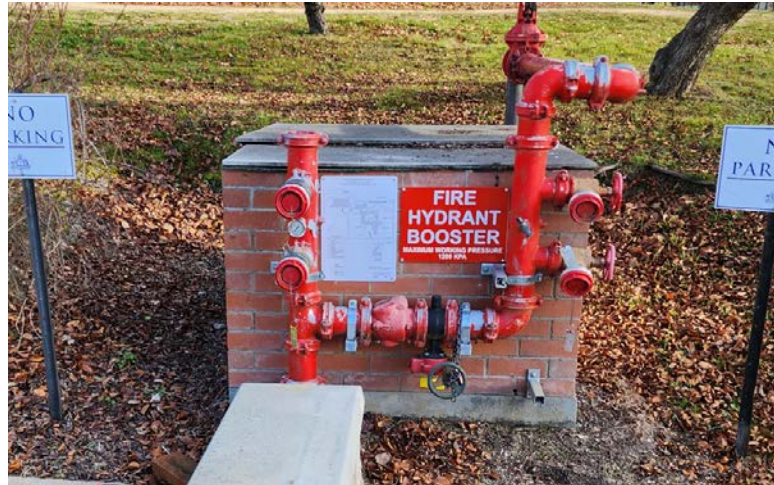
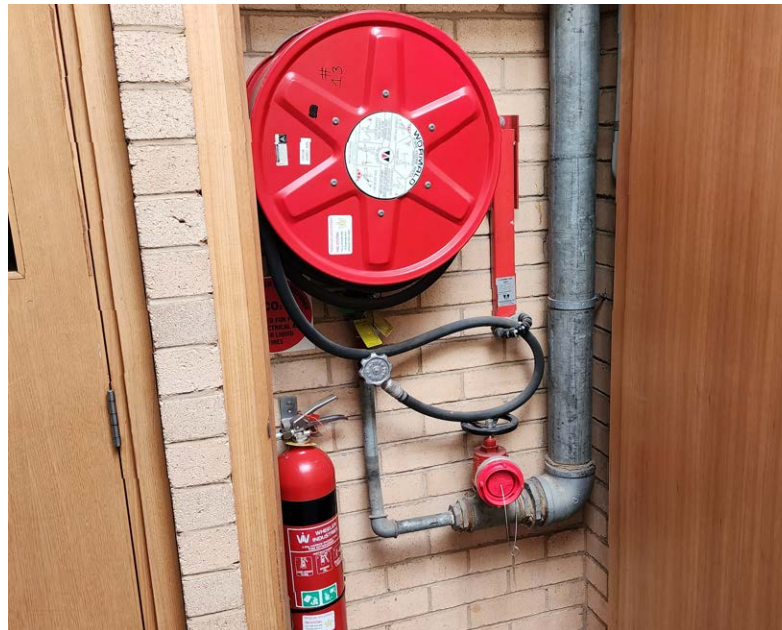
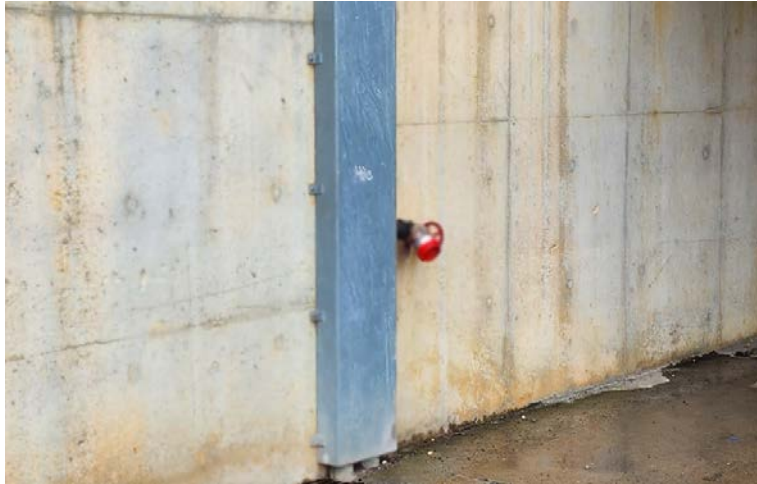
Observations made during the site inspection indicate the fire brigade booster assembly has been configured to AS 2419.1-1994, whereas the hydrants appear to have been installed to Ordinance 70. This conclusion is based on the location (generally outside of the fire stairs), number of external single valve hydrants, and configuration of valves. Refer to the example photographs below.

Some of the significant matters are discussed below, however, during the site inspection, multiple other minor issues were observed with specific valves, such as valves facing into the ground, no clearance around hand wheels, hydrants located more than 4 m from an exit and a lack of clearance provided for hose connections.

It is recommended the existing hydrant system be upgraded to comply with E1D2 and AS 2419.1-2021. Discussions with the incumbent fire contractor indicate a hydrostatic test has been conducted and the existing pipework is able to withstand the system pressures required by AS 2419.1-2021.

The full final design will be subject to a full review by a hydraulic engineer. However, our preliminary review indicates this is likely to include the existing pipework being retained and upgrade works to the existing hydrant valves (such as the location, configuration, hand wheels, clearances), flows/ pressures, fire brigade booster assembly and signage.

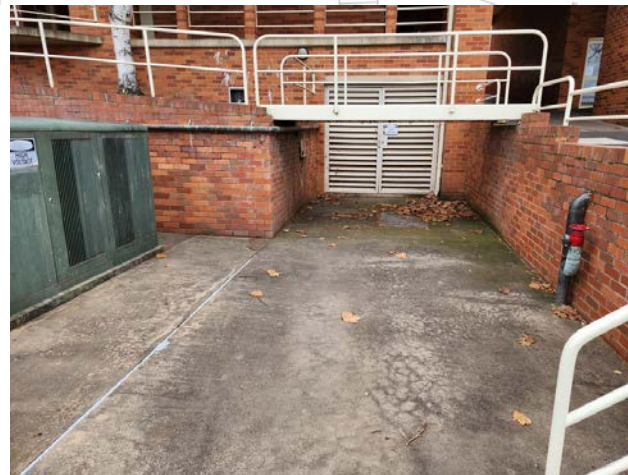
**Block F - External hydrant**

The external fire hydrant located near the basement boiler room under Block F is located within 10 m of an electrical substation.

It is recommended the existing external fire hydrant be re-located to be at least 10 m from any high voltage electrical equipment to comply with 3.5.3.1(b)(ii) of AS 2419.1-2021.
