# FIRE SAFETY UPGRADE STRATEGY REPORT

220 Bentinck Street, BATHURST NSW 2795

| <b>Client:</b> | St Stanislaus College |
| <b>Reference:</b> | 23175 |

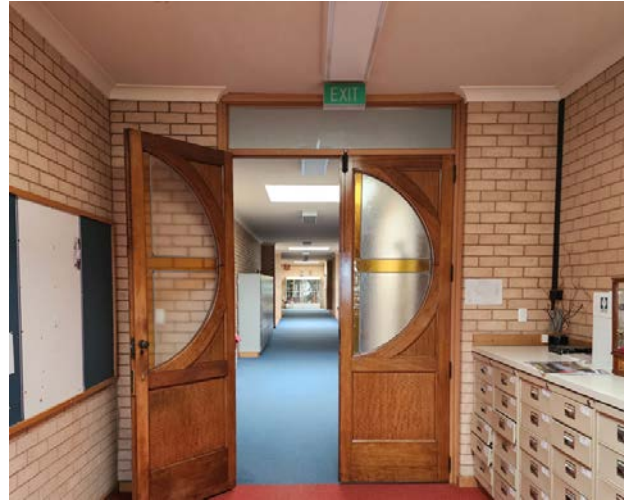
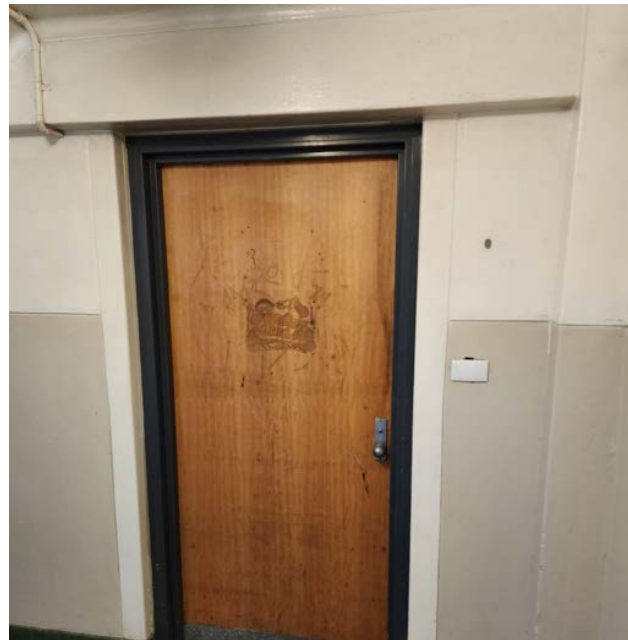
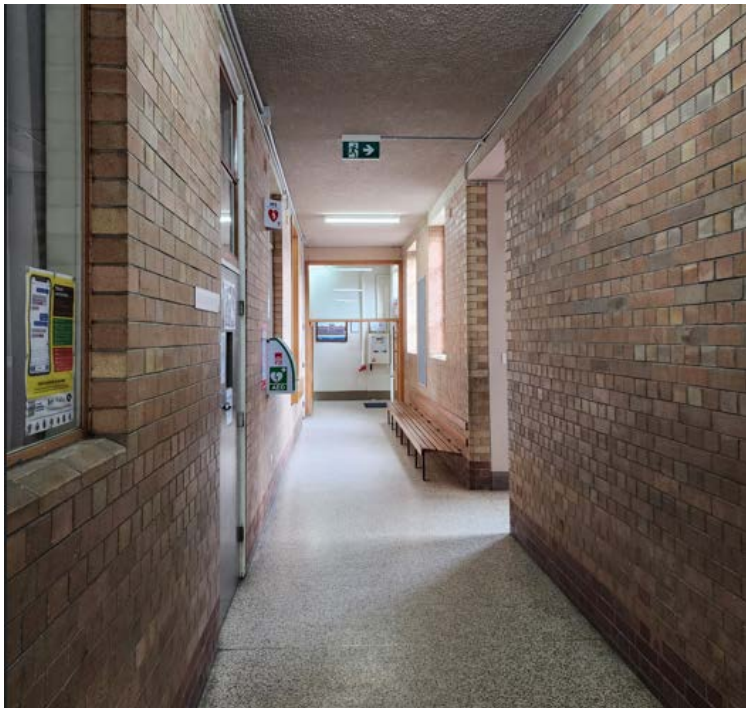
| PART E4: VISABILITY IN AN EMERGENCY, EXIT SIGNS AND WARNING SYSTEMS | | | |
|---|---|---|---|
| E4D5<br>[E4.5] | Exit signs | <p>The AFSS indicates the existing building is not provided with any exit signs or directional exit signs.</p> <p>During the site inspection, some exit signage was observed. The standard of performance varied from Ordinance 70 to AS 2293.1-2005. Most exit signs was observed to be damaged, missing, installed more than 2.7 m above the finished floor or not capable of performing. Refer to photographs of examples below.</p> | <b>Upgrade Recommended</b> |

| | | <p>It is recommended new exit signs and directional exit signs be installed throughout the whole building in accordance with AS 2293.1-2018 (Amendment 1), E4D5 and NSW E4D6.</p> | |

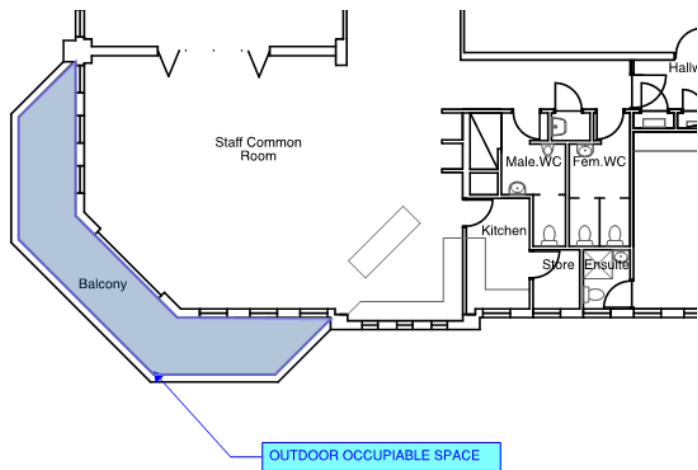
| PART G6: OCCUPIABLE OUTDOOR AREAS | | | |
|---|---|---|---|
| G6D1-G6D10<br>[G6.1-G6.10] | Application of Part | <p>The existing building contains two outdoor occupiable areas located on the Second Storey of Block F.</p> <p><u>Balcony</u><br/>The following marked-up floor plan shows the location of the existing balcony off the staff common room. The balcony is not provided with any emergency lighting, exit signage or warning system and sprinkler system.</p> <p>It is recommended the balcony area be provided with emergency lighting, exit signage, emergency warning intercom system and a sprinkler system as recommended in Part E1 and E4 of this report.</p> | <b>Upgrade Recommended</b> |

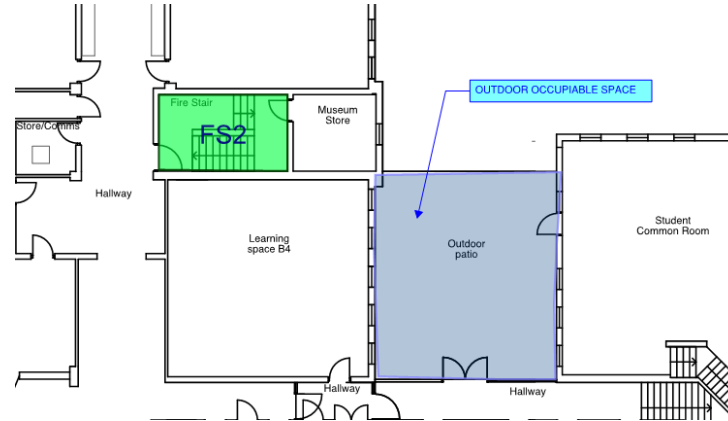
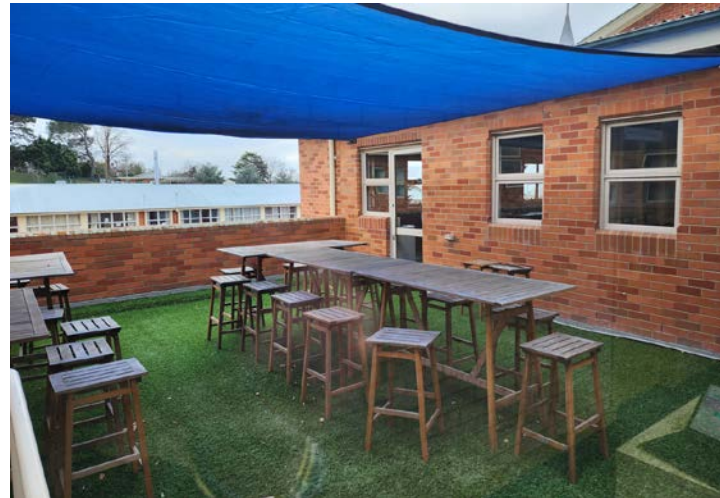
### Outdoor Patio

The following marked-up floor plan shows the location of the existing outdoor patio.

It is recommended the combustible shade sail be removed, and the area be provided with emergency lighting, exit signage, emergency warning intercom system and a sprinkler system as recommended in Part E1 and Part E4 of this report.
