### **RFI Response**

**Response to RFI IDAS-2025-10715 from  
Department Climate Change, Energy, the  
Environment and Water – Water Group**

Document Number: DCCEEW01  
Title: RFI Response  
Project: Lithgow Mountain Bike Park, DA170/25  
Author: Paul Smith (RPEng 918356-1758)

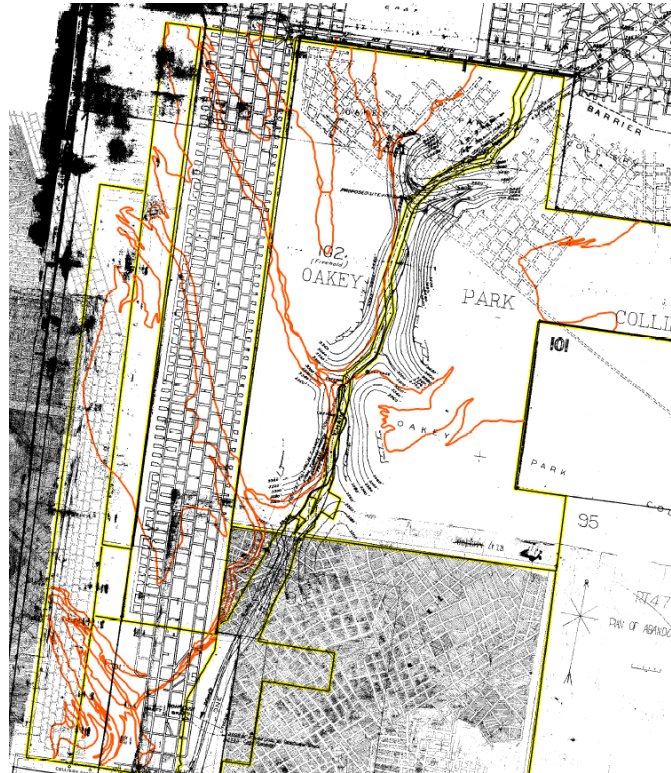
**Figure 1: Mountain Bike Trails Sitting Directly Above Abandoned Lithgow State Mine.**

The figure below (extracted from the DA Mine Subsidence Report – Attachment E) shows the proposed trail alignments on the surface mapped against subterranean mining voids from past activities. This shows that the Site sits on top of legacy, heavily disturbed sub-terranean, mine interference.

Based on the above, and as detailed in the Mine Subsidence Report (**Attachment E**), the subterranean area below the Site is potentially heavily disturbed with underground voids and associated cracks.

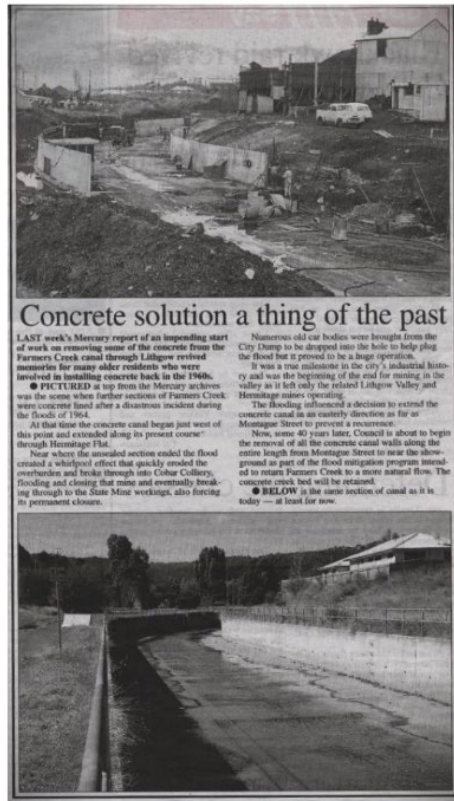
**Figure 2: Extract from the Lithgow Mercury regarding the destruction of Farmers Creek (downstream of our proposed development.)**

It is also understood that the mine was abruptly closed in 1964 due to catastrophic flooding. The 1964 floods saw Farmers Creek break into the Cobar Park Mine (adjacent to the Lithgow State Mine) which subsequently 'broke through' to Lithgow State Coal Mine, flooding and immediately causing abandonment of the mine. Farmer's creek then continued to run into the Cobar Park Mine ceasing downstream flows. Flow was re-established by installing concrete lining along 2.7km of Farmers Creek in the center of Lithgow (see Figure 2).

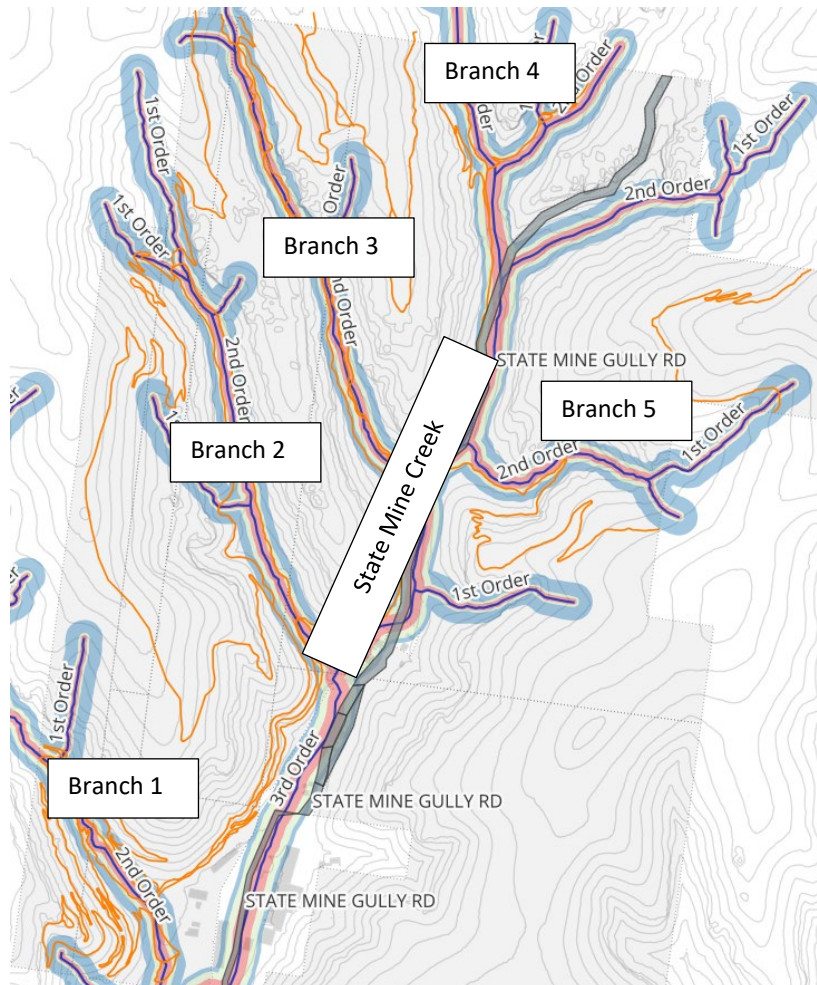
**Figure 4. Riparian Corridor Branch & System locations**

Based on anecdotal evidence collected during the site inspection, and through consultation with the land owner, it is understood that branches 1, 2, 3 and 5 are normally dry and do not usually flow (ephemeral streams) except in extreme flood conditions. Branch 1, 2, 3 and 5 are estimated to flow about once every 10 years according to the owners of the City of Lithgow State Mine Heritage Museum.

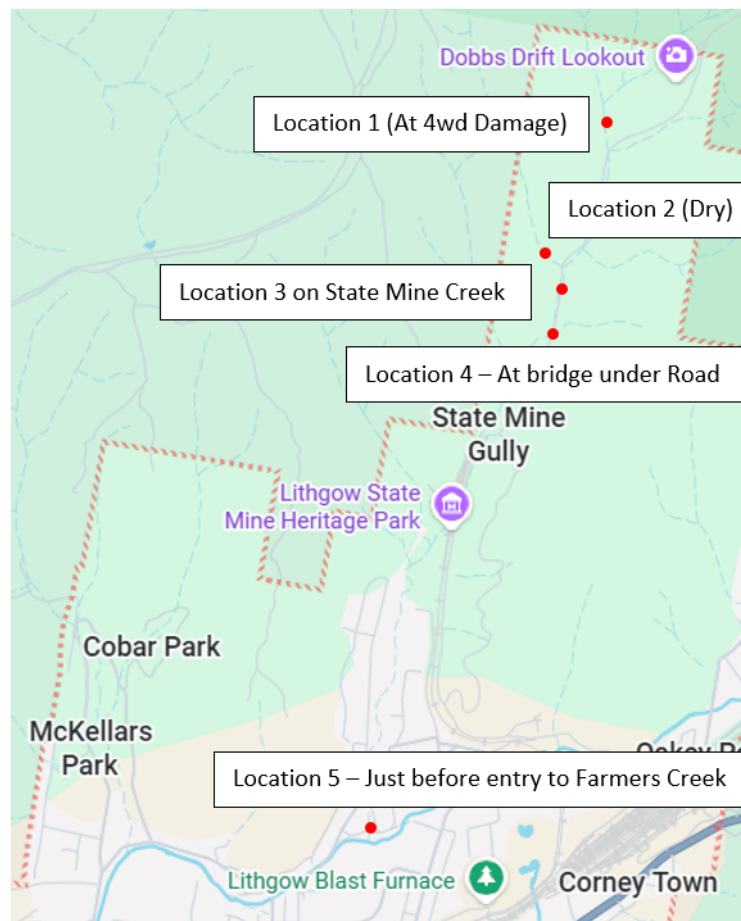
**Figure 17. Turbidity Sampling Locations after rain event**

This data is reported and attached as 'Attachment D - COA Turbidity Readings 10 Feb & 4th Mar 26 Reports' and aligns with the historical readings taken by the Lithgow Environment Group. The turbidity results were very low with a maximum of 3.4NTU recorded on Location 1 (4WD Damage). This indicates that the catchment, even with an existing 1500m mountain bike trail over Branch 3 and extensive 4wd damage in and around the watercourses, is highly resistant to turbidity.
