**One Investment Management Pty Ltd AFT  
The Recap IV Management No. 4 Trust**

**Preliminary Site Investigation**

4 – 6 Bligh Street, Sydney NSW

25 July 2017

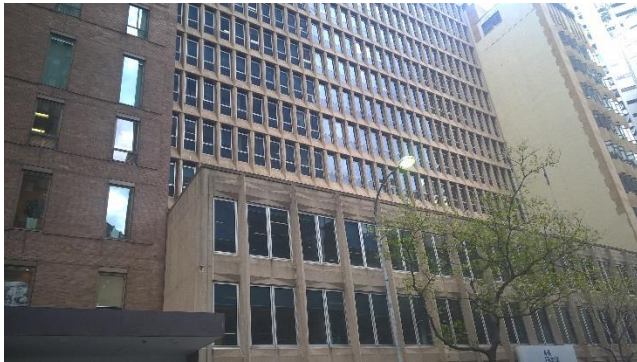
**Photograph 1:**

- The site is currently occupied by multi-storey building (Photograph 1) which consists of 19 floors of commercial space over ground floor commercial and retail units with one level of basement car-parking and one level of building plant room. The height of the current plant room is equivalent to approximately 2 basement levels (i.e. 6m). A design map identified in the plant room was dated 1964, which was confirmed by the Client to be the year of which the building was built.

Current site conditions at 4-6 Bligh Street, Sydney NSW.

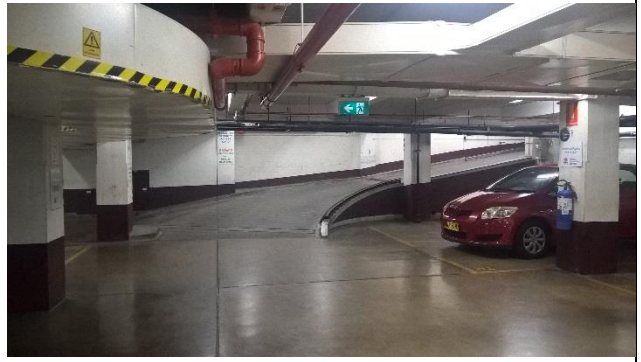
**Photograph 2:**

- The site is accessible via Bligh Street, with a lobby located on ground floor. Basement access is provided by a ramp located within the south western corner of the site (Photograph 2).

Basement car park level with access from the south western corner of the site off Bligh Street.
