## Hazardous Building Materials Report

Sites 1 and 2  
Cnr Todman Ave & Anzac Parade  
Kensington  
NSW

Prepared for  
Toga Group

Project 84823.01  
April 2015

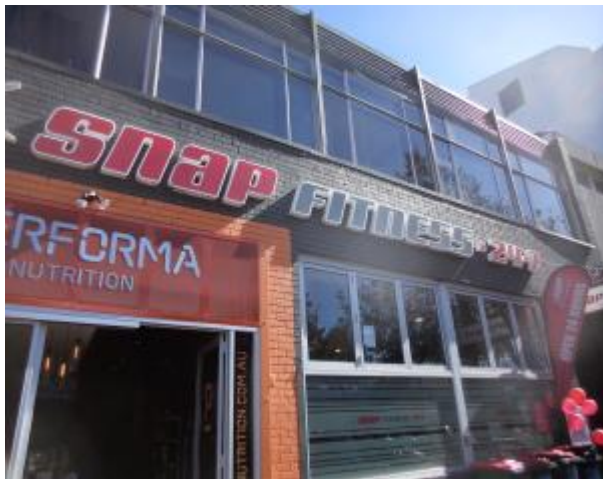
**Figure 1**

113 – 115 Anzac Parade is occupied by Snap Fitness Gym and Performa Nutrition. It is a two level steel framed concrete and brick structure with metal framed windows and presumed to have a profiled metal roofing system. Internals are recently refurbished with new floor coverings and suspended ceiling tiles throughout. The entrance canopy is lined with gyprock. See Figure 1.

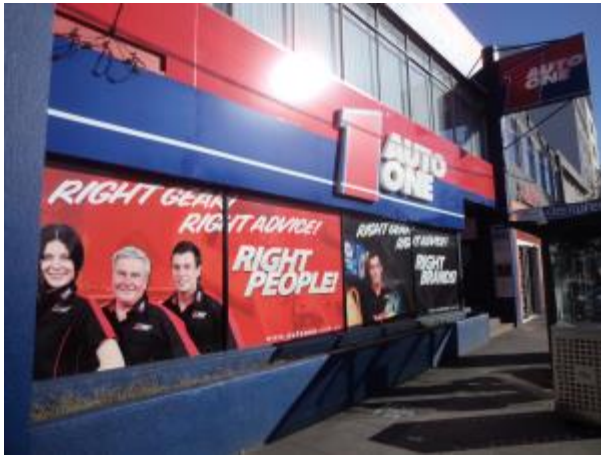
**Figure 2**

117 – 119 Anzac Parade is occupied by Auto-one on the ground floor and rear and by mixed tenancies on level 1 (Wellbeing, Hypnotherapy and a Dental Clinic). It is a two level concrete and brick structure with metal framed windows and a profiled metal roofing system.

The ground floor has vinyl tiles to concrete slab with suspended ceiling tiles in the shop area and mostly bare structure to the rear stores. The rear car park is concrete hardstand and three adjacent brick garages with metal roofing provide extra storage for Auto-one.

Level 1 has fitted carpets/floor coverings and suspended ceiling tiles throughout. The entrance canopy is lined with wooden slats. See Figure 2.

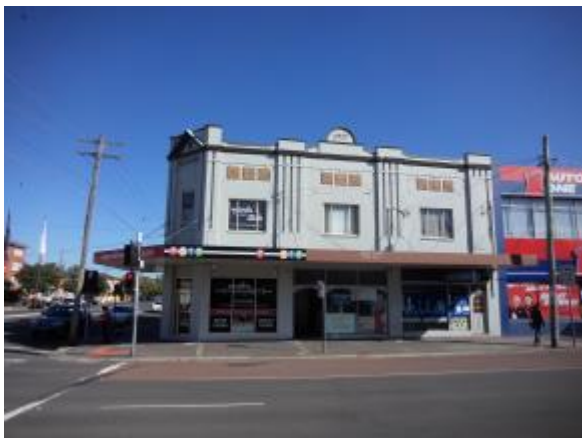
**Figure 3**

121 – 125 Anzac Parade is a two level brick structure on the corner of Todman Ave with parapets to the frontage dating the building as being built in 1917. Renovations to level 1 have extended the building to the rear forming residential units above 121 and 123 and additional space to level 1 of 125. The extension is of timber construction with cement wall cladding and there is profiled metal roofing system throughout.

Ground floor of 121 is a sushi restaurant with tiled floor, rendered brick walls and gyprock ceilings. Ground floor of 123 is a launderette with tiled floor, rendered brick walls and gyprock ceilings except in rear store room above boiler which has cement ceiling lining. Level 1 of 121-123 is comprised of residential units with original plaster ceilings to the front and gyprock and cement ceilings to the rear. No access could be afforded to unit 1, but it is thought to be of similar construction to unit 2. 125 is occupied by Maths Not Squiggles which has been recently refurbished with fitted carpets, gyprock partitions throughout and suspended ceiling on ground floor and original plaster ceilings / gyprock ceilings on level 1. The canopy over the public pavement is of metal construction. See Figure 3.
