# WESTS MAYFIELD TREE ASSESSMENT REPORT: FIG TREES

## TREE ASSESSMENT REPORT : FIG TREES

LOCATION: 32 INDUSTRIAL DRIVE, MAYFIELD

PROJECT NO. 11964.5  
DATE: OCTOBER 2018  
REVISION B

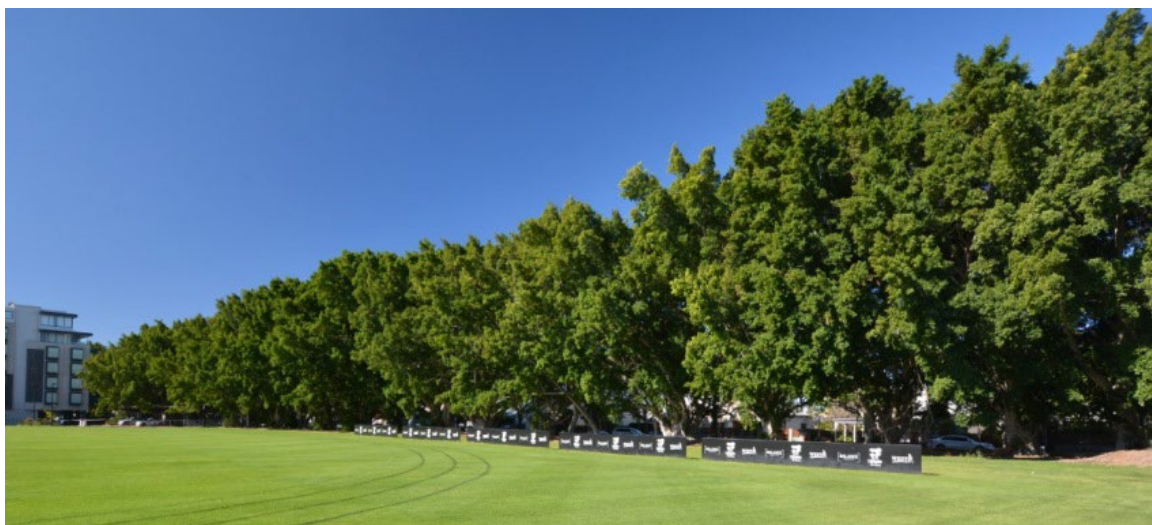
The subject trees are growing parallel to the eastern boundary of the site which it shares with William Street, Mayfield. The trees form a single row broken into two groups: Group 1 contains Trees 1-4 that are located alongside a sealed car park; and, Group 2 contains Trees 5 – 20 that located next to Avon Oval. A pathway providing access from William Street to the club and associated facilities divides the two groups. All trees were found to be growing in a mulched garden bed with a concrete retaining wall located on the boundary approximately 2.6 metres from the centre of the trees.

**FIGURE 1:** OVERALL VIEW OF THE TREES FROM AVON OVAL

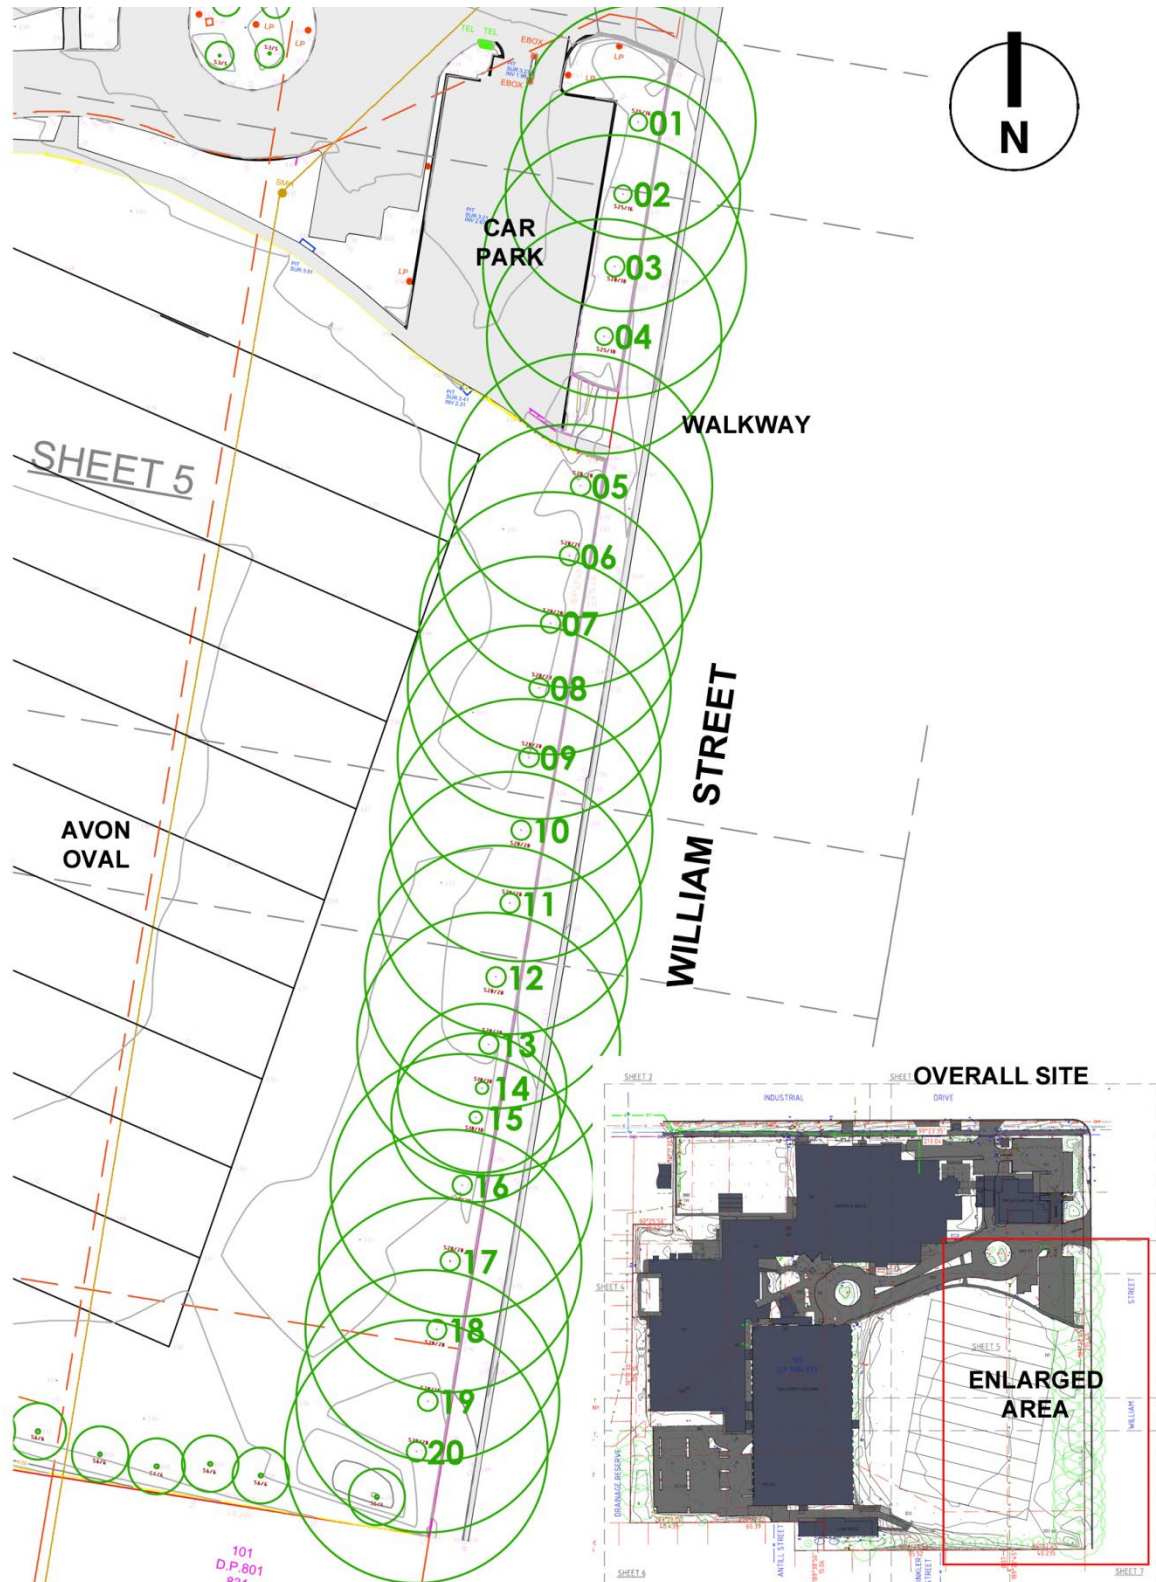
**FIGURE 3: TREE LOCATIONS** [SOURCE: DE WITT CONSULTING, DETAIL CONTOUR SURVEY, 18/01/2018]

A total of 20 trees have been assessed. The tree numbers and locations are shown in Figure 3 with an overall summary of data collected and assessment comments given in Appendix A.

Trees 1-13 and Trees 16-20 are all approximately the same size and appearance. They have been planted at roughly 7.5 metre (25') centres. These trees are generally healthy specimens with vigorous growth, free of pests and significant disease. In some locations where limbs have been lost and not properly attended to, decay has occurred but confined to small areas. All trees appeared to have had some branches removed via pruning. Some larger limbs have been removed to allow for a carport to be constructed near to Trees 1-4 or to relieve pressure on the boundary fence, often after the top rail has buckled. Large surface roots are common, generally up to 3-4 metres beyond the trunk, but do not appear to have sustained any damage assisted by the fact that mowing is not required to maintain turf underneath.

The most striking and common characteristic that these trees have is either multiple trunks or very short trunks with large, first order branches originating close to the base of the trees. Included bark is present in some branch unions but not common throughout.

The life expectancy of Trees 1-13 and Trees 16-20 could be extended by implementing the following recommendations:

- Routinely monitor the trees on an annual basis with inspections by an AQF5 arborist.
- Inspect the trees after heavy storms and where winds exceed 50 km/hr<sup>3</sup>. This may be carried out by an employee of the club with some familiarity of the trees. The aim of the inspection will be to identify obvious occurrences such as: cracked, damaged or hanging branches; splits in the trunk possibly leading to the separation of the multiple trunks; trunks with excessive leans; cracks forming in the ground (being evidence of loss of support by the soil/roots); and, anything that looks to be unusual. If detected, restrict access and have the trees inspected by an AQF5 arborist as soon as possible.

- Improve soil conditions around the bases of trees with regular mulching. An organic mulch shall be maintained at a thickness of 75mm for the purpose of retaining moisture, increasing biological activity within the soil and providing protection to the roots.

- Water the trees during periods of prolonged dry spells (i.e. no significant rain<sup>4</sup> in any 4 week period).
- Tidy up any broken branches by removing stubs in accordance with AS 4373 – *Pruning of amenity trees*.

- Reduce the end-weight on branches when there exists: a significant imbalance; faults within branches; or, where there is an increased hazard based on a heightened level of use.

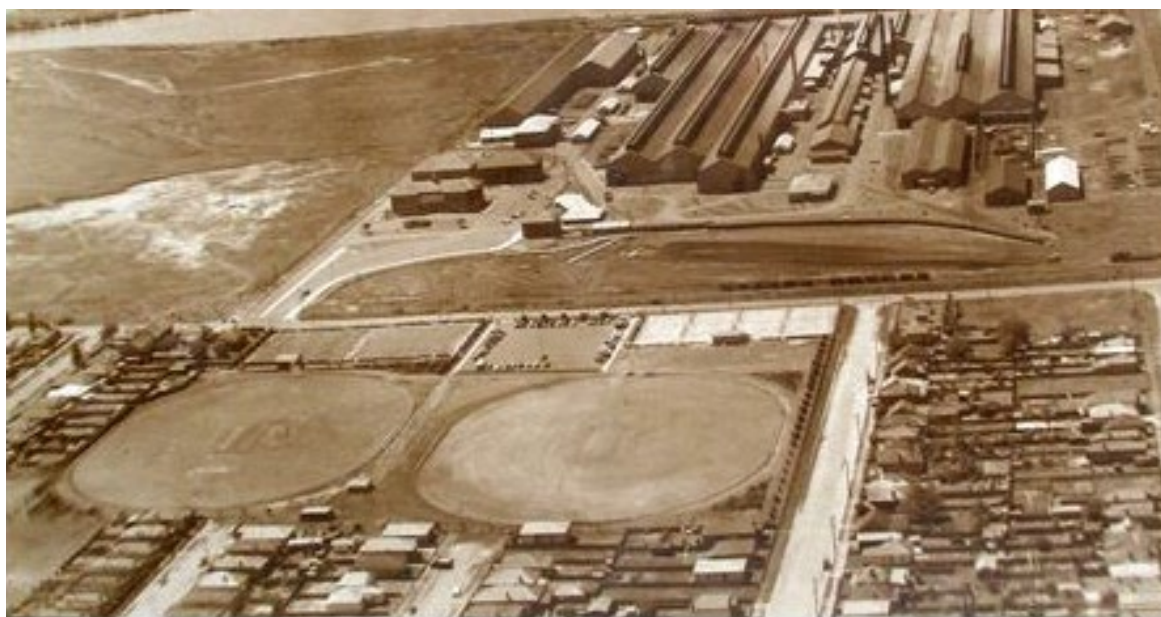
It would seem that the majority of trees (i.e. Trees 1-13 and Trees 16-20) were planted in the late 1930-early 1940s as evidenced in the below aerial image taken c.1950 which shows the trees as being well established [FIGURE 4]. It has been suggested in a report prepared by Newcastle City Council (NCC, 2012) that the figs planted within Newcastle in this period were propagated from cuttings taken from a specimen growing in a Brisbane Park. These trees, such as the former Laman Street and Tighes Hill TAFE figs, had a structural weakness resulting in an inherent defect in branch attachment, the impact of which has become apparent in recent years as the trees have matured and reached their full adult size. This inherent defect was compounded by pruning practices whereby trees were lopped with the intention of keeping trees neat and rounded. This practice stopped in the 1970 and so allowing trees to reach heights in excess of 25 metres.

**FIGURE 4:** c.1950 AERIAL VIEW OF STEWARTS & LLOYDS WITH AVON OVAL AND FIGS IN THE FOREGROUND  
[SOURCE: NEWCASTLE REGION LIBRARY PICTURE GALLERY/ACCESSION No. 345 000321]
