Slope Risk Assessment Report

Patyegarang Project

Reference No. 30012988
Prepared for Metropolitan Local Aboriginal Land Council
14 July 2023

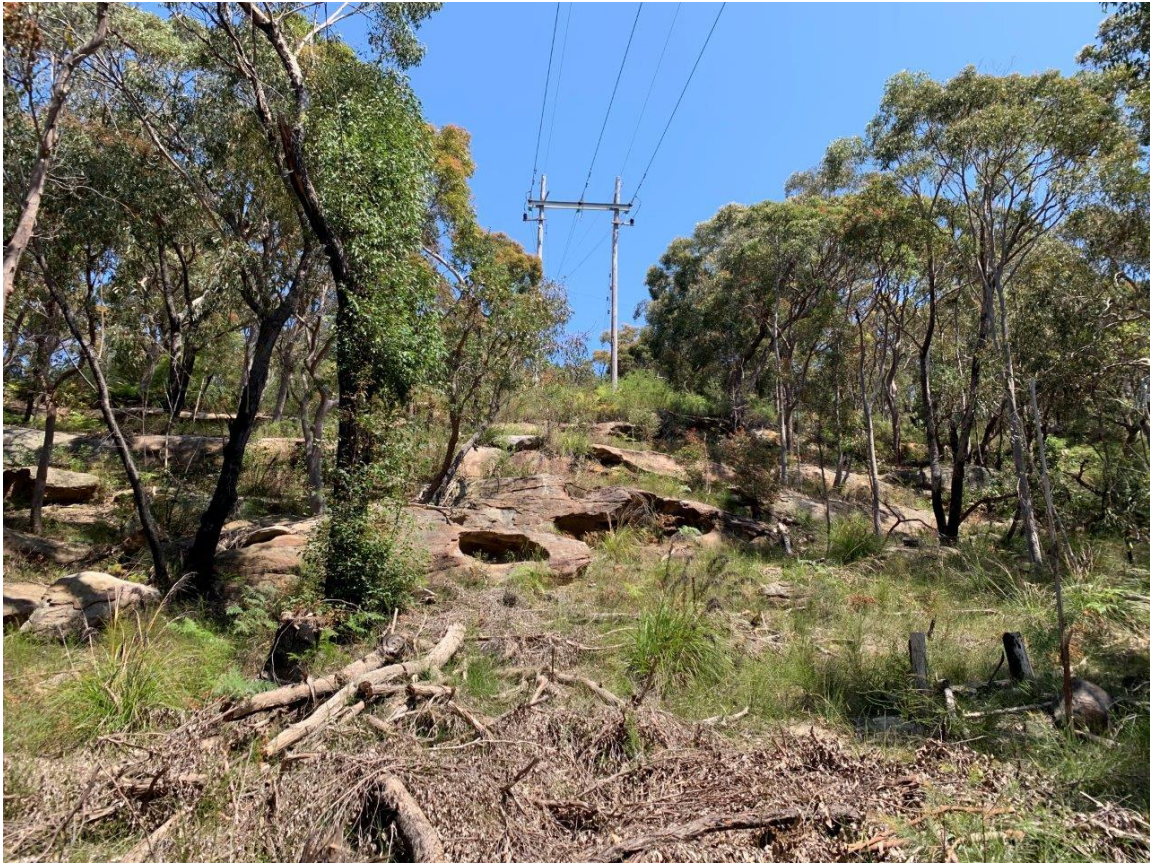
Photograph 1: View looking west, power line and rock outcrop slopes

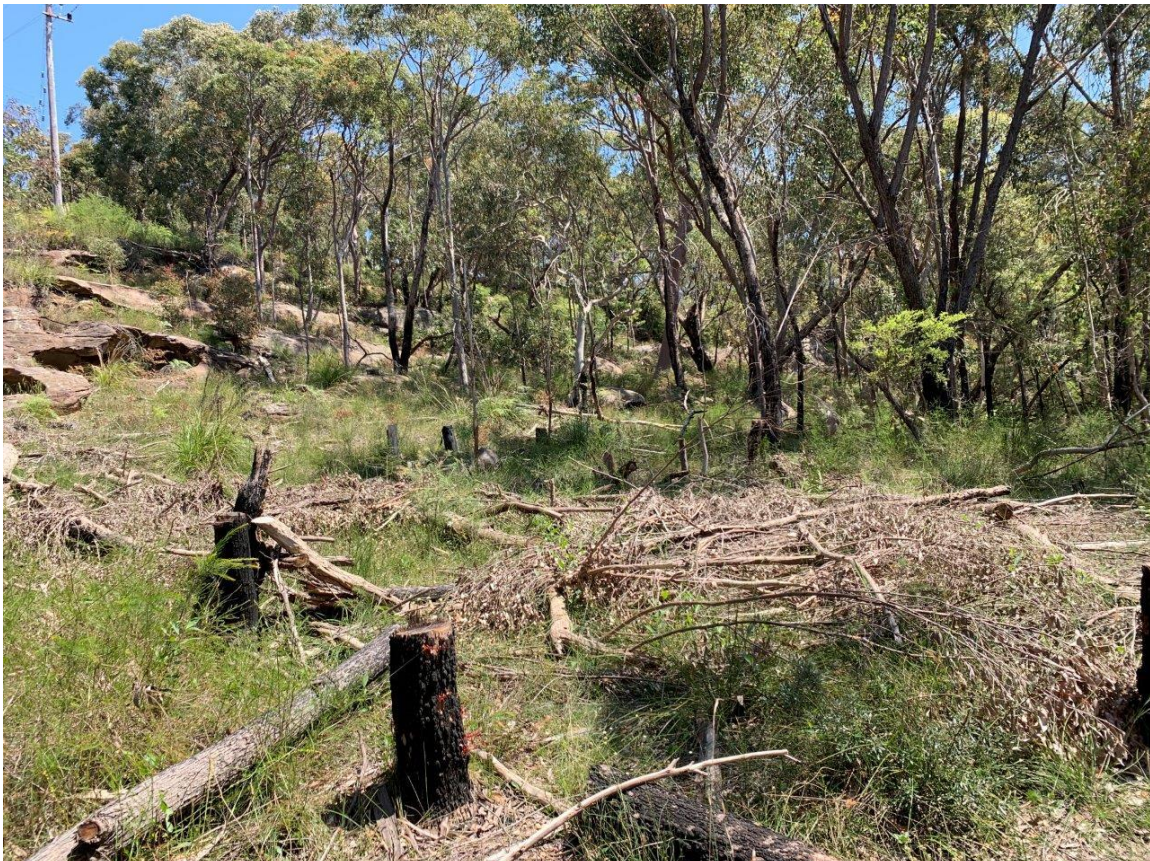
Photograph 2: View looking north-west, recent devegetation underneath power lines

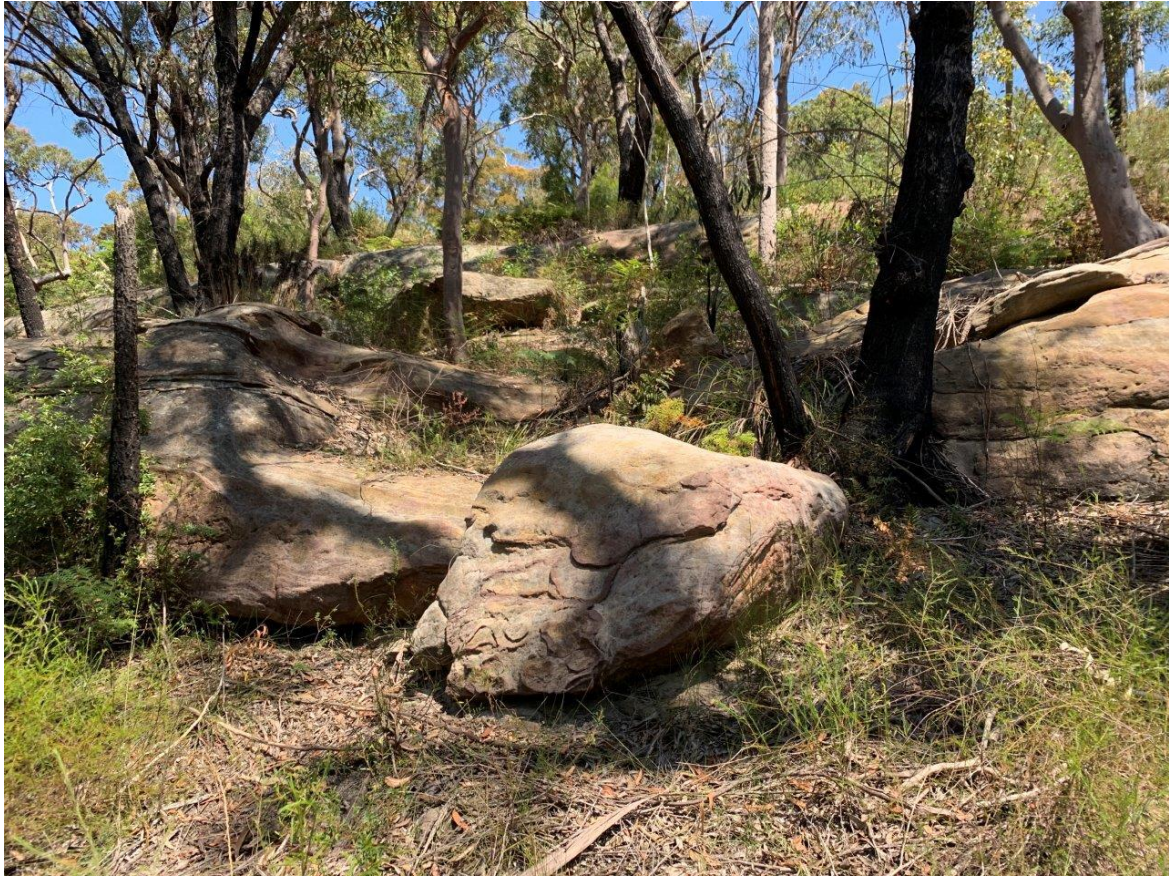
Photograph 3: View looking south west, large blocks up to 1.5m at toe of slope

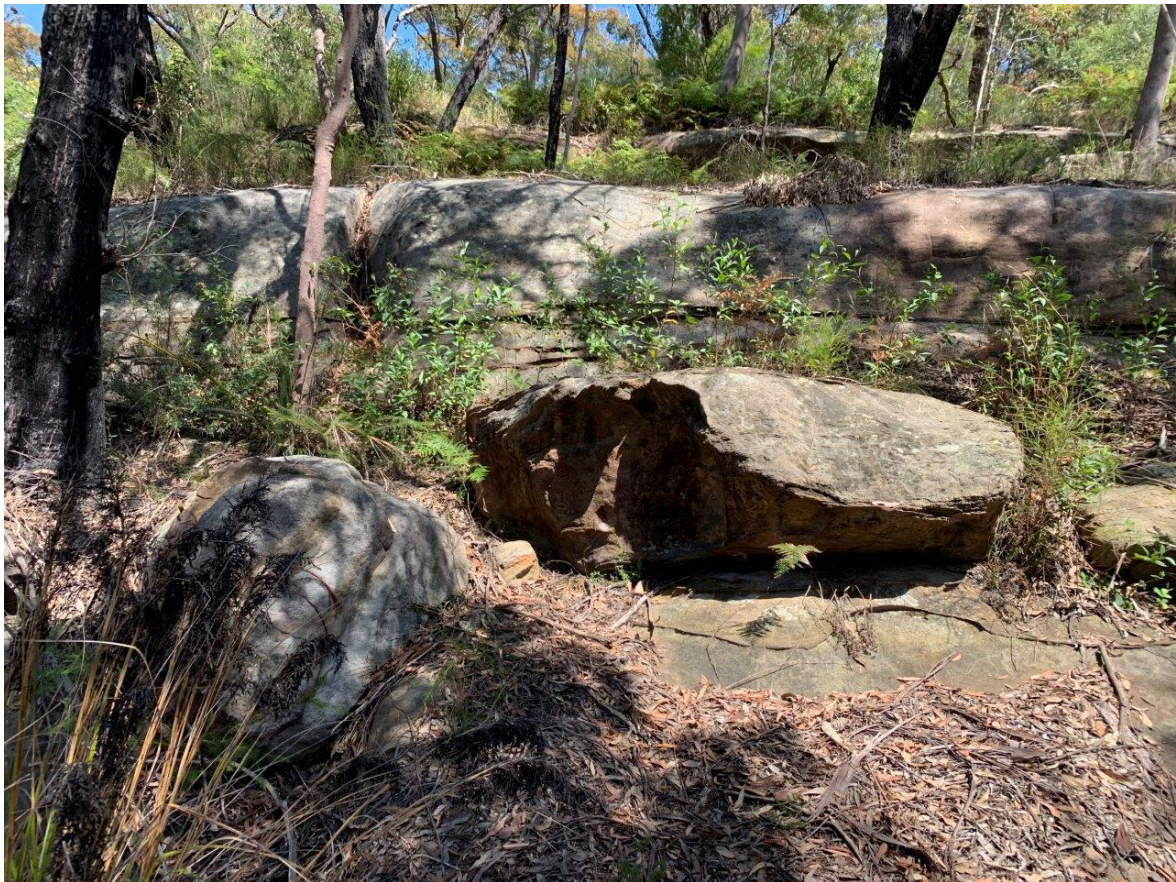
Photograph 4: View looking west, large detached block on slope suspect previous fall

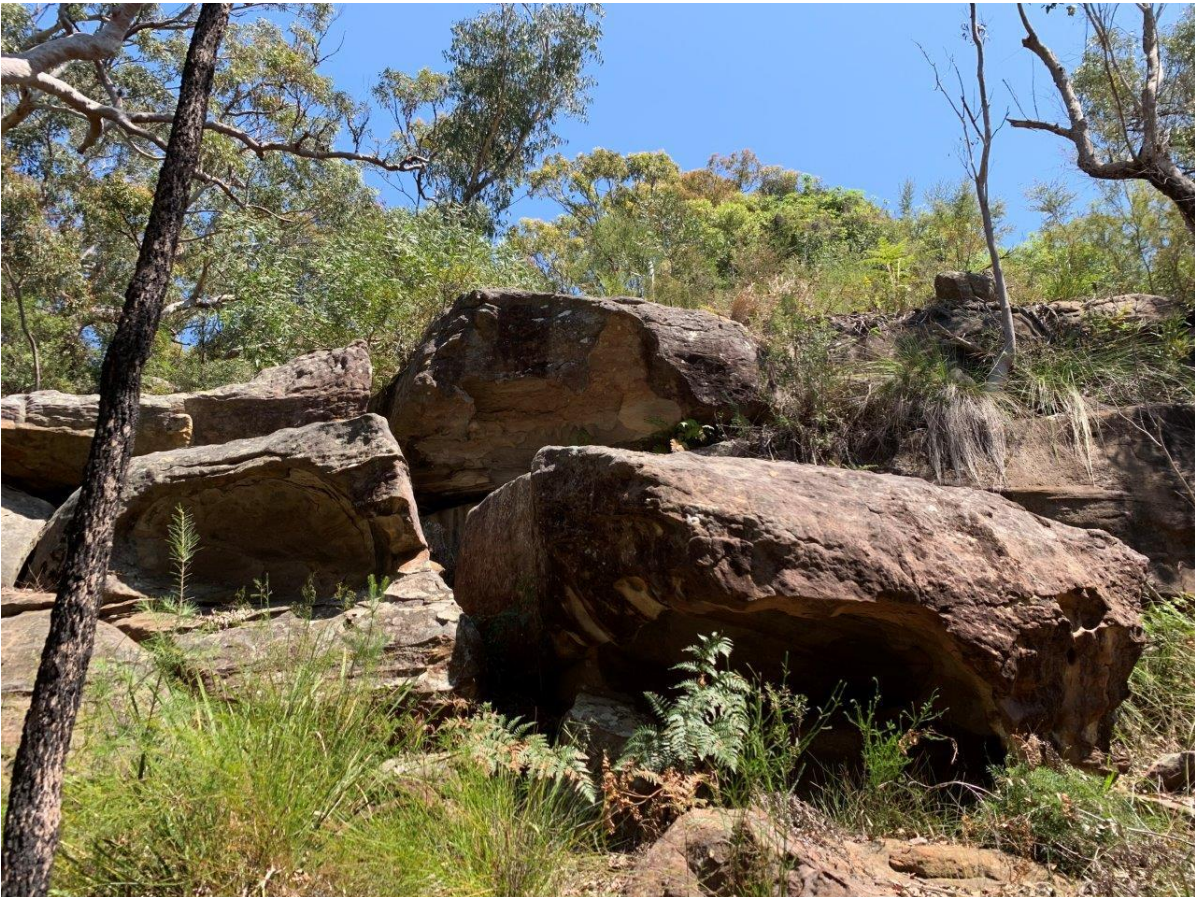
Photograph 8: View of large overhangs at crest

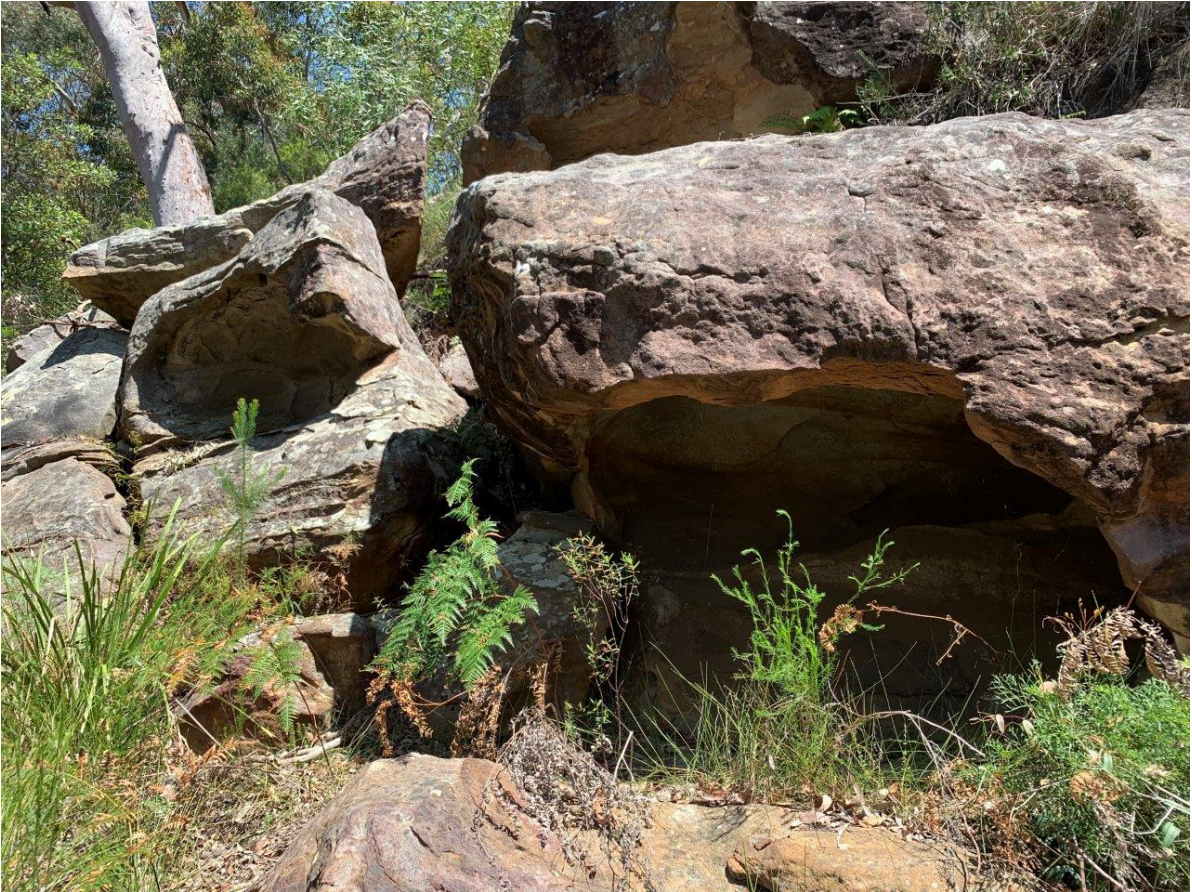
Photograph 9: View of sandstone weathered at crest creating cavern like features

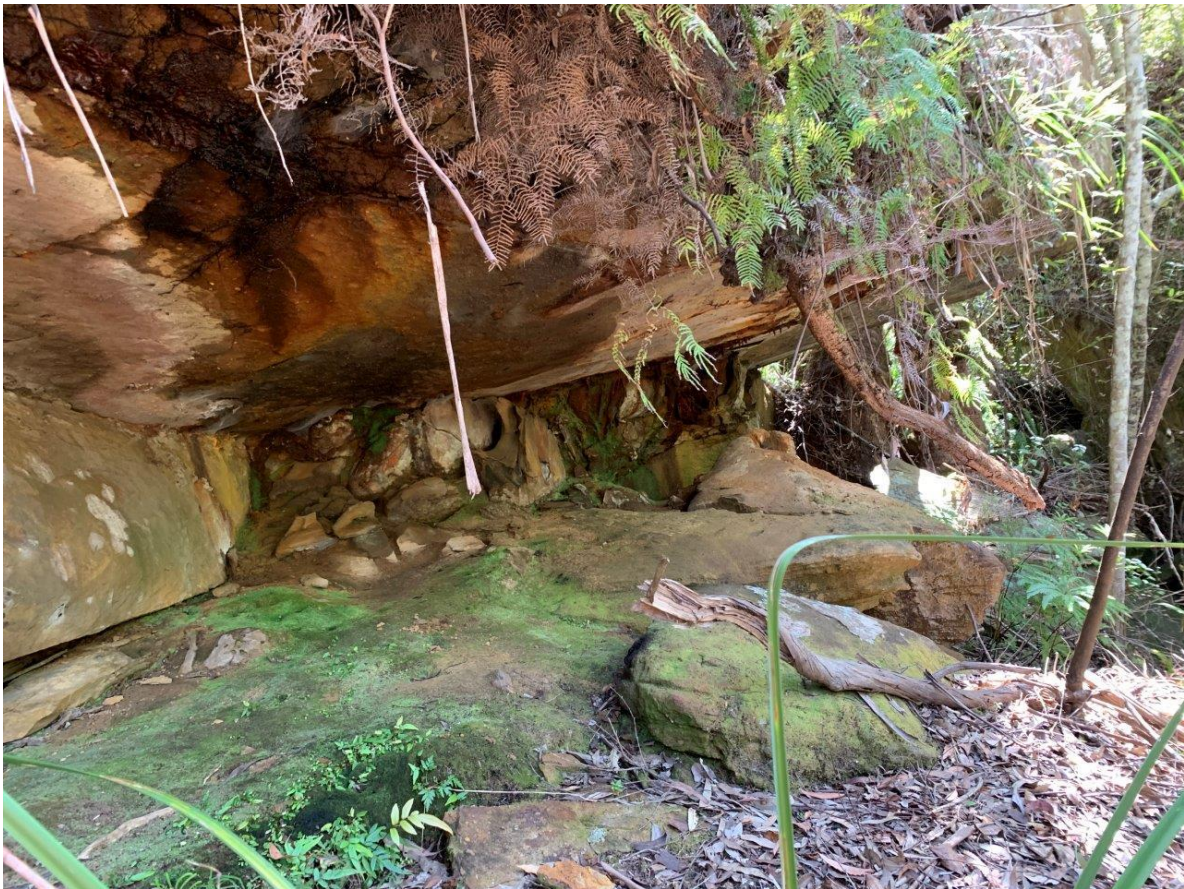
Photograph 6: View underneath undercut sandstone bed

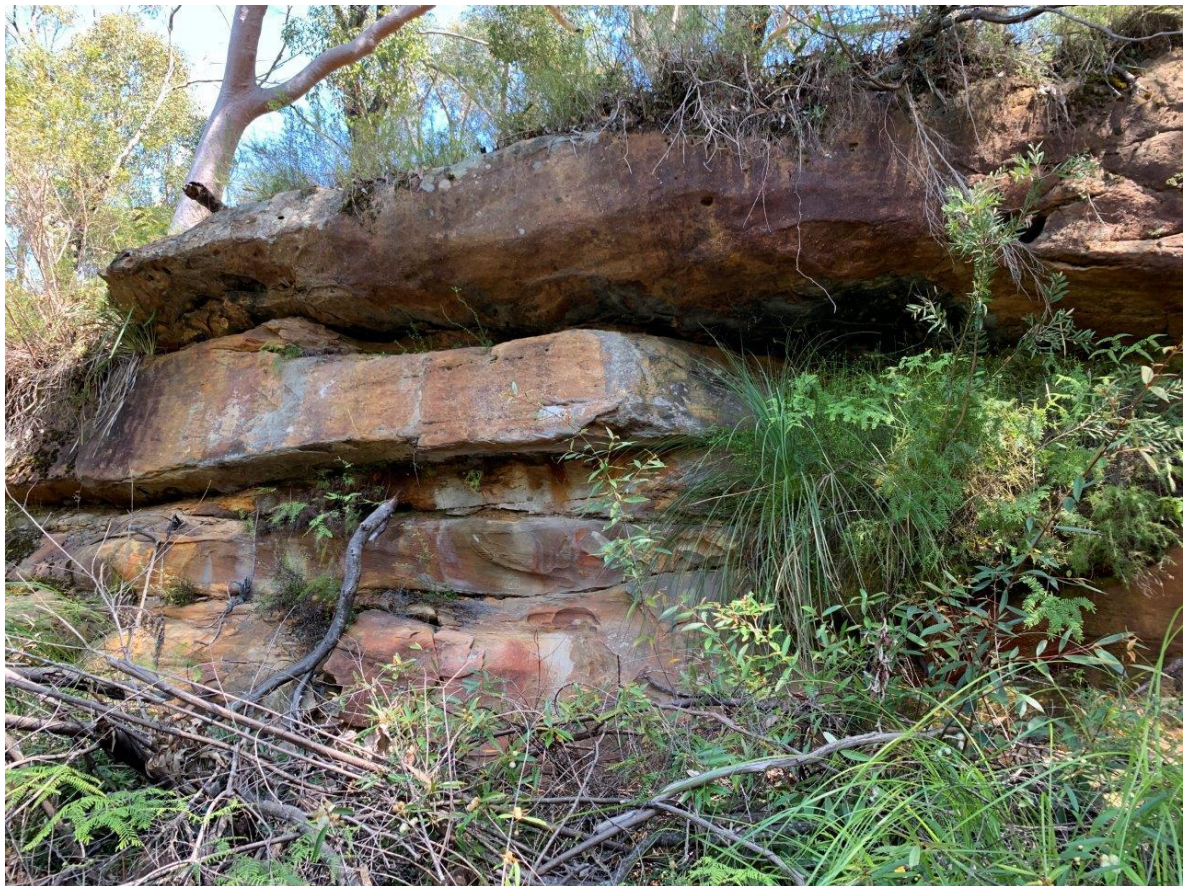
Photograph 8: View looking west at sandstone precipice, weaker eroded beds creating overhangs of larger beds

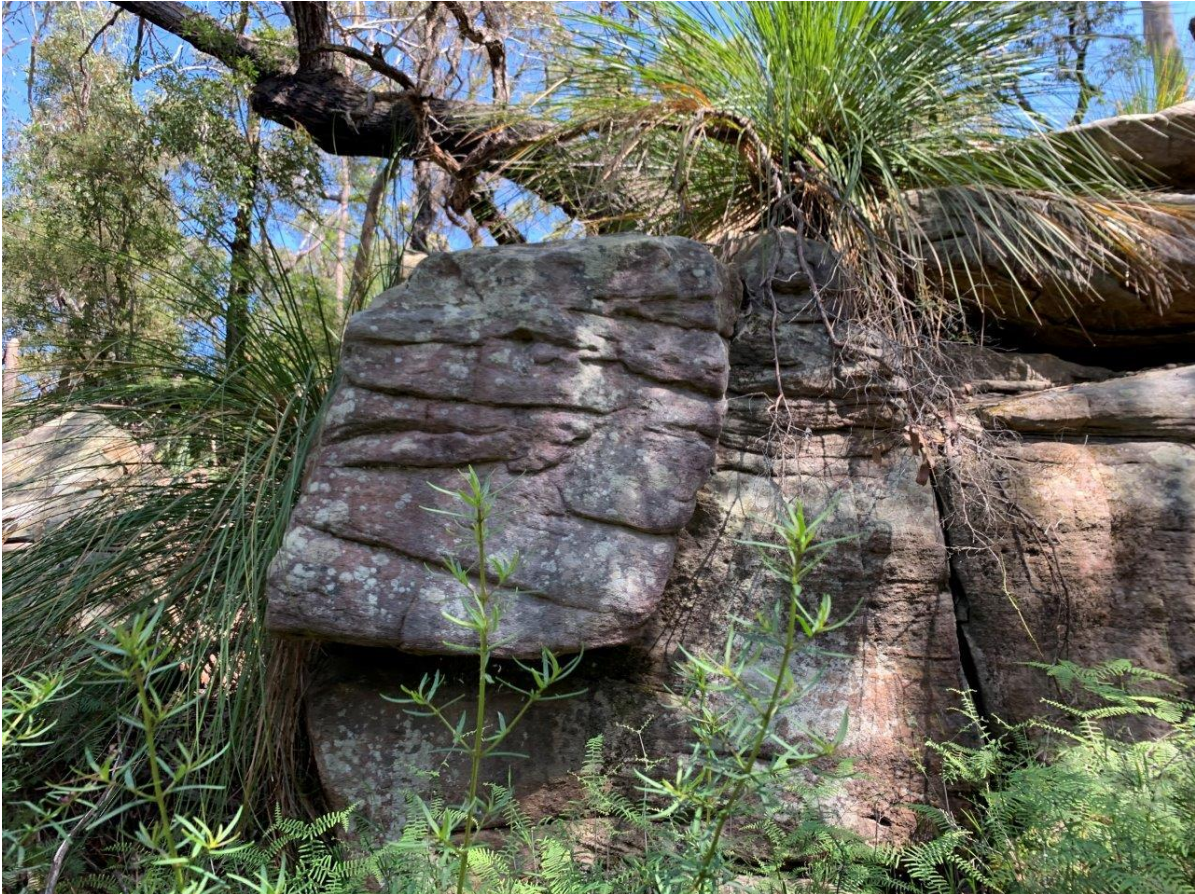
Photograph 3: View of large block, potential for collapse

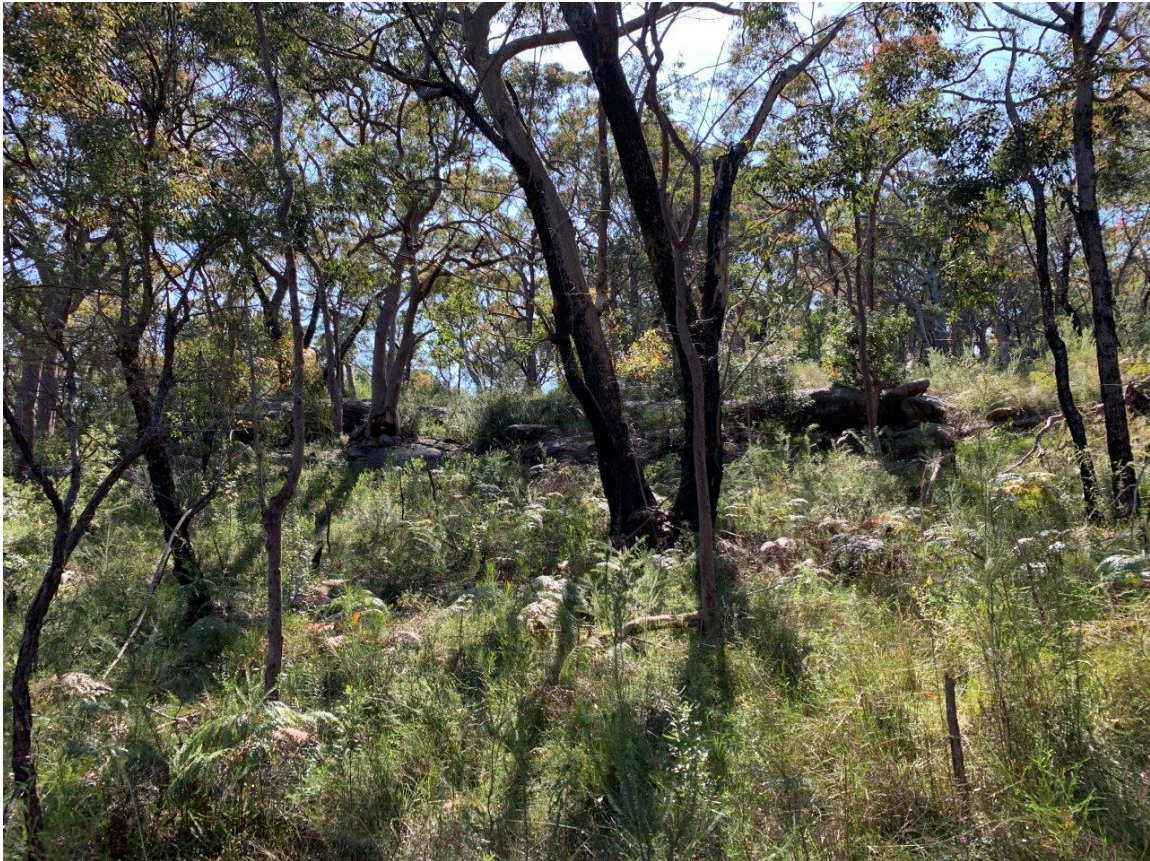
Photograph 1: View looking east towards sandstone precipice up to 4.5m height

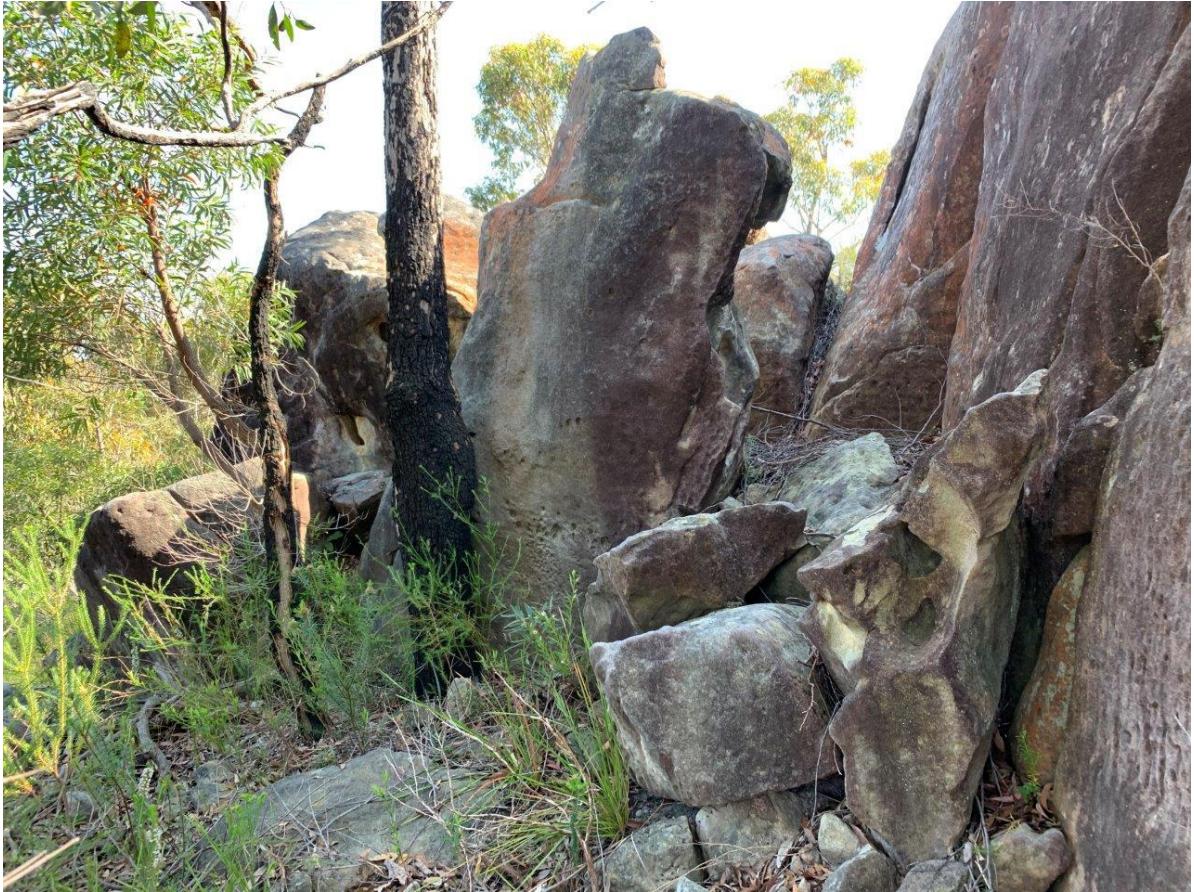
Photograph 5: View of previous falls up to 2m

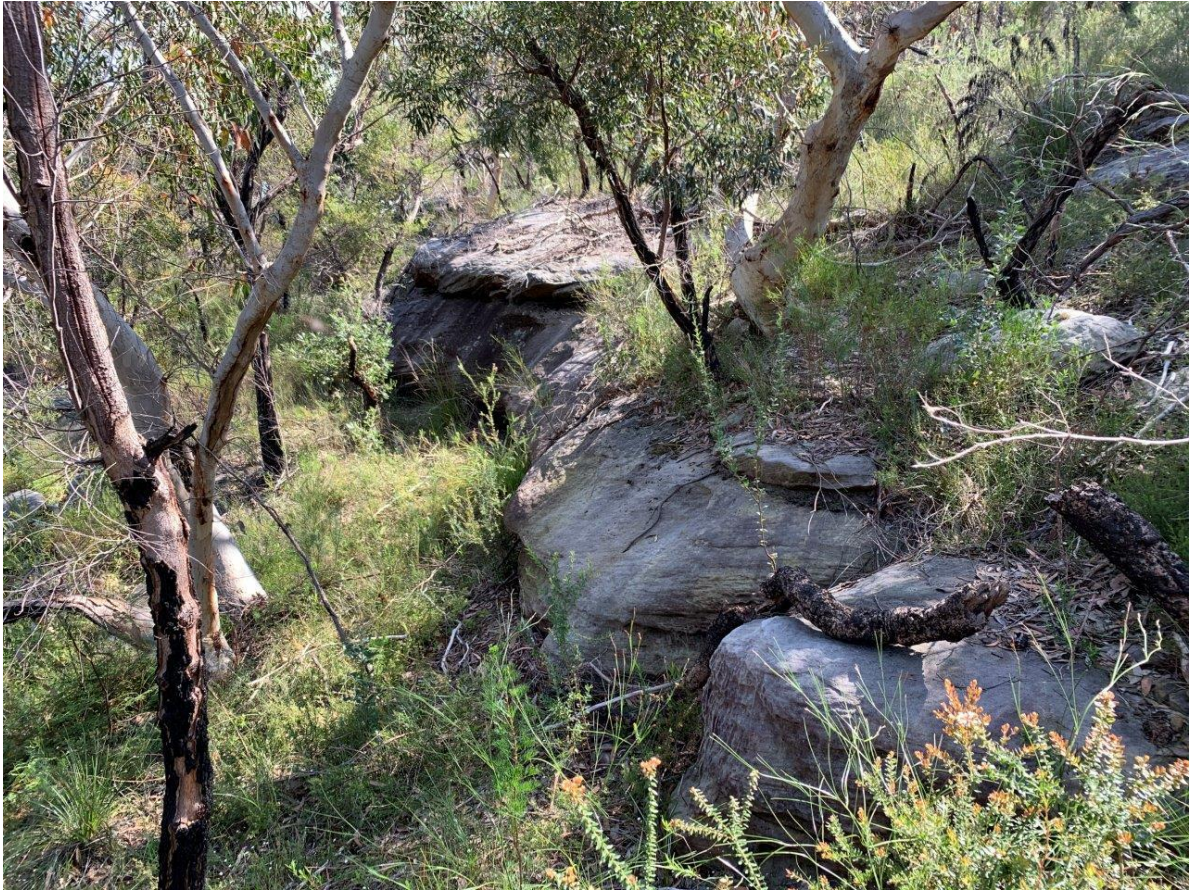
Photograph 7: View looking north along sandstone precipice up to 1.5m height

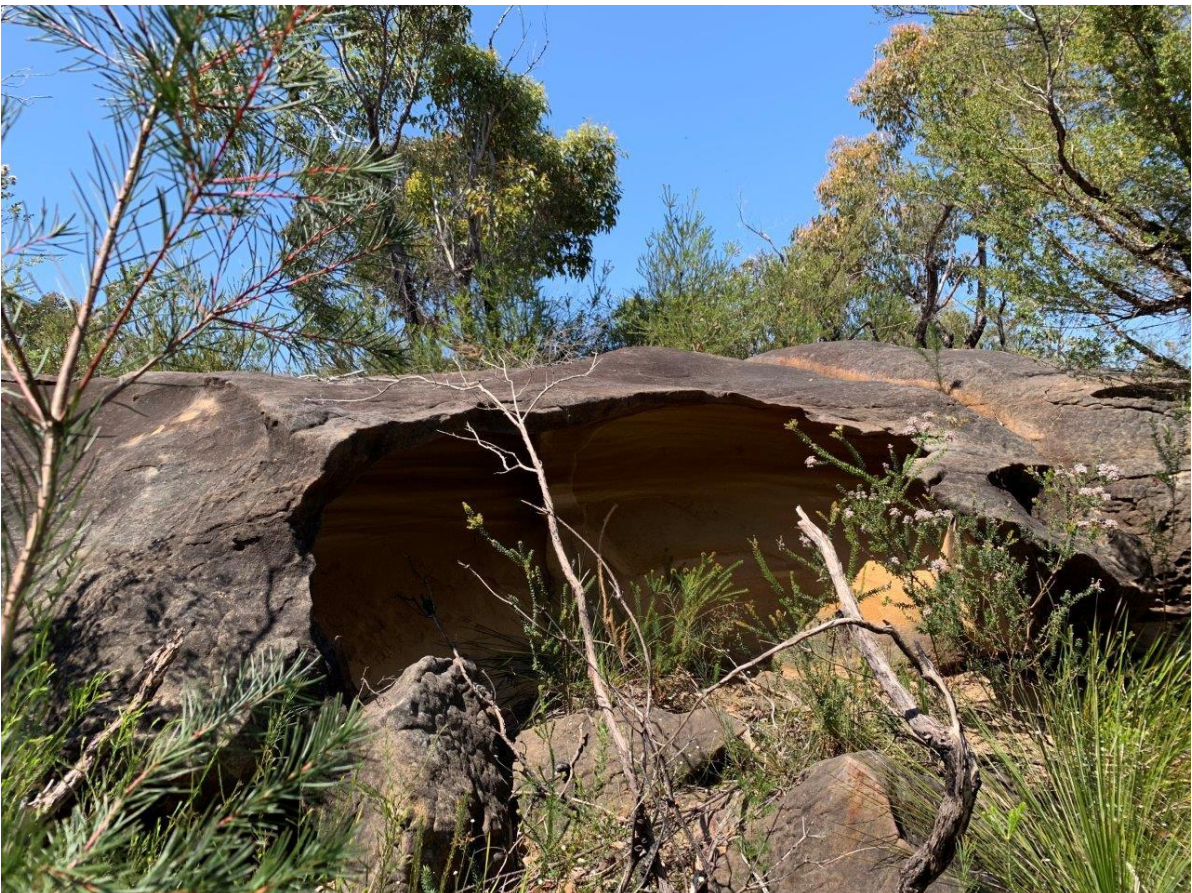
Photograph 8: View of weathering in sandstone precipice creating cavern like feature

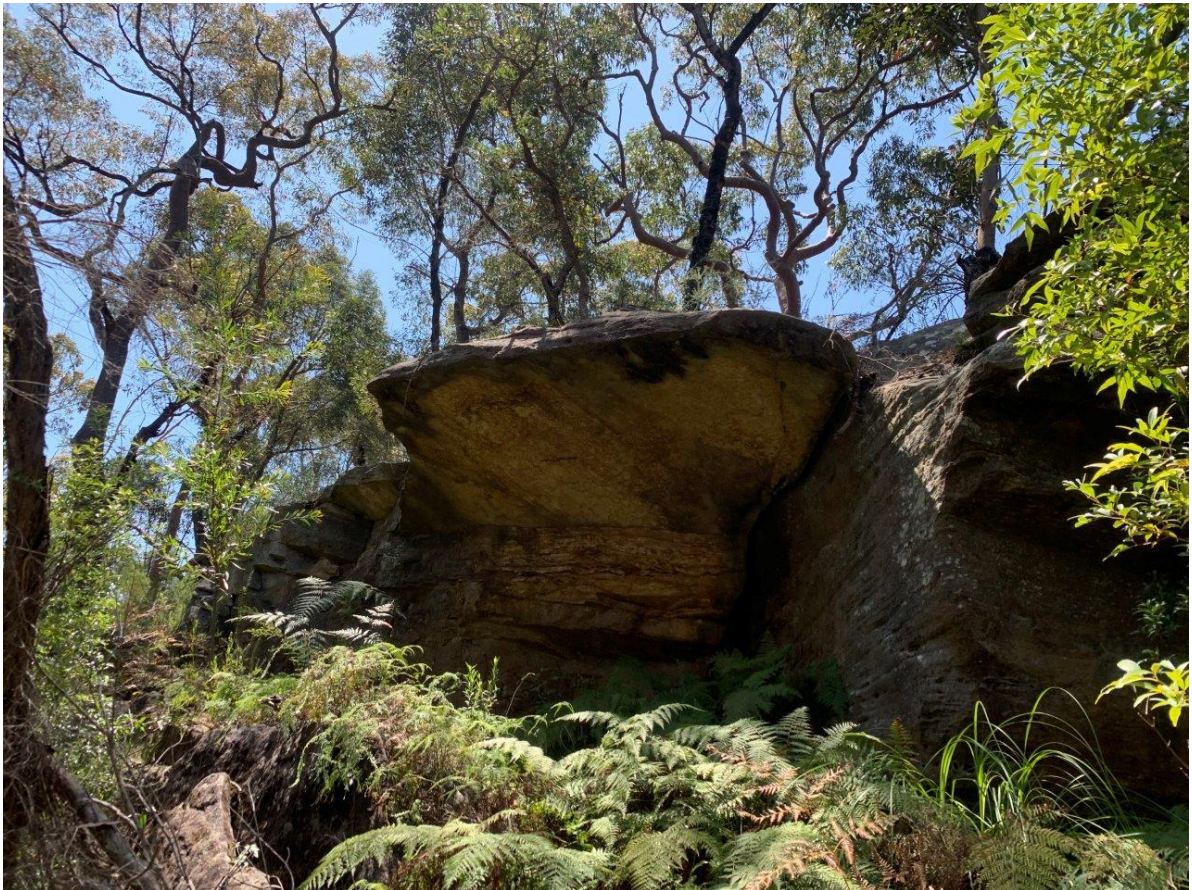
Photograph 10: View looking east, large overhang up to 2m at crest of precipice

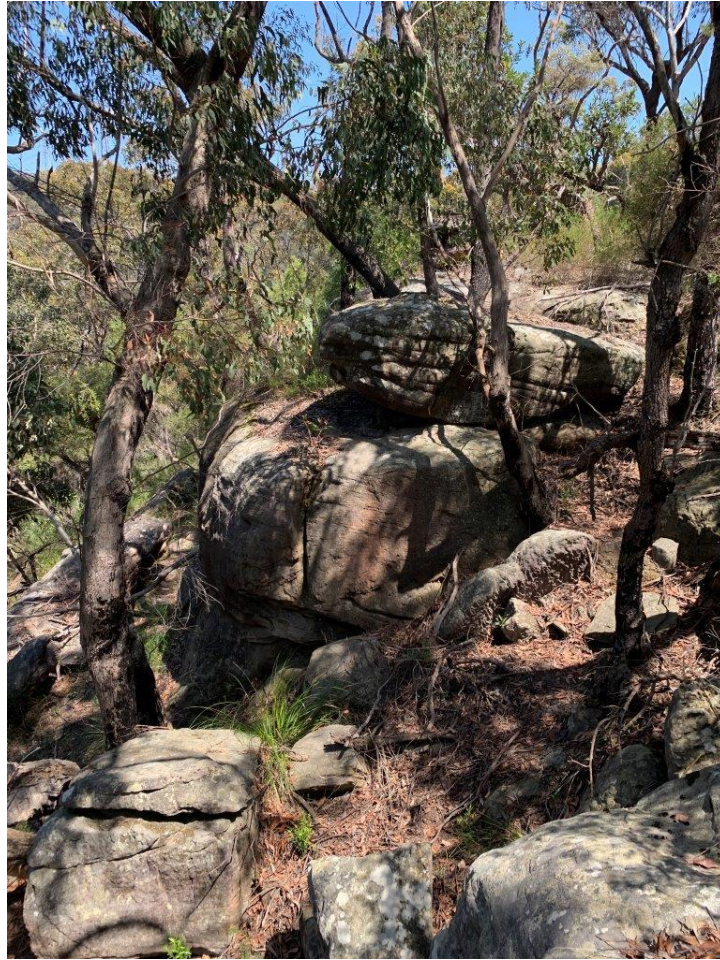
Photograph 3: View looking south-west, overhangs and undercut blocks

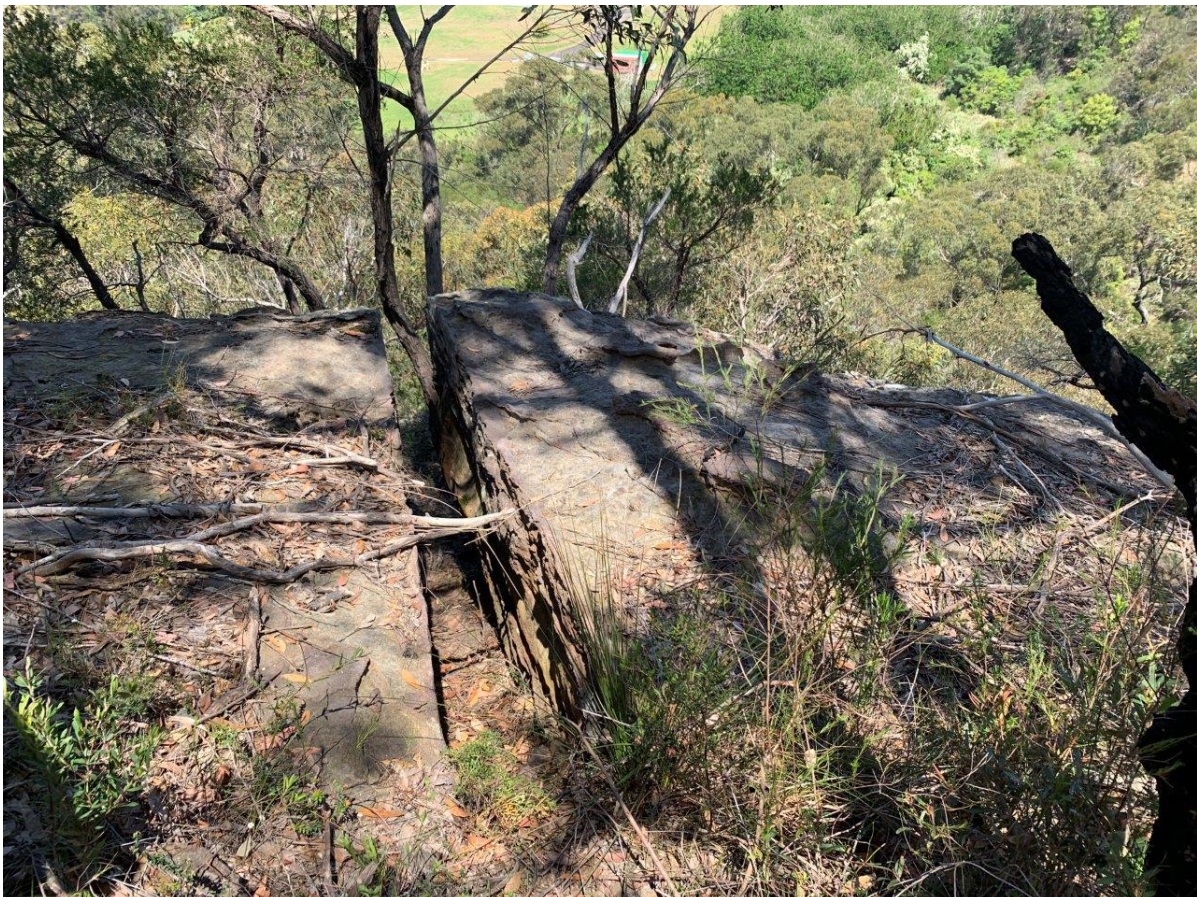
Photograph 6: View looking south at crest, open void ~0.3m with large overhanging blocks at crest

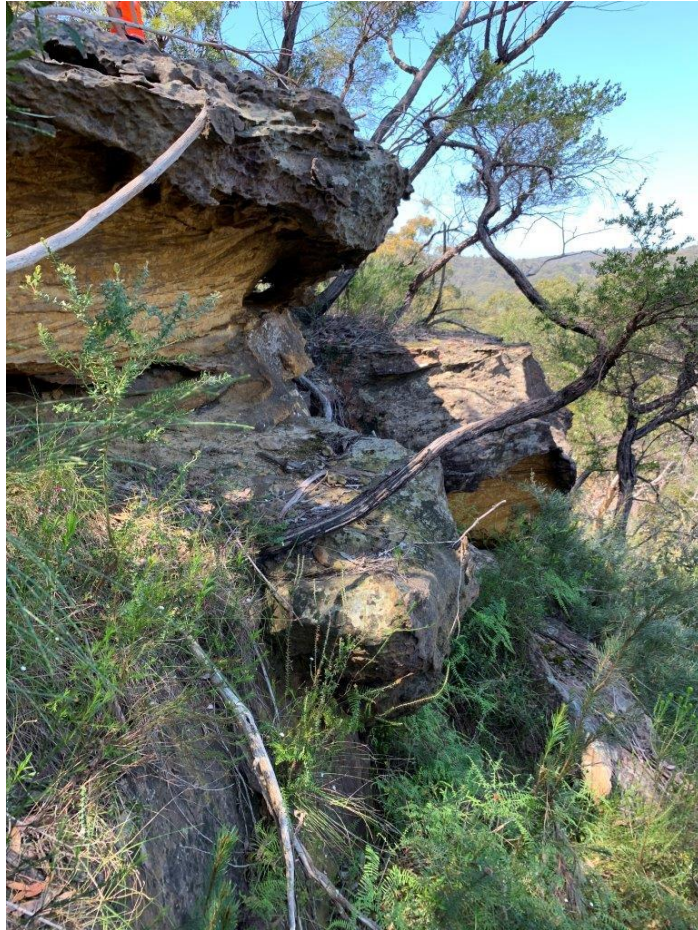
Photograph 7: View of large overhangs along crest of cliff line

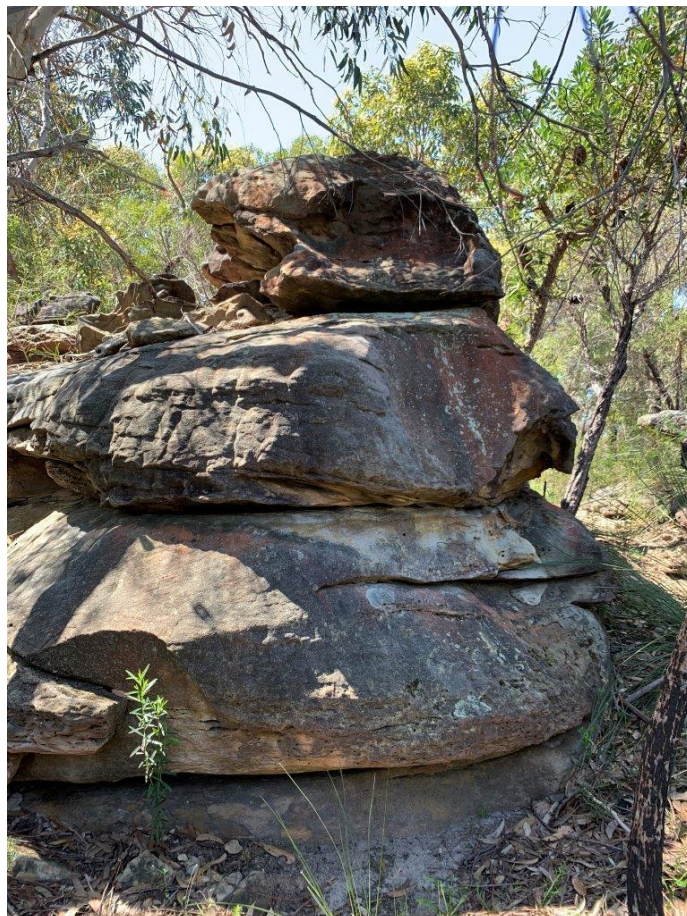
Photograph 8: View of large loose block at crest of 2m high precipice

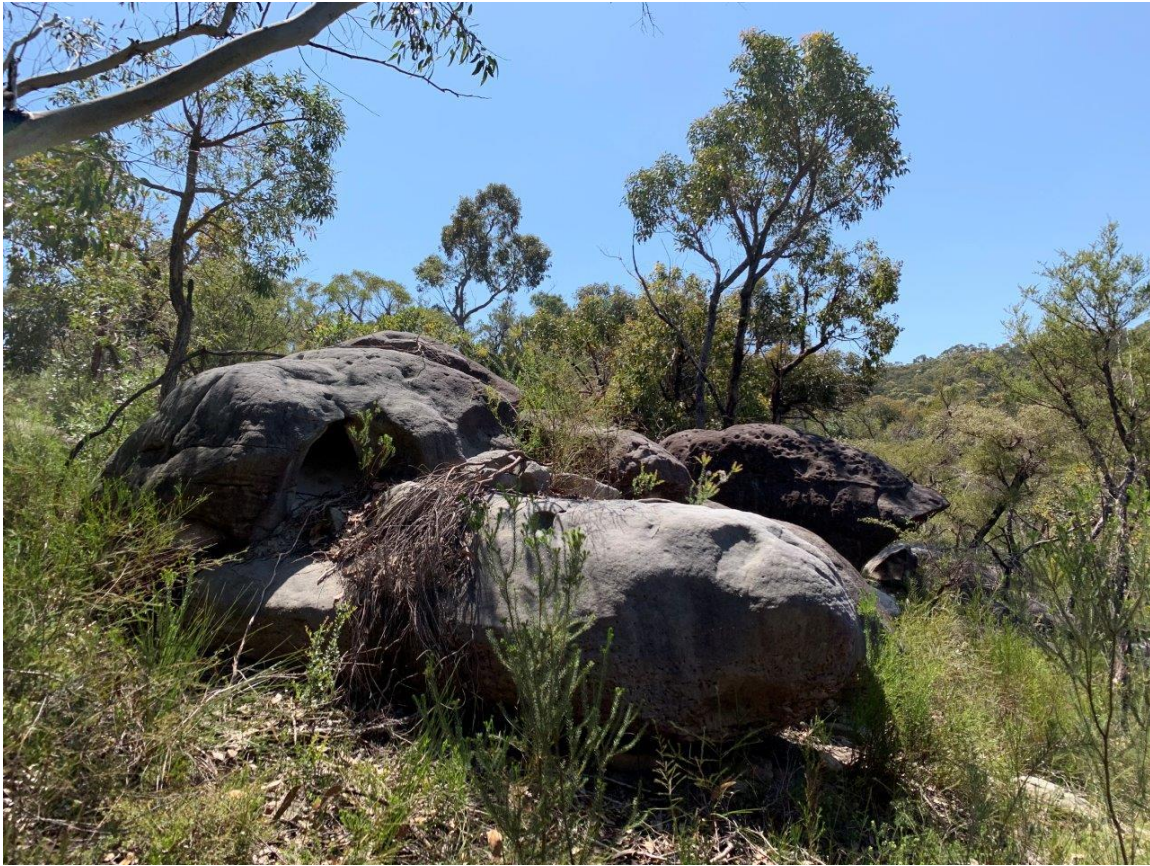
Photograph 1: View looking north at sandstone precipice

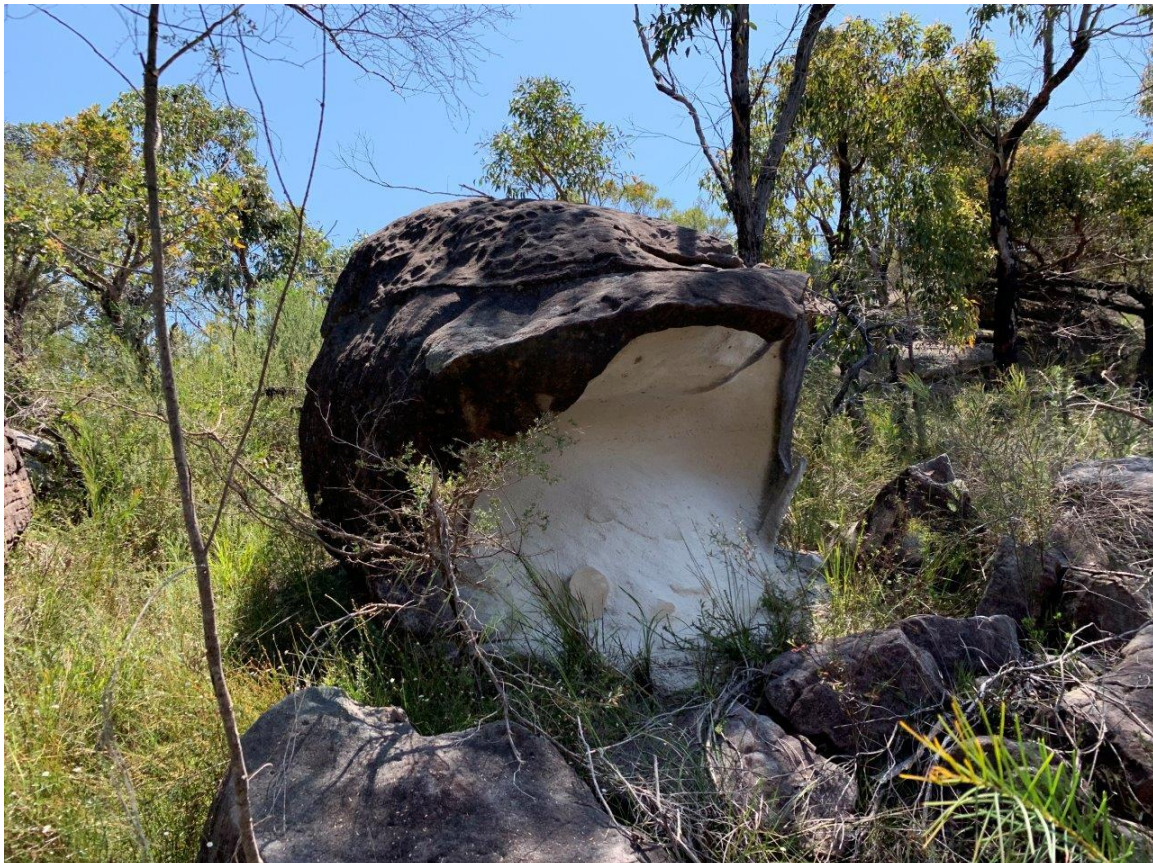
Photograph 2: View of weathering of sandstone boulder up to 2m, weathering creating cavern like feature

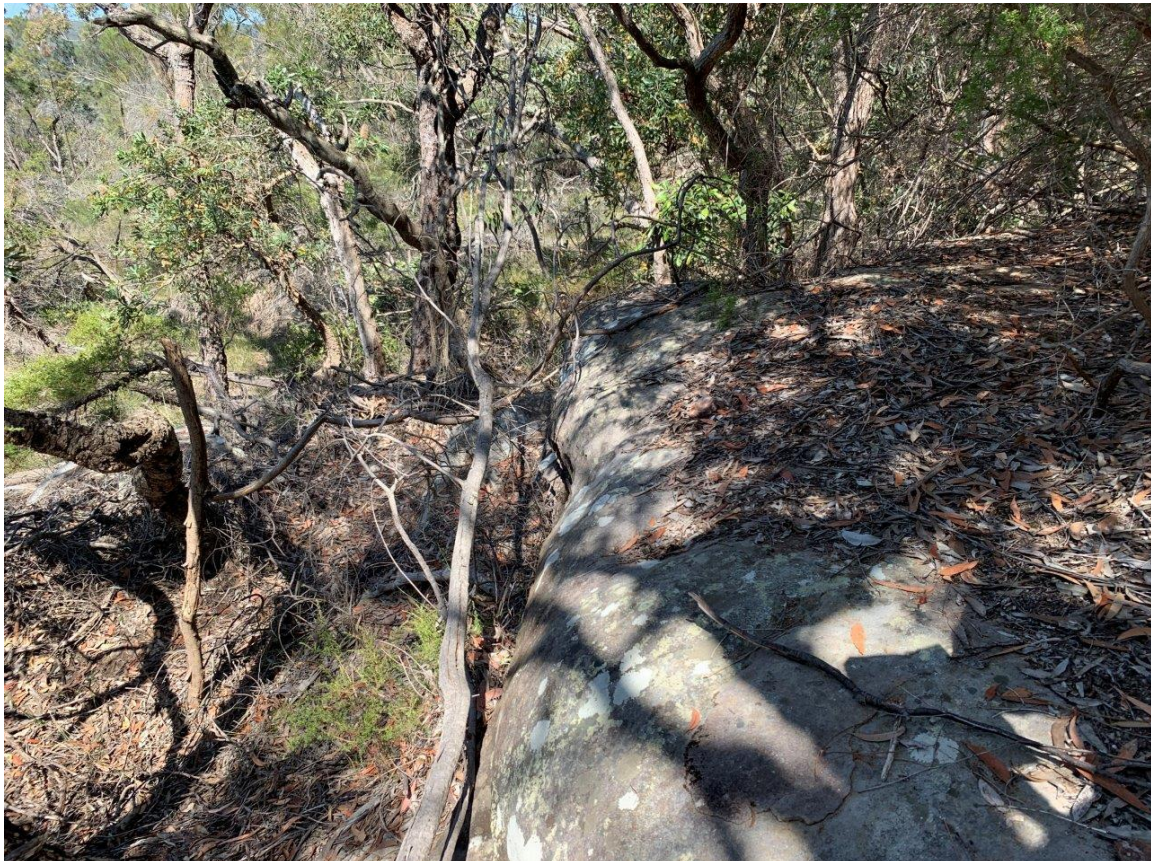
Photograph 2: View looking south along sandstone outcrop

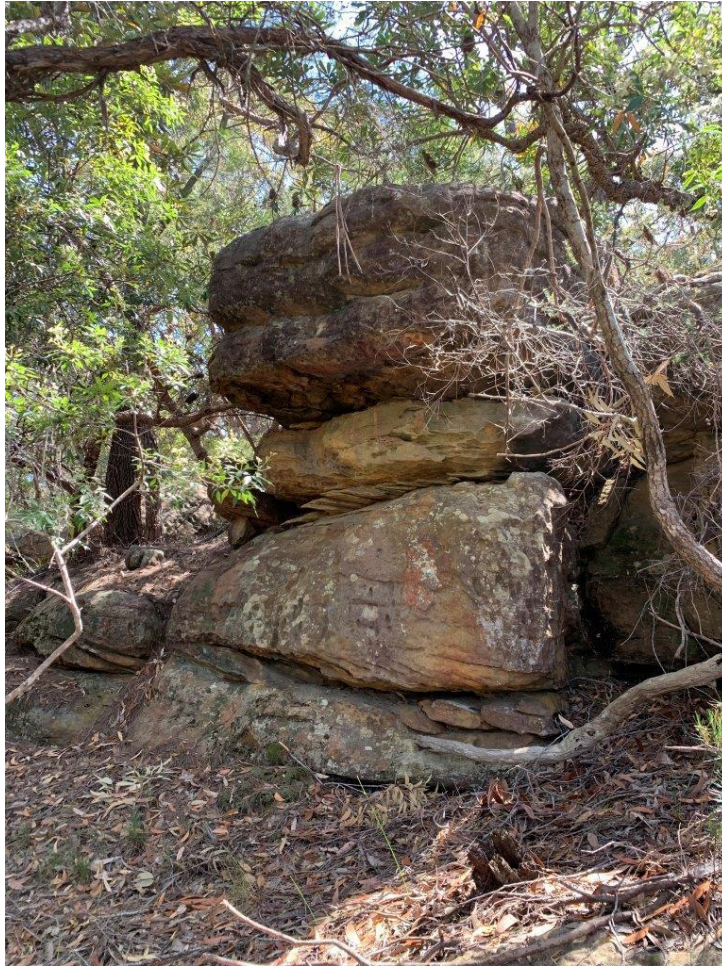
Photograph 5: View looking south, large loose sandstone bed with fractured weathered seam, potential of fall/topple
