Report on
Geotechnical Investigation

Proposed Townhouse Development
54 Terry Road, Rouse Hill

Prepared for
Prisma Rouse Hill Development Pty Ltd

Project 94508.00
August 2018

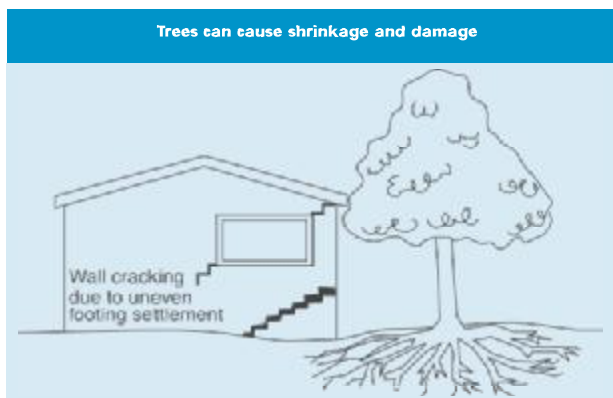
As the moisture absorption process completes its journey to the innermost areas of the building, the internal footings will rise. If the spread of moisture is roughly even, it may be that the symptoms will temporarily disappear, but it is more likely that swelling will be uneven, creating a difference rather than a disappearance in symptoms. In buildings with timber flooring supported by bearers and joists, the isolated piers will rise more easily than the strip footings or piers under walls, creating noticeable doming of flooring.

As the weather pattern changes and the soil begins to dry out, the external footings will be first affected, beginning with the locations where the sun's effect is strongest. This has the effect of lowering the external footings. The doming is accentuated and cracking reduces or disappears where it occurred because of dishing, but other cracks open up. The roof lines may become convex.
