Refurbishment of Pygmy Possum Lodge, Charlotte Pass

5. Executive Summary

Elouera Ski Club Pty Ltd (ACN: 002703988) is the owner operator of the Pygmy Possum Ski lodge at Charlotte Pass. The lodge operates under a 40-year sub-lease to the main lease holder Charlotte Pass Ski Resort. The Elouera Ski Club lease expires on 11 September 2058. The Pygmy Possum Lodge was constructed in 1984-5 with 24 SOUs and was expanded in 1992 with the addition of four SOUs. The 1992 expansion was undertaken to improve the fire exits at the rear of the lodge. This point requires further improvement and is addressed in this document. Under the lease the lodge accommodation is capped at 54 adults. The Pygmy Possum Lodge is now 37 years old and requires considerable refurbishing to provide a safe and viable accommodation to 2058 and beyond.

This document has been written to accompany a DA submission for this refurbishment. The purpose of the document is to inform the various approving parties such as CPSR, NPWS and NSW planning. Elouera Ski Club operates with a continual rotation of volunteer members in executive and other roles consequently the document is important as a knowledge deposit for future c

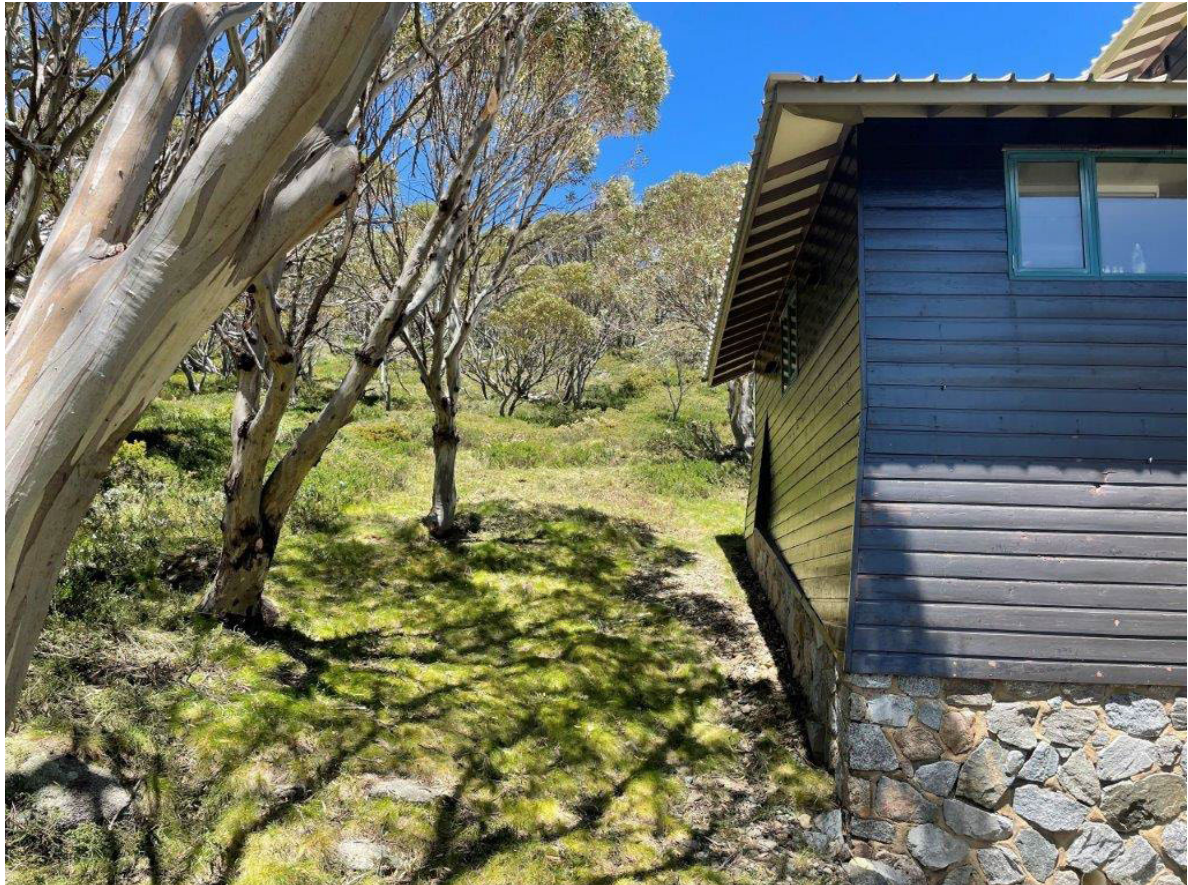
Figure 1: Typical western red cedar panels on Pygmy Possum Lodge. Photo also highlights exposed timber in eaves and timber barge boards. APZ clearance is approximately 5m to east of lodge. APZ clearance highlighted by change in ground vegetation height.

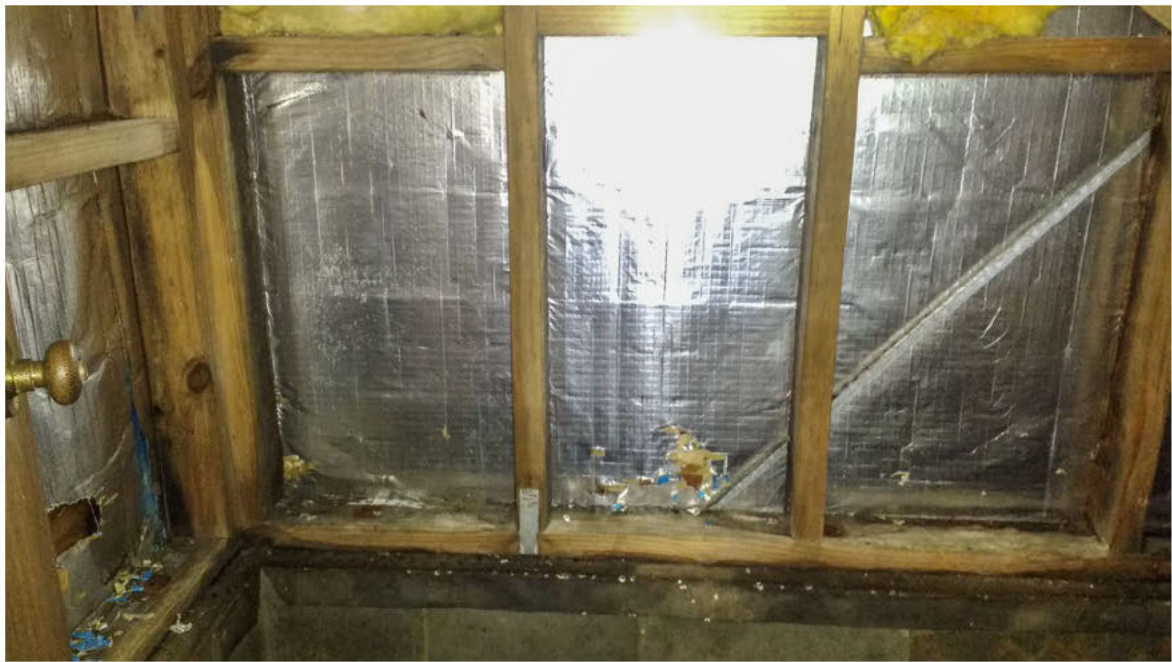
Figure 2: Lodge frame below east wing rear exit stairs. This are was constructed in 1994 and is now 28 years old.

3. Inspection of the lodge frame, in May 2022, indicated some water ingress and development of mould. The inspected area was on the southeast of the lodge. This area is naturally damper than the front of the lodge. The south side of the lodge is close to the natural ground level, is subject to longer snow burial and has low sun exposure. Regardless of this small sample and its location bias, we consider that all the cladding needs removal so the frame can be inspected and repaired. Figures 2 and 3 show the moisture in the existing frame (May 27, 2022). Removal of the cladding will allow for frame inspection, frame repair (as required), upgrading of the insulation and upgrading of the moisture membrane.

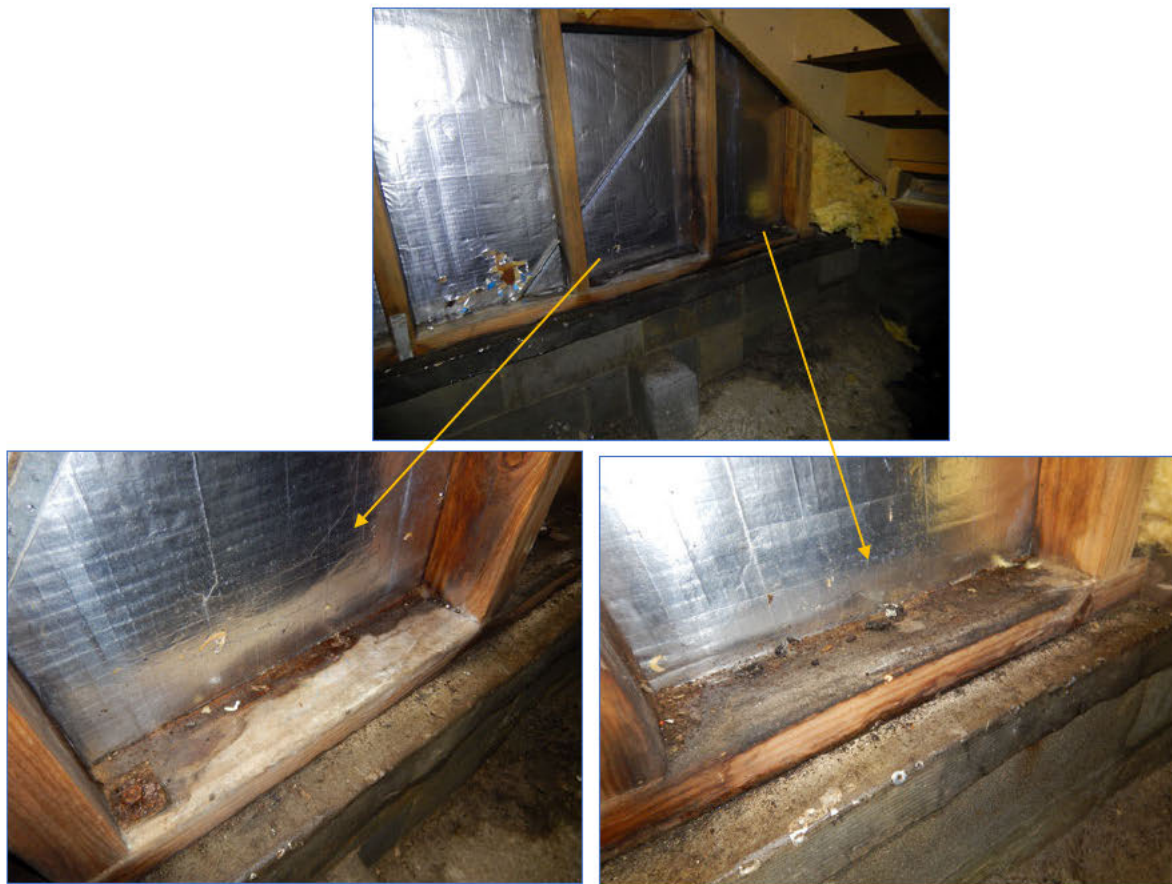
Figure3: Detail of same area highlighting moisture in frame.

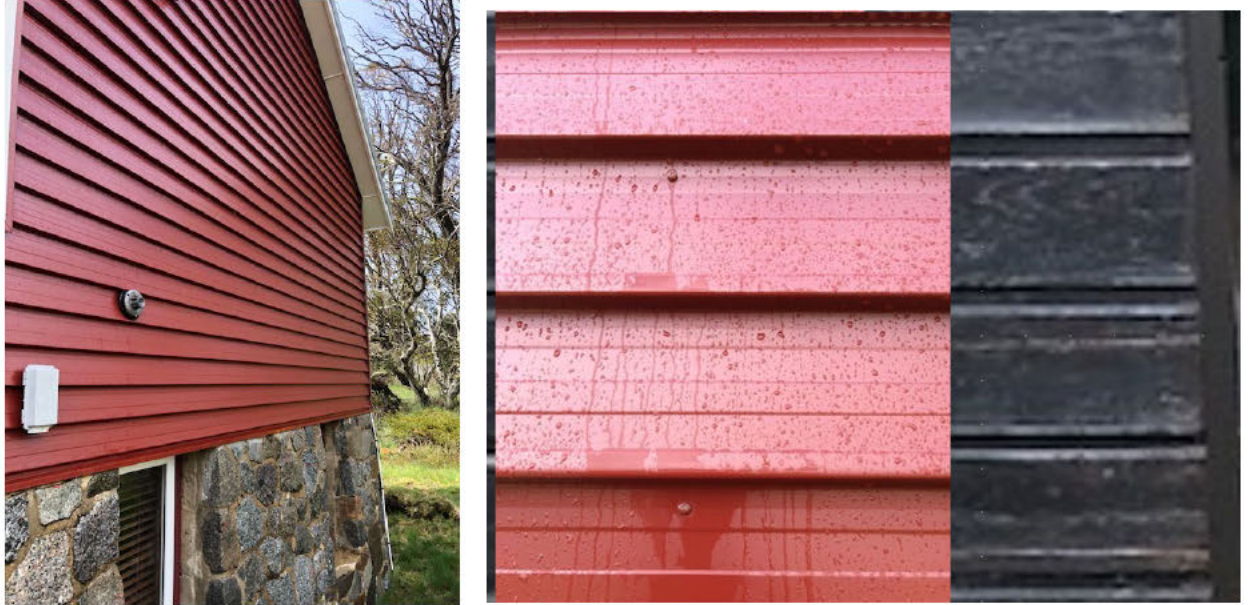
Figure 4: Example horizontal cladding at Langlauf Lodge (Perisher Valley), highlighting “timber” look. Pygmy Possum colour will be in Colorbond Monument.

6. Affix the Morclad timber look steel cladding. The Morclad product installed horizontally will mimic the existing timber look. Figure 4 shows an example of the Morclad product installed at Langlauf Lodge in Perisher. The Langlauf Lodge is clad in Manor Red; this colour is not suggested for Pygmy Possum. The Pygmy Possum colour will be Monument which is similar to the existing lodge colour.

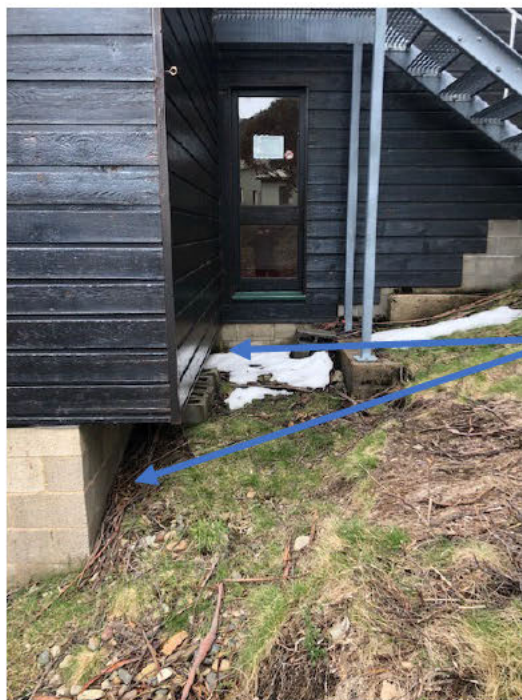
Figure 5: Minor areas requiring meshing with stainless steel 2mm aperture mesh to reduce fuel build-up. View is of the west side; a similar situation exists on the east side.

Mesh
this area

9. Infill all eaves with Miniorb (or similar) in Surfmist Matt. The current eaves are open with exposed timber beams.
 10. Infill in 2mm stainless mesh two ground areas where leaf litter accumulates. The west wing area of concern is shown in Figure 5; a similar area exists on the east wing.

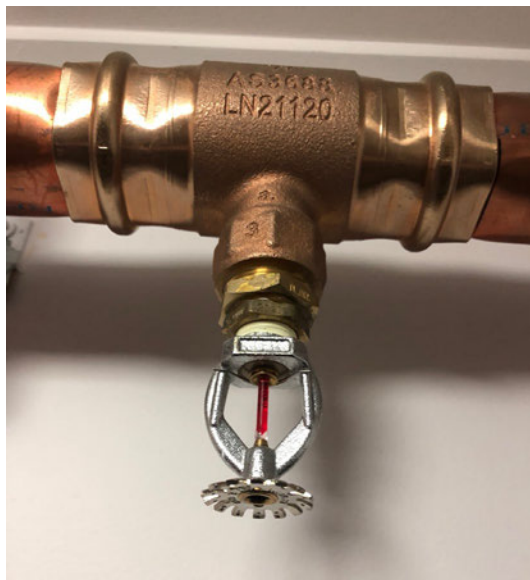
Figure 6: Example exposed copper sprinkler installation in YCA Thredbo. Glass rod breaks at 55-77°C. The glass colour indicates the temperature range. Red is a low temperature range. All joints are pressure crimps, this reduces install costs as no welding or soldering is involved

Figures 6 and 7 show examples of an exposed sprinkler system in the YCA Thredbo.

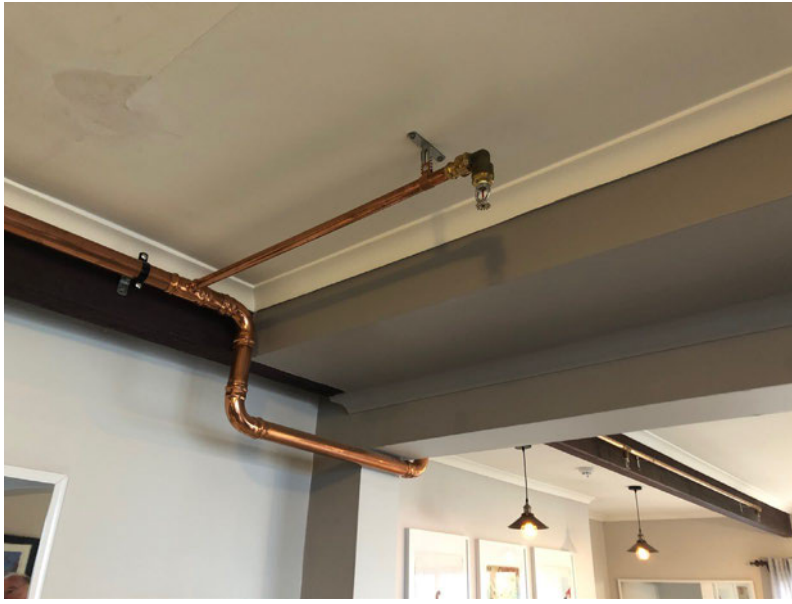
Figure 7: Installation in YCA Thredbo.

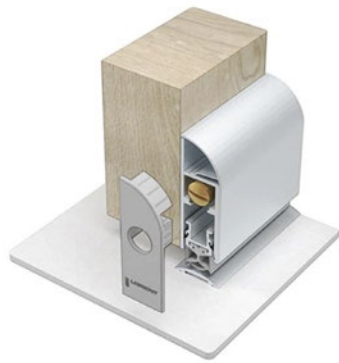
Figure 8: Lorient 8009 bottom smoke seal

2. Corridor Exit Doors opening onto stairs. The same eight doors will be fitted with a spring-loaded smoke seal on the base edge and a compression seal on the side and top edges. On the lower floor edge, the Lorient 8009 system, as shown in Figure 8 will be installed. According to the manufacturer web site the system meets the *"medium temperature smoke approvals for use on AS6905 compliant smoke door assemblies and conforms with BCA Specification C3.4 smoke sealing requirements"*.
<https://www.stylefinishdesign.com.au/products/8009-automatic-door-bottom-seal>

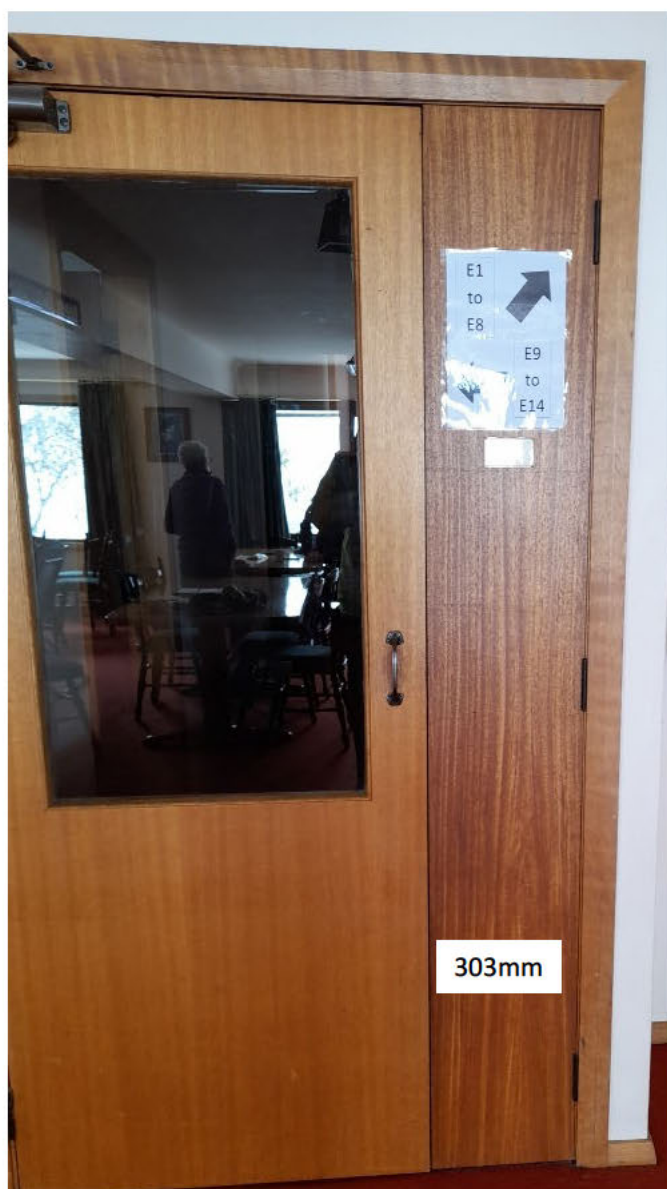
Figure 10: Saloon type door set up in east and west wing leading to the Level 2 SOU corridors.

-
7. The two doors, on level 2, between the lounge-dining and the SOU corridors have an asymmetrical saloon door setup. This is illustrated in Figure 10. The smaller hinged 303mm wide door, will be replaced with a new stud wall covered with two layers of 16mm firecheck plasterboard on both the kitchen and SOU side. This will ensure that the effectiveness of the new FRL-/60/30 door set is not compromised.

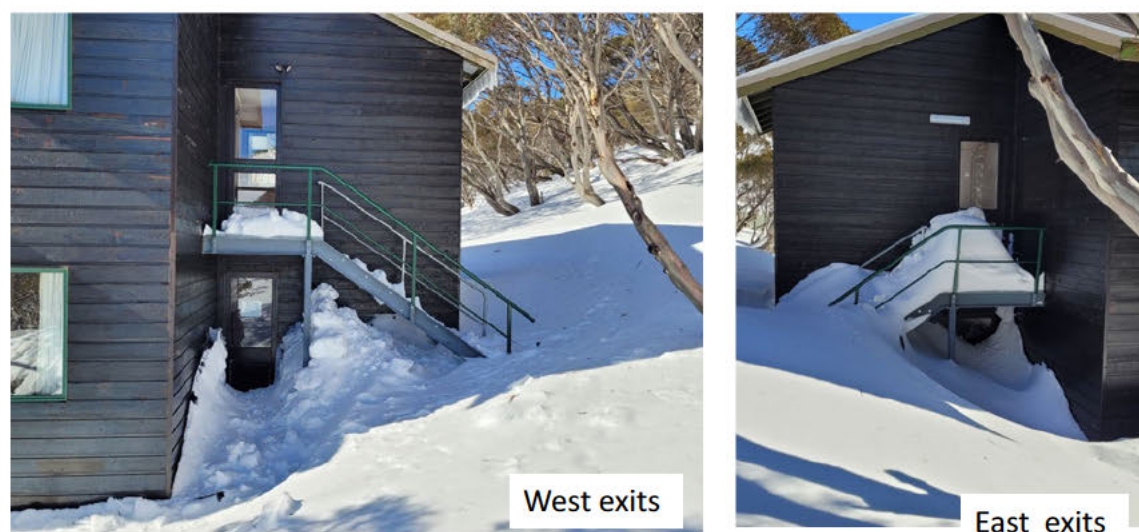
Figure 12: Rear exits on June 14, 2022, showing snow build-up, particularly on east of lodge.

The 1993 rationale remains valid. However, neither of the rear exits are 100% satisfactory and neither exit provides a reasonable exit path to the front roadway. Figure 12 shows the rear west and rear east exits after the June 2022 snow falls (approximately 1m cumulatively) and after some melt.

The new fire exit doors will be located partway between Level 2 and Level 3 such that the door exits slightly above natural ground level. The porticos will be fitted with an expanded mesh walkway and suitable steps or ramps to natural ground level. All existing exits will be closed and the existing steel stairs will be removed. The two existing upper-level doors, visible at the top of Figure 11, will be replaced with internal gyprock, timber framing, R2.7 insulation and steel cladding. Ambient natural light is adequately provided on this level from an existing window. The two lower-level doorways will be replaced with gyprock, timber framing, R2.7 insulation and steel cladding to approximately 1200mm height. The top section of these doors will be replaced with an 800mm x 800mm double glazed window. These two new windows will be covered with 2mm aperture stainless steel mesh. The existing west wing lower-level doorway is visible in Figure 12 (left). The existing east wing lower-level doorway is snow covered in Figure 12 (right).

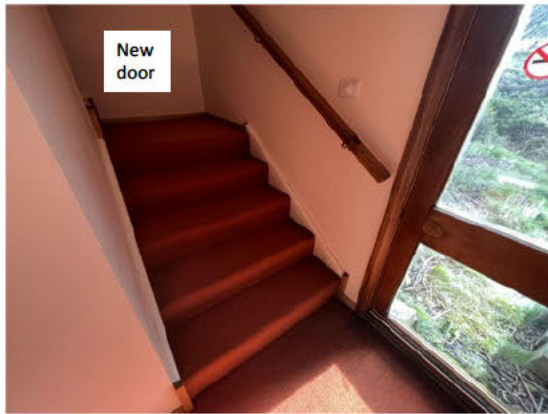
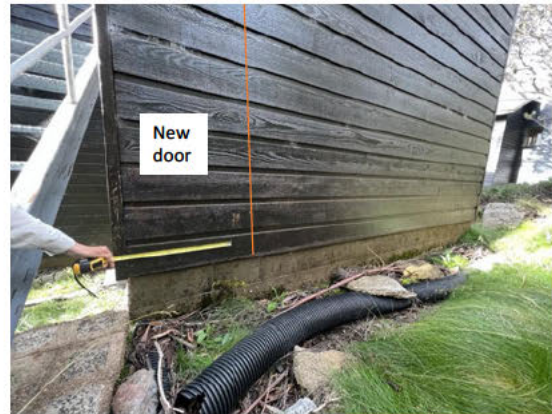
Figure 13: Proposed new door location west wing. Left photo shows existing glass door at lower exit and location of new door. Right photo shows the outside location of the new door. Steel tape marks the foot of the new door.

Figure 13 shows the location of the proposed new door on the west wing. Figure 14 shows the new west wing portico design. The concept on the east side is similar and is not shown here; both sides are detailed in the architectural plans and the Camstruct structural plans.

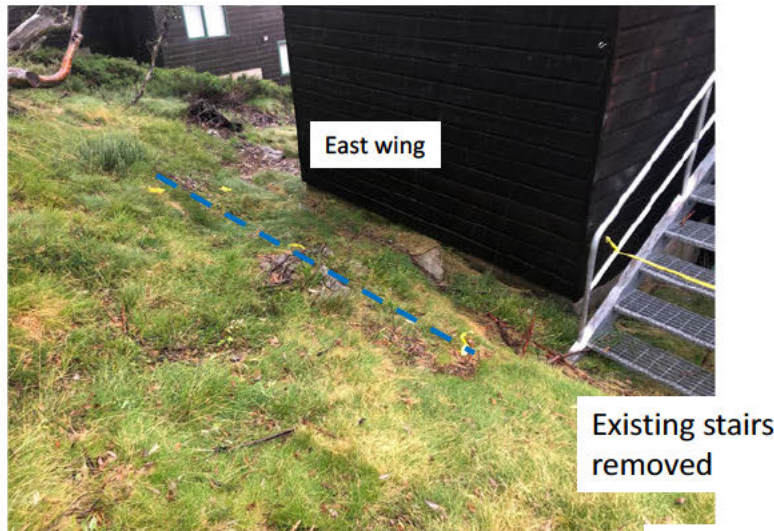
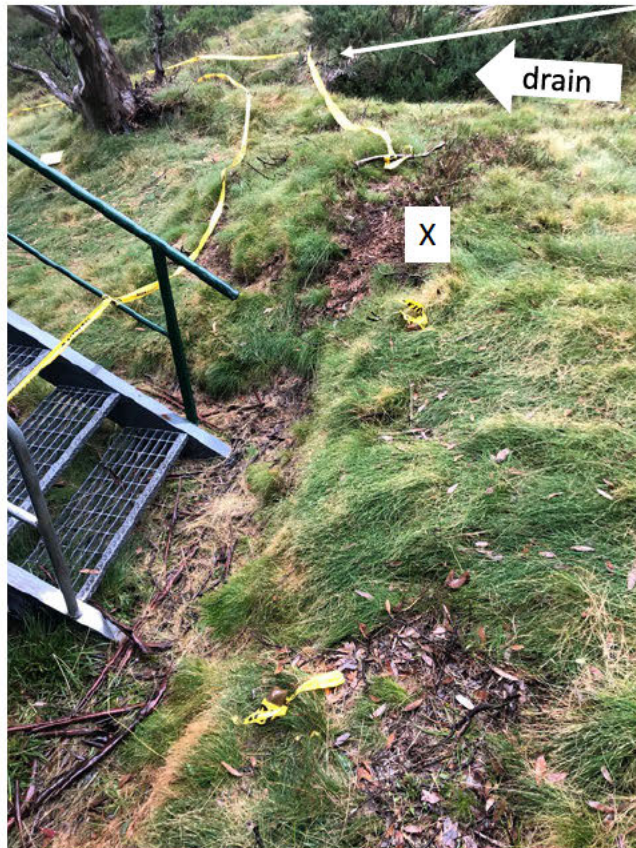
Figure 16: Path at rear of east wing. Dashed blue line shows edge of portico structure.

Two ski poles to define path at drain

Looking east from east wing.

Path to cross the drain at top of photo with an ag pipe covered with gravel or crushed stone.

6. Figure 15 shows the overview plan of the east path.
7. Figures 16 to 19 show the pathway in more detail. The captions on Figures 16 to 19 detail specifics for each photo.

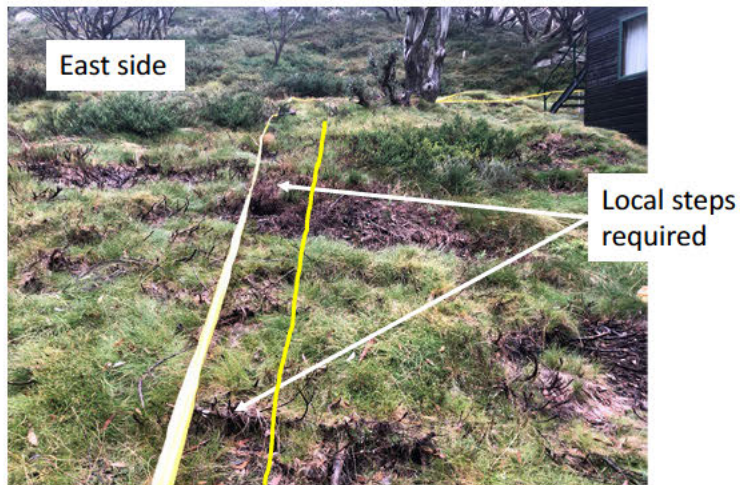
Figure 17: Path down east side of lodge. Path is well clear of lodge and within Lot 108. Granite flagstones will be required in some areas.

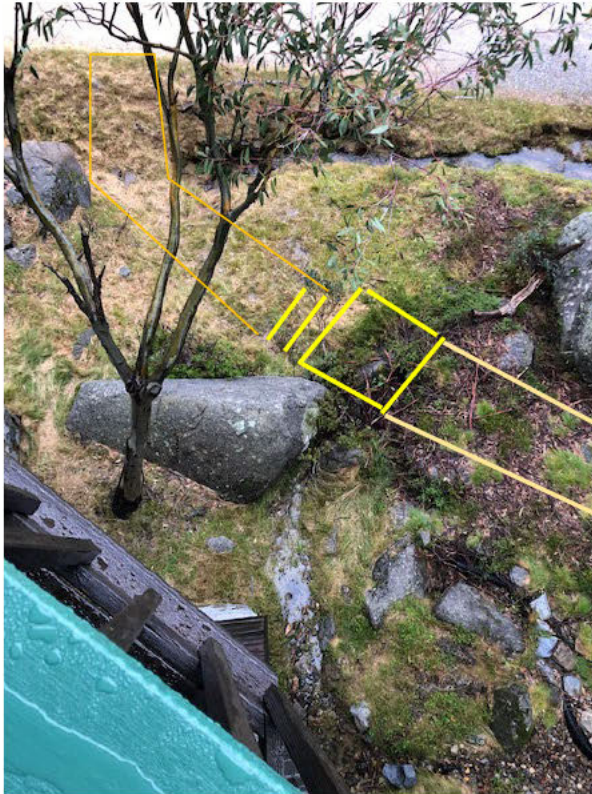
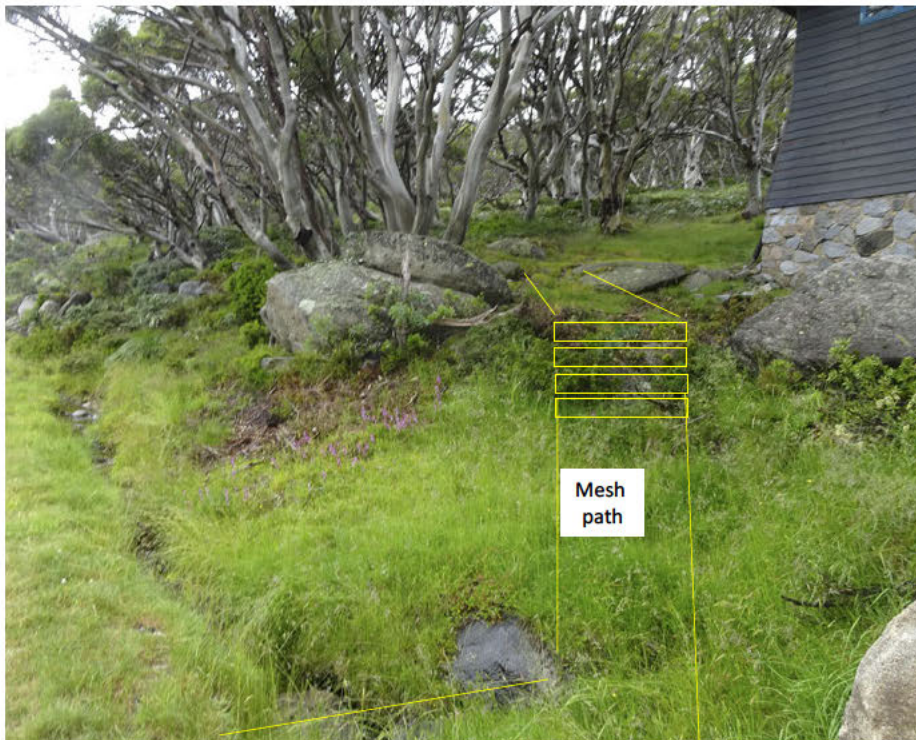
Figure 18: Path on east side of lodge in road area. This water course is semi-permanent and will be crossed with a steel expanded mesh walkway approximately 200mm above the drain. This walkway will daylight on the road edge.

Road access area.

1. Path travels to low spot, immediately east of large boulder.
2. Expanded mesh platform with three stairs to NW
3. Platform supported with rock bolts to boulder & steel posts
4. Hand rail on lower side
5. Mesh path & steps as required to road

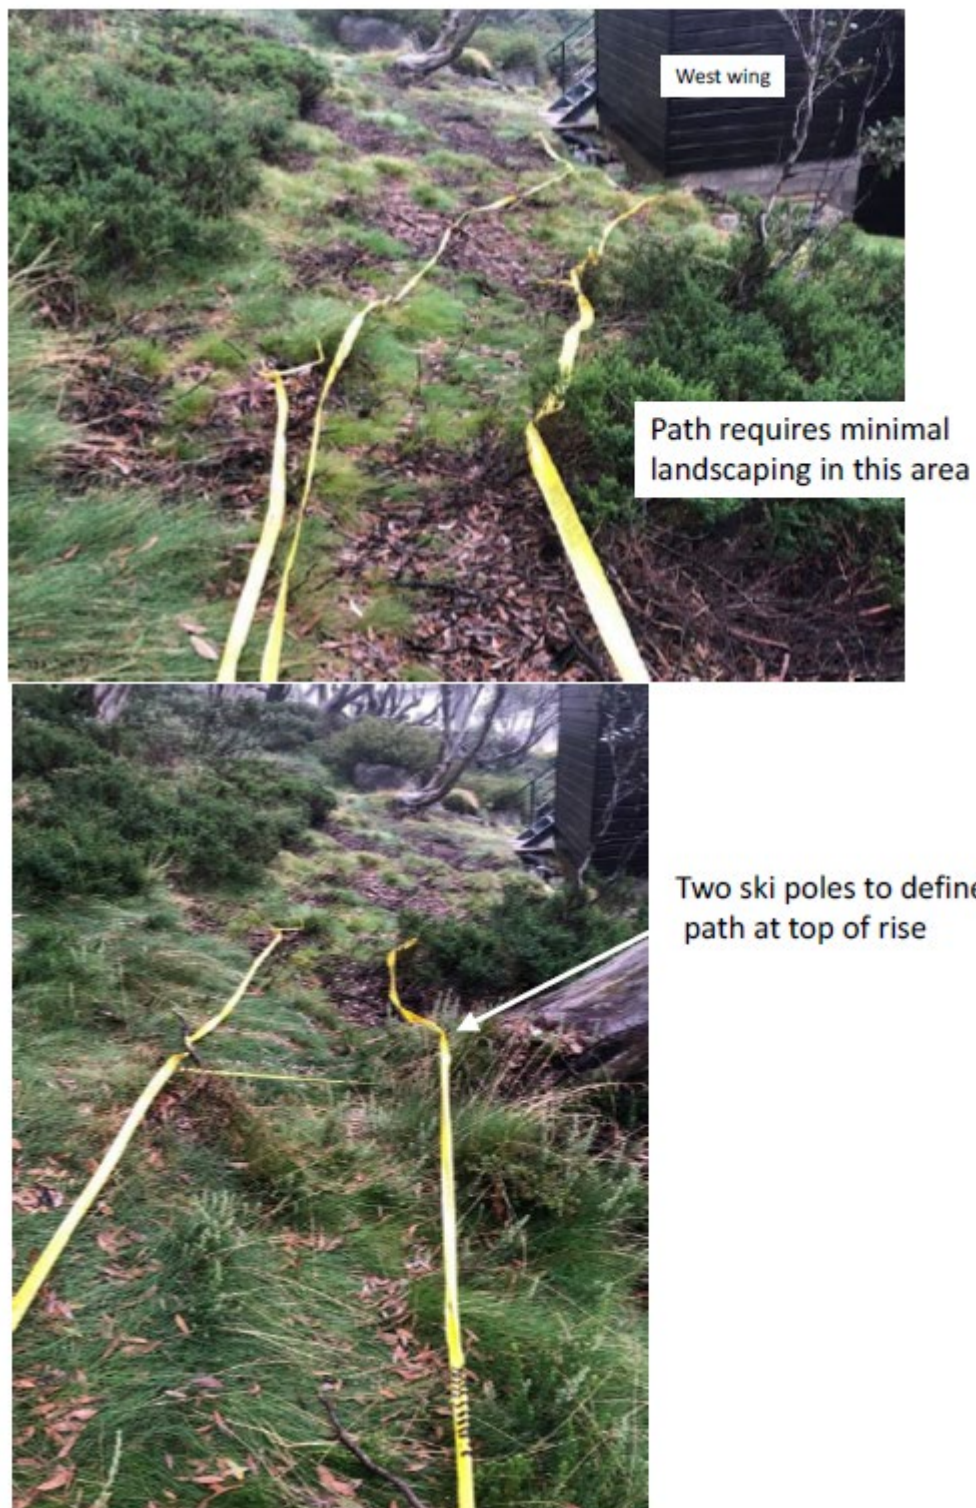
Figure 19: Path connecting west portico to east portico and east path. Width indicated by tape is approximately 1m.

8. A small walkway will connect the west portico with the east portico and east path. This path will also be marked with ski poles as required. When occupied, the path will be kept clear of deep snow by a combination of shovel clearance and tramping. Figures 20 and 21 show the path area.

The construction of the exit path in this area includes provision for ski poles to mark the alignment. These poles are noted in Figure 19 and 20 (of this report). Additional poles will be added as required.

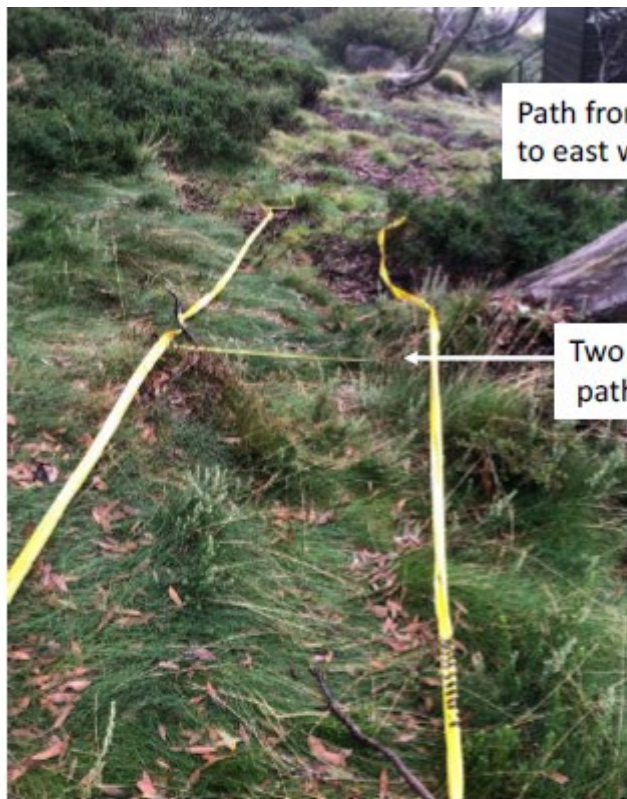
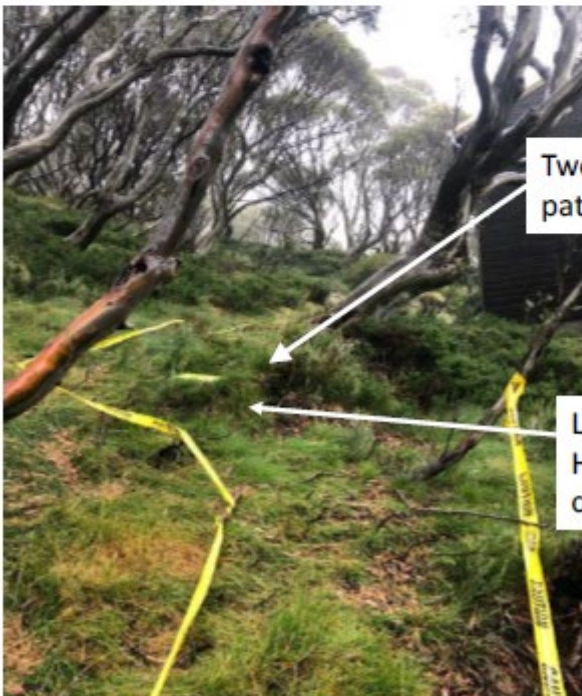
Figure 20: Continuation of path between west and east wings.

Two ski poles to define path

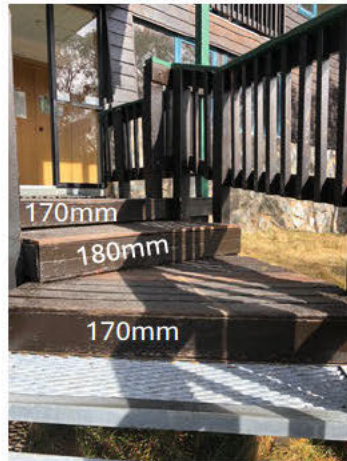
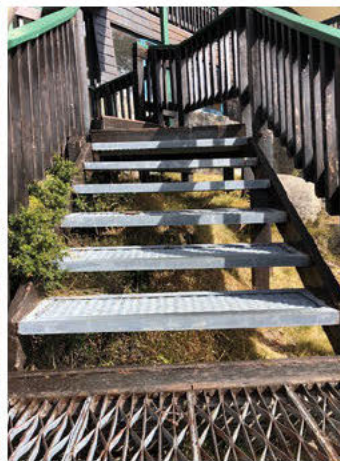
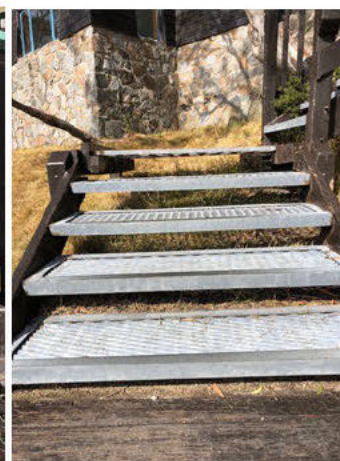
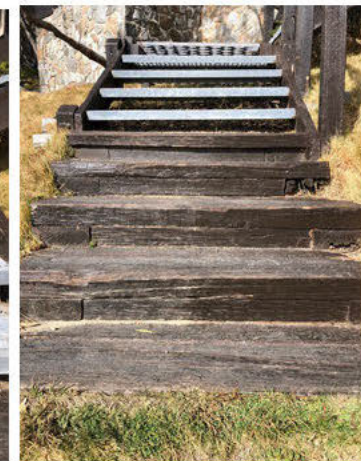
Figure 23: Lodge front steps “as is”.

Lodge Landing
170mm, 180mm, 170mm
risers

Top steel flight
170mm risers &
300mm treads.

Lower steel flight
160mm risers &
300mm treads.

Bottom timber flight
130mm to 140mm risers &
300mm treads.

The front of lodge entrance stairs are a mix of timber and steel treads with various riser heights. Figure 23 shows the "as is" layout. The proposed layout will maintain the top lodge landing as is. These treads (at 170, 180, 170mm) are variable but are within BCA limits.

The lower steel flight will be replaced with a new steel flight with 170mm risers and 300mm treads. This flight will extend downwards to replace the timber flight. Details are provided in the architectural plans. The cost of this item is estimated at \$4,000.

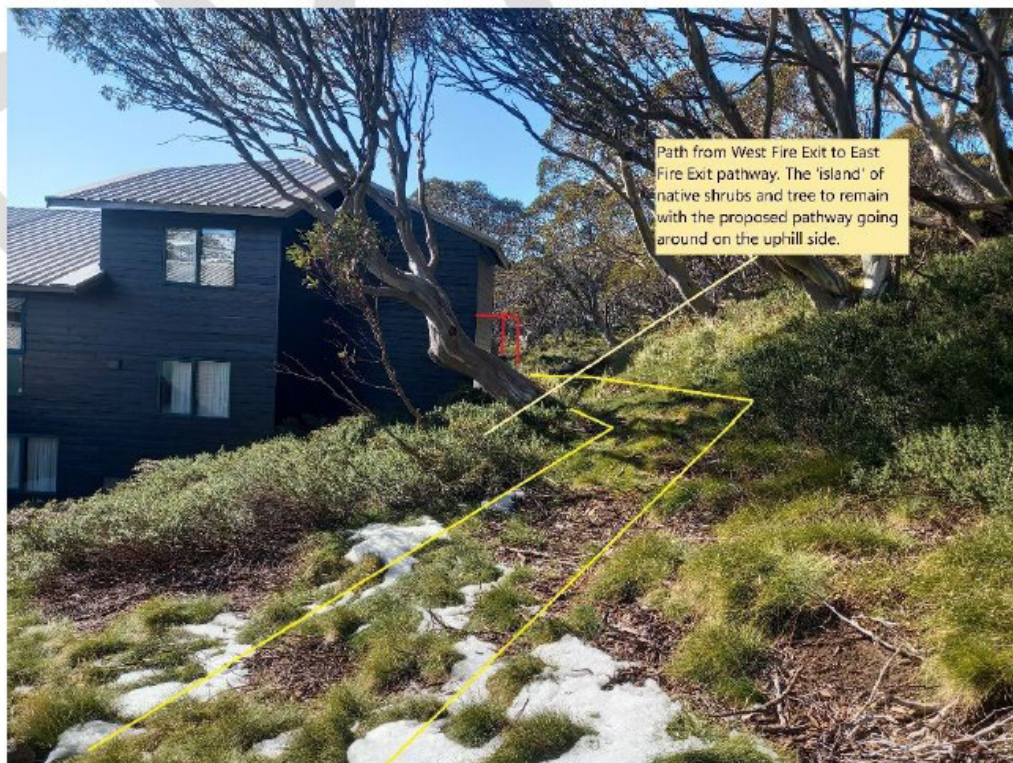
Figure 26: Copy of Fauna and Flora Assessment report Image 1.

Image 1: A pathway will be defined between the west wing fire exit and the east wing fire exit. The proposed path is routed around a small clump of shrubs and snowgum stand.

This area is better described as south of the leaning tree which is shown in Figure 25 (right), Figure 26 and Figures 19 and 20. The dogleg in the proposed fire exit path accommodates this island. David Woods in the Flora and Fauna Assessment provided a more succinct photo in his report. Wood's report Image 1 is shown here as Figure 26.

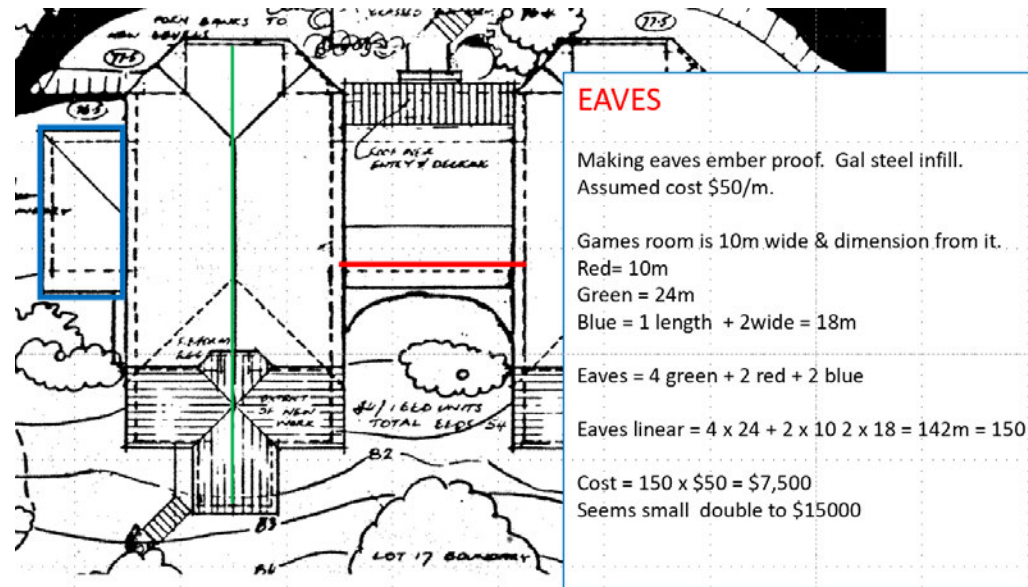
Figure A4: Eaves

Table A1: Estimated cost of Cladding for Pygmy Possum Lodge.					
Description	Source:	Area sq m	Length met	Unit Cost	Extended
Front	Figure A1	200		\$125	\$25,000
Rear	Figure A2	200		\$125	\$25,000
Sides	Figure A3	560		\$125	\$70,000
Subtotal Cladding		960			
Insulation area		960		0	
Enviroseal area		960		\$0	
Eaves	Figure A4		150	\$100	\$15,000
Barge Boards	Figure A4		150	\$100	\$15,000
Sub total					\$150,000
Verbal quotation from Mountain Metal Roofing (May 2022)					\$175,000
Frame Damage					\$25,000
Scaffolding Hire					\$110,000
Sub Total					\$310,000
