Hanlon Industries Pty Ltd
22 Clevedon Street
Botany NSW 2019

Project 220606.00
13 February 2023
R.001.Rev0
AK

Preliminary Geotechnical Assessment
Proposed Digital Sign
331 Pacific Highway, Lindfield

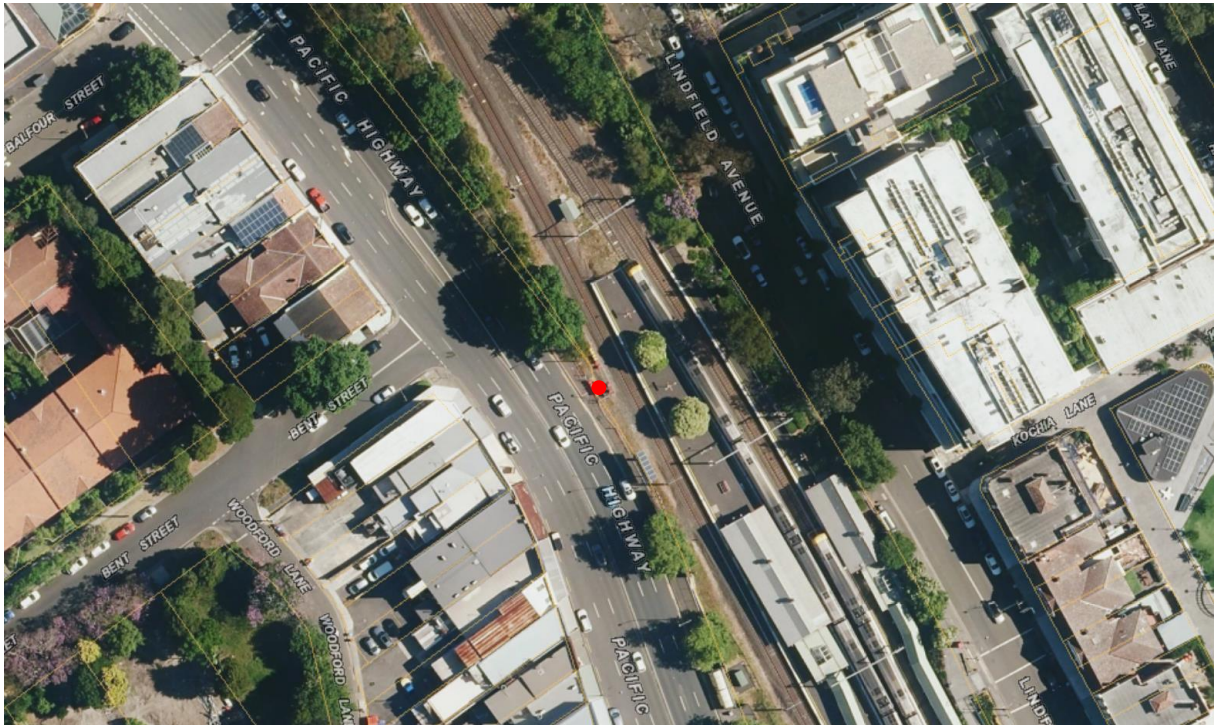
Figure 1: Aerial photograph of the site area (red mark)

The site of the proposed sign is located at the south-eastern end of the bin storage area of Lindfield Railway Station, within the railway corridor. The bin storage area is bounded by the Pacific Highway to the south-west and by the railway corridor on its remaining sides, with the down line to the north-east. An aerial photograph showing the indicative location of the proposed sign is shown in Figure 1.

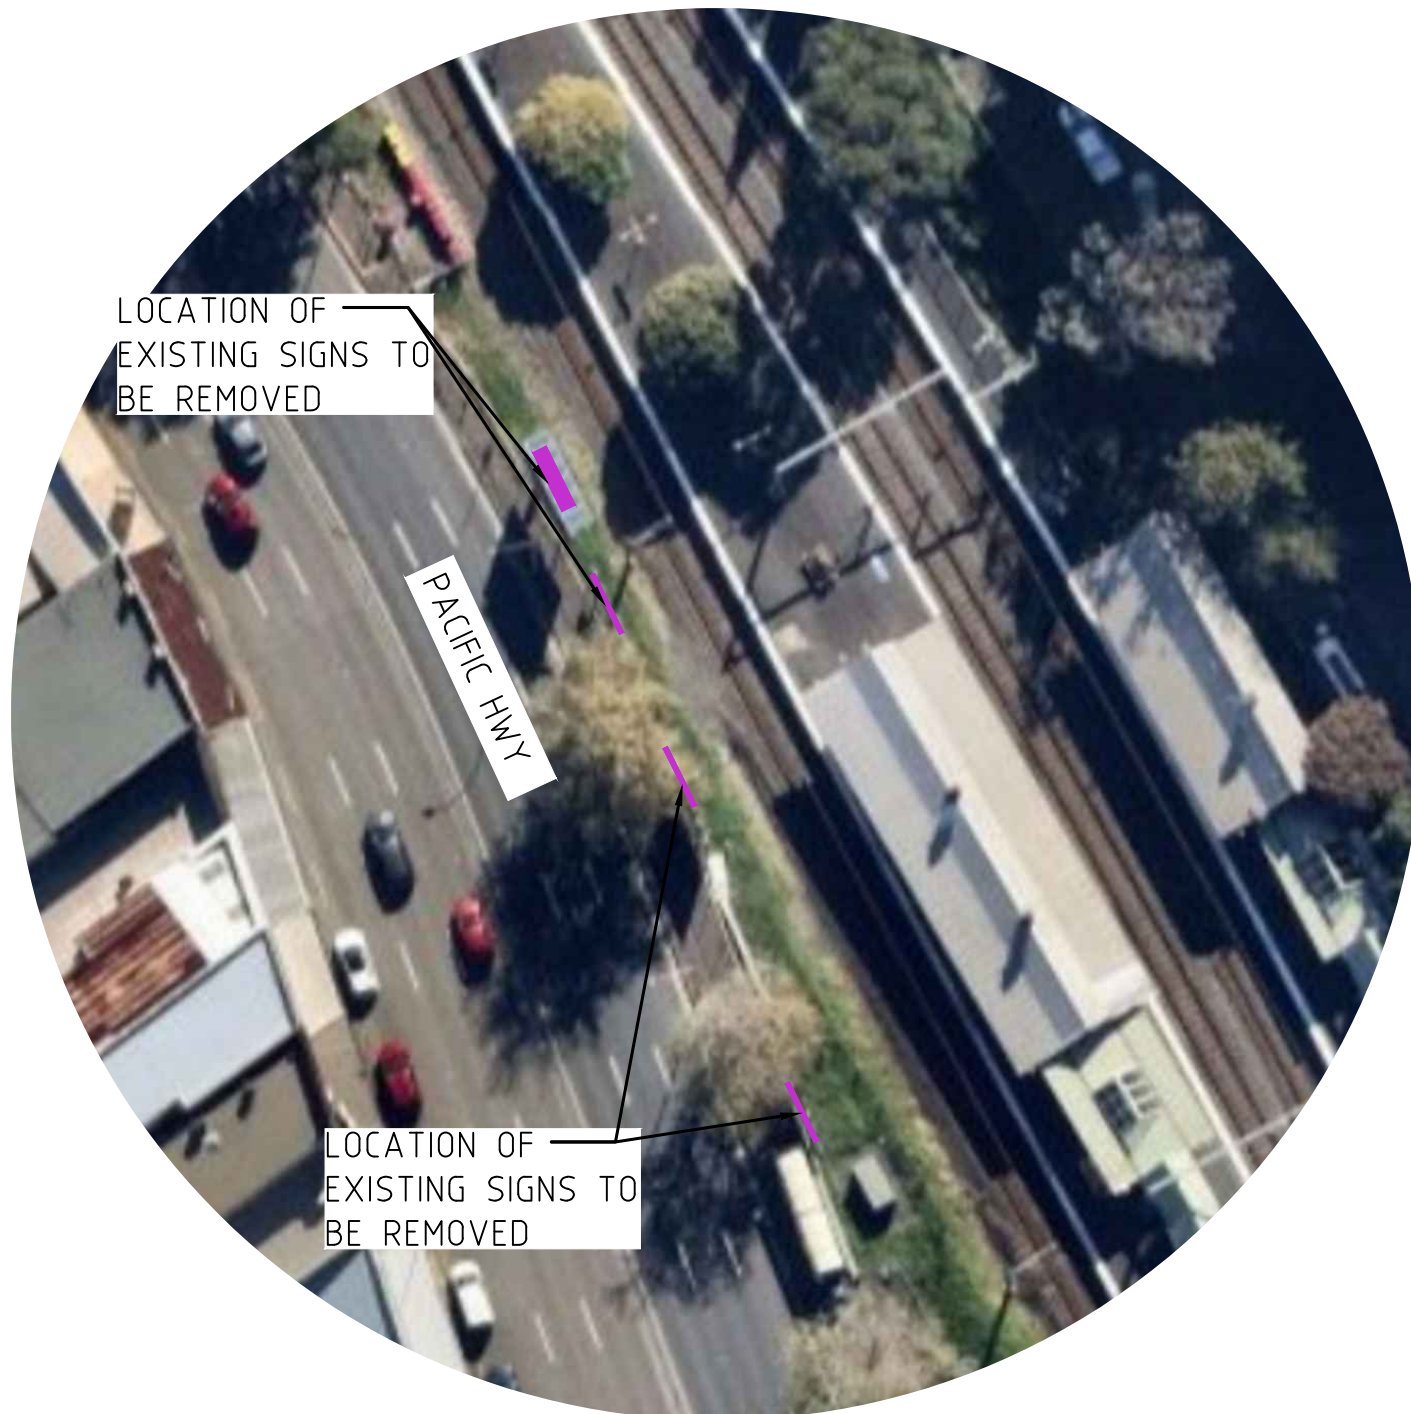
AERIAL PHOTO
NTS

DEMOTION PROCEDURE FOR EXISTING SIGNS

1. REMOVE STEEL FRAMES.
2. CUT BACK EXISTING PILES TO A DEPTH OF 300M BELOW GROUND.
3. COAT ANY EXPOSED REINFORCEMENT WITH AN APPROVED EPOXY GROUT.
4. REINSTATE SOIL OVER THE TOP OF THE PILES.

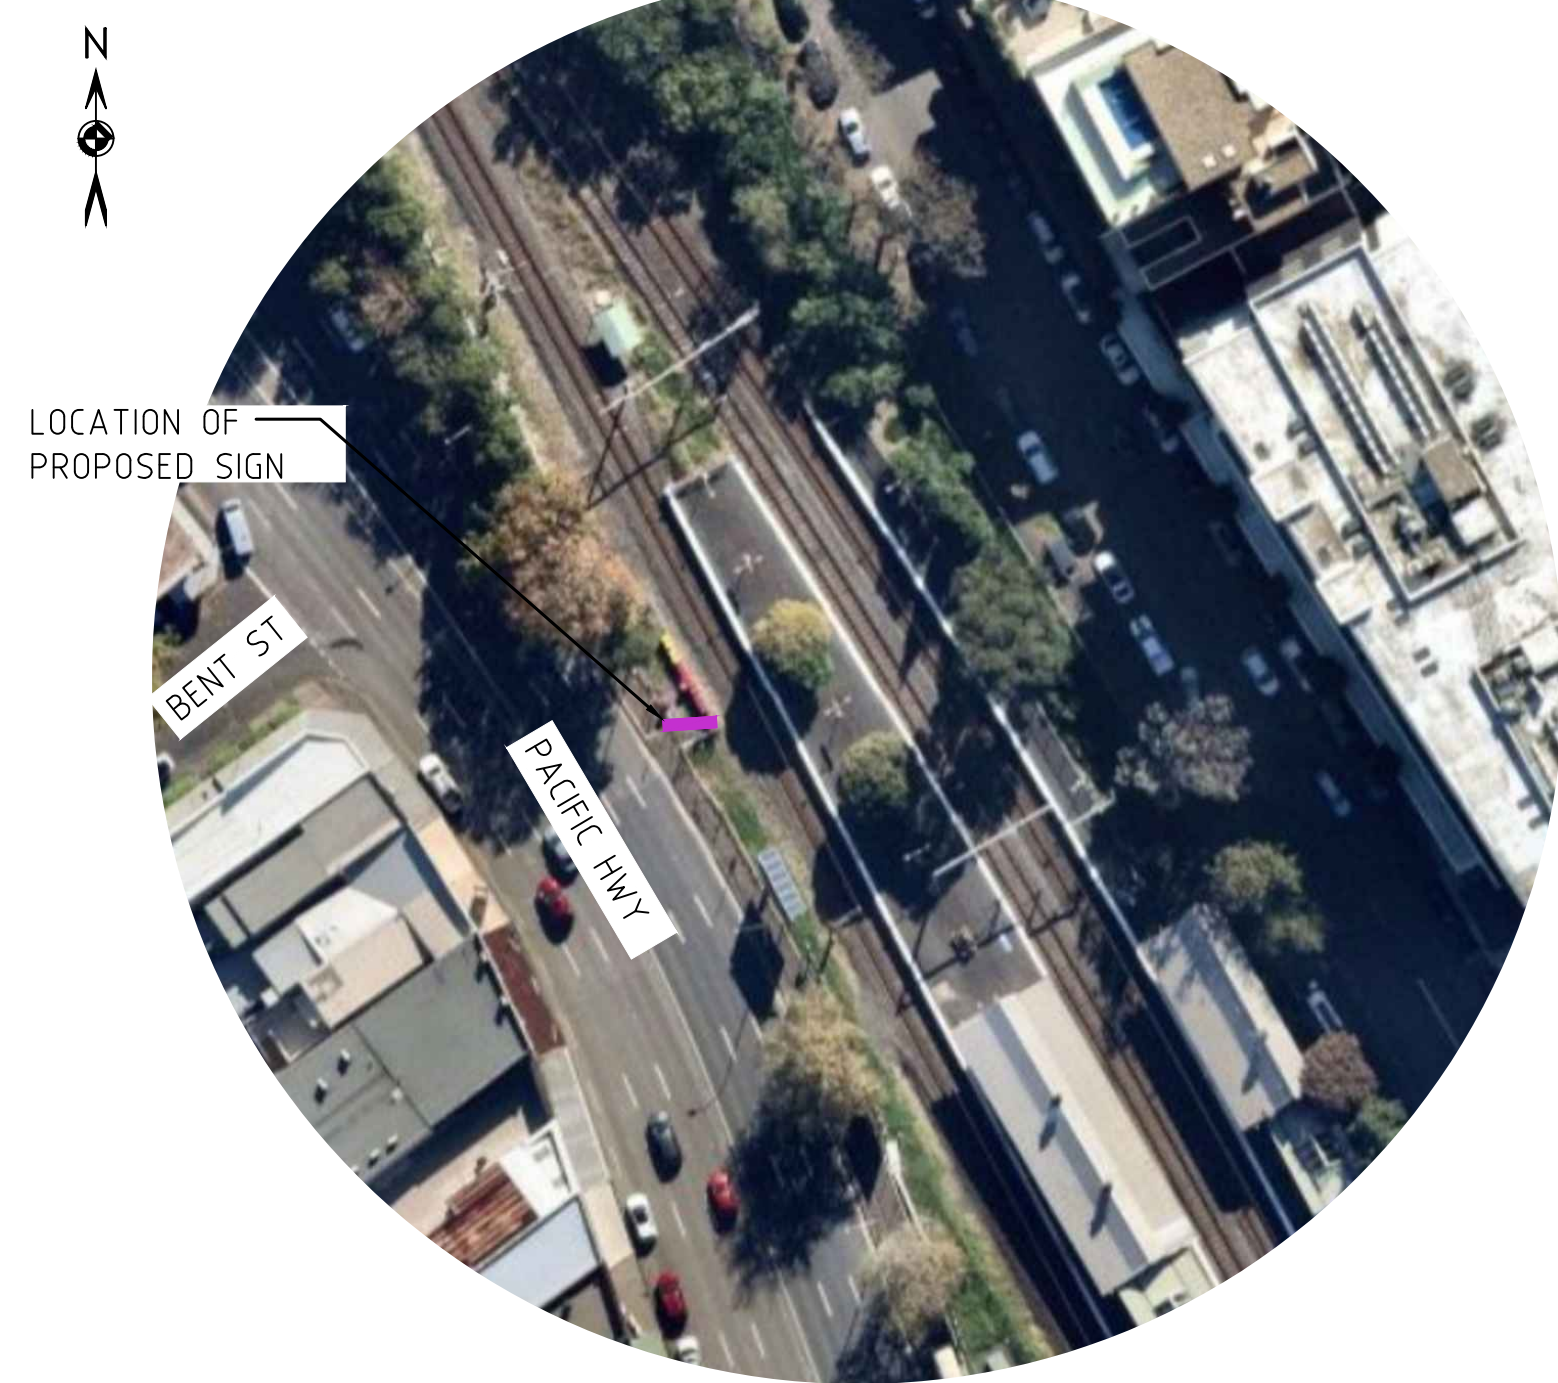
AERIAL PHOTO
NTS

LOCATION OF
PROPOSED SIGN
