Annex to Terara Shoalhaven Sand – Application for Extension of Dredge Area Supplementary Information – Geomorphology

Fluvial Systems Pty Ltd

February 2023

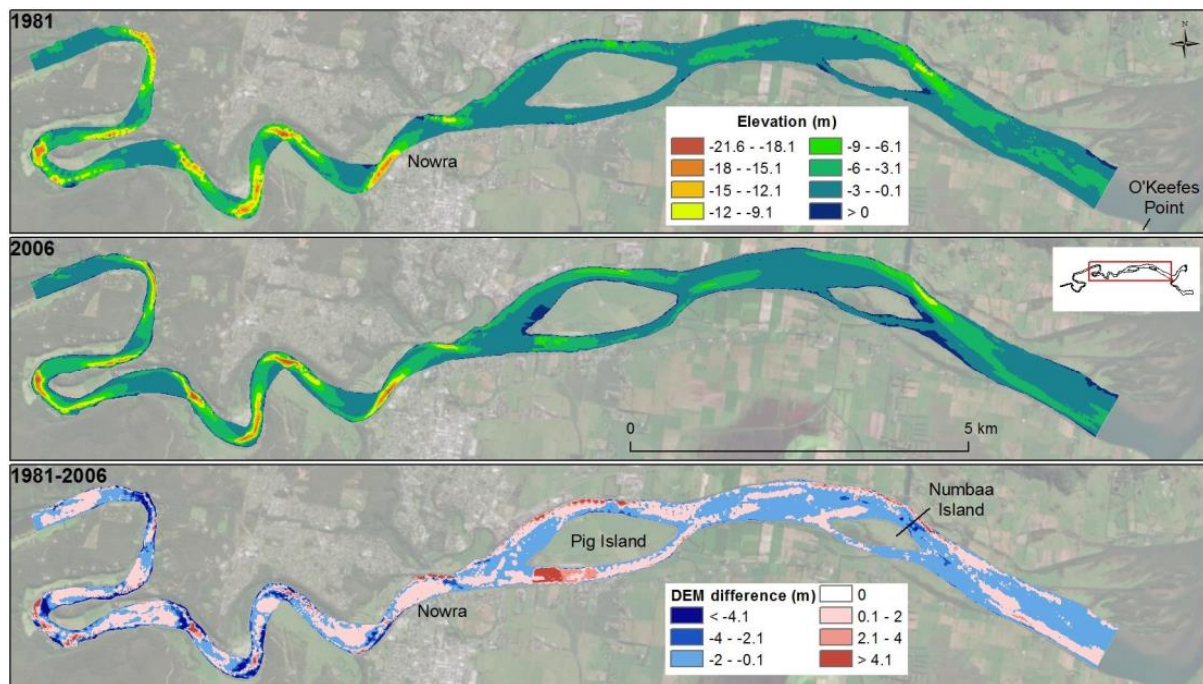
Figure 1. Bathymetric variation in the Shoalhaven estuary between Long Reach and O'Keefes Point in 1981 and 2006. In the lower map, red polygons indicate areas where erosion occurred whereas blue polygons indicate areas of accretion over time. Source: Figure 4.3 from Carvalho (2018, p. 60).

Carvalho's (2018) comparison of Shoalhaven River bathymetric surveys taken in 1981 and 2006 indicated that the river bed from Long Reach to upstream of O'Keefes Point aggraded approximately 2,000,000 m³, while downstream of O'Keefes Point the river bed scoured approximately 1,600,000 m³. Upstream of O'Keefes Point, areas of bed scour occurred on the north of Pig and Numbaa Islands. Upstream of Nowra, scour occurred in some pools, while others indicated deposition. Despite these changes, pools, and the shallow areas between pools, were in the same positions in both surveys, as the distribution of bedforms is controlled by the pattern of hydraulics, which is determined by the meander pattern. The Shoalhaven River has been dredged to facilitate navigation since the 1860s. Active mining for coarse river sand within the Shoalhaven River in the vicinity of Terara and Pig Island has been ongoing since the late-1960s or early-1970s. There is no evidence in the data or literature of a migrating head cut forming in the bed of the Shoalhaven River in response to dredging operations. Rather, limited repeat survey data suggests that infilling, or partial infilling, of dredge holes has occurred (Gippel, 2022). This suggests that a head cut is not currently a threat to the integrity of Nowra Bridge. Also, Nowra Bridge was constructed at a point on the river where the bed is composed of sand (Figure 2). In this situation it would be standard engineering practice to assume bed scour around piers and abutments during flood events, and this would be taken into account in the design.

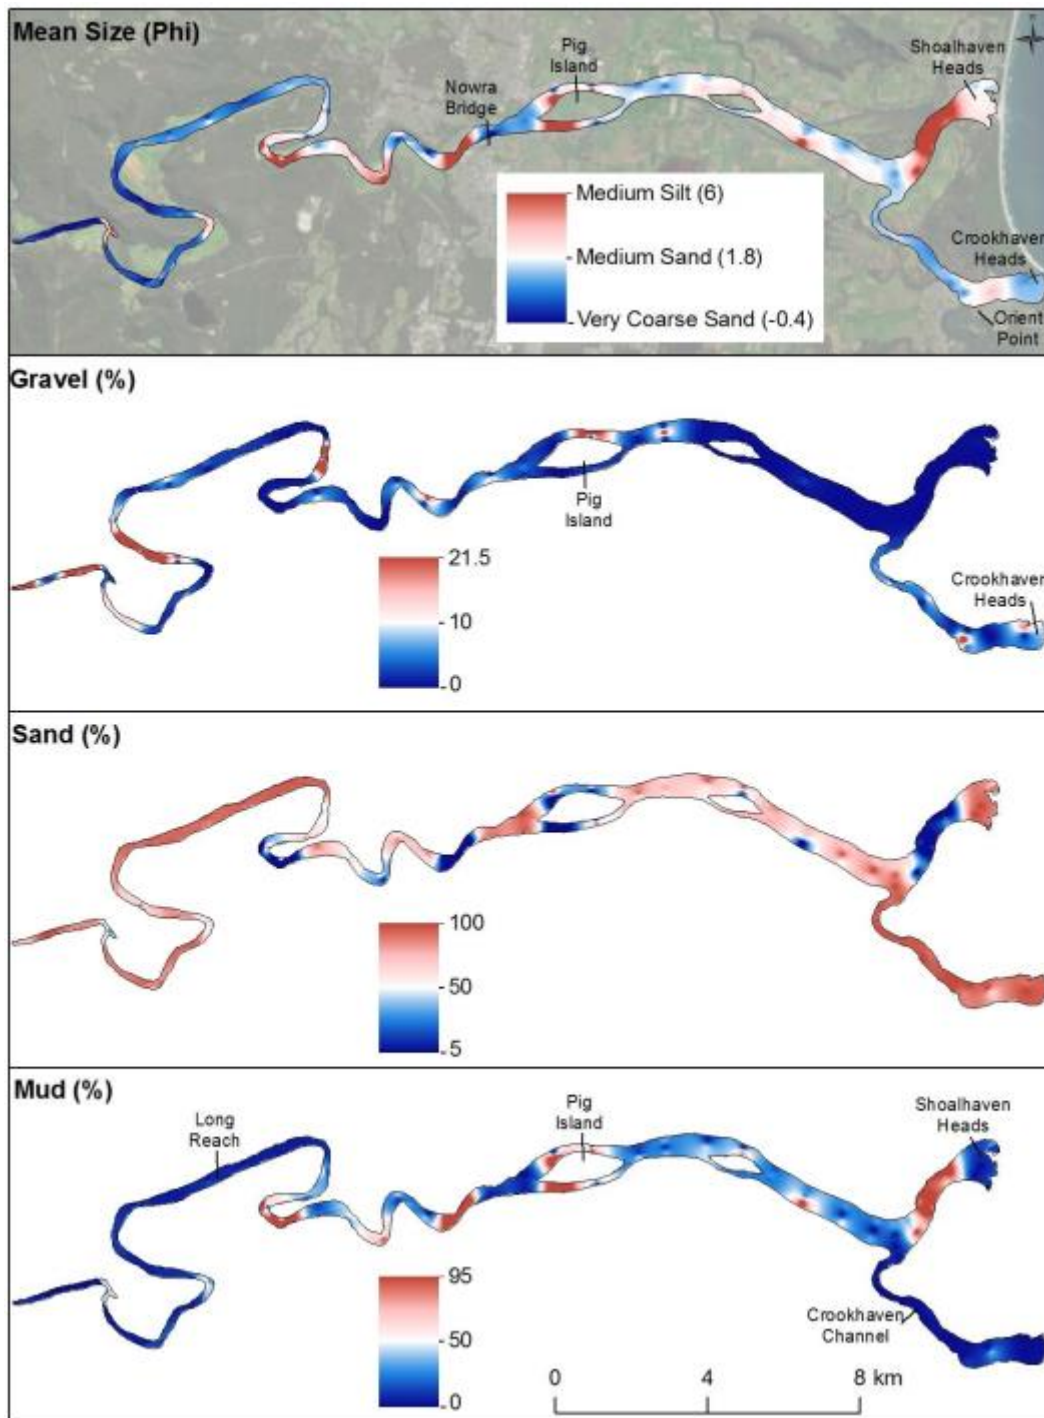
Figure 2. Mean grain size and percentage of gravel, sand and mud content in estuarine samples. Source: Figure 4.13 from Carvalho (2018, p. 76).

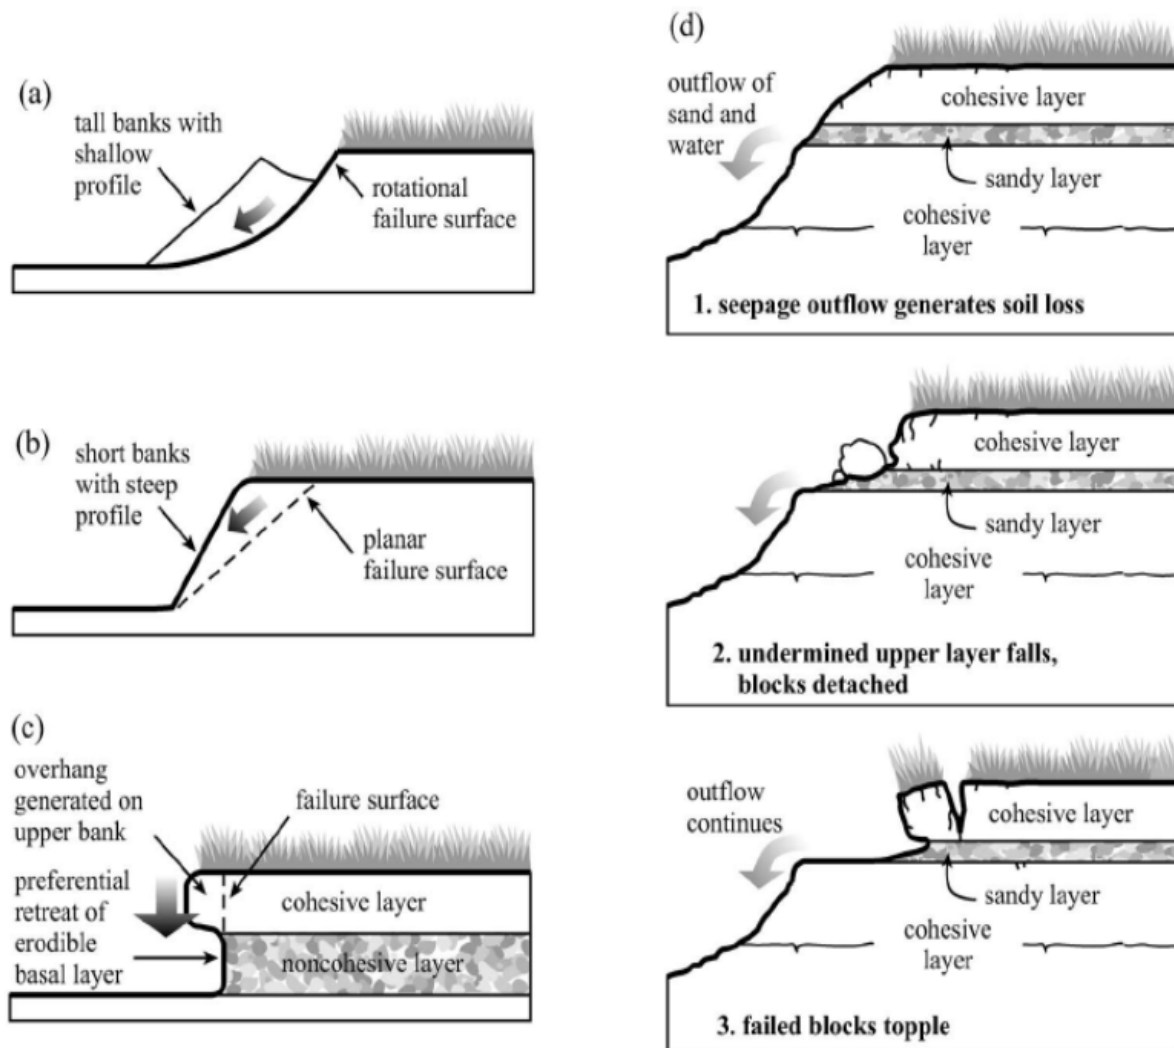
Figure 3. Bank failure mechanism: (a) Rotational; (b) Planar; (c) Cantilever and (d) Piping or sapping. Source: Imanshoar et al. (2012).

Imanshoar et al. (2012) provided illustrations of some main mechanisms of bank erosion (Figure 3). The three types of fluvial scour (hydraulically-induced) failure were illustrated by O'Neill and Kuhns (1994) (Figure 4).

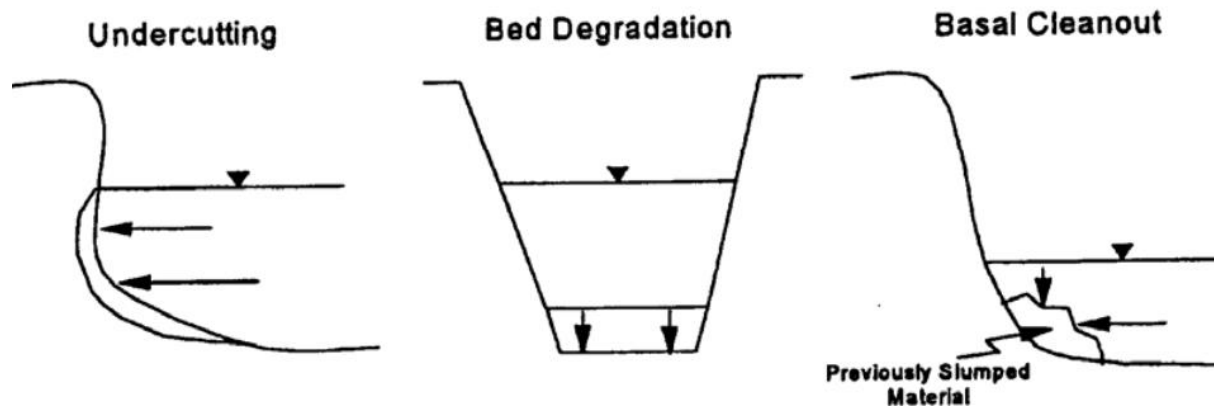
Figure 4. Hydraulic failure mechanisms. Source: O'Neill and Kuhns (1994).

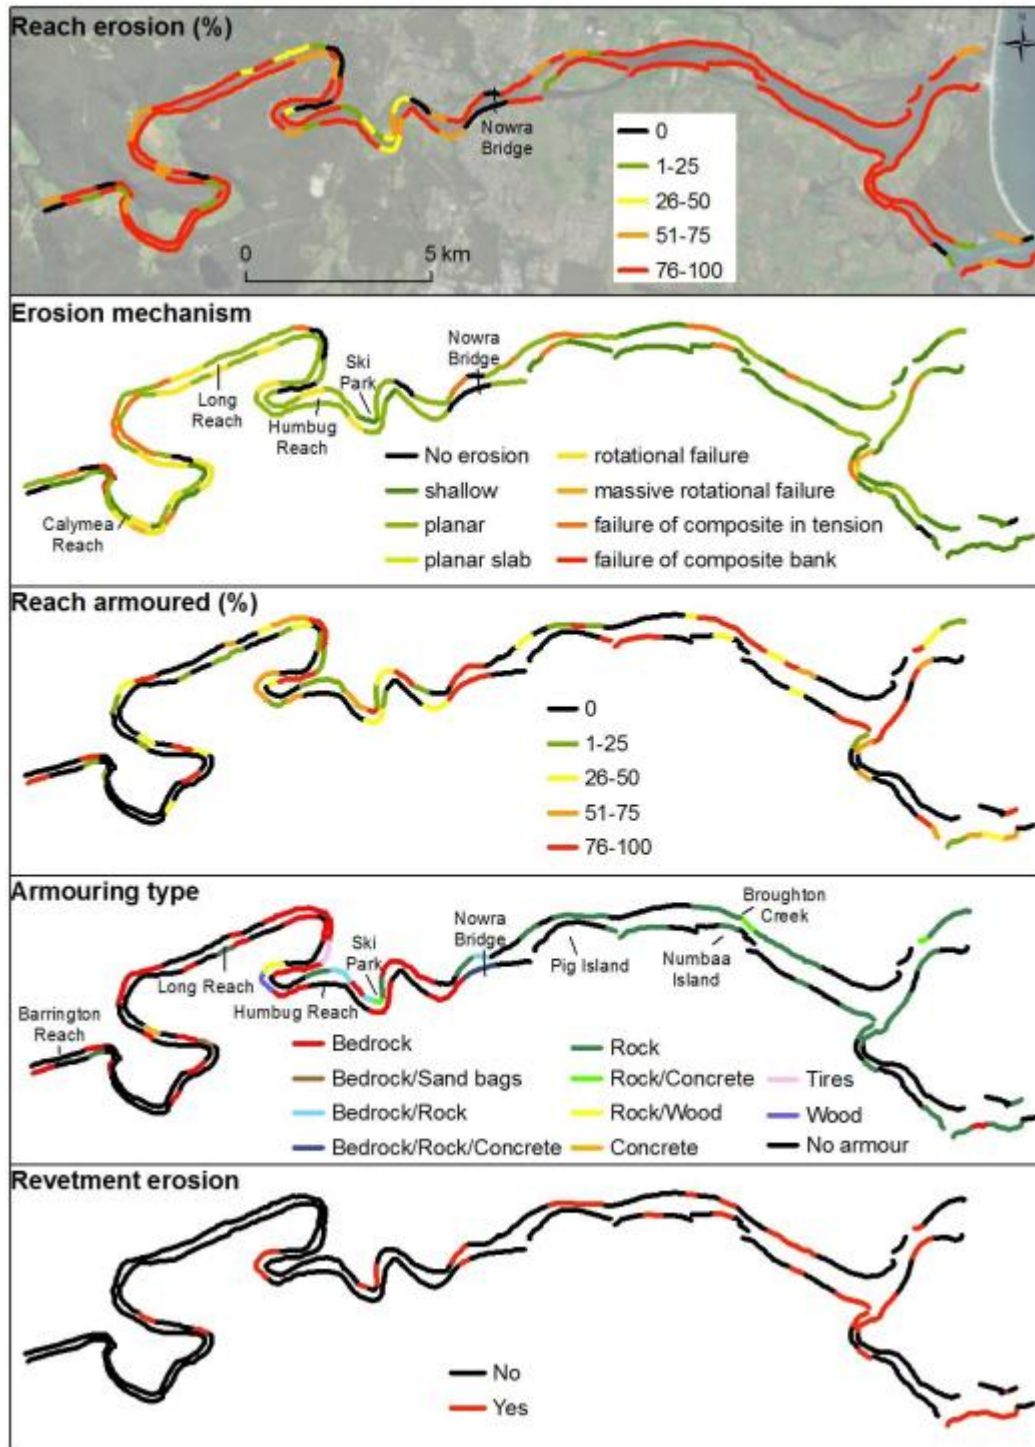
Figure 5. Bank erosion in the Shoalhaven estuary based on field observation datasheet surveys conducted in 2015. Maps from top to bottom indicate percent erosion in each of the 193 reaches (each of 500 m length); erosion mechanism; percentage of the reach that is armoured; type of natural and/or engineered bank armouring; and the existence of erosion behind the artificial armouring (revetment). Source: Figure 4.9 in Carvalho (2018, p. 70).

Carvalho (2018, p. 69) reported that evidence of erosion was observed in most of the reaches on both banks of the estuarine river channel (Figure 5). Evidence of erosion was not observed in only 14 (7.2%) out of 193 reaches. Evidence suggested that shallow and planar erosion were the two most common erosive mechanisms as they occurred in 79 (40.1%) and 57 (29.5%) of the reaches, respectively. Evidence of rotational failure and failure of composition was also observed. It appears that Carvalho (2018) classified most of observed bank erosion as mass failure rather than fluvial scour.

Most of the reaches surveyed by Carvalho (2018) (105 of the 193 reaches) had no natural and/or artificial armouring, whereas 88 (45.6%) of the reaches had armouring along their extent (Figure 5). Armouring types were identified as natural (bedrock) and engineered (revetment), with several reaches where both were present. Erosion behind the revetment was also found in 34 (17.6 %) reaches. Carvalho (2018) found the banks in the vicinity of Nowra Bridge were not eroded, as they were protected by revetment (Figure 5). It is common practice to fortify river banks with revetment for some distance upstream and downstream of bridges, due to higher risk of erosion due to confinement of the flow causing increased shear stress, and desire to protect the asset. Carvalho (2018) reported that the revetment in the area of the bridge was not degraded by erosion (Figure 5).

Under Existing conditions, the right bank had particularly high bed shear stress in the vicinity of Nowra Bridge, on both right (Figure 7) and left banks (Figure 8). These conditions are highly erosive to unprotected banks, but in these areas the banks are protected by revetments (Figure 5). Elsewhere, bed shear stress on the right and left banks exceeds 200 N/m² under large flood conditions in some locations, more so on the left bank. Bed shear stress is less than 100 N/m² along most of the lengths of the banks (except in the vicinity of Nowra

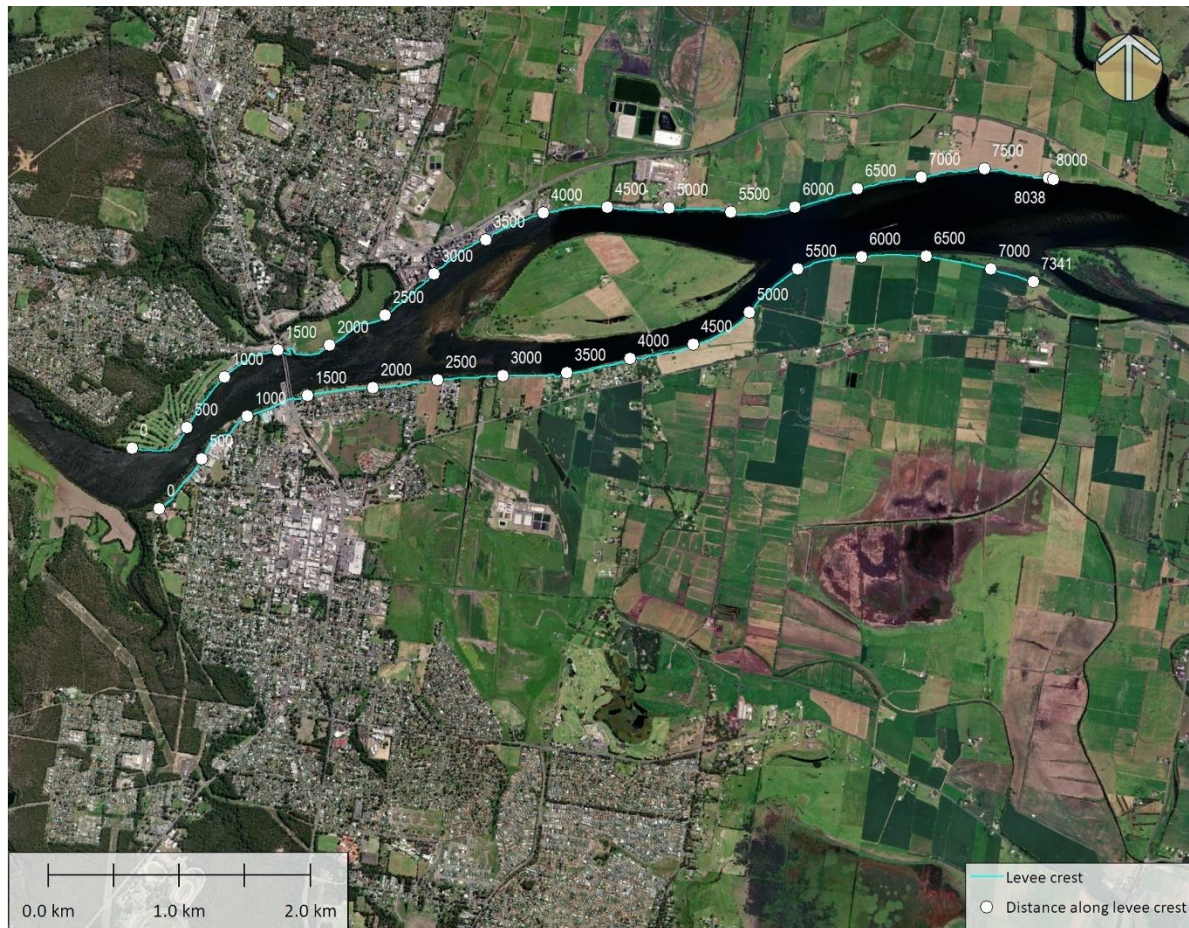
Levee crest location from Nowra Ck to Numbaa Is

Figure 6. Levee crest location showing chainage downstream from Nowra Creek. Left/right bank is from perspective of looking downstream.

Within the reach selected for analysis, the crests of the left and right bank levees were of different lengths, the left being 8038 m and the right being 7341 m (Figure 6). Thus, the downstream chainages of features such as Nowra Bridge and Pig Island differ somewhat between left and right banks.

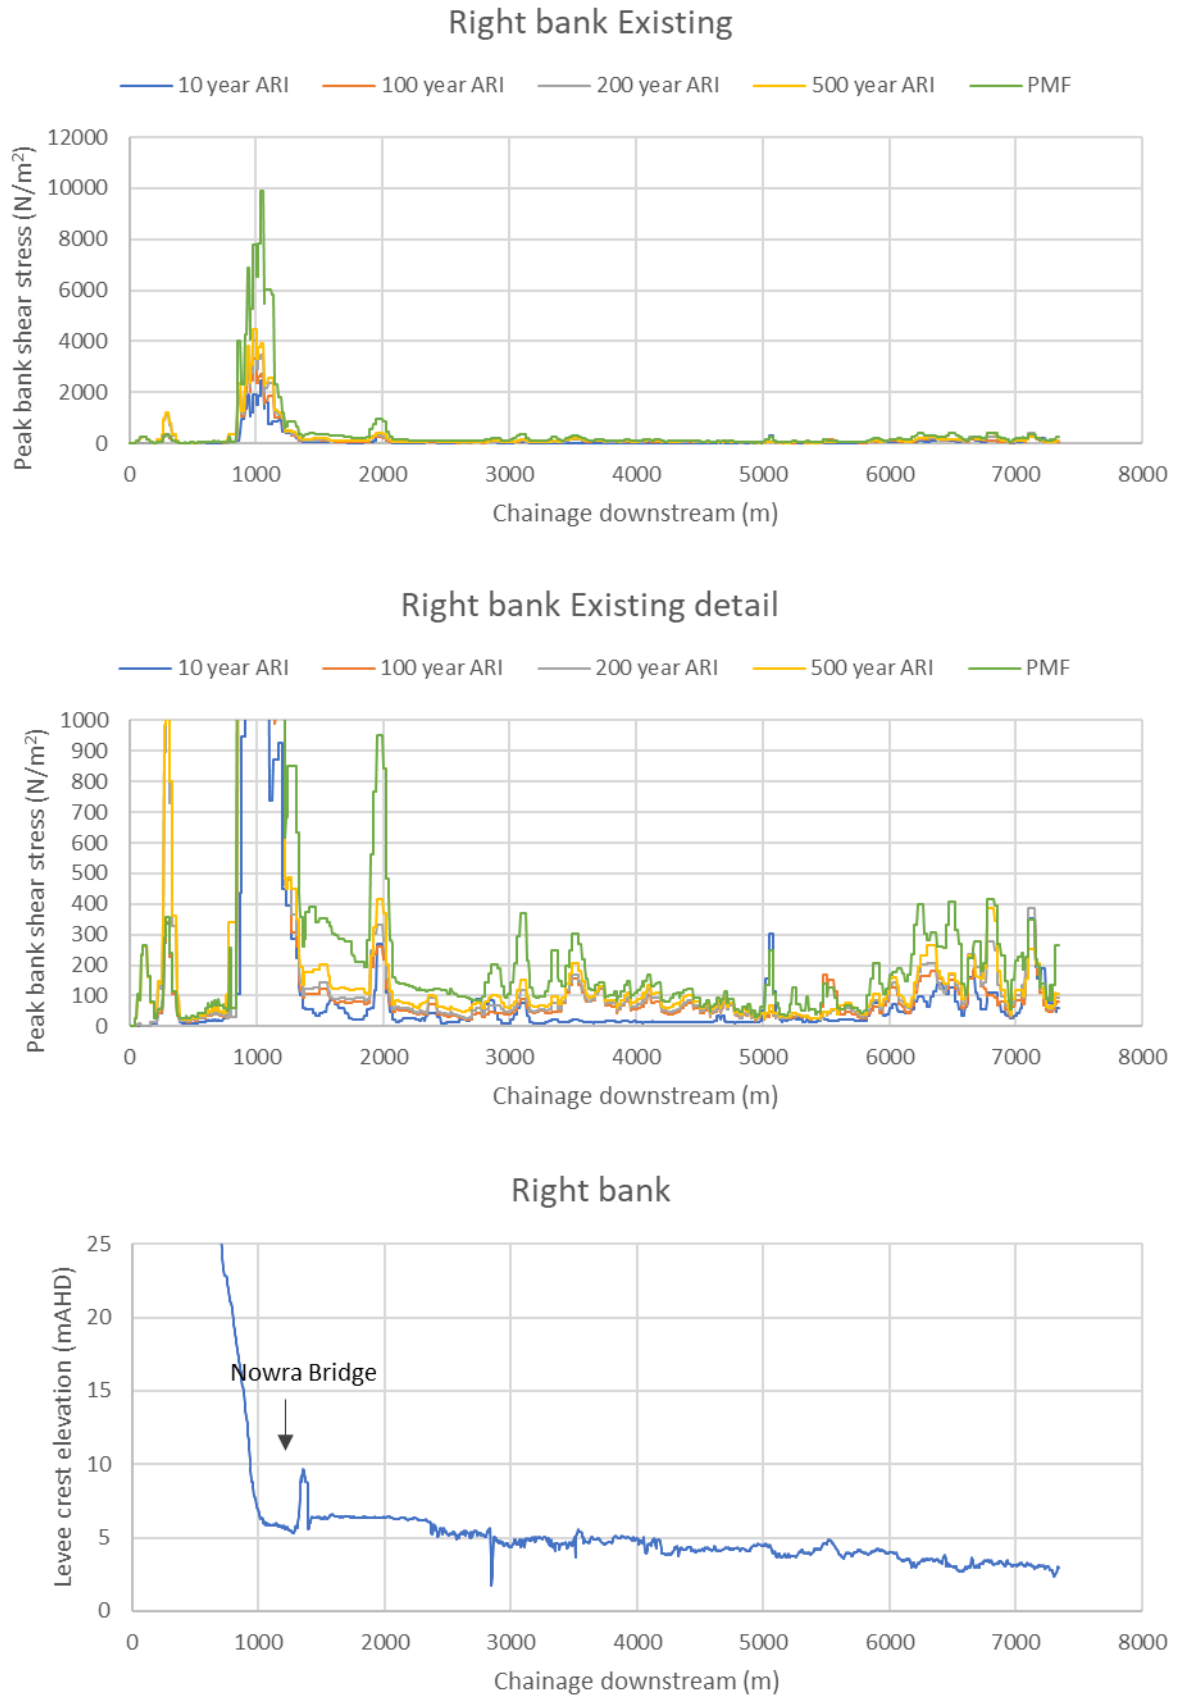
Figure 7. Peak bed shear stress, Existing conditions, in the right bank zone from the levee crest to 60 m within the channel. Bank crest elevation shown for reference. Levee begins at 1000 m chainage.

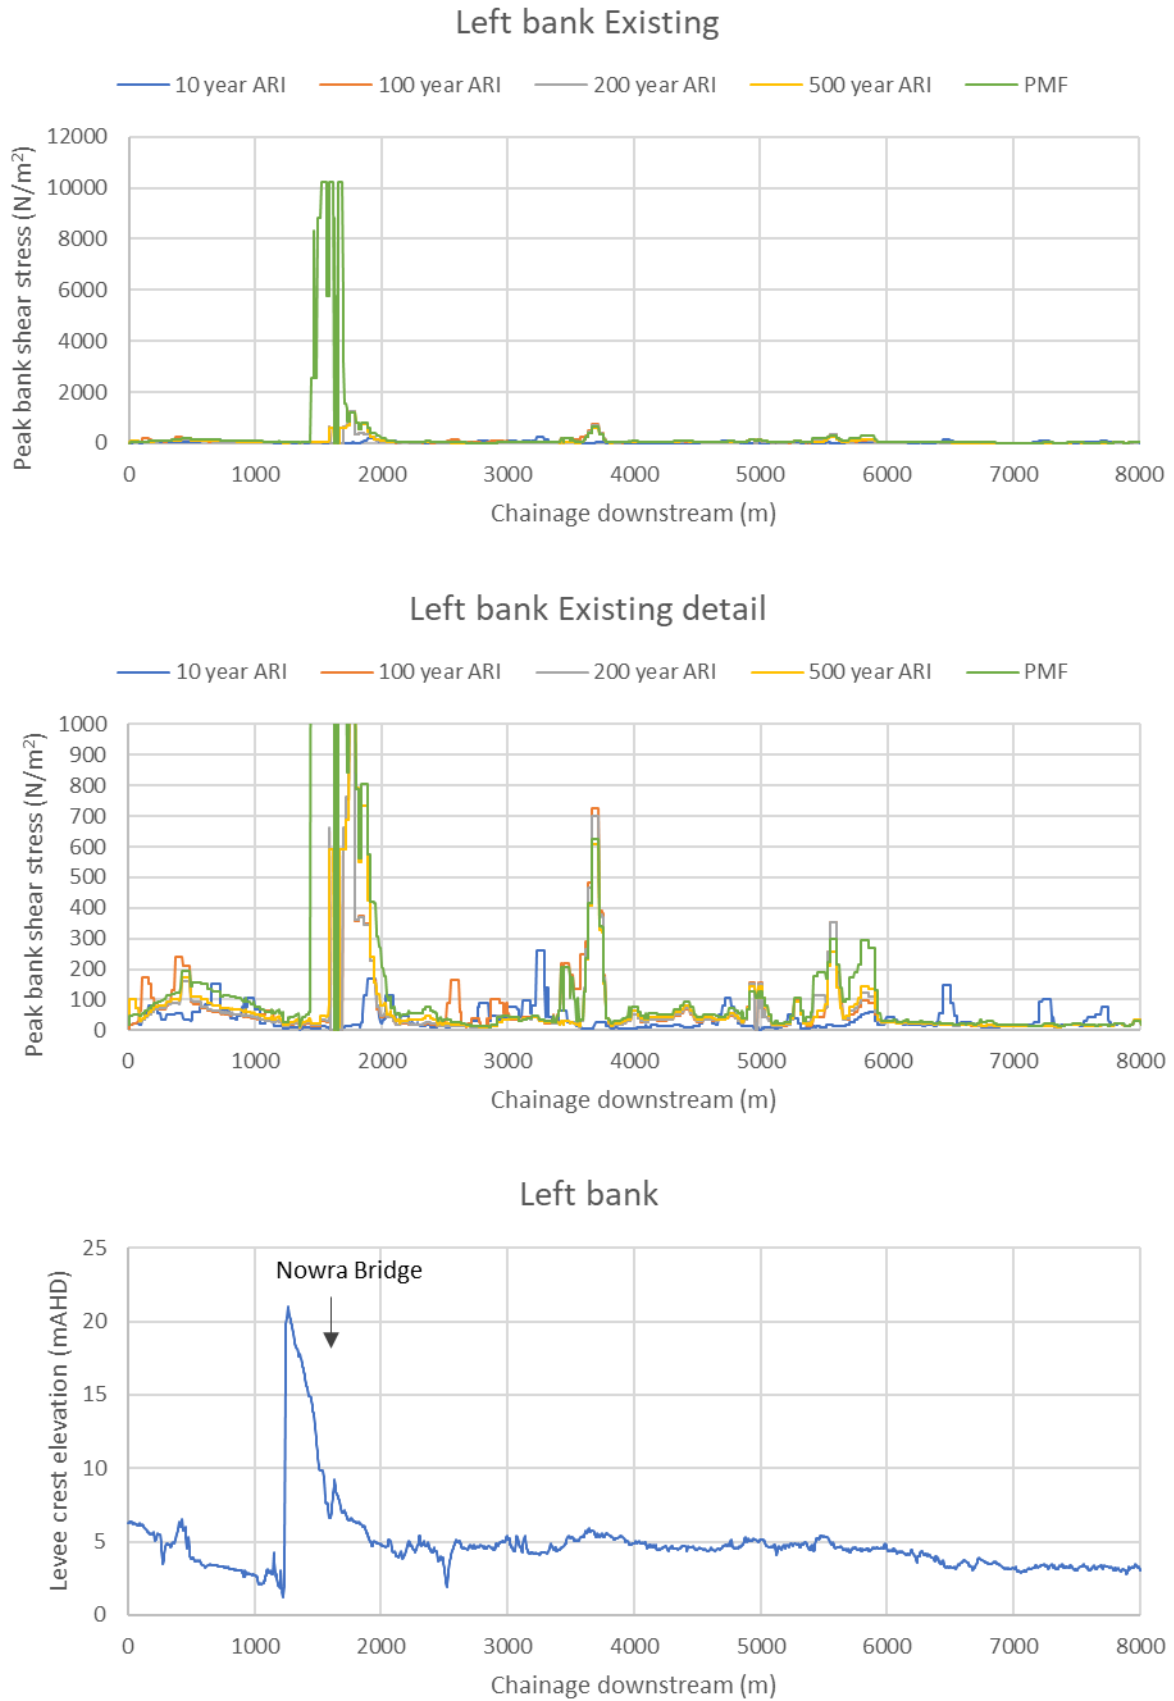
Figure 8. Peak bed shear stress, Existing conditions, in the left bank zone from the levee crest to 60 m within the channel. Bank crest elevation shown for reference.

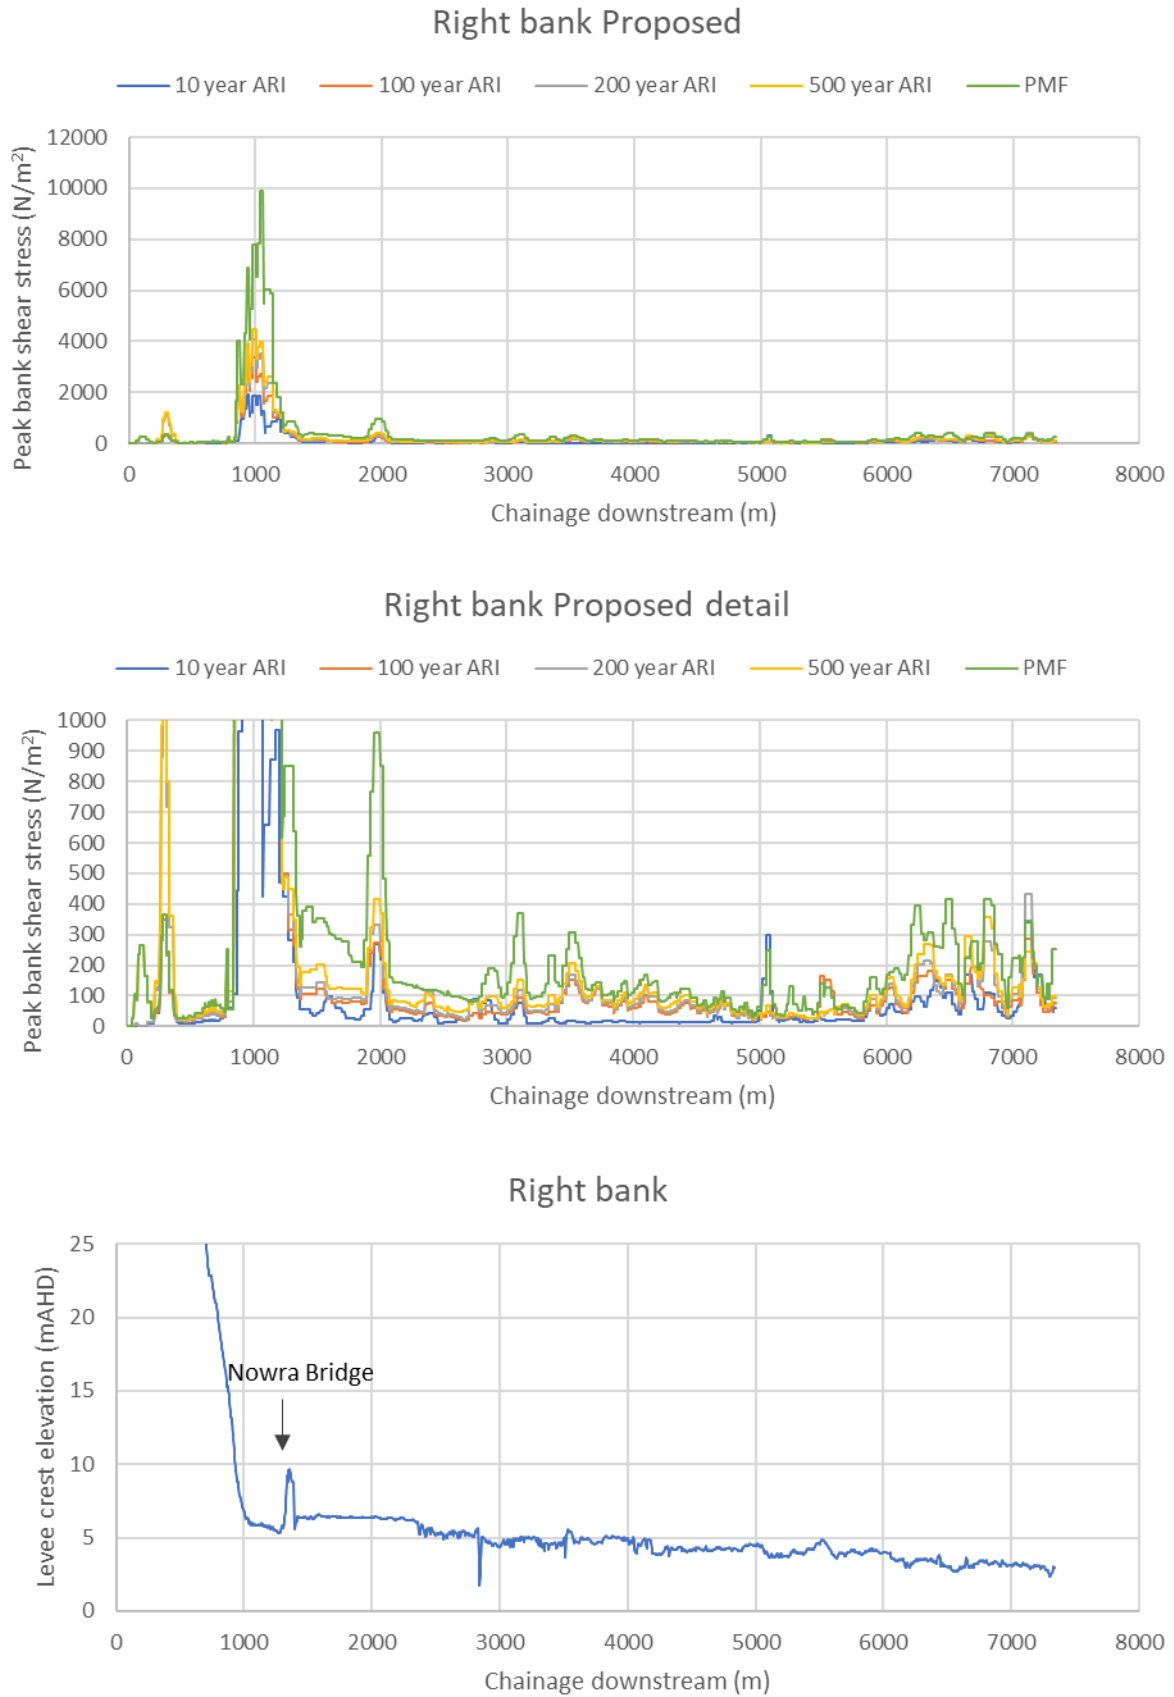
Figure 9. Peak bed shear stress, Proposed conditions, in the right bank zone from the levee crest to 60 m within the channel. Bank crest elevation shown for reference. Levee begins at 1000 m chainage.

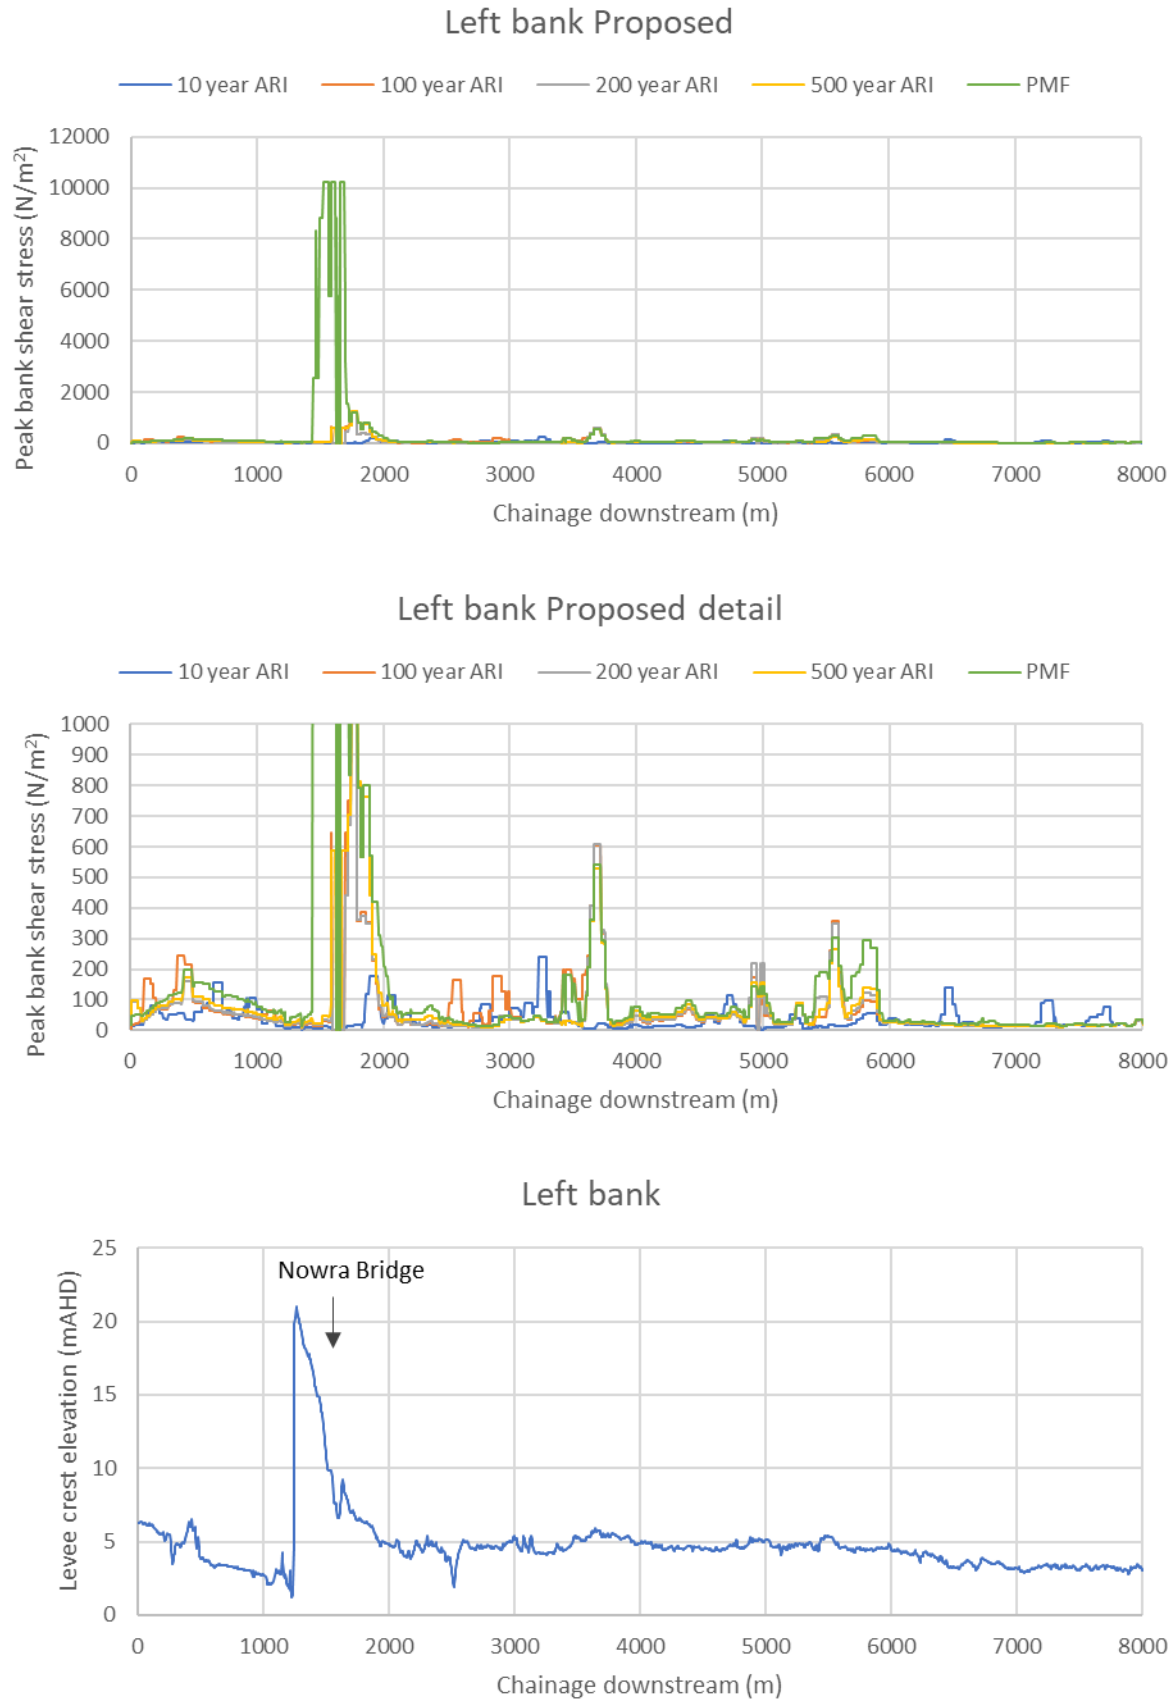
Figure 10. Peak bed shear stress, Proposed conditions, in the left bank zone from the levee crest to 60 m within the channel. Bank crest elevation shown for reference.

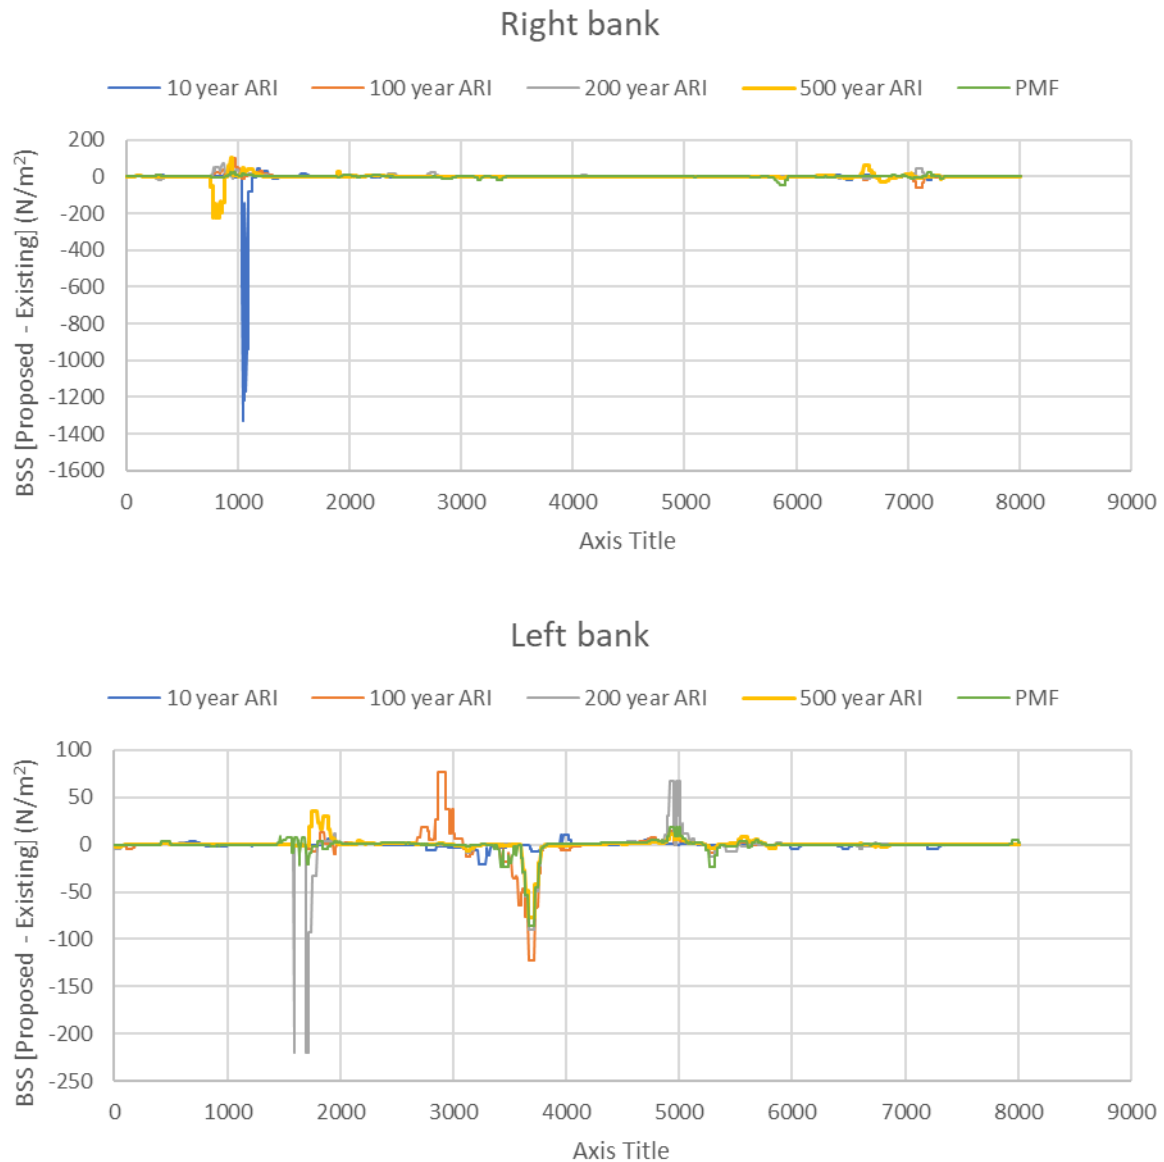
Figure 11. Difference in peak bed shear stress, Proposed conditions minus Existing conditions, in the right and left bank zones from the levee crests to 60 m within the channel.

The differences in bank bed shear stress between Existing and Proposed conditions were mostly small and inconsequential. In some locations the proposed conditions created lower bed shear stress and in other locations, higher bed shear stress. Special attention should be made to monitor banks in the locations with predicted elevated bed shear stress on the banks.
