Stanton Dahl Architects

Stormwater Issues for proposed development
70-72 Gordon Avenue, South Granville NSW
Ref: OA2022/0010

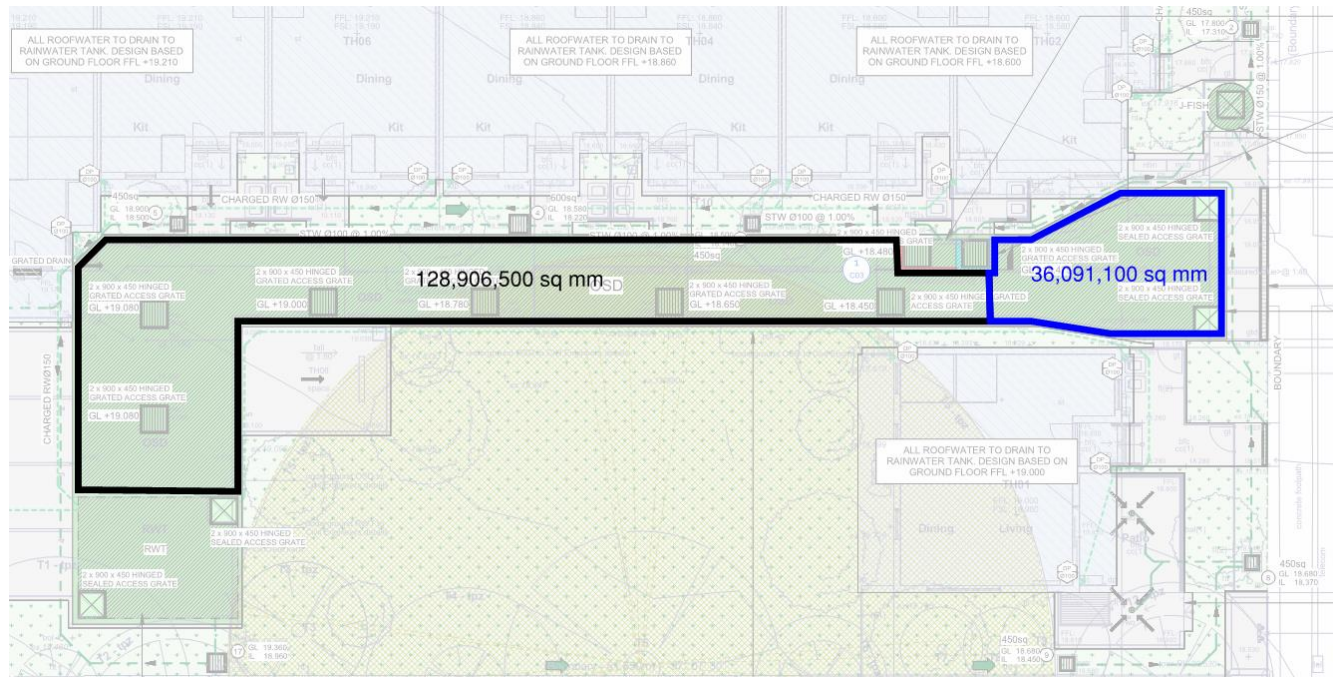
= 17.55m AHD. Average base RL therefore equals +17.50m AHD. TWL – average base RL = average depth = 0.423m. Therefore volume achieved in blue section = 15.2m³

Total volume = 74.1 + 15.2 = 89.3m³ > 82.6m³ in submerged case. Design allows for 6.7m³ of structural walls internal.
