Residential Site Investigation Report

3 Cooke Avenue and 1,3 and 5
Deegan Drive, Alstonville NSW

(Our Reference:39844-GR01_A)
© Barnson Pty Ltd 2022. Confidential.

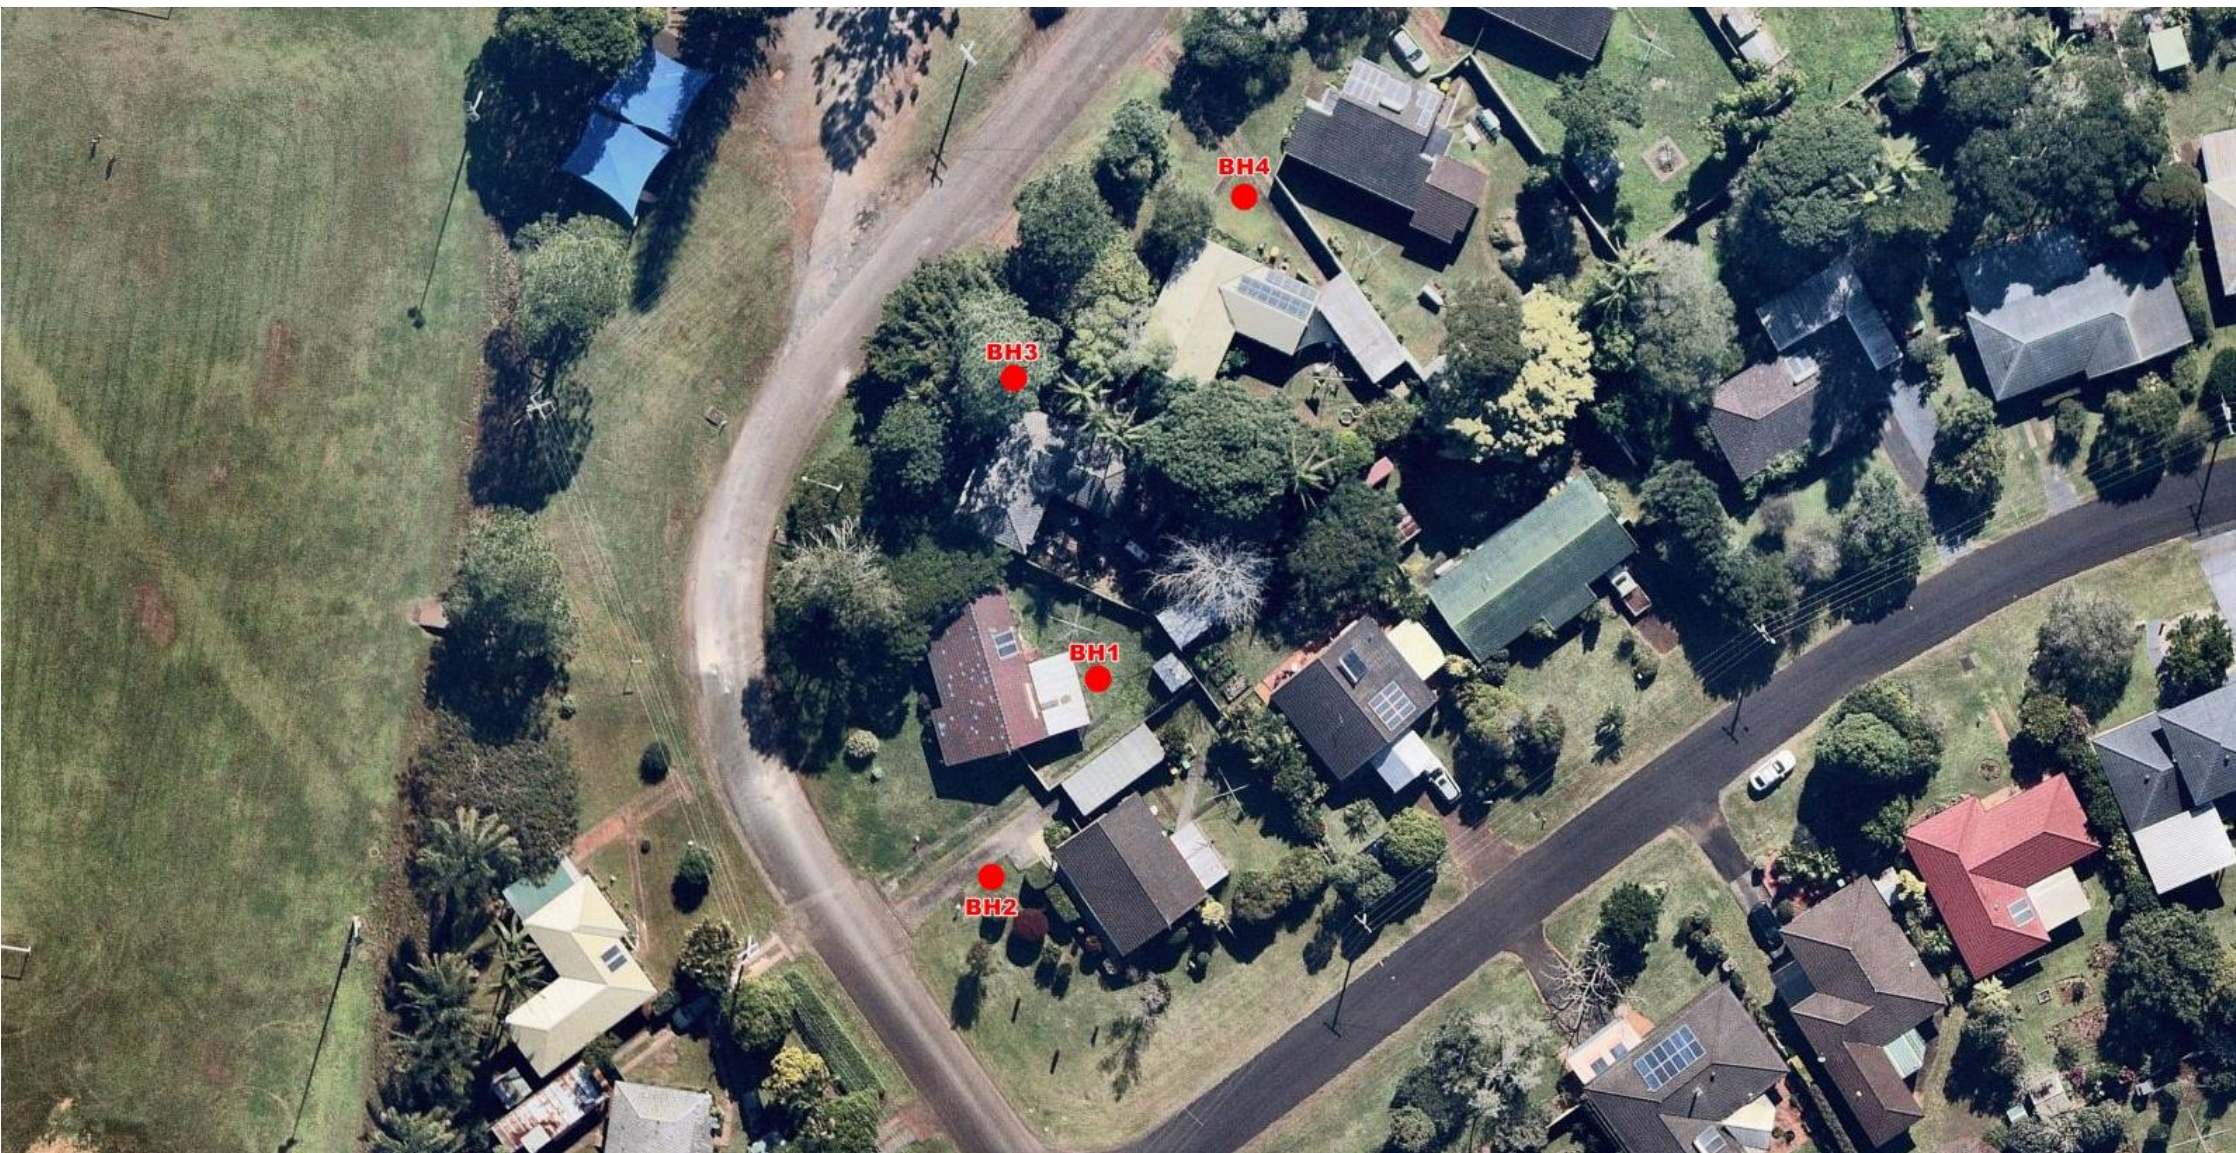
Borehole 4 terminated at 3m

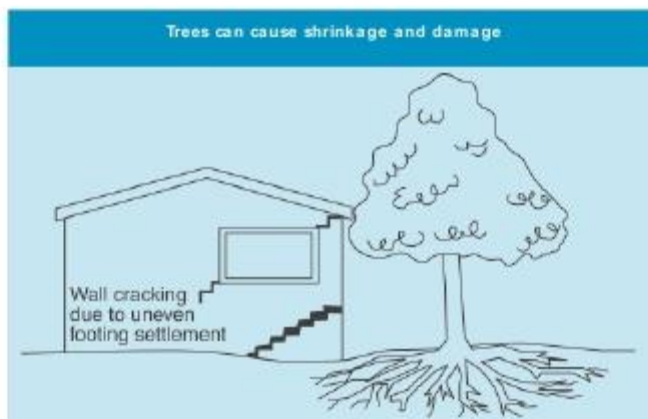
As the moisture absorption process completes its journey to the innermost areas of the building, the internal footings will rise. If the spread of moisture is roughly even, it may be that the symptoms will temporarily disappear, but it is more likely that swelling will be uneven, creating a difference rather than a disappearance in symptoms. In buildings with timber flooring supported by bearers and joists, the isolated piers will rise more easily than the strip footings or piers under walls, creating noticeable doming of flooring.

As the weather pattern changes and the soil begins to dry out, the external footings will be first affected, beginning with the locations where the sun's effect is strongest. This has the effect of lowering the external footings. The doming is accentuated and cracking reduces or disappears where it occurred because of dishing, but other cracks open up. The roof lines may become convex.
