12 May 2022  
File No. E25060.E99.008\_Rev4

## **RE: Detailed Scope of Methodology for Non-friable and Concrete Slab Removal - 42-50 Parramatta Road, Forest Lodge NSW**

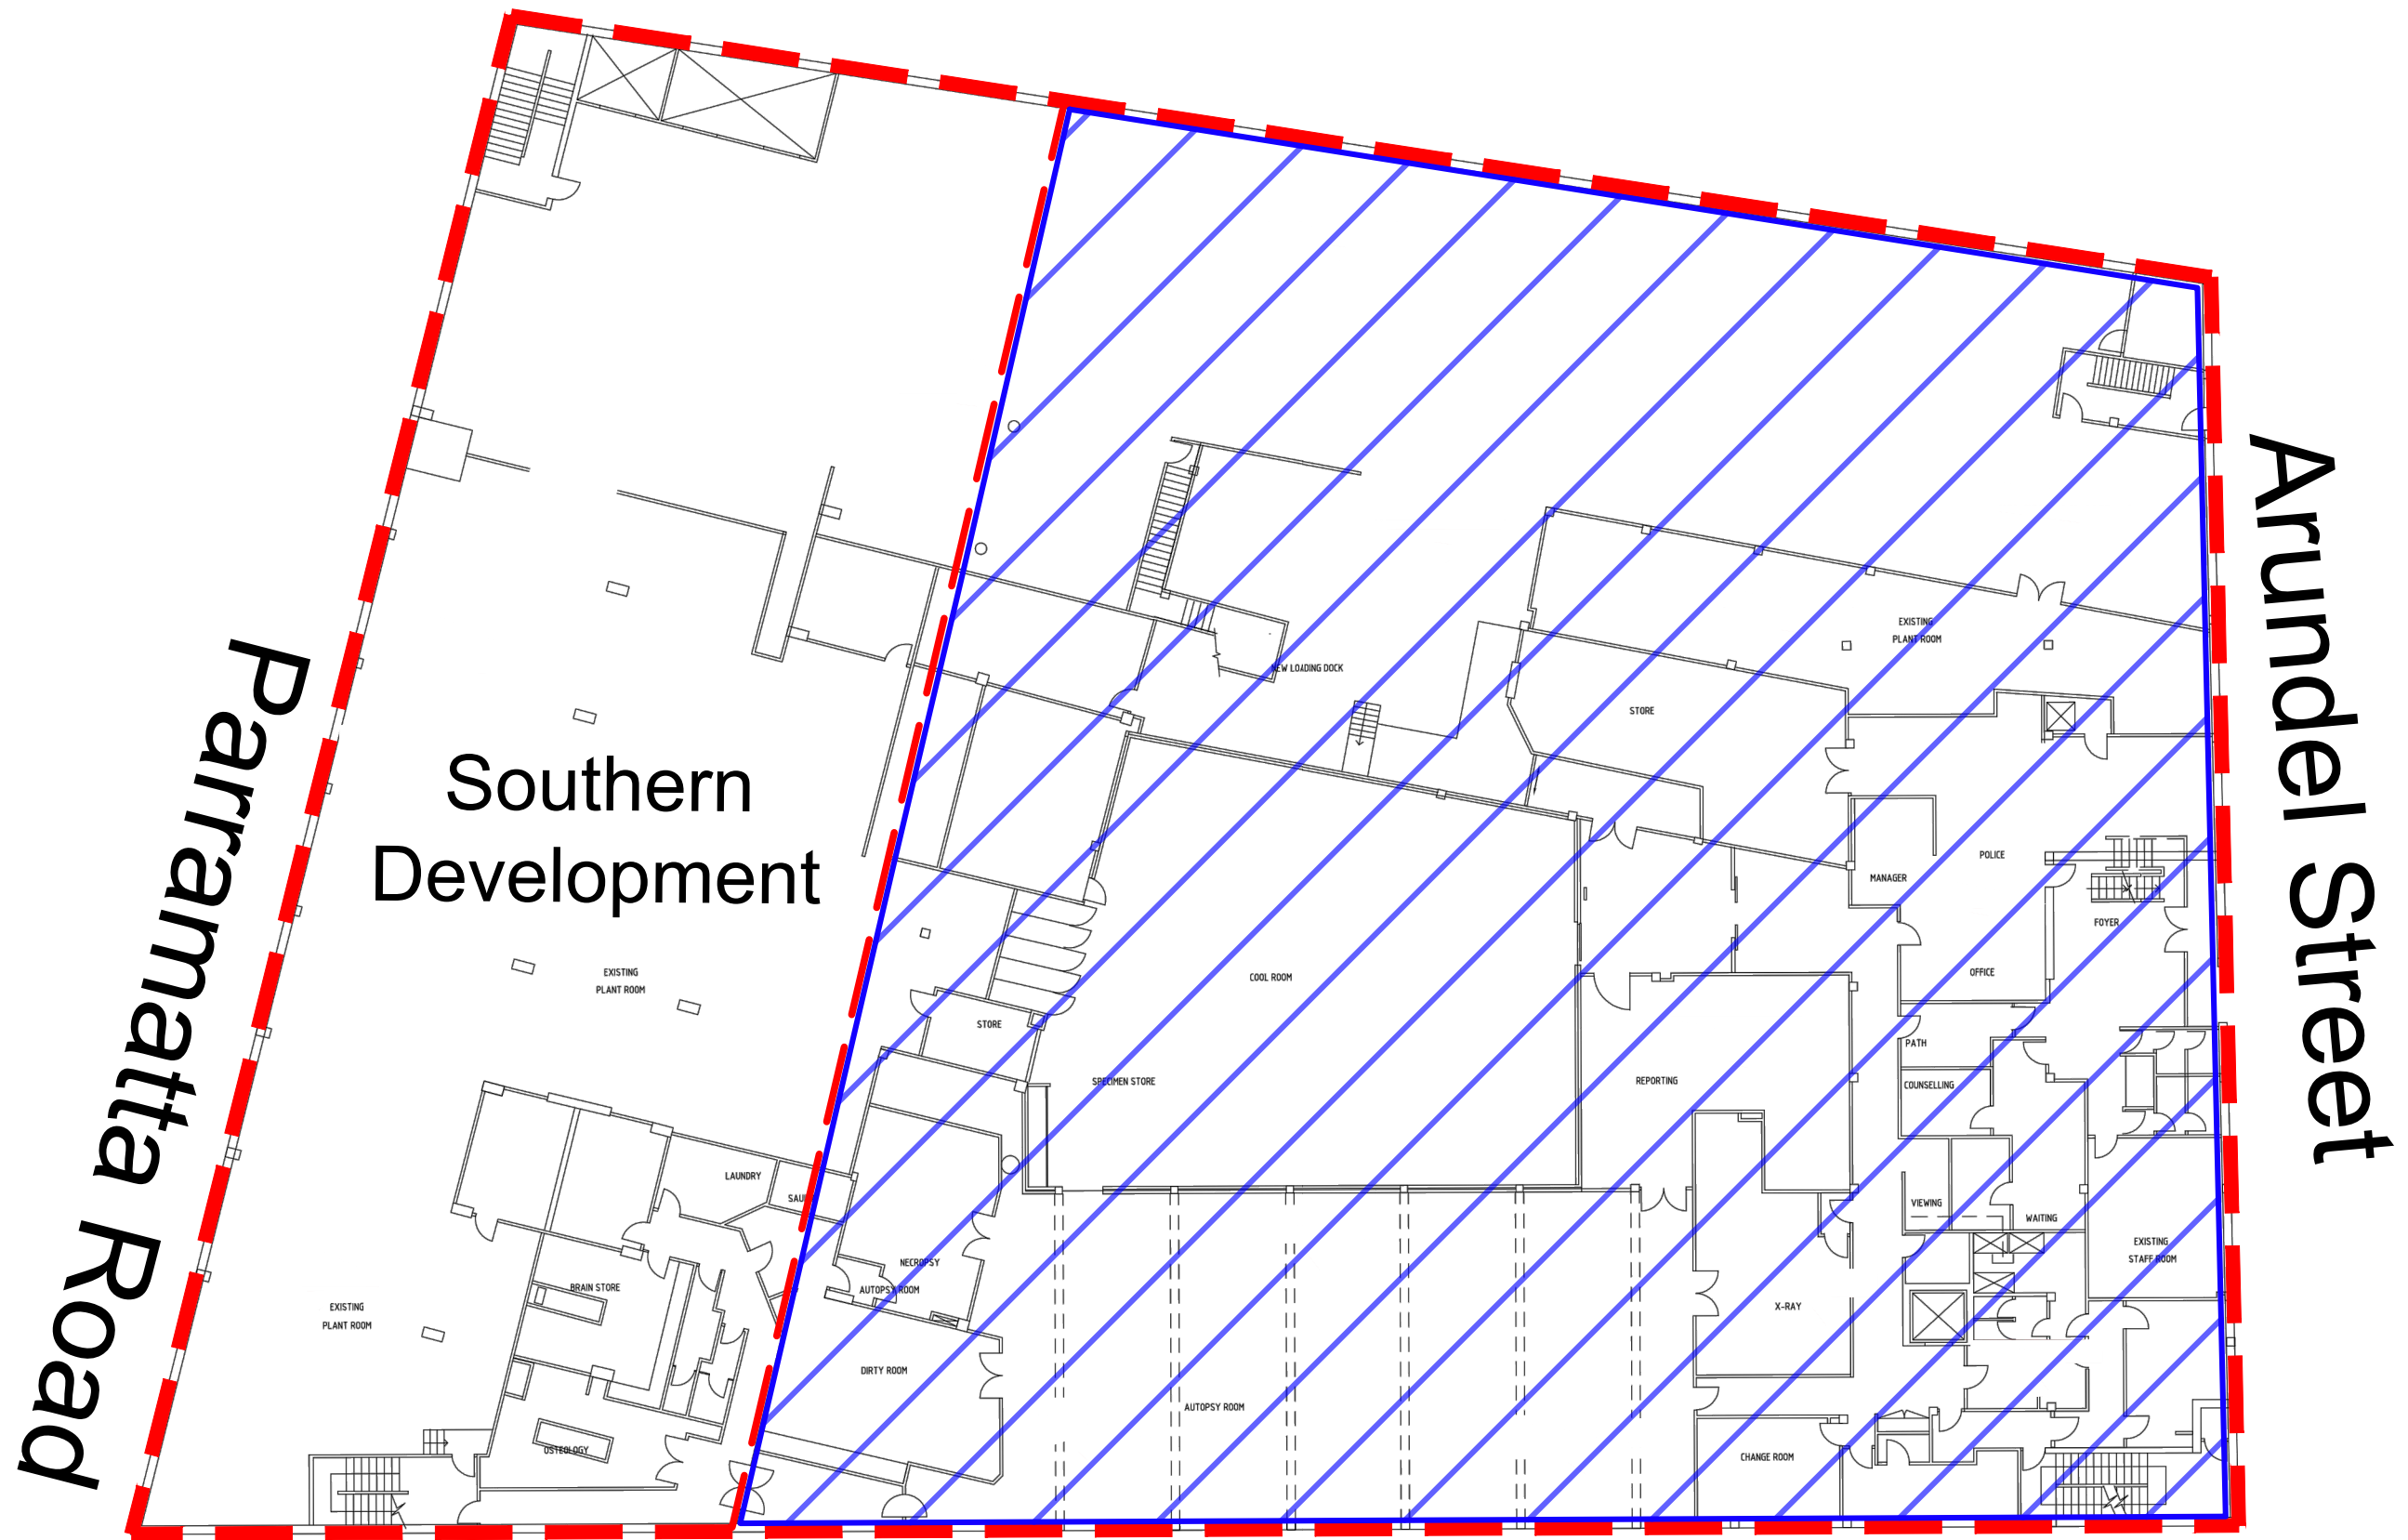
### **ASBESTOS REMOVAL LOCATION MAP**

Map Source: J. ROXBURGH & PARTNERS Pty Ltd Drawing number: SK-1
