RGS32576.1 - AM

**RE: A2 Banksia Unit, Tamworth Hospital – Dean Street, Tamworth
Desktop Groundwater Assessment**

Regional Geotechnical Solutions Pty Ltd (RGS) has undertaken a desktop groundwater assessment for A2 Banksia Unit, Tamworth Hospital to be located on Dean Street, Tamworth. RGS previously undertook geotechnical investigations and assessment for this development with results presented in report RGS32576.1 – AH dated 31 March 2021. It is understood that the project is under review and additional information on groundwater impacts is required.

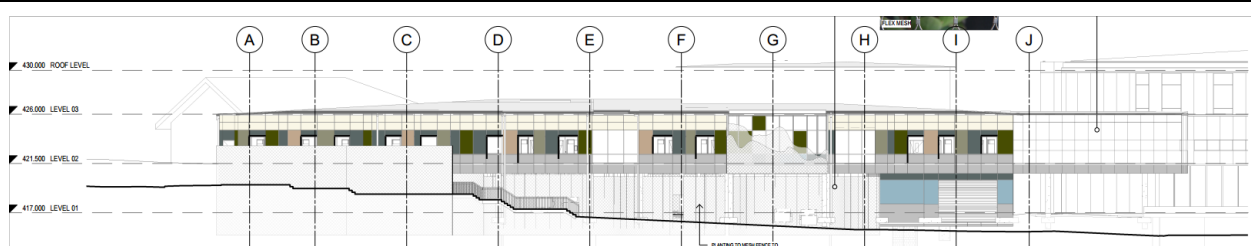
Proposed elevations.
