# Geotechnical Investigation

1H Hospital Road, Concord West NSW

**Report No:** E25996.G03

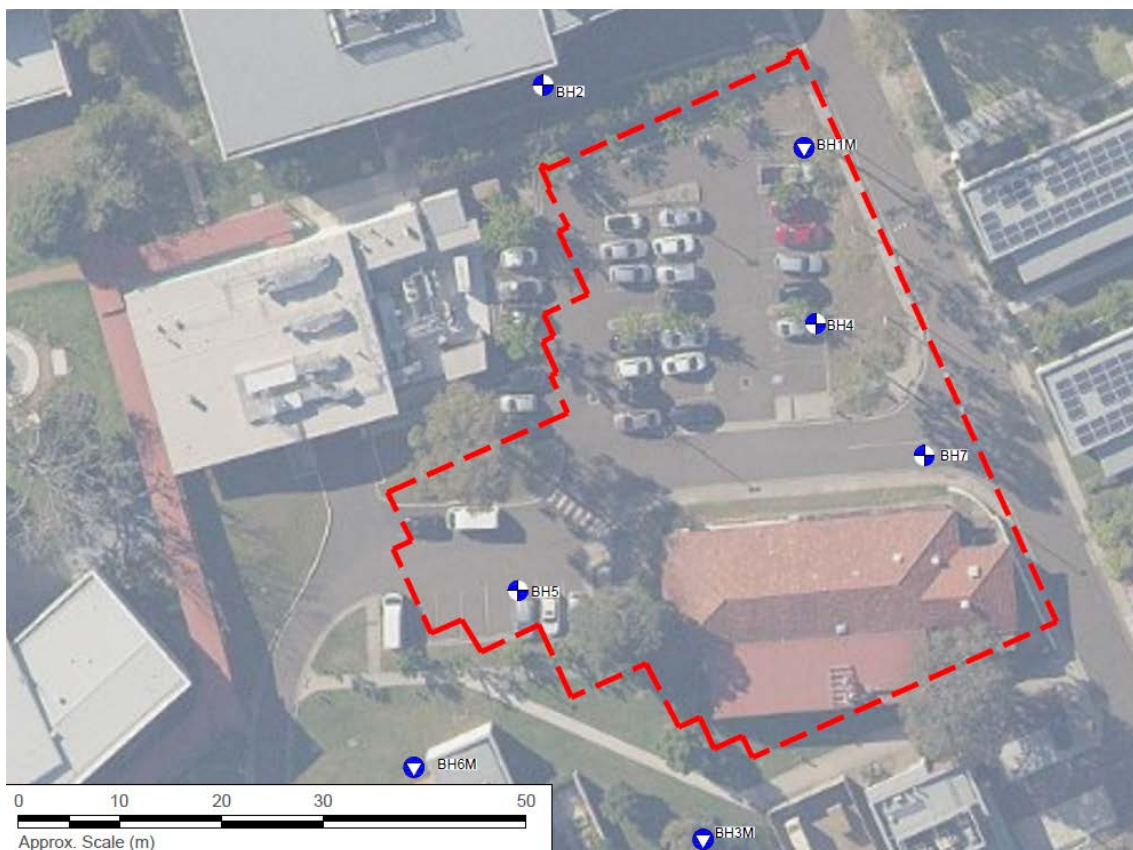
**Plate 1:** Aerial photograph of the site (source: SIXMaps, accessed 30/5/23)

The site identification details and associated information are presented in **Table 2-1** below while the site locality is shown on **Figure 1**. An aerial photograph of the site is presented in **Plate 1** below.

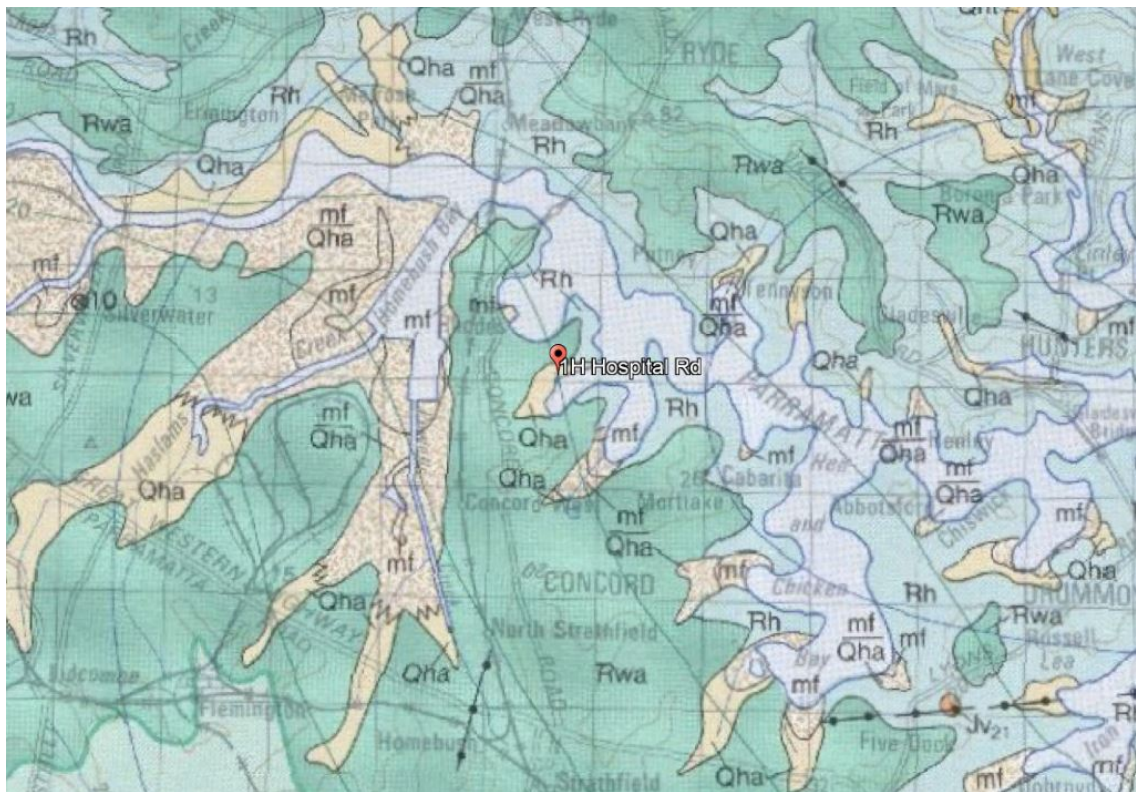
**Plate 2:** Excerpt of geological map showing location of site.

Attribute	Description
Topography	The site is located at the central portion of the Concord Hospital within gently (0° to 5°), south-west dipping topography.
Regional Geology	<p>Information on regional sub-surface conditions, referenced from the Department of Mineral Resources Geological Map Sydney 1:100,000 Geological Series Sheet 9130 (DMR 1983) indicates the site to be underlain by Quaternary Aged Holocene deposits (Qha) associated with stream alluvial and estuarine sediments, which consists of silty to peaty quartz sand, silt, and clay, Ferruginous and humic cementation in places, and common shell layers. It is expected that the soils are underlain by Hawkesbury Sandstone.</p> <p>Previous geotechnical site investigations by Coffey Services Australia were carried out as part of the Phase 2 redevelopment of the hospital precinct in 2016 to 2017. The Phase 2 redevelopment footprint investigated by Coffey was located west and south-west of the subject site. The borehole encountered Ashfield Shale (Rwa) and Hawkesbury Sandstone (Rh) beneath the overburden soils. Depending on location, a residual soil profile was encountered beneath the Quaternary alluvium. Shale bedrock was encountered at depths ranging from 1.2m to 2m below ground surface levels underlain by Sandstone at depths of about 8m to 10m.</p>

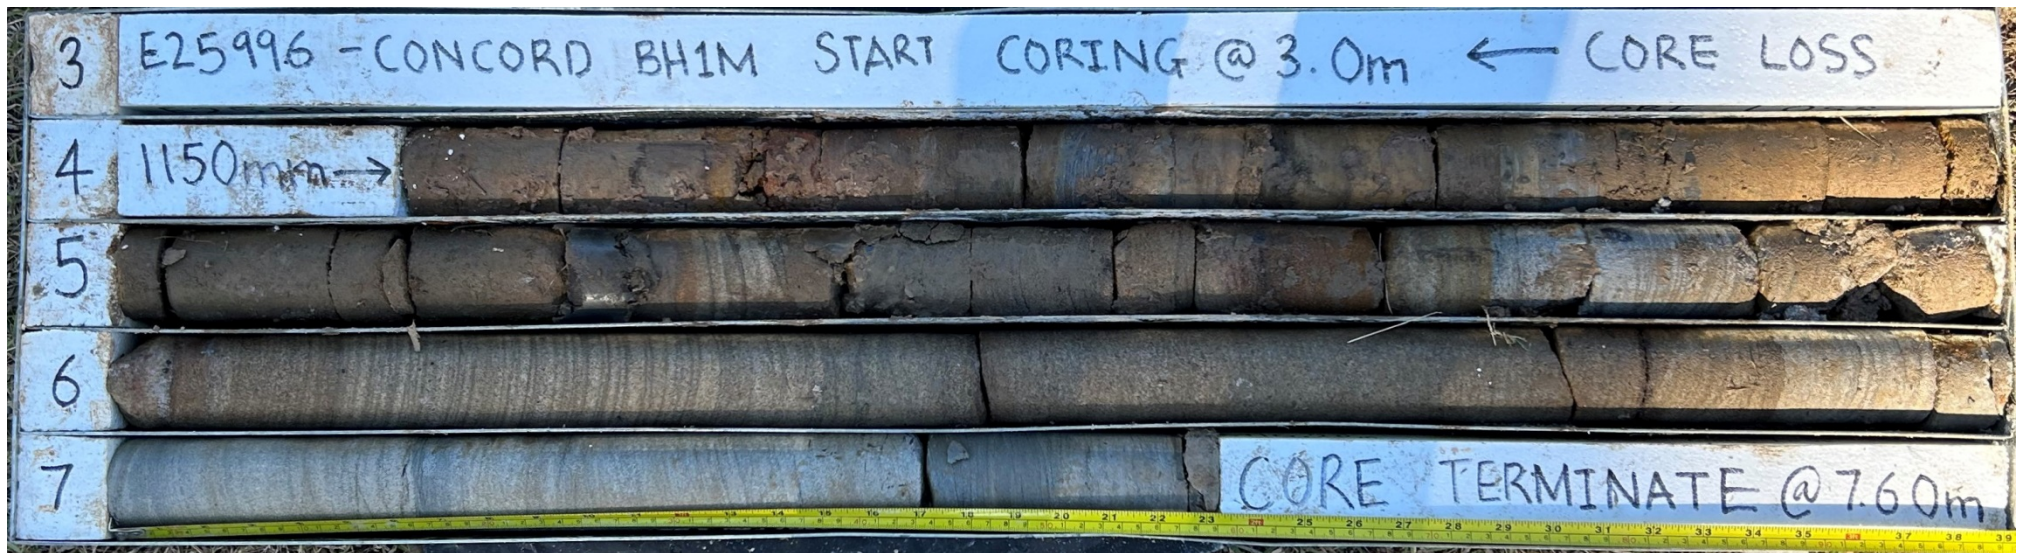
# CORE PHOTOGRAPH OF BOREHOLE: BH1M

<b>Project</b>	Proposed Redevelopment	<b>Depth Range</b>	3.0m to 7.60m BEGL	
<b>Location</b>	1H Hospital Road, Concord West, NSW	<b>Contractor</b>	Geosense Drilling Engineers Pty Ltd	
<b>Position</b>	See Figure 2	<b>Drill Rig</b>	Comacchio GEO 205	
<b>Job No.</b>	E25669.G03	<b>Logged</b>	JO	<b>Date</b> 24 / 05 / 2023
<b>Client</b>	Lipman Pty Ltd	<b>Box</b>	1 of 1	<b>Checked</b> KX <b>Date</b> 16 / 06 / 2023

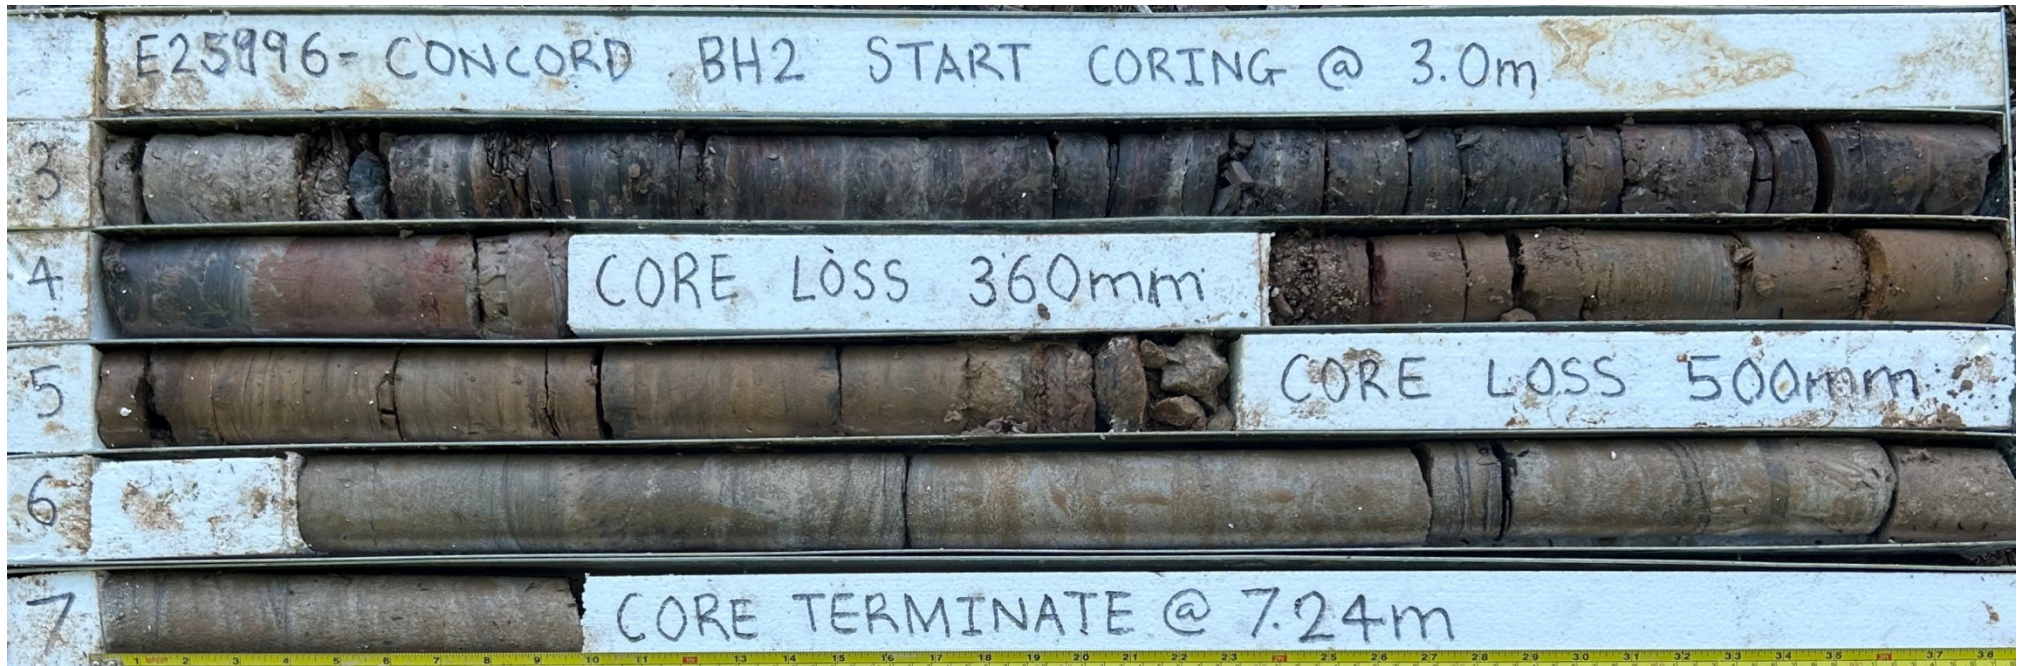
## CORE PHOTOGRAPH OF BOREHOLE: BH2

<b>Project</b>	Proposed Redevelopment	<b>Depth Range</b>	3.0m to 7.24m BEGL	
<b>Location</b>	1H Hospital Road, Concord West, NSW	<b>Contractor</b>	Geosense Drilling Engineers Pty Ltd	
<b>Position</b>	See Figure 2	<b>Drill Rig</b>	Comacchio GEO 205	
<b>Job No.</b>	E25669.G03	<b>Logged</b>	JO	<b>Date</b> 24 / 05 / 2023
<b>Client</b>	Lipman Pty Ltd	<b>Box</b>	1-2 of 2	<b>Checked</b> KX <b>Date</b> 16 / 06 / 2023
<b>Surface RL</b> ≈ -		<b>Inclination</b>	-90°

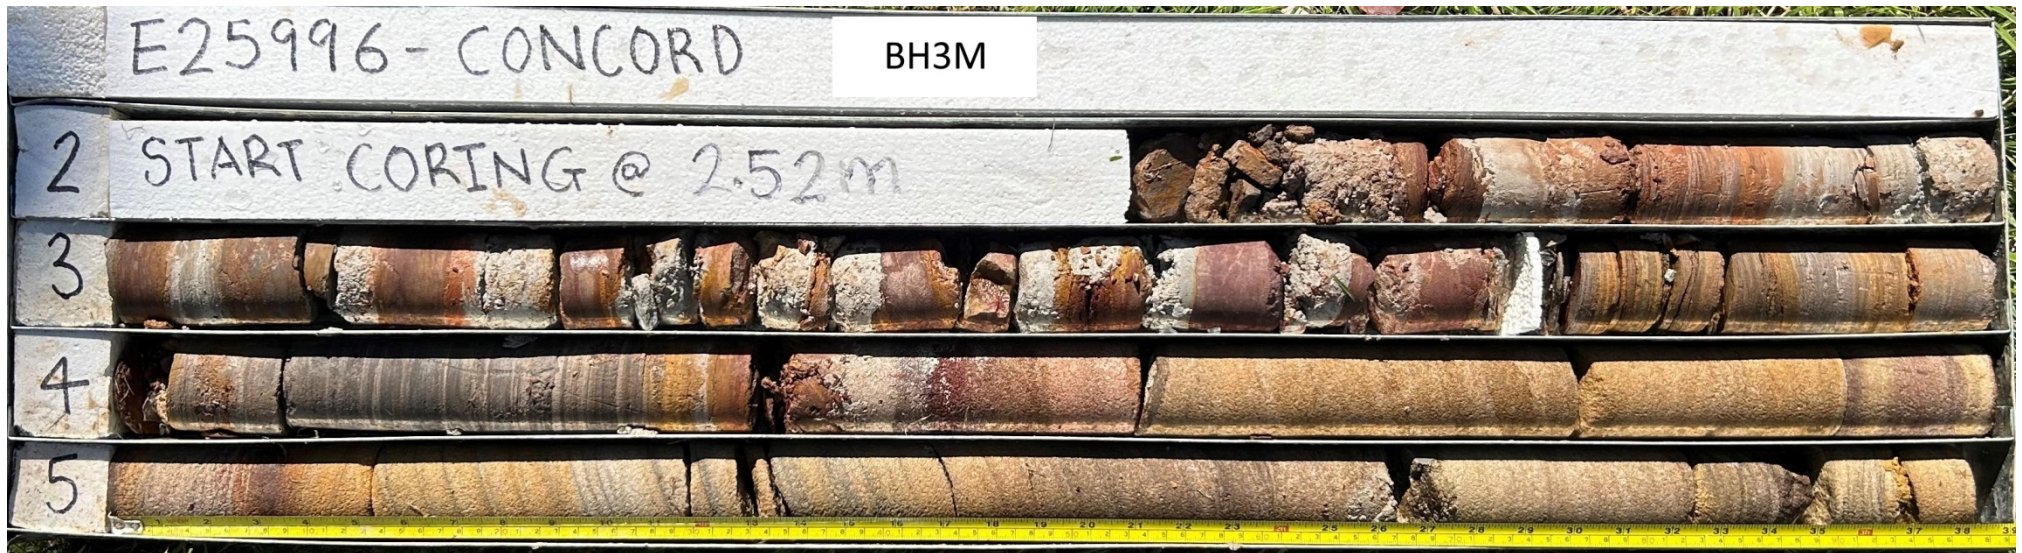
# CORE PHOTOGRAPH OF BOREHOLE: BH3M

<b>Project</b>	Proposed Redevelopment	<b>Depth Range</b>	2.52m to 6.0m BEGL	
<b>Location</b>	1H Hospital Road, Concord West, NSW	<b>Contractor</b>	Geosense Drilling Engineers Pty Ltd	
<b>Position</b>	See Figure 2	<b>Drill Rig</b>	Comacchio GEO 205	
<b>Job No.</b>	E25669.G03	<b>Logged</b>	JO	<b>Date</b> 23 / 05 / 2023
<b>Client</b>	Lipman Pty Ltd	<b>Box</b>	1 of 1	<b>Checked</b> KX <b>Date</b> 16 / 06 / 2023

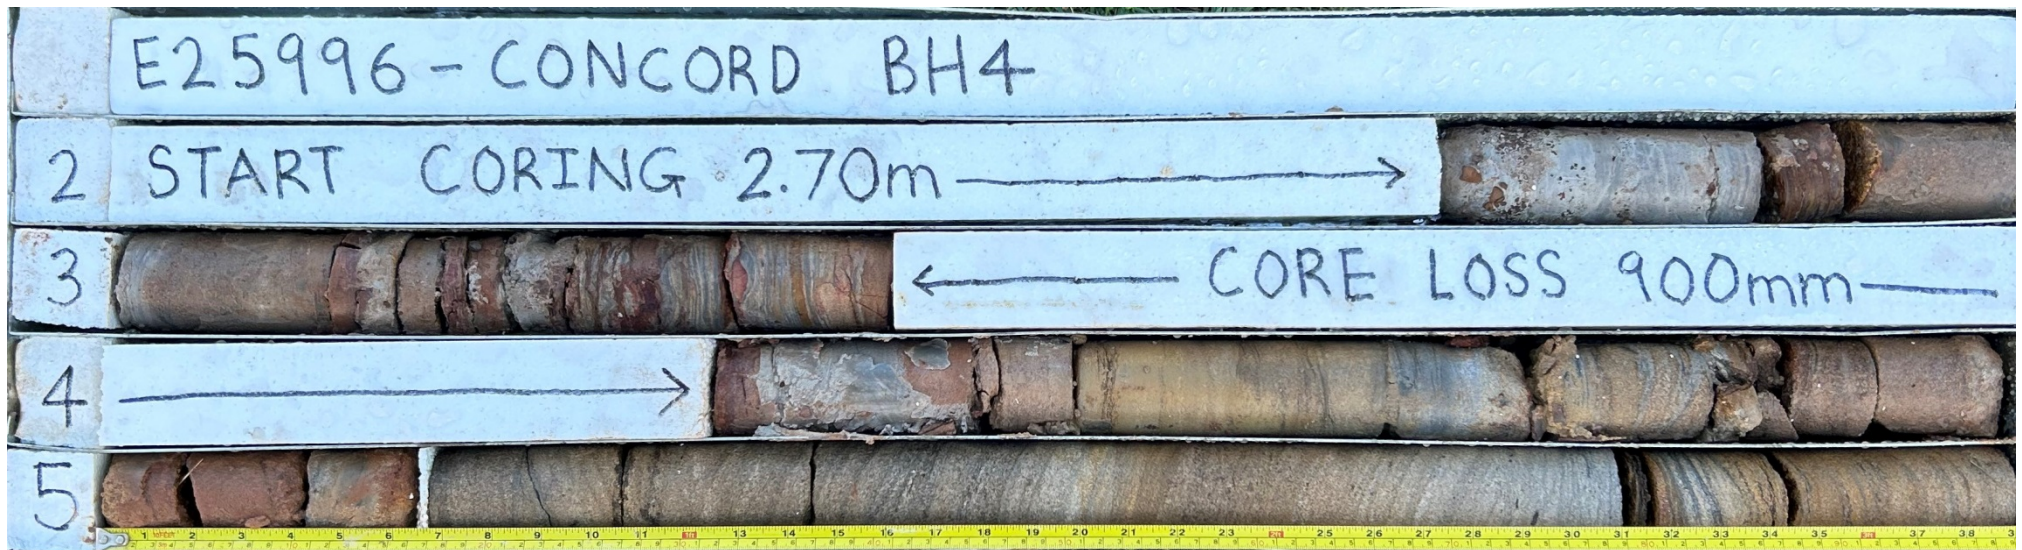
## CORE PHOTOGRAPH OF BOREHOLE: BH4

<b>Project</b>	Proposed Redevelopment	<b>Depth Range</b>	2.70m to 6.0m BEGL	
<b>Location</b>	1H Hospital Road, Concord West, NSW	<b>Contractor</b>	Geosense Drilling Engineers Pty Ltd	
<b>Position</b>	See Figure 2	<b>Drill Rig</b>	Comacchio GEO 205	
<b>Job No.</b>	E25669.G03	<b>Logged</b>	JO	<b>Date</b> 23 / 05 / 2023
<b>Client</b>	Lipman Pty Ltd	<b>Box</b>	1 of 1	<b>Checked</b> KX <b>Date</b> 16 / 06 / 2023

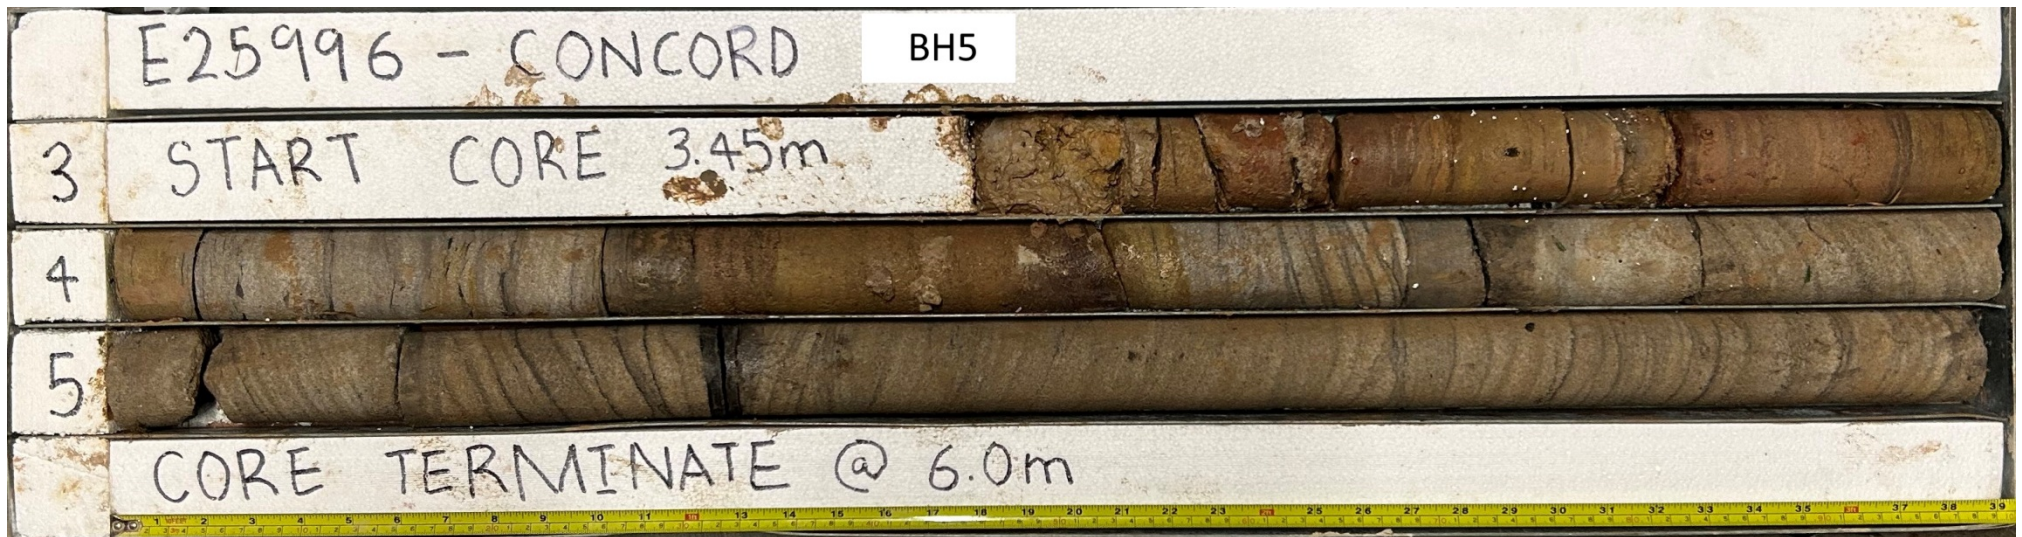
# CORE PHOTOGRAPH OF BOREHOLE: BH5

<b>Project</b>	Proposed Redevelopment	<b>Depth Range</b>	3.45m to 6.0m BEGL	
<b>Location</b>	1H Hospital Road, Concord West, NSW	<b>Contractor</b>	Geosense Drilling Engineers Pty Ltd	
<b>Position</b>	See Figure 2	<b>Drill Rig</b>	Comacchio GEO 205	
<b>Job No.</b>	E25669.G03	<b>Logged</b>	JO	<b>Date</b> 23 / 05 / 2023
<b>Client</b>	Lipman Pty Ltd	<b>Box</b>	1 of 1	<b>Checked</b> KX <b>Date</b> 16 / 06 / 2023

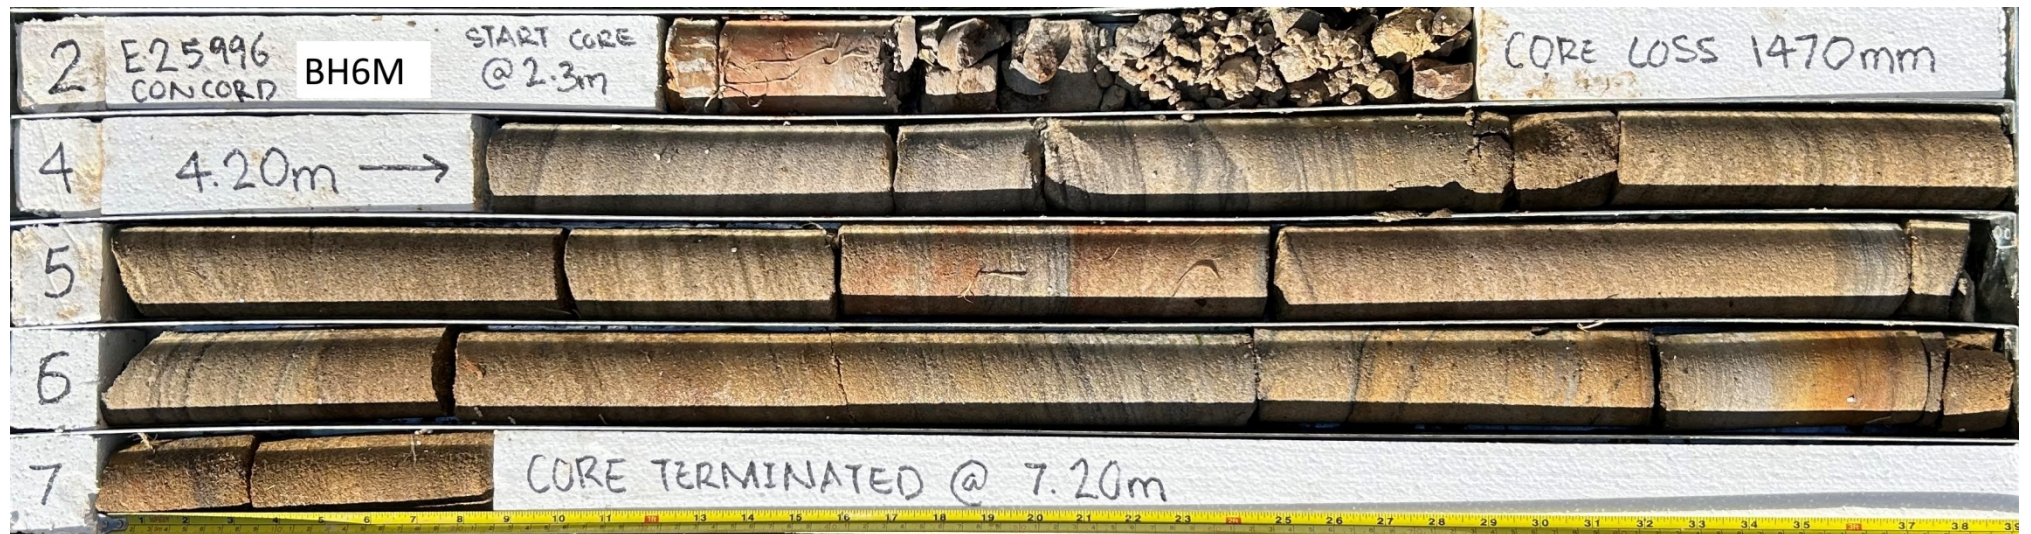
# CORE PHOTOGRAPH OF BOREHOLE: BH6M

<b>Project</b>	Proposed Redevelopment	<b>Depth Range</b>	2.3m to 7.2m BEGL	
<b>Location</b>	1H Hospital Road, Concord West, NSW	<b>Contractor</b>	Geosense Drilling Engineers Pty Ltd	
<b>Position</b>	See Figure 2	<b>Drill Rig</b>	Comacchio GEO 205	
<b>Job No.</b>	E25669.G03	<b>Logged</b>	JO	<b>Date</b> 22 / 05 / 2023
<b>Client</b>	Lipman Pty Ltd	<b>Box</b>	1 of 1	<b>Checked</b> KX <b>Date</b> 16 / 06 / 2023

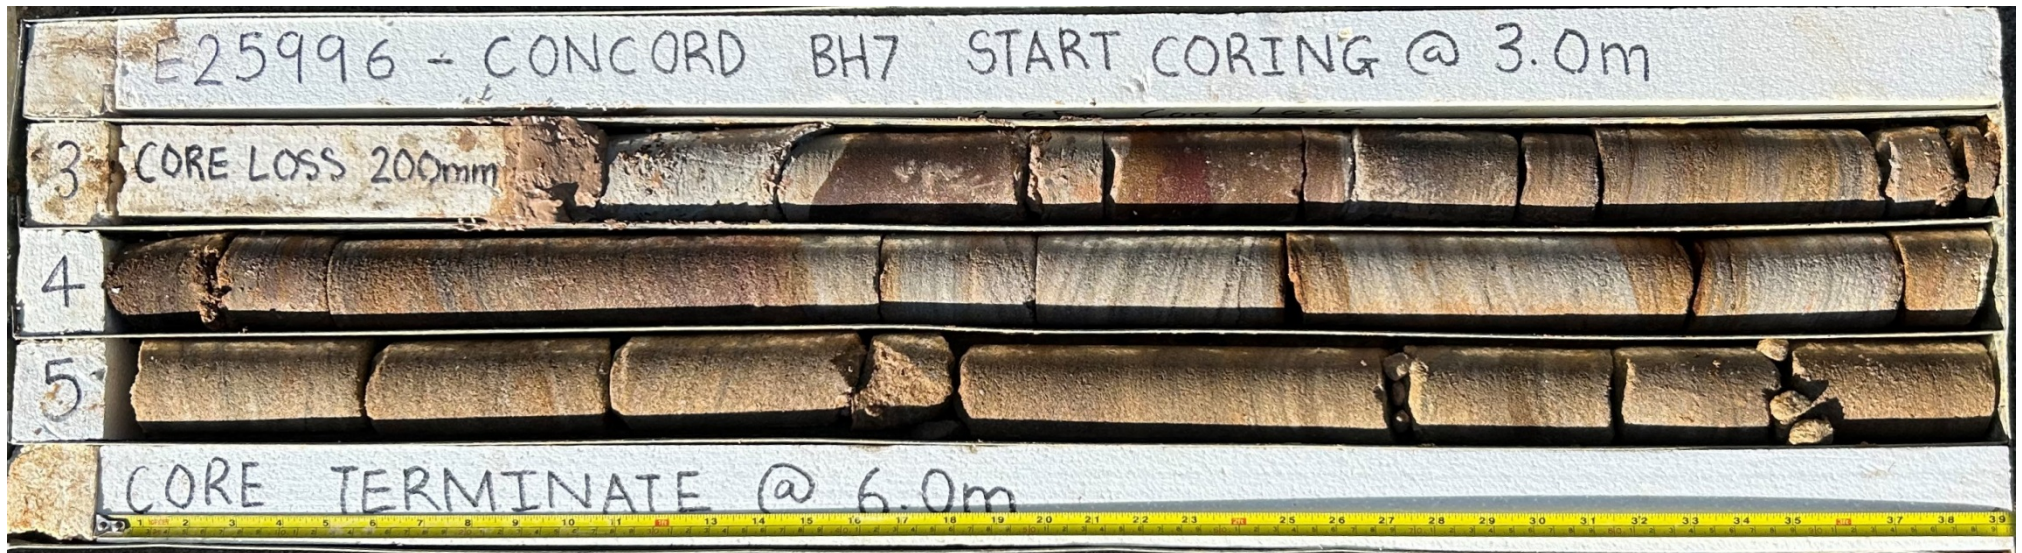
# CORE PHOTOGRAPH OF BOREHOLE: BH7

<b>Project</b>	Proposed Redevelopment	<b>Depth Range</b>	3.0m to 6.0m BEGL	
<b>Location</b>	1H Hospital Road, Concord West, NSW	<b>Contractor</b>	Geosense Drilling Engineers Pty Ltd	
<b>Position</b>	See Figure 2	<b>Drill Rig</b>	Comacchio GEO 205	
<b>Job No.</b>	E25669.G03	<b>Logged</b>	JO	<b>Date</b> 24 / 05 / 2023
<b>Client</b>	Lipman Pty Ltd	<b>Checked</b>	KX	<b>Date</b> 16 / 06 / 2023
		<b>Surface RL</b>	≈ -	
		<b>Inclination</b>	-90°	
		<b>Box</b>	1 of 1

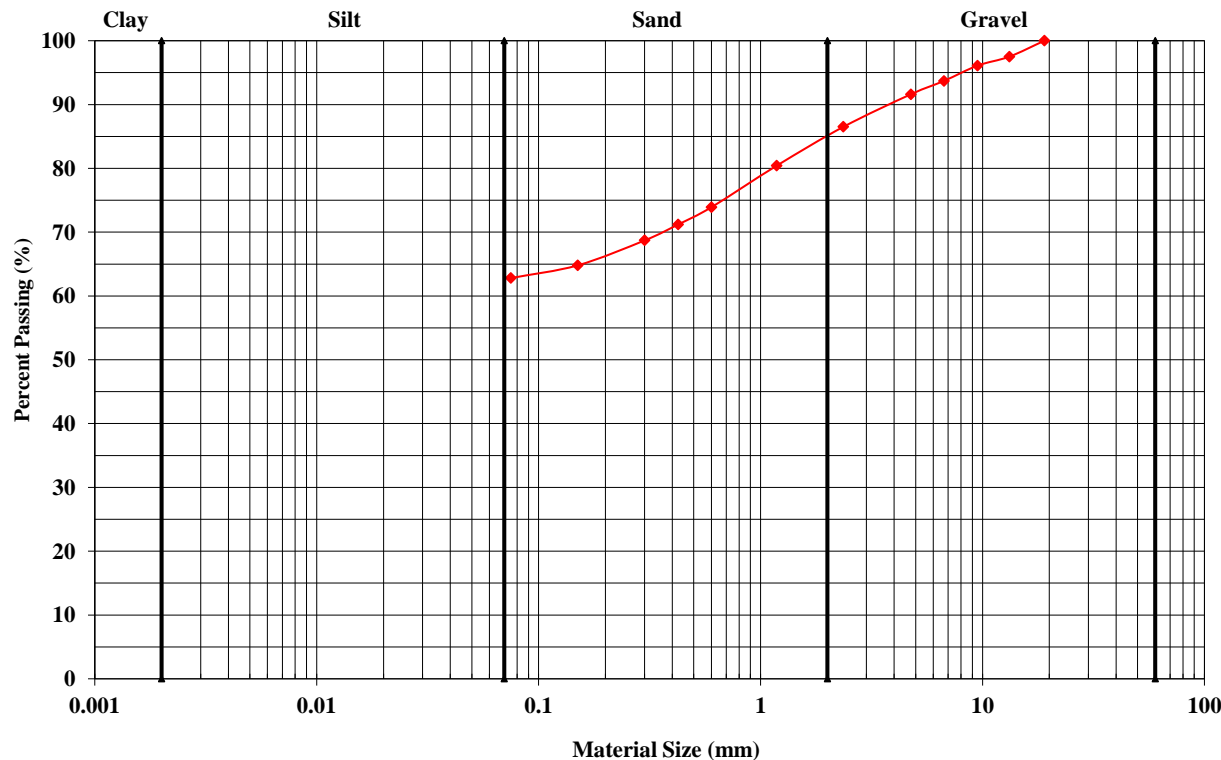
Sieve Size (mm)	Percent Passing (%)
19.0	100.0
13.2	97.5
9.5	96.1
6.7	93.7
4.75	91.6
2.36	86.5
1.18	80.4
0.60	73.9
0.425	71.2
0.30	68.7
0.15	64.8
0.075	62.8

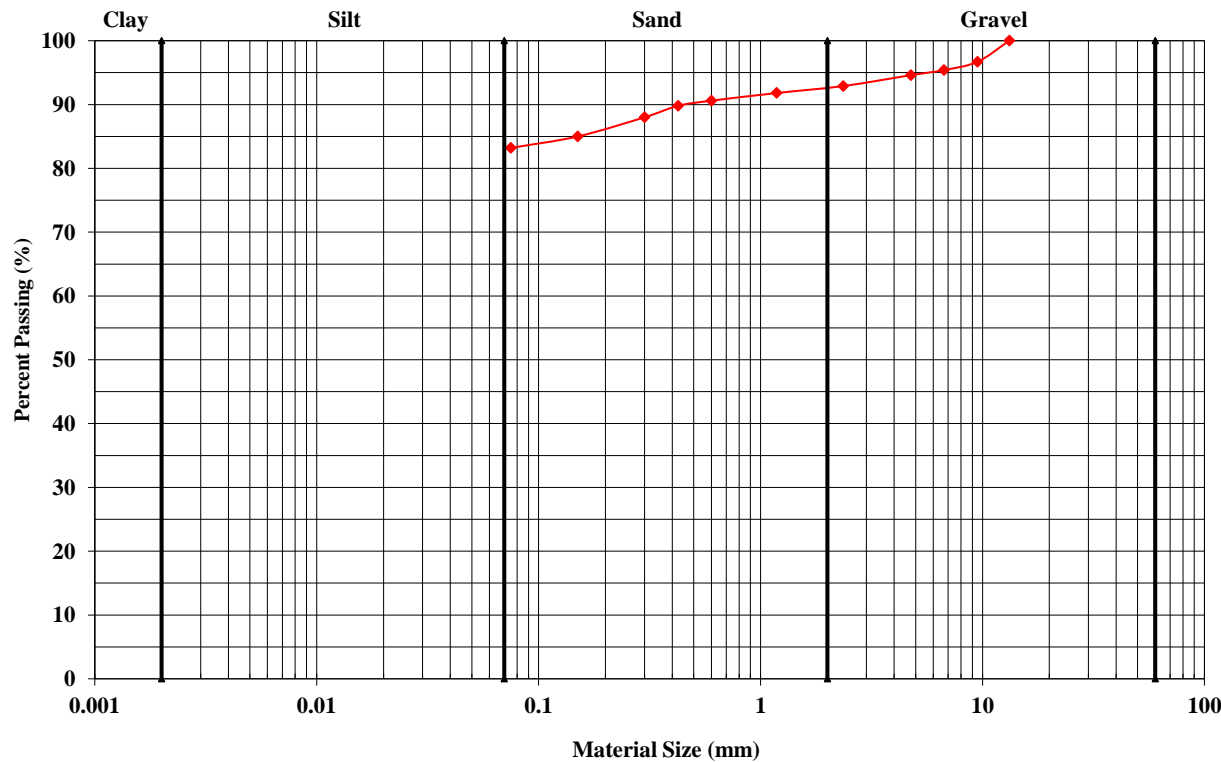
Sieve Size (mm)	Percent Passing (%)
13.2	100.0
9.5	96.7
6.7	95.4
4.75	94.6
2.36	92.9
1.18	91.8
0.60	90.6
0.425	89.8
0.30	88.0
0.15	85.0
0.075	83.2
