St George Hospital Stage 3 - REF Planning Approval Pathway - Refurbishment & Additional Scope

Geotechnical Desktop Report

Reference: SYDGE311083_AP

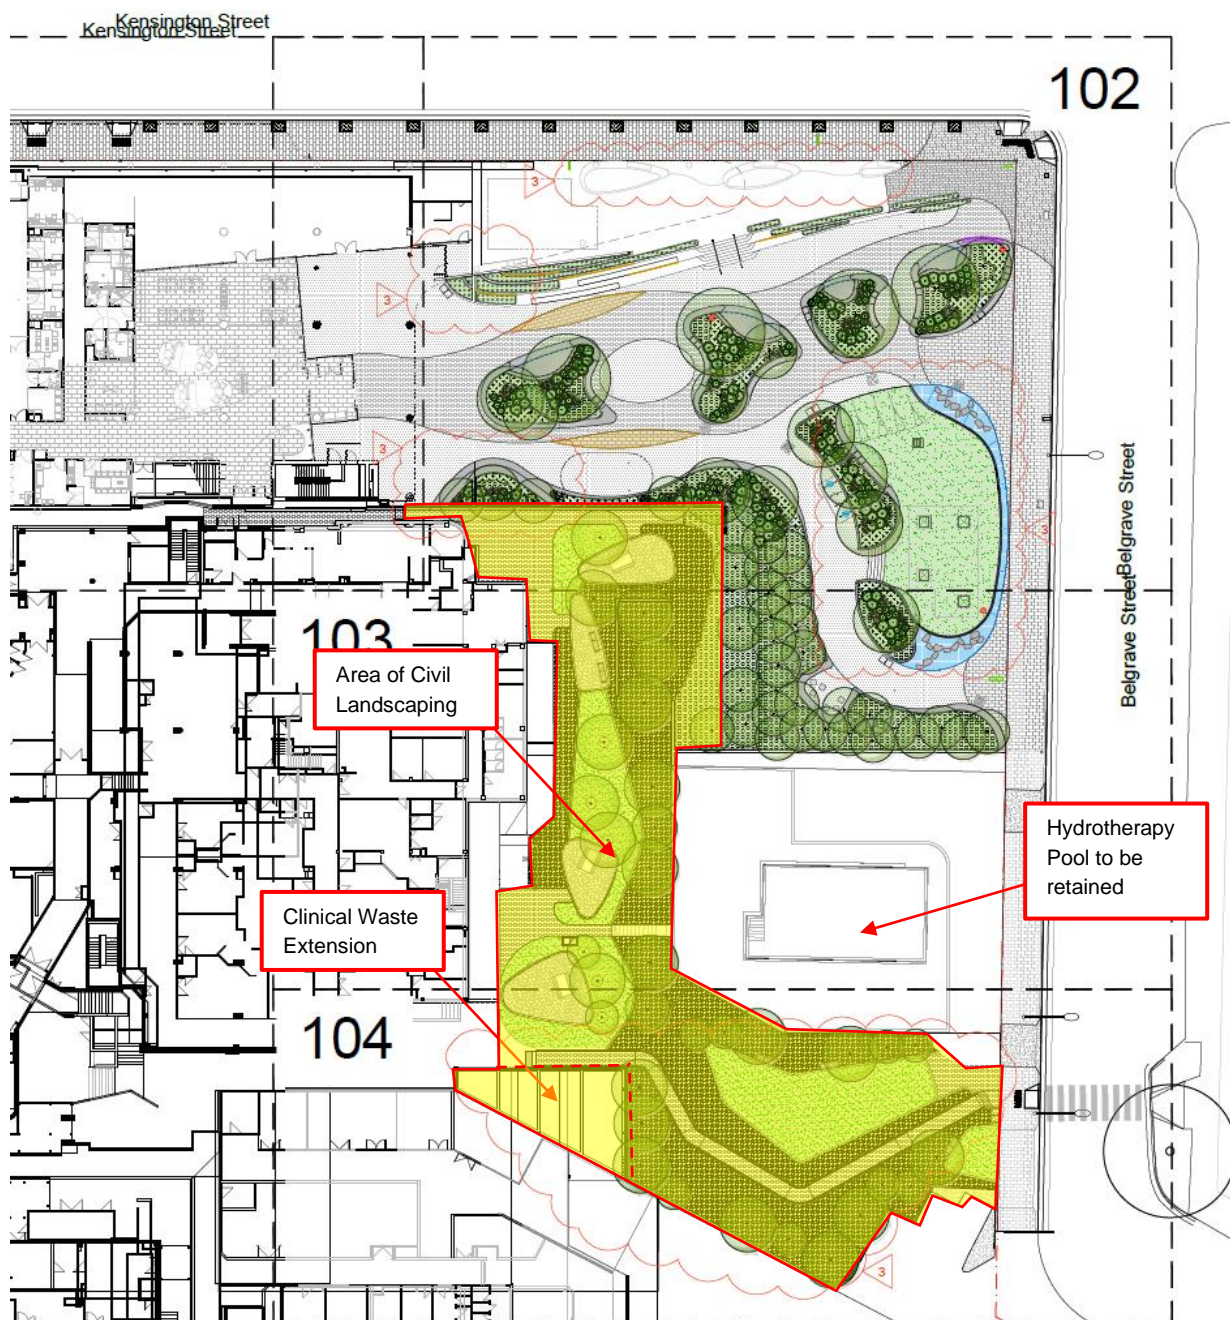
Figure 2. Proposed civil landscaping and Waste extension building in northern area (extract from Site Image Landscape Plan SGHS3-LA-DG-100)

The approximate location and areas of these works are illustrated in Figure 1 and Figure 2 overleaf.

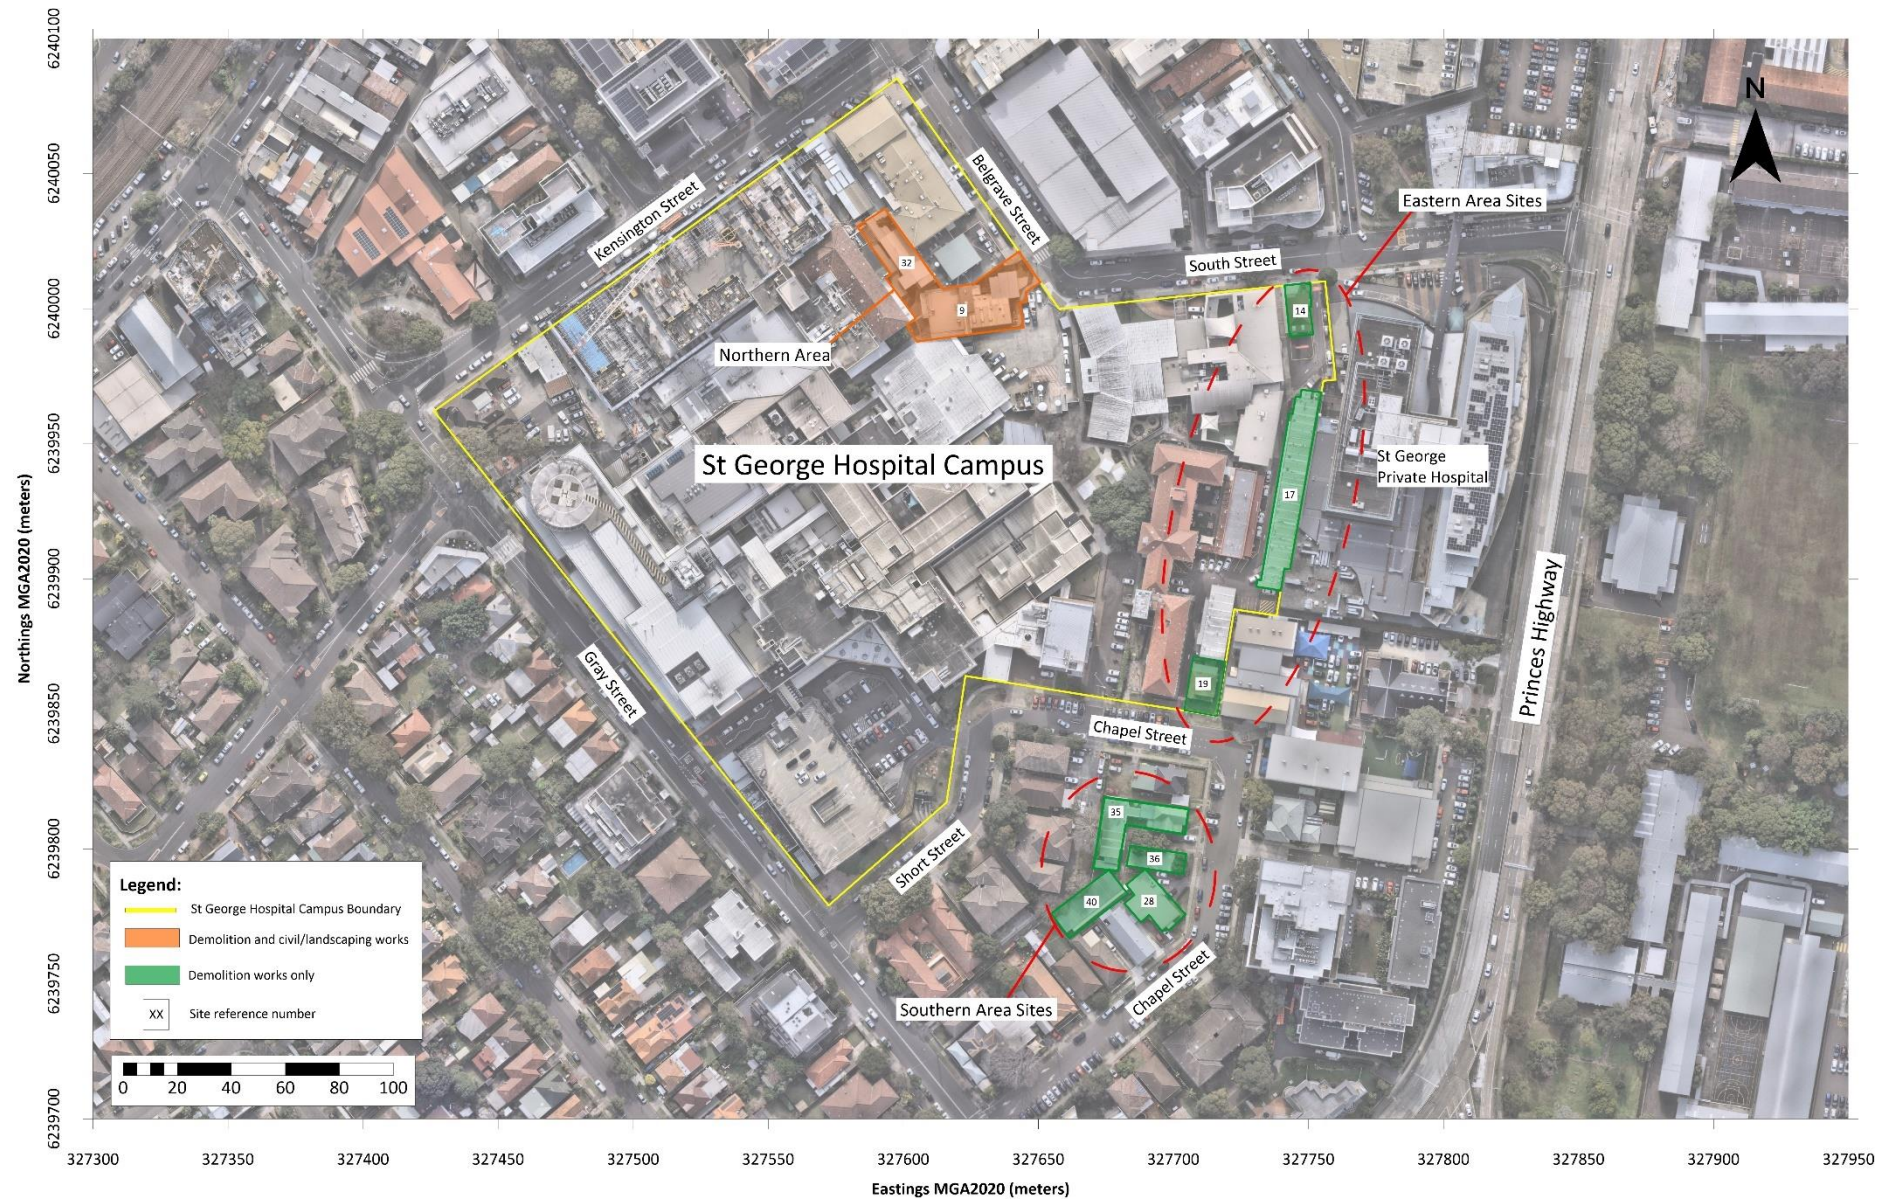
Figure 3. Aerial image of St George Hospital site with site areas (Extract from Nearmap, dated 22 July 2024)

Figure 3 overleaf shows the locations of these Areas on a recent aerial image of the site from July 2024.

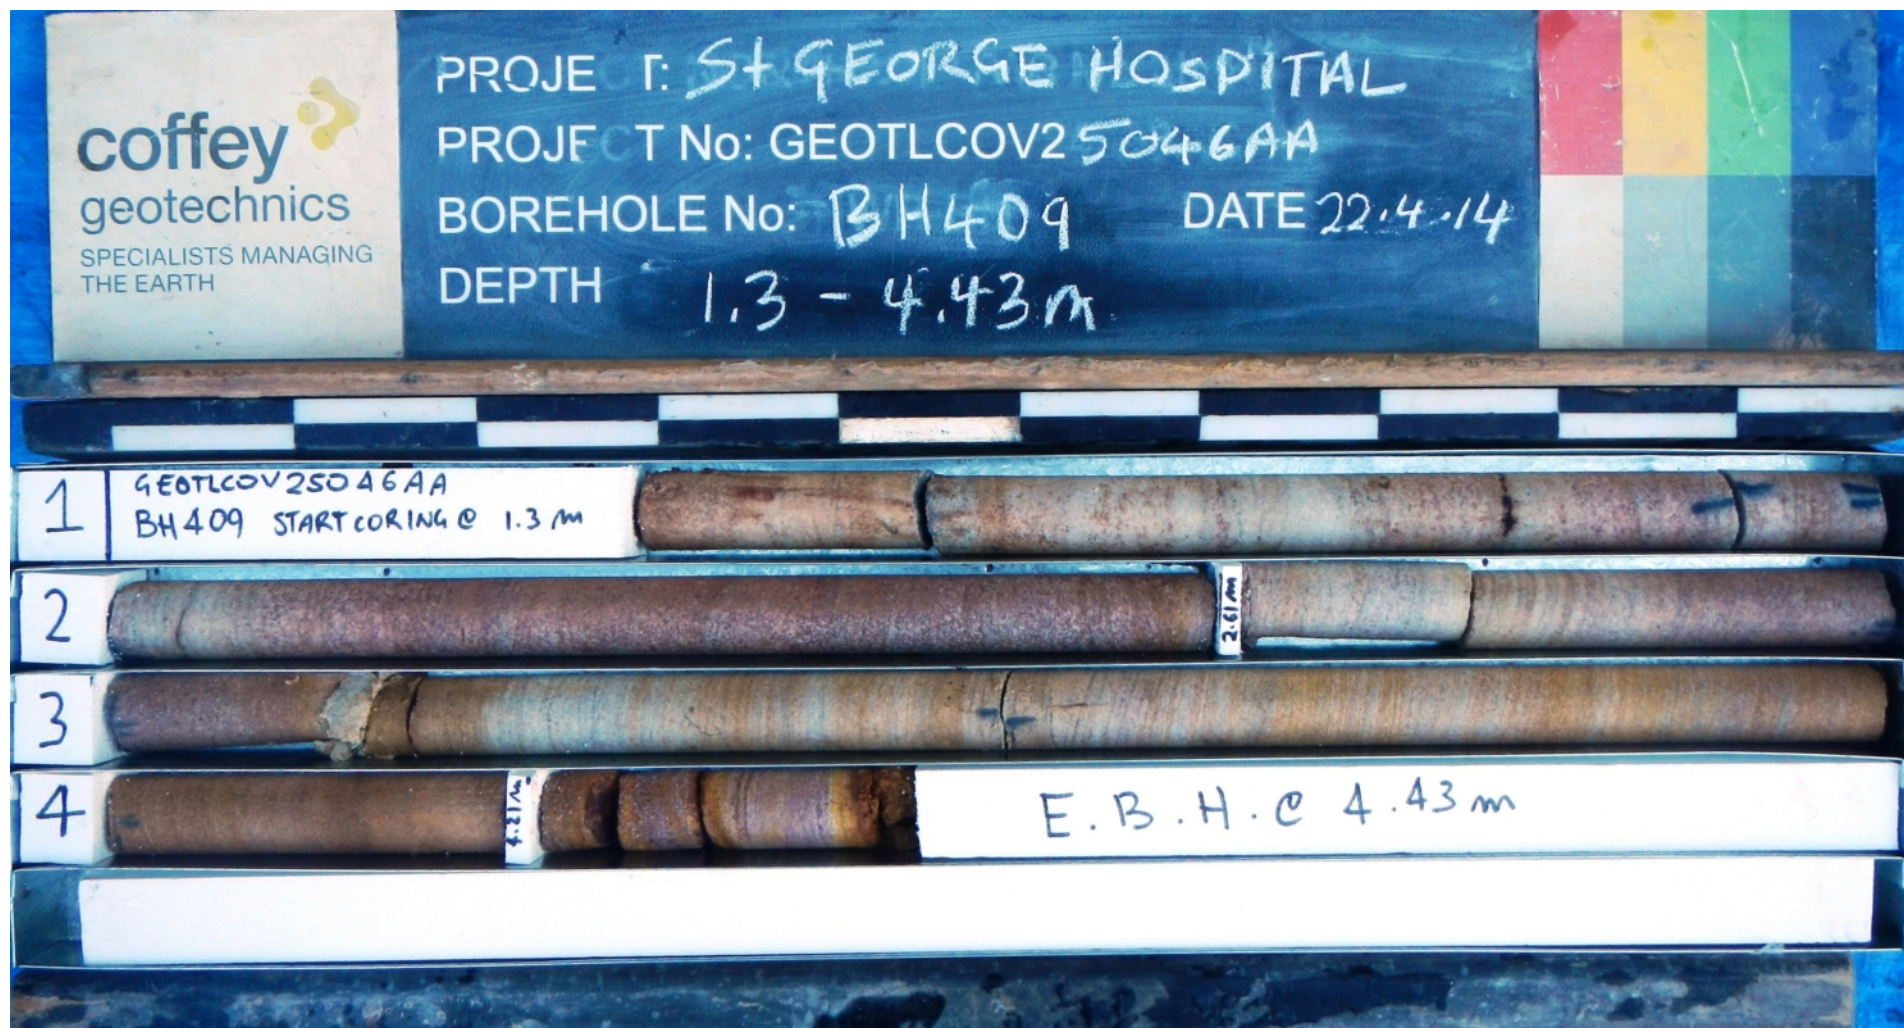
PointID : BH409 Depth Range: 1.30 - 4.43 m

drawn	SP		client:	Health Infrastructure		
approved	AJH		project:	St George Hospital Site Investigation St George Hospital		
date	25/06/2014		title:	CORE PHOTOGRAPH BH409		
scale	N.T.S.		project no:	GEOTLCOV25046AA	fig no:	FIGURE 1
original size	A4		rev:

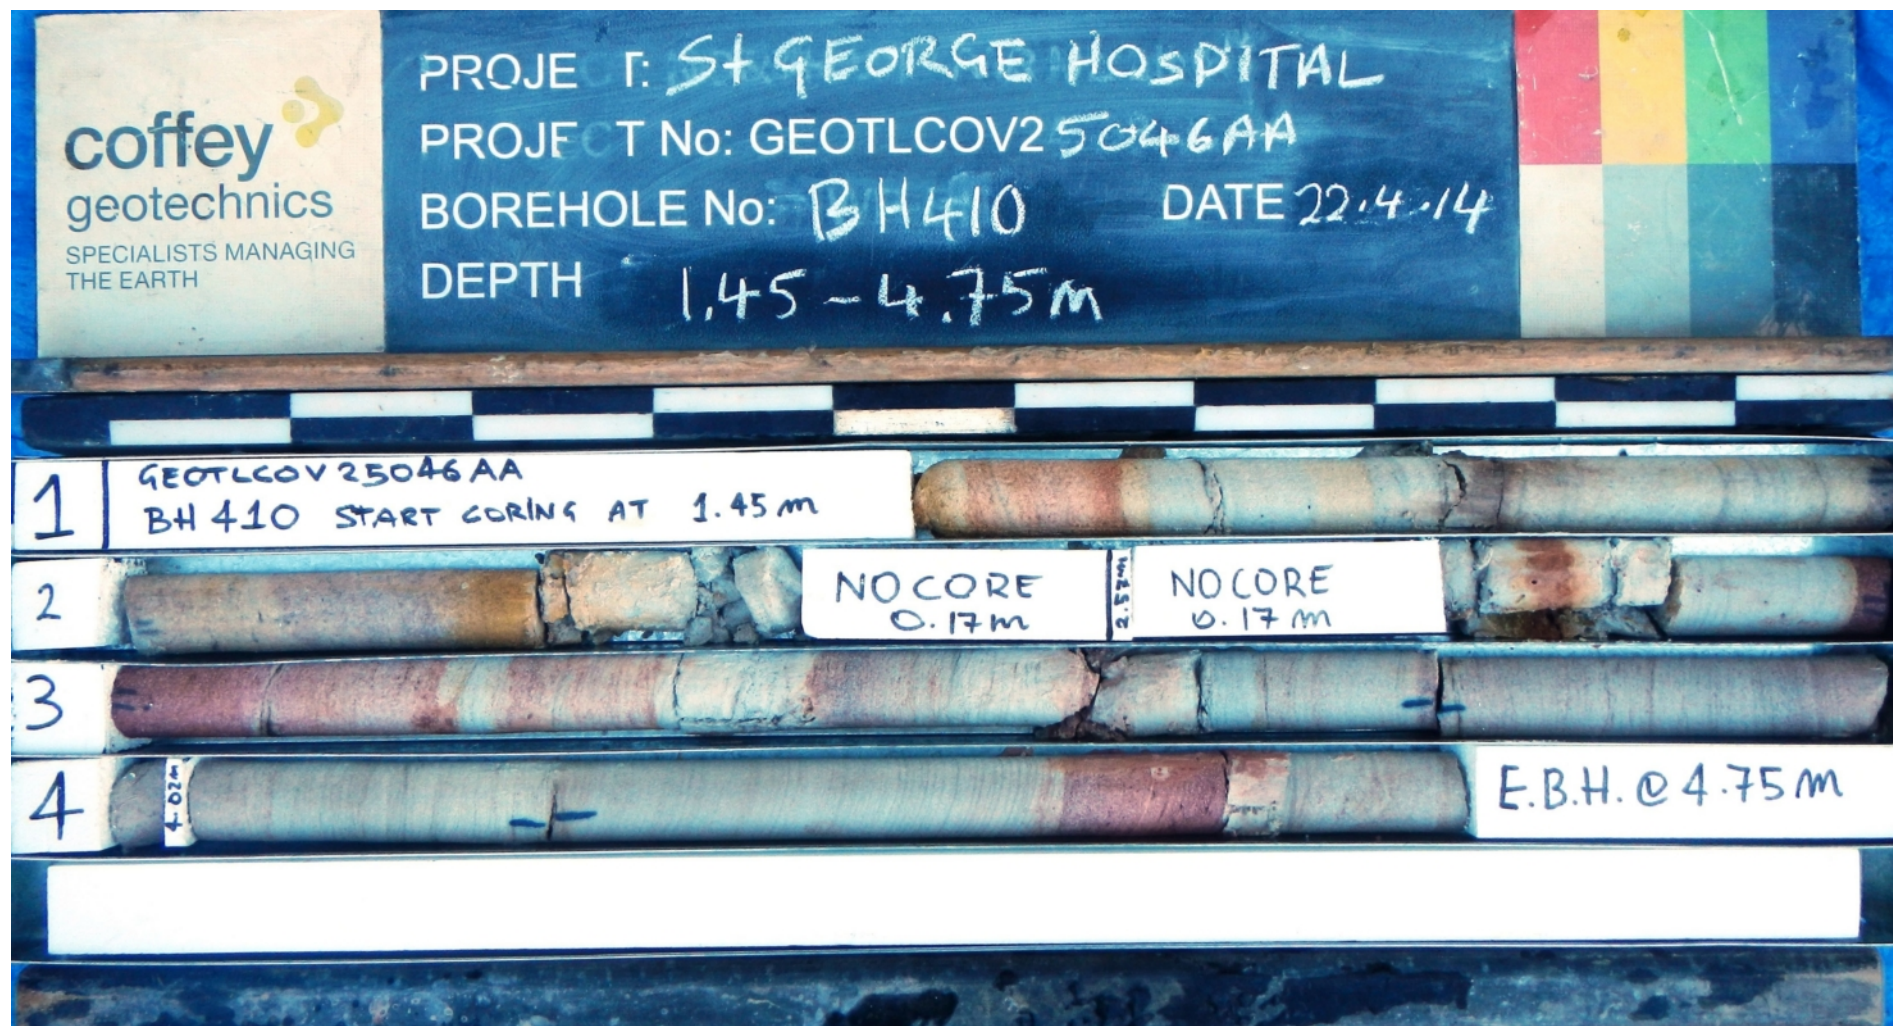
PointID : BH410 Depth Range: 1.45 - 4.75 m

client:	Health Infrastructure		
approved	AJH		project:	St George Hospital Site Investigation St George Hospital		
date	25/06/2014		title:	CORE PHOTOGRAPH BH410		
scale	N.T.S.		project no:	GEOTLCOV25046AA	fig no:	FIGURE 1
original size	A4		rev:

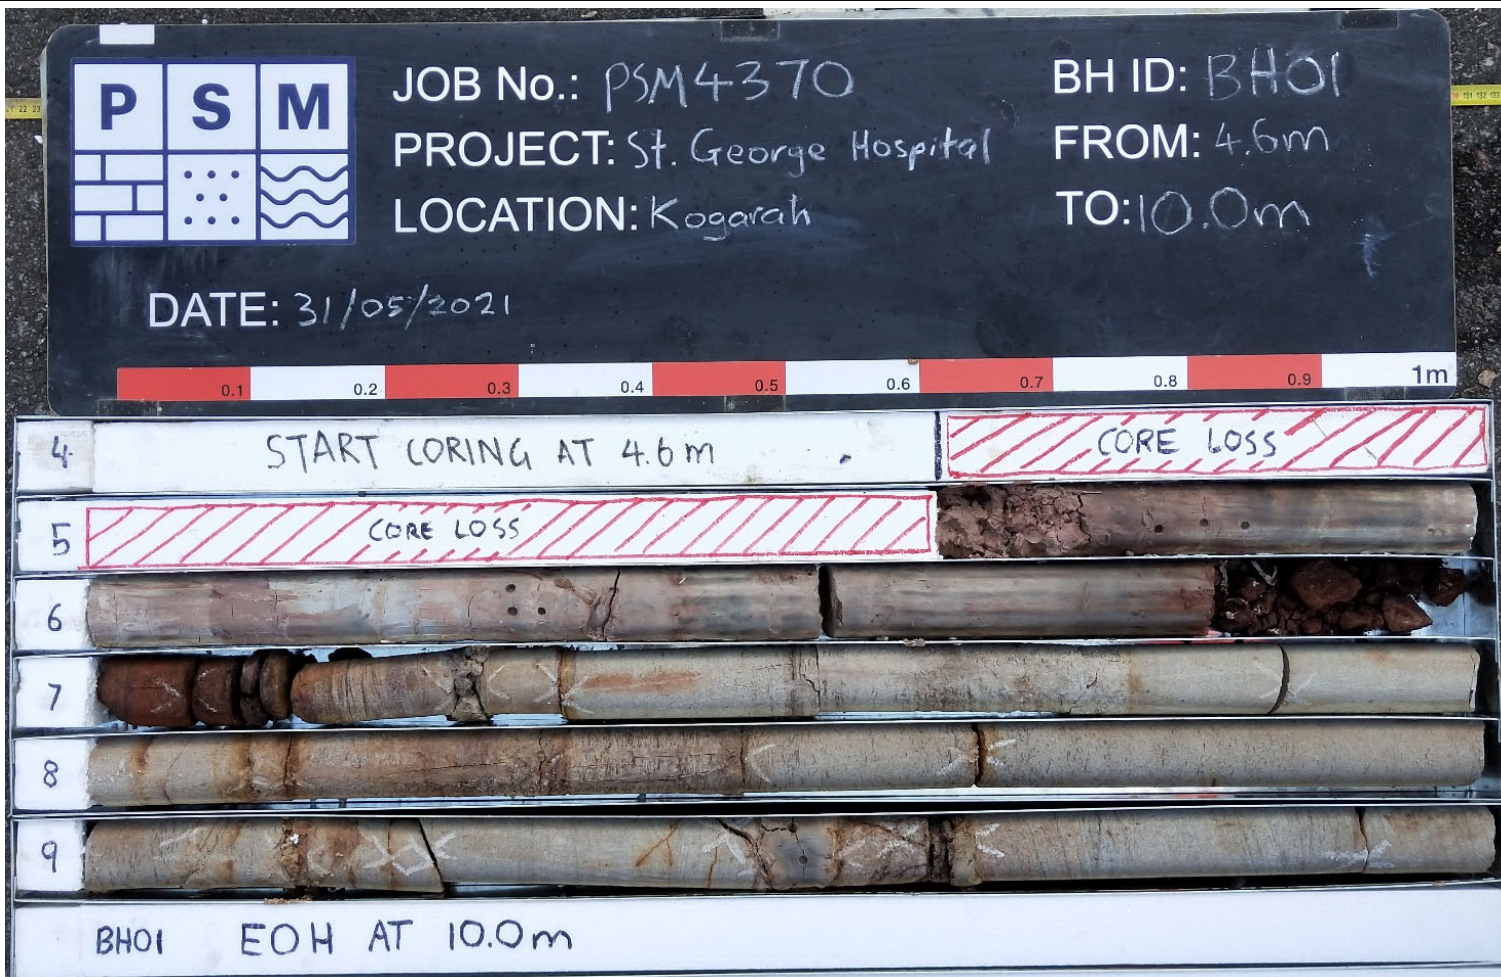
JBS&G St. George Hospital Kogarah, NSW STAGE 3 GEOTECHNICAL INVESTIGATION CORE PHOTOGRAPHY - BH01	
PSM4370-003L	Appendix B

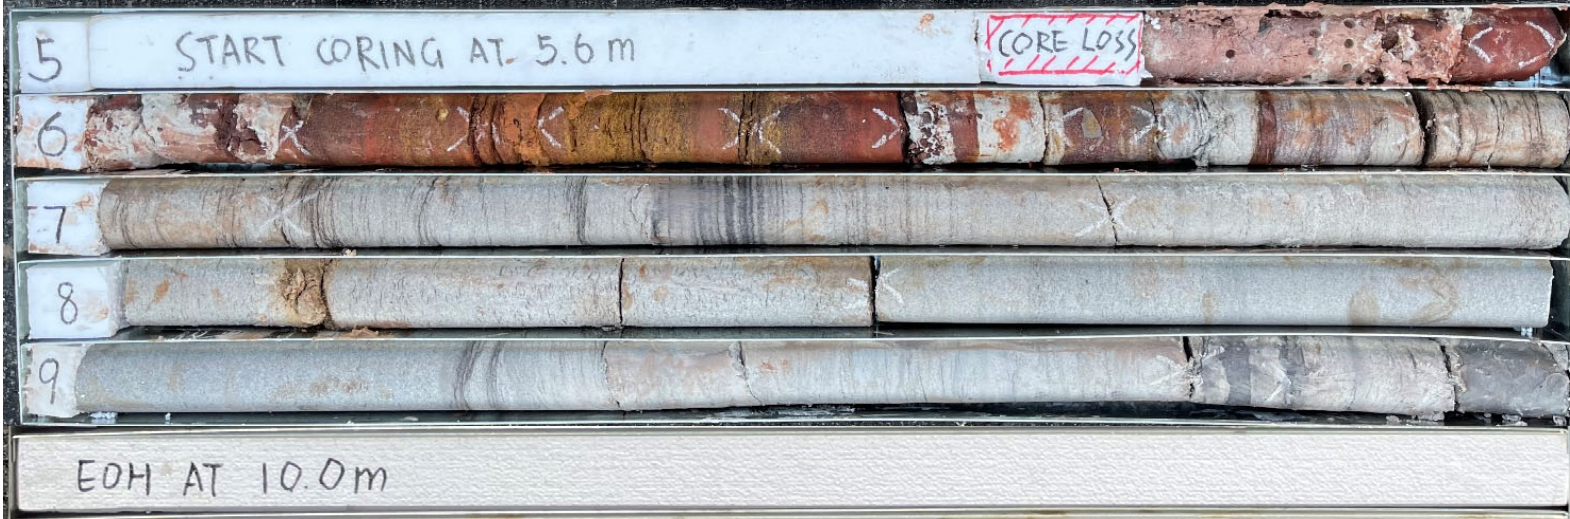
STAGE 3 GEOTECHNICAL INVESTIGATION
CORE PHOTOGRAPHY - BH02

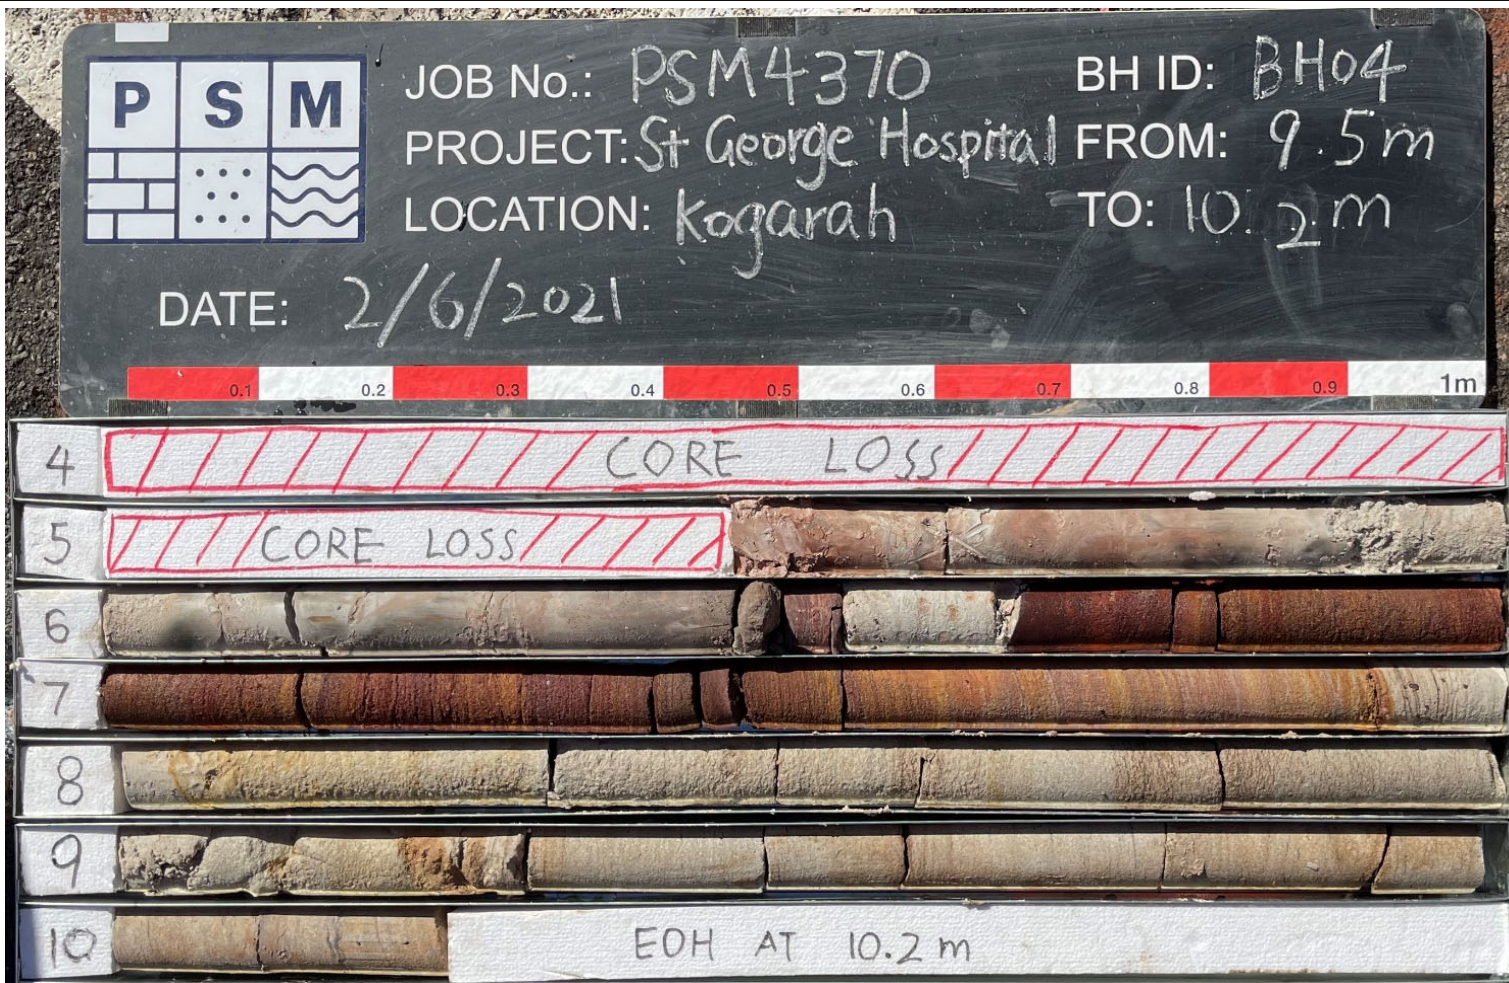
JBS&G
St. George Hospital
Kogarah, NSW
STAGE 3 GEOTECHNICAL INVESTIGATION
CORE PHOTOGRAPHY - BH04
