GEOTECHNICAL INVESTIGATION BATHURST HOSPITAL REDEVELOPMENT 361-365 HOWICK ST, WEST BATHURST NSW 2795 Prepared for HEALTH INFRASTRUCTURE Prepared by RCA AUSTRALIA RCA ref 16547-202/4 OCTOBER 2024

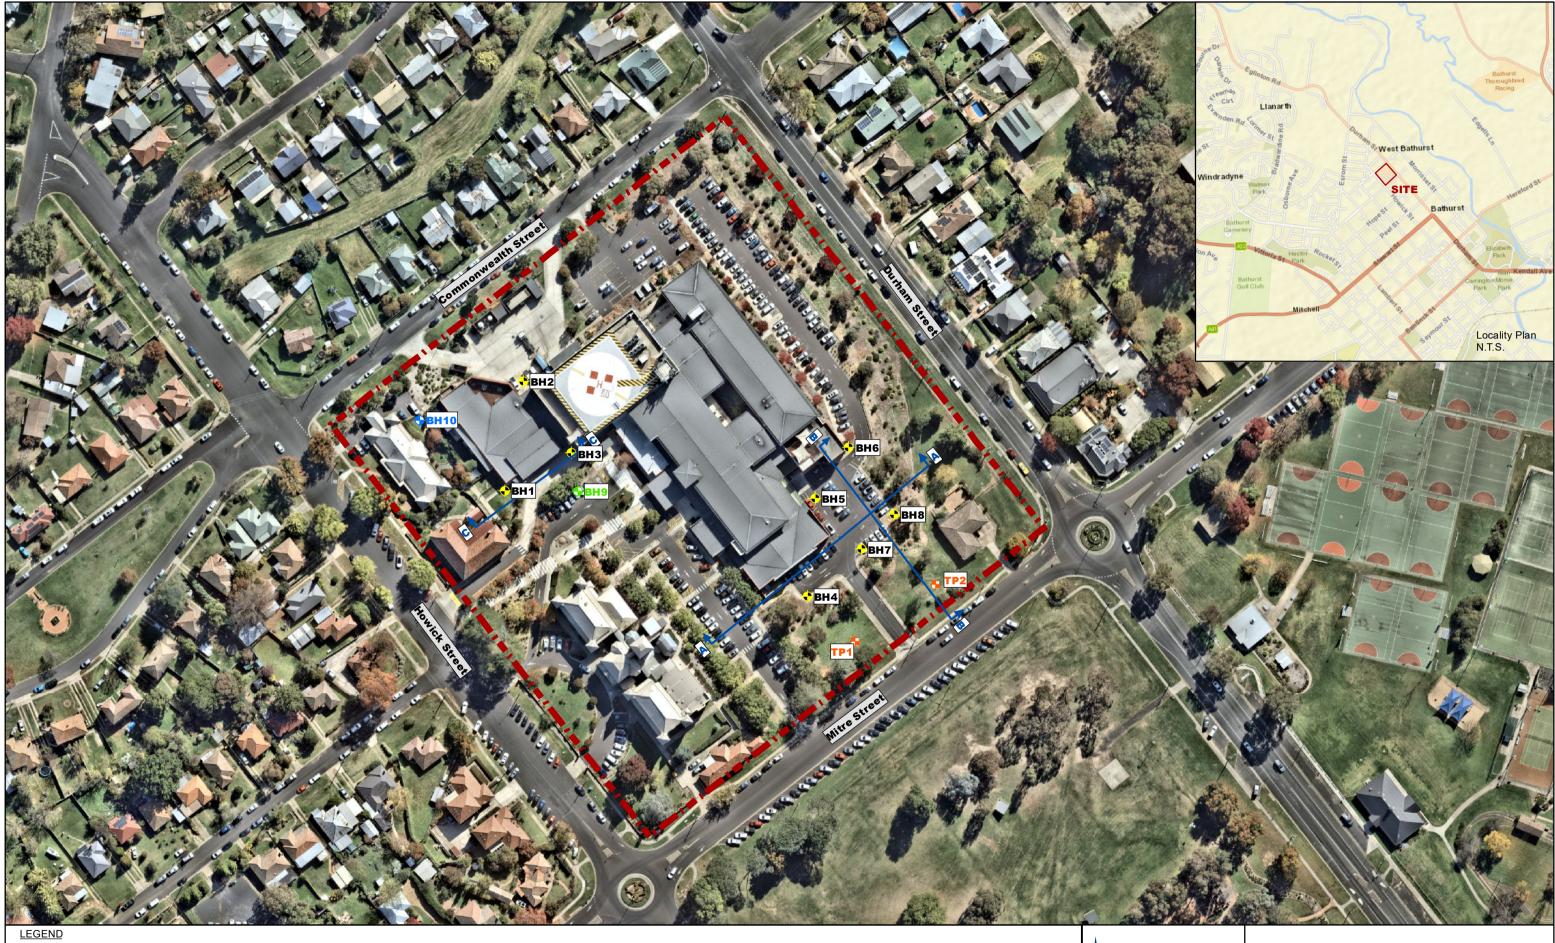
#### SITE AND TEST LOCATION PLAN BATHURST HOSPITAL BATHURST

- Approximate site boundary
- Geotechnical section
- Approximate test pit location
- Approximate borehole location
- Approximate hand auger location
- Approximate 300mm dia.pavement borehole location

- Drawing 1 Site and Test Location Plan
  - Drawing 2 Geotechnical Section A-A
  - Drawing 3 Geotechnical Section B-B
  - Drawing 4 Geotechnical Section C-C

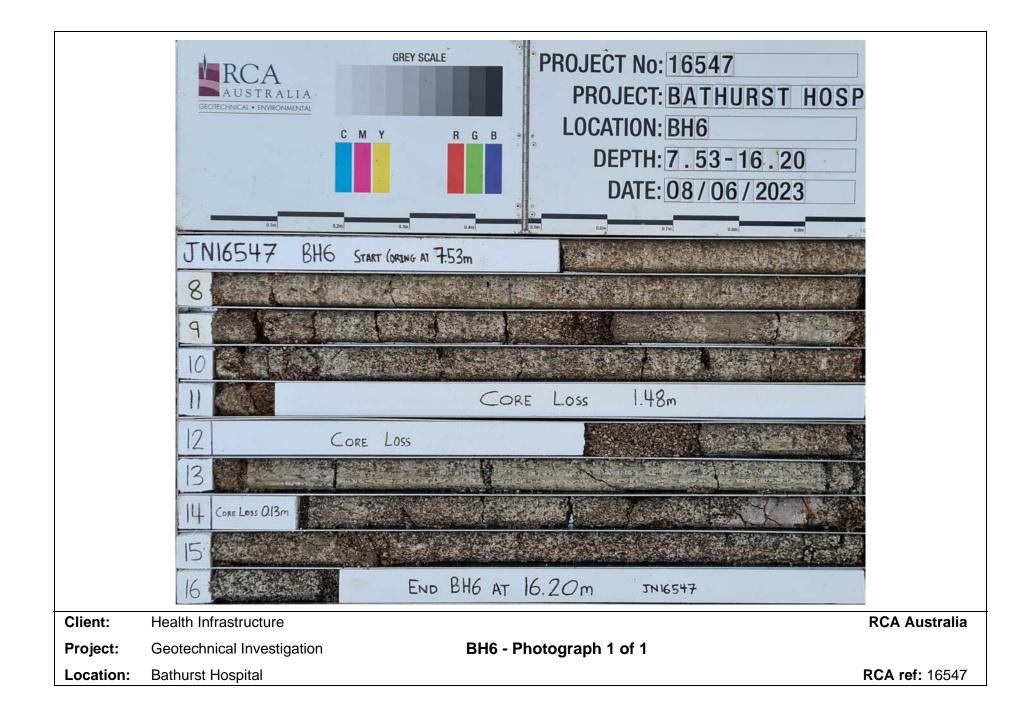
Bor	ehol	e Inf	orr	matic	n		Field Material Description
METHOD	WATER LOSS	CORE	RQD		RL (m AHD)	DEPTH (m)	GRAPHIC LOG	DESCRIPTION (SOIL NAME; plasticity/grain size, colour, particle shape, secondary components, minor constituents) (ROCK NAME; grain size, colour, minor constituents)       O RUE (SOUL (ROCK NAME; grain size, colour, minor constituents)       INFERRED (ROCK NAME; grain size, grain size, colour, minor constituents)       AVERAGE DEFECT (SOUL (SOUL) (SOUL (SOUL) (SO
				66	-  94.5	- - - 5.40 -	· + + · + + · + + · + + · + +	GRANITE, coarse grained, red-brown, crystalline XW
				66	- - 54.0	- 5.5 - -	+ + + + + + + + + + + + + + + +	GRANITE, coarse grained, pale grey, dark grey and orange-brown, crystalline texture, indistinct fabric
		100	73		- - - - - -	- 6.0  	· + · + + · + + · + + · + +	
oy Datgel					-	- - 6.5 -	+ + + + + + + + + + + + + +	dark brown zone from 6.6m to 6.7m
u4/U8/2/23 13:13 Froduced by gin I Froressonal, Developed by Uarge NMLC				66	i3.0 - - -	- - - 7.0 -	· + + + + + + + + + + + + + + + + + + +	dark brown zone from 6.6m to 6.7m

66	;2.5 - -	- - - 7.5 -	+ + + + + + + + + + + + + +	
				66	- 2.0 - -	- - 8.0	· + + + · + + · + + · + + · + +	becoming white, dark grey and brown at 7.7m
		100	97		- 51.5 -	- - - 8.5	+ + + + + + + + + + + + + + + +	
סואומאורטמרד רמל אמא ממעבד המערומבר רמל ומאו-דמפטימר אי				66	- 51.0 -	- - - 9.0	- + + - + + - + + - + + - + + - + + - + +	
				66	- - 	- - - - 9.5	+ + + + + + + + + + + + + + + + + +	CS with fresh granite corestone fragments
				66	- - 60.0 -	-	+ + + + + + + + + + + + + + + +	
e'	.00	GEI	' D: R	С				CORED BOREHOLE BH7 TERMINATED AT 10.00 m CHECKED: MA DATE: 04/08/2023
