REPORT TO
HEALTH INFRASTRUCTURE

ON
HAZARDOUS BUILDING MATERIALS SURVEY

FOR
MOREE HOSPITAL REDEVELOPMENT

AT
MOREE HOSPITAL, ALICE STREET, MOREE, NSW

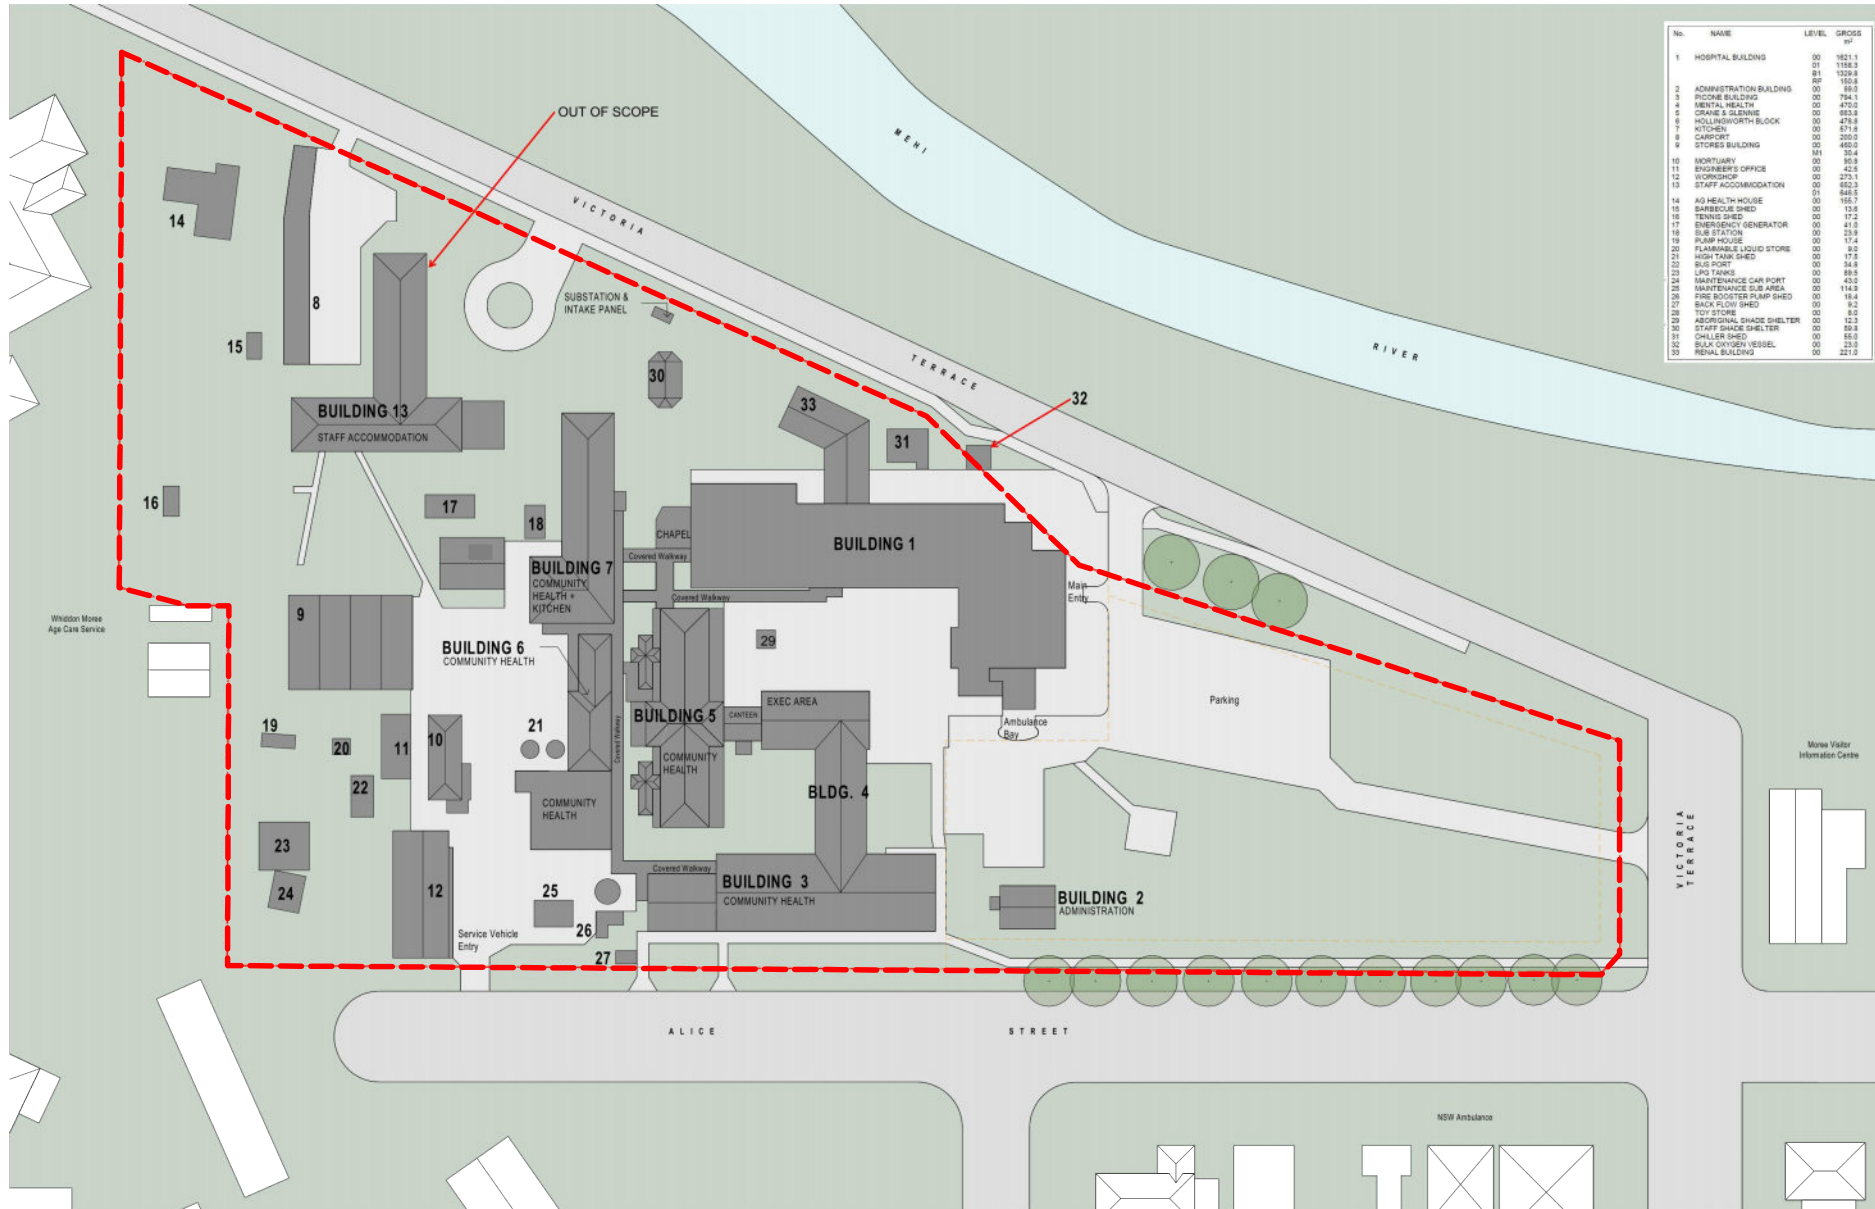
BUILDINGS/STRUCTURES INCLUDED IN SURVEY

MR01	Hospital Building
MR02	Administration Building
MR03	Picone Building
MR04	Mental Health
MR05	Crane & Glennie
MR06	Hollingworth Block
MR07	Kitchen
MR08	Carport
MR09	Stores Building
MR10	Mortuary
MR11	Engineer's Office
MR12	Workshop
MR14	Ag Health House
MR15	Barbeque Shed
MR16	Tennis Shed
MR17	Emergency Generator
MR18	Substation
MR19	Pump House
MR20	Flammable Liquid Store
MR21	High Tank Shed
MR22	Bus Port
MR23	LPG Tanks
MR24	Maintenance Car Port
MR25	Maintenance Sub Area
MR26	Fire Booster Pump Shed
MR27	Back Flow Shed
MR29	Aboriginal Shade Shelter
MR30	Staff Shade Shelter
MR31	Chiller Shed
MR32	Bulk Oxygen Vessel

Health Infrastructure ('the client') commissioned JK Environments (JKE) to undertake a hazardous building materials (HAZMAT) survey for the proposed Moree Hospital Redevelopment at Moree Hospital, Alice Street, Moree, NSW ('The Site'). The Site location is shown on Figure 1 and the survey was confined to The Site buildings/structures as shown on Figure 2 attached in the appendices.

- A detailed inspection of the existing building and structures shown on Figure 2;
- Review of existing HAZMAT register information;
- Sampling of representative materials in accordance with the survey criteria and inspection procedure outlined in Section 4;
- Documentation of inspection finds including sample location, material type, condition, friability, photographic evidence and site location;
- Laboratory analysis of selected representative materials; and
- Preparation of a report presenting the results of the HAZMAT survey and a risk assessment of each HAZMAT identified, and a HAZMAT register per material type (and building), for the site.
