REVIEW OF ENVIRONMENTAL FACTORS (REF) FORESHORE PROTECTION AND ENHANCEMENT LAKE CONJOLA FORESHORE LOTS 486 AND 487 DP 861543

LAKE CONJOLA FORESHORE CONCEPT DESIGNS

Connecting Community to Shoalhaven Waterways - Bank Stabilisation Projects – Options Assessment

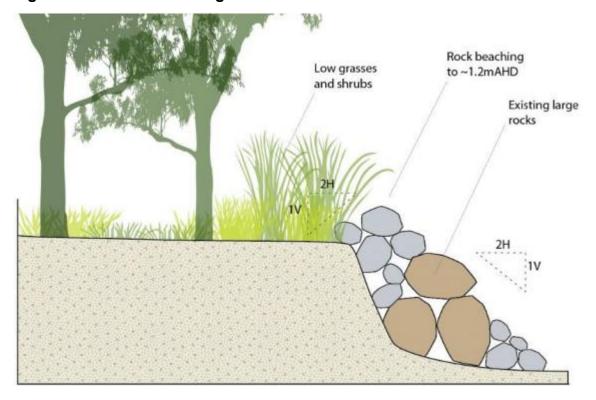
Figure 3 Rock Beaching

The existing rock beaching consists of one to two rows of large rocks, 500 - 700 mm diameter on the bank face (Figure 3 below). The existing rock beaching is in poor condition and the rocks are providing limited protection to the bank. The large rock beaching would be supplemented with smaller, graded rocks to form an interlocking rock riprap. Rock beaching should be formed from graded quarry rock with a median rock size (D50) of approximately 350mm. The intent of the smaller rocks is to provide more complete protection to the foreshore bank by filling the large gaps in the existing rocks. Furthermore, the smaller rock arrangement will be flexible enough to accommodate minor changes in the foreshore geometry that are expected to occur over time. The supplemented rock beaching arrangement is also expected to improve upon the ad hoc and uneven appearance of the existing arrangement and provide a safer and more consistent surface for tourist park users. (Water Technology 2025).

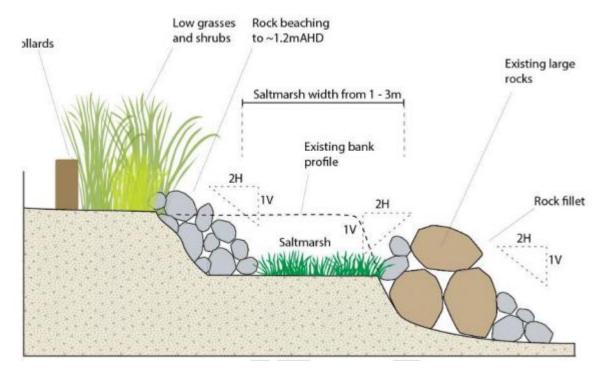
Figure 4 Saltmarsh Bench

This involves the formation of saltmarsh benches in targeted locations along the length of the foreshore (Figure 4 below). A bench is formed by locally excavating the foreshore surface that will be periodically inundated with tides (e.g. during spring tides) to allow the planting and establishment of saltmarsh comprising locally occurring species (e.g. Sea Rush *Juncus krausii*, Bare Twig-rush *Baumea juncea*, Saltwater Couch *Sporobobulus virginicus*) and mangroves. The saltmarsh bench is to be protected at the lakeward side by a low rock fillet and the landward bank is to be armoured with rock beaching. The intent of the saltmarsh bench is to provide a stable buffer between the lake and the tourist park that will accommodate minor changes in the foreshore geometry that are expected to occur over time. Furthermore, there are many expected co-benefits of the saltmarsh benches including creation of marine habitat, filtering of stormwater runoff and providing the opportunity for education through interpretive signage.

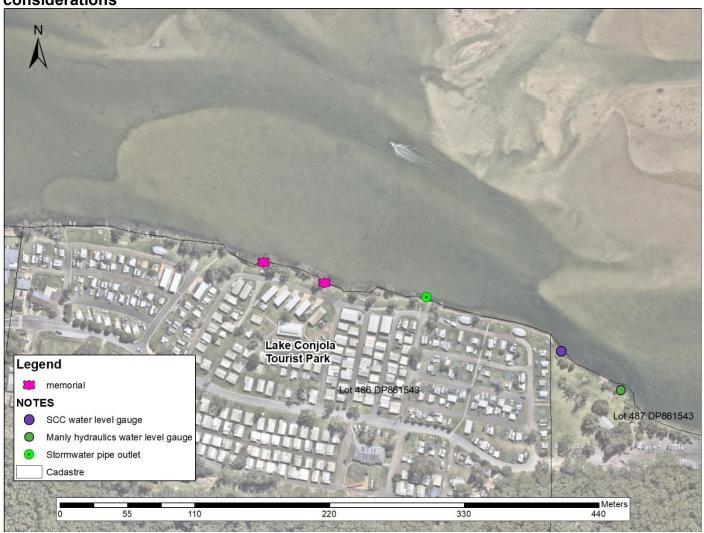
Figure 8 Infrastructure and other features that require protection or other considerations

Along the foreshore a number of infrastructure features will require protection during the proposed activity including water level gauges and an existing stormwater outlet pipe (Figure 8 below and photos in Section 2.5).

A couple of memorial plaques have also been installed on rocks forming the existing revetment wall (Figure 8 below and photos in Section 2.5). Although these plaques have been installed without approval it is <u>recommended</u> that they be retained or relocated if possible. This may avoid emotive reactions from owners/installers of the plaque.

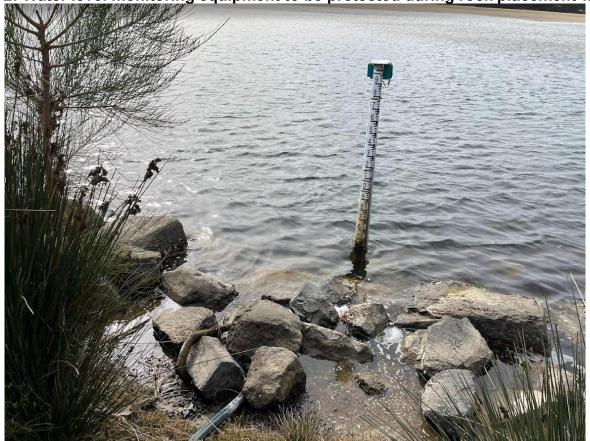
Photo 2: Water level monitoring equipment to be protected during rock placement works.

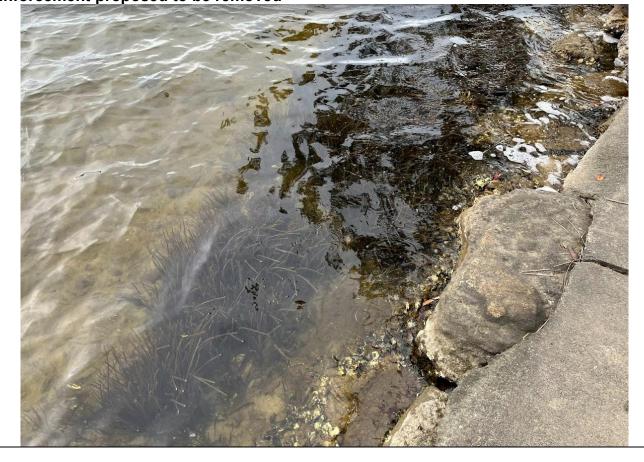
Photo 5: Zostera at the toe of the existing revetment. Also showing the concrete reinforcement proposed to be removed

The supplementary rock revetment works would likely impact a thin strip (0.5 metres) of seagrass (*Zostera spp.*) of varying densities where it currently occurs at the base of the existing rock revetment in patches over a length of approximately 170 metres (Figure 6 p.15). The proposed activity may also, inadvertently, harm a single mangrove seedling currently growing within the existing rock revetment (Figure 6 p.15). Both the Eelgrass and Mangrove are "protected marine vegetation" regulated under the NSW *Fisheries Management Act 1994*. A Fisheries Permit would be required prior to commencement of works (refer to Section 4.3 of this REF for further information).

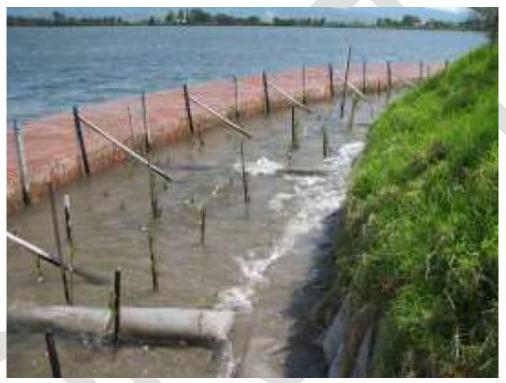
Figure 2-1 Sandbags and fencing used to shelter mangrove seedlings along Shoalhaven River (Source: Shoalhaven Riverwatch, 2013)

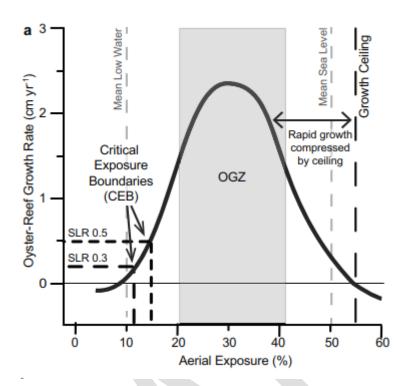
Figure 2-2 Oyster Reef Optimal Growth Zone (OGZ) at exposures between 20-40% (Source: Ridge et al. 2015)

There are several key considerations for site selection for adopting oyster reef as a form of foreshore protection. These include hard substrate, presence of shells on the bed, water quality (including temperature) and the location setting (e.g. slope, tidal range, water depth). The latter has a direct impact of the optimal growth conditions of the oyster reefs. Specifically, the percentage (%) time the reef is exposed (above water) is a key consideration for the successful implementation (Figure 2-2).

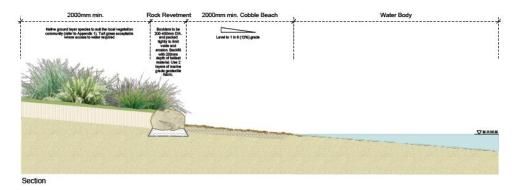
Figure 2-3 Concept design of rock revetment on foreshore bank with cobble beach extending into the water (Source: Lake Macquarie City Council, 2024)

Cobble beach can be an effective measure to restore foreshore slopes and act as a barrier to foreshore erosion. It typically comprises of small cobble-sized stones overlain on the existing foreshore. Cobble beach will be suitable for foreshore that has a gentle foreshore gradient and typically encounters low wave energy. If the foreshore bank has a steep escarpment, additional treatments, such as rock revetment can be used in conjunction with a cobble beach (Figure 2-3).

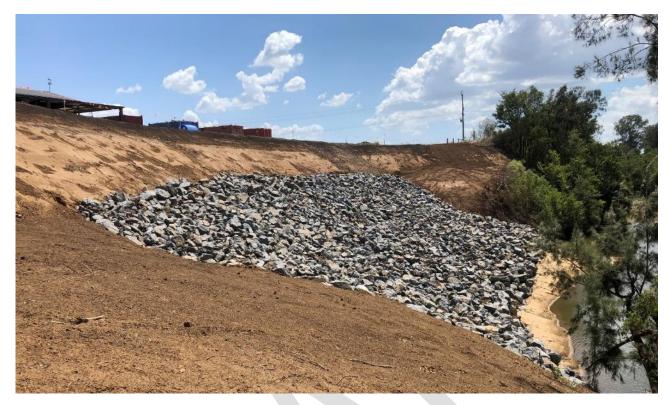
Figure 2-4 Rock Beaching, Logan River, Beaudesert.

Rock Beaching involves the placement of graded angular quarry rock against a stream or foreshore bank to remove the pressures of moving water against the material contained within the bank profile, and therefore protect it from most mechanisms of bank erosion (Figure 2-4). Revegetation behind the rock beaching is essential to the long-term stability of the site.

A foundation of rock is usually placed across or excavated into the riverbed to ensure that scour of the bed does not undermine the rock beaching. Rock is placed to a design thickness to ensure that it forms an interlocking mass and is not easily washed away. It is essential that the rock beaching is designed with a geometry and rock size appropriate to the expected hydraulic conditions. This will ensure that the structure remains stable under a range of expected flow conditions.

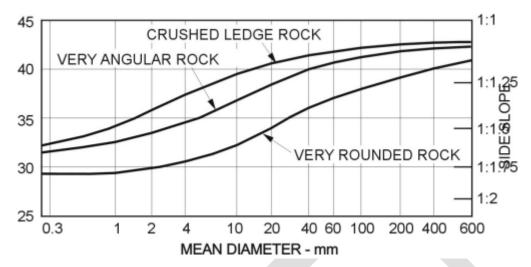
Figure 2-5 Angle of repose of dumped riprap. (Source: Simons and Senturk, 1977)

- Hydraulic calculations that inform the riprap design should account for the angle of repose and specific gravity associated with the rock being used. The program RipRap (Keller, 2005) allows for such parameters to be directly input.
- Where possible, rock should be tested to confirm these parameters.
- Rock should be graded and stockpiled on site prior to placement.
- Final placement of rock should be overseen by a suitably qualified and experienced engineer.

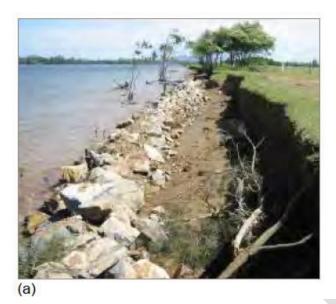
Figure 2-6 Rock fillet work allowing mangrove seedlings to establish (a) Hasting Rivers and (B) Dumaresq Island, Manning River (Source: AECOM, 2010)

Rock fillets are structures made of rocks placed along the edges of waterways, such as riverbanks or shorelines, to address erosion issues. They are designed to stabilise these areas by acting as barriers, dissipating the energy of waves or currents and preventing further erosion of the bank or shoreline. In addition to providing erosion control rock fillets encourage the deposition of sediments, which can help rebuild eroded areas. Critically, rock fillets also promote the growth of vegetation, such as mangroves or other riparian plants, which further stabilize the area and provide habitats for aquatic and terrestrial species. Figure 2-6 shows how placement of rock fillets in front of an eroding bank provides shelter for establishing mangroves.

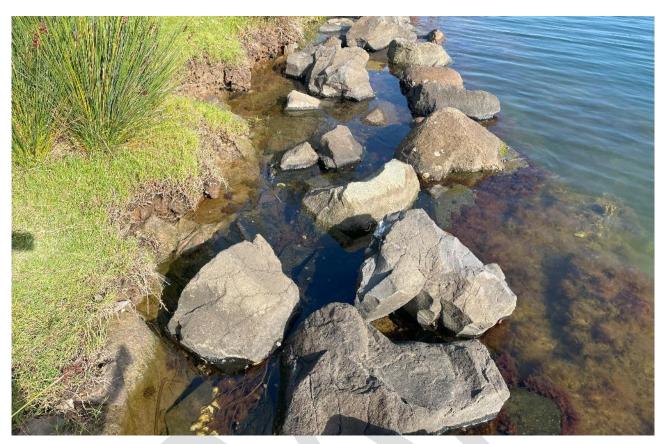
Figure 3-4 Ineffective Foreshore Rock Protection

The next 50-100m (Reach 2) is an open space area – grass parkland with isolated tall woody vegetation on the foreshore, poor and discontinuous reeds (Figure 3-3). Previous foreshore erosion treatment consists of poorly graded (i.e. little variation in size) large rocks (~400-500mm diameter). The rock protection consists of a few isolated rows of rock that are approximately 1m wide. Importantly, they are only one rock deep (not stacked or interlocking) and there are significant gaps between the rocks. The rocks are providing a good substrate habitat for aquatic life such as fish and oysters. Juvenile mangroves are also observed growing up through the rocks. It is observed on site that scouring is occurring behind the rocks and the foreshore is receding (Figure 3-4). As a result, the existing foreshore alignment is unarmoured.

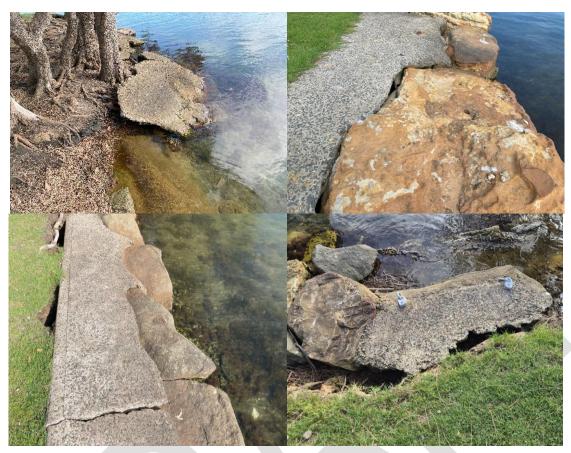
Figure 3-6 Examples of concrete reinforcement in poor conditions

The bank is mostly unvegetated and treated with a combination of large rock (1-2 rows of 500-700mm diameter) on the bank face and cast in-situ, reinforced concrete on the top of bank. The concrete treatment is inconsistent, absent in parts and up 1 m wide in others. However, concrete is not sympathetic with any natural processes. The condition of concrete is generally poor (cracked and uneven), with moderate scour of bank material behind the concrete (Figure 3-6). While the concrete has failed in parts, failure does not seem imminent for most of the remaining concrete. Given time however, the concrete will almost certainly fail along the whole reach. In addition, rocks are observed to have fallen away from the concrete and into the lake in some locations (Figure 3-7).

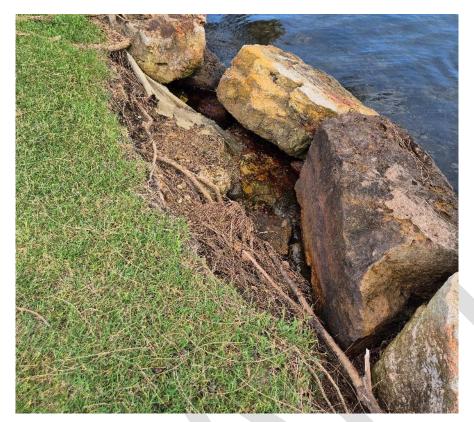
Figure 3-7 Rocks collapsed into the lake

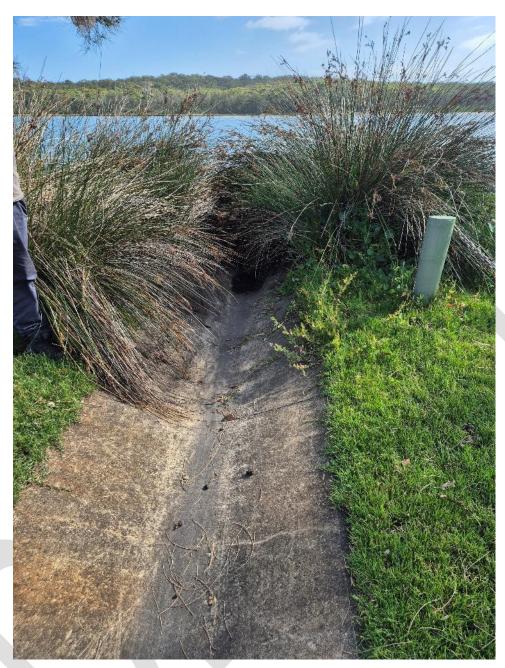
Figure 3-8 Example of Spoon Drain in Reach 3 of Site 1 (Left: Looking away from Lake and Right: Looking towards Lake)

Figure 3-9 Spoon drain terminating at a stormwater pit.

The concrete drains along Reach 3 should be removed where possible and replaced with grass swale and a pit and culvert arrangement in line with WSUD principles.

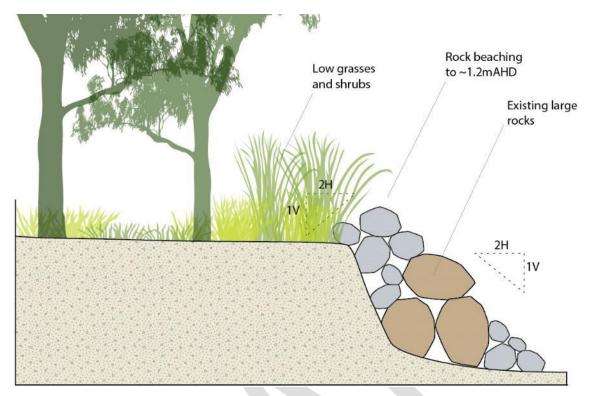
The existing rock beaching consists of one to two rows of large rocks, 500-700mm diameter on the bank face. The rock beaching is in poor condition and the rocks are providing limited protection to the bank from the identified mechanisms of erosion. It is recommended that the large rocks be supplemented with smaller, graded rocks to from an interlocking rock riprap. Rock beaching should be formed from graded quarry rock with a d_{50} of approximately 350mm. The intent of the smaller rocks is to provide more complete protection to the foreshore bank by filling the large gaps in the existing rocks. Furthermore, the smaller rock arrangement will be flexible enough to accommodate minor changes in the foreshore geometry that are expected to occur over time. The supplemented rock beaching arrangement is also expected to improve upon the ad hoc and uneven appearance of the existing arrangement and provide a safer and more consistent surface for caravan park users. A profile view of the recommended arrangement is shown in Figure 3-10.

Figure 3-10 Rock beaching

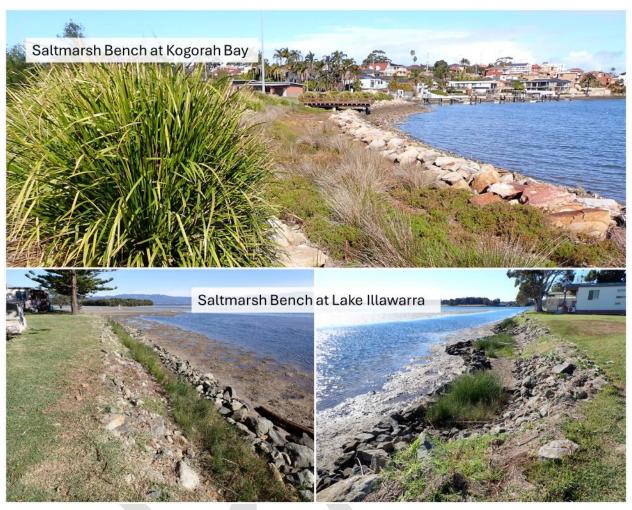
Figure 3-11 Example of saltmarsh benches at Lake Illawarra and Kogorah Bay.

foreshore geometry that are expected to occur over time. Furthermore, there are many expected co-benefits of the saltmarsh benches including creation of marine habitat, filtering of stormwater runoff and providing the opportunity for education through interpretive signage. Figure 3-11 above shows examples of recently constructed saltmarsh benches in similar environments. Figure 5-10 below shows a typical design profile of a saltmarsh bench for Sussex Inlet.

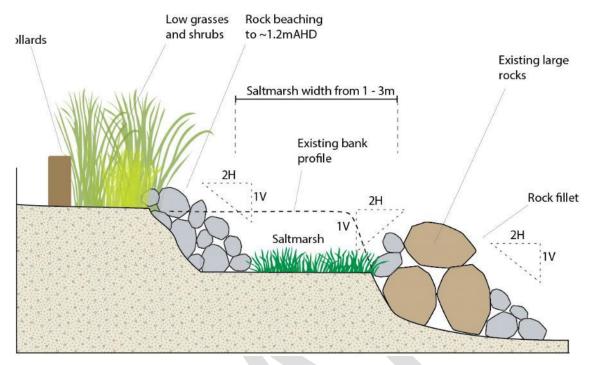
This involves the formation of saltmarsh benches in targeted locations along the length of the foreshore. A bench is formed by locally excavating the foreshore surface that will be periodically inundated with tides (e.g. during spring tides) to allow establishment of saltmarsh. The saltmarsh bench is to be protected at the lakeward side by a low rock fillet and the landward bank is to be armoured with rock beaching. The intent of the saltmarsh bench is to provide a stable buffer between the lake and the caravan park that will accommodate minor changes in the foreshore geometry that are expected to occur over time. Furthermore, there are many expected co-benefits of the saltmarsh benches including creation of marine habitat, filtering of stormwater runoff and providing the opportunity for education through interpretive signage. Figure 3-11 shows examples of recently constructed saltmarsh benches in similar environments. Figure 3-12 shows a typical design profile of a saltmarsh bench for Lake Conjola.

Figure 3-12 Typical design profile for saltmarsh bench

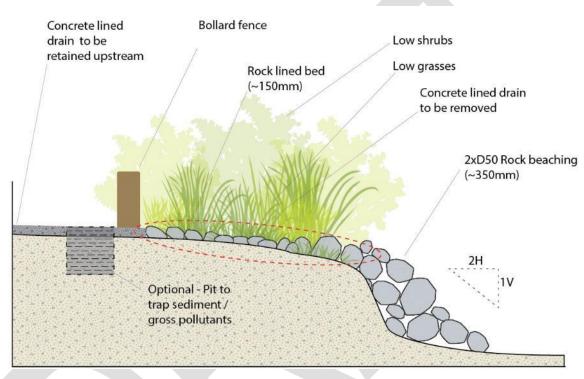
A vegetated swale is a shallow, open channel designed to convey stormwater while also filtering pollutants and reducing runoff velocity. Unlike the existing concrete drainage systems, vegetated swales use grass, shrubs, and other vegetation to slow down water flow, allowing sediments and contaminants to settle before reaching the lake. The outlets may contain pit drains that will allow easy maintenance. This would be approximately 0.8x0.8x0.8m inline pit with metal grate that one person can clean out without specialised equipment. Figure 3-13 shows a typical design profile of a vegetated swale/ stormwater outlet for Lake Conjola.

Figure 3-13 Typical design profile of a vegetated swale/ stormwater outlet for Lake Conjola

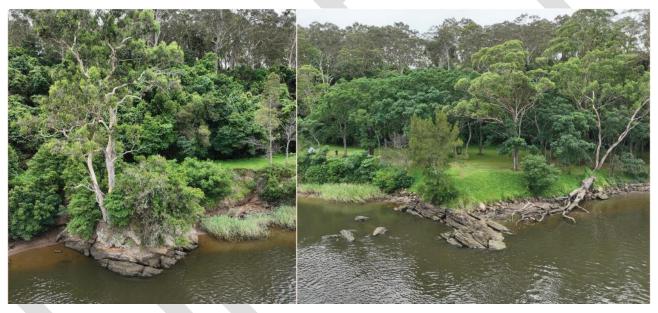
Figure 4-1 Vegetated bedrock outcrops, resistant to erosion

The riverbank in this location is approximately 5–6 meters high and the reach of concern, approximately 160 meters in length. Active bank erosion is progressing towards the bedrock cliffs. The erosion is occurring in sections, with other sections stabilised by a combination of exposed bedrock outcrops, individual large rocks and large trees (Figure 4-1). The primary erosion mechanism appears to be slumping and undercutting of the bank. The bank is undercut in some areas, and tension cracks are visible on the surface at the top of the bank (Figure 4-2).

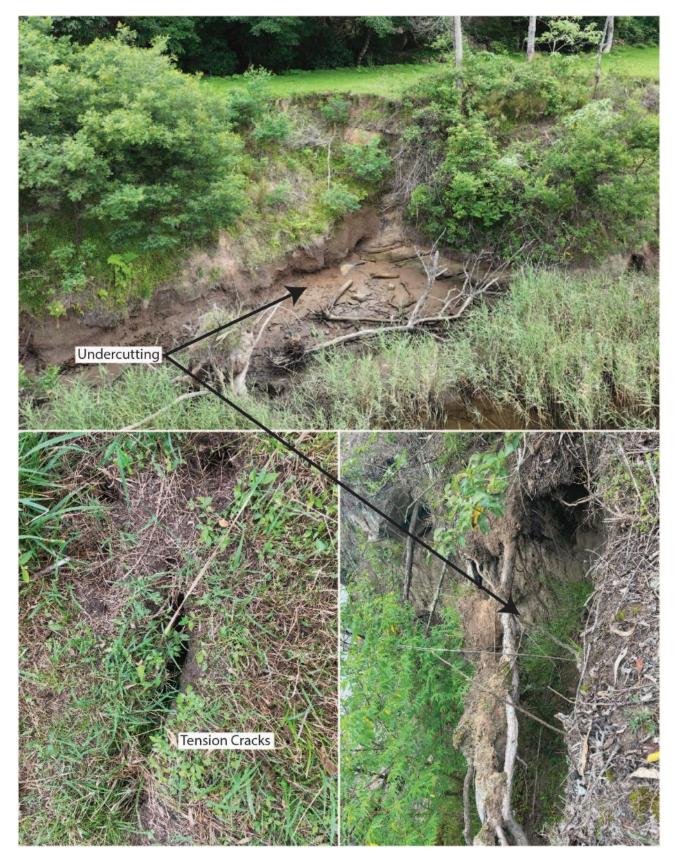
Figure 4-2 Undercutting of the bank captured by the drone and from the bank. Tension cracks in the top of the bank viewed from above.

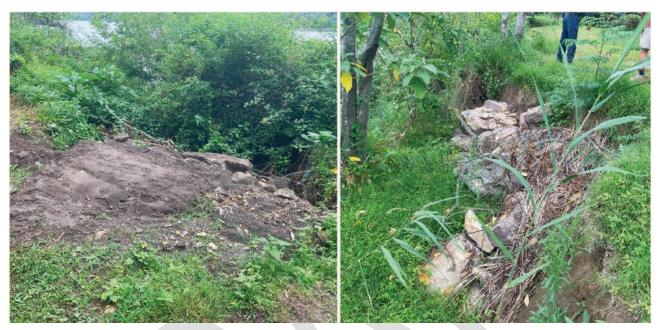
Rocks have been informally placed by the landholder on the upper bank face, but this measure is unlikely to address the identified erosion mechanism. Overland flow is concentrating in low points on the terrace and discharging down the bank face, likely contributing to the erosion. Informal repairs have also been made to address this process by backfilling the erosion extent. Similarly, this is not likely to address the erosion mechanism.

Figure 4-3 Informal works to treat erosion.

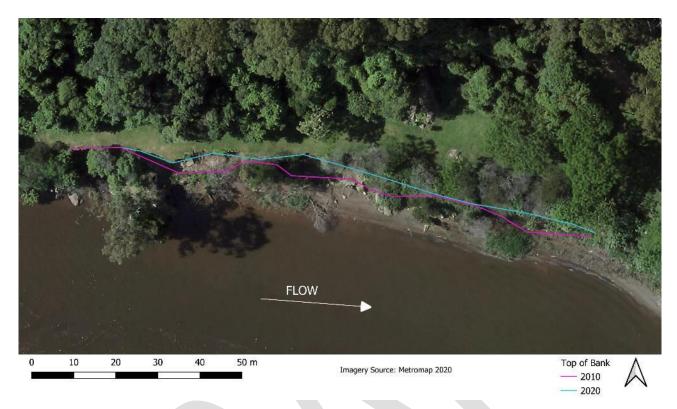
Multi temporal topographic datasets are not available to measure the extent of erosion over time. Measuring the top of bank alignment from the 2010 LiDAR and the 2020 aerial imagery indicates bank retreat in the order of 5m over this time (Figure 4-4).

Figure 4-4 Indication of bank movement based on 2010 LiDAR and 2020 aerial imagery.

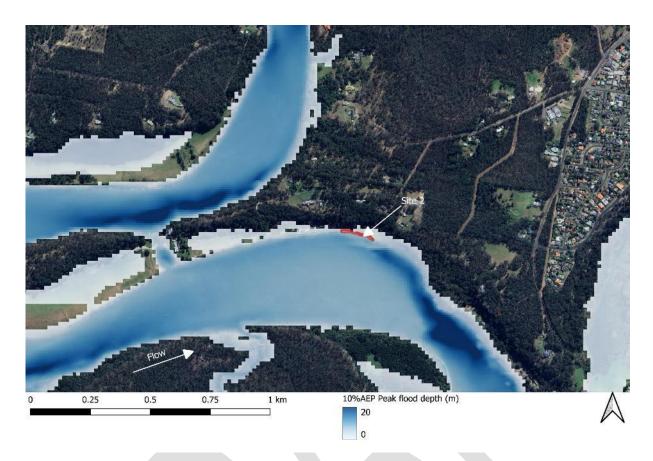
According to the Lower Shoalhaven Flood Study Report (Cardno, 2022) while the lower Shoalhaven River is tidal for a large extent upstream the Coorong Road site, riverine flood flows are dominant in determining water levels during floods within the Shoalhaven River upstream of Nowra. Review of the Lower Shoalhaven Flood Study model results suggest that relative depths of flow at the site range from over 8 metres in the 10%AEP flood to over 12 metres in the 1%AEP event². Flood maps indicate that parts of the terrace are inundated in events greater than the 10%AEP flood (Figure 4-5).

Figure 4-5 10%AEP flood extent and depth (Cardno, 2022)

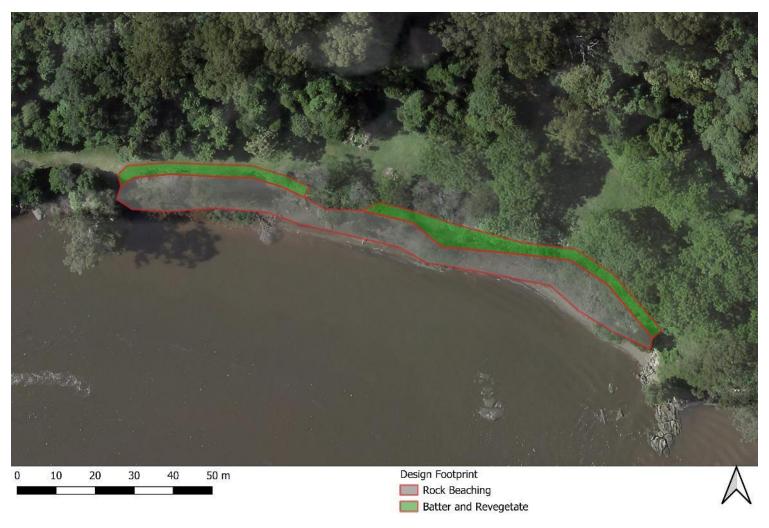
Figure 4-6 Plan view of rock beaching concept

Figure 4-6 and Figure 4-7 illustrate this concept. Note that the design footprint presented in Figure 4-6 may be refined to exclude some area based on topographic or geotechnical survey and to suit budget constraints. The design footprint indicated, and the associated material and cost estimates, are therefore conservative, representing maximum likely values.

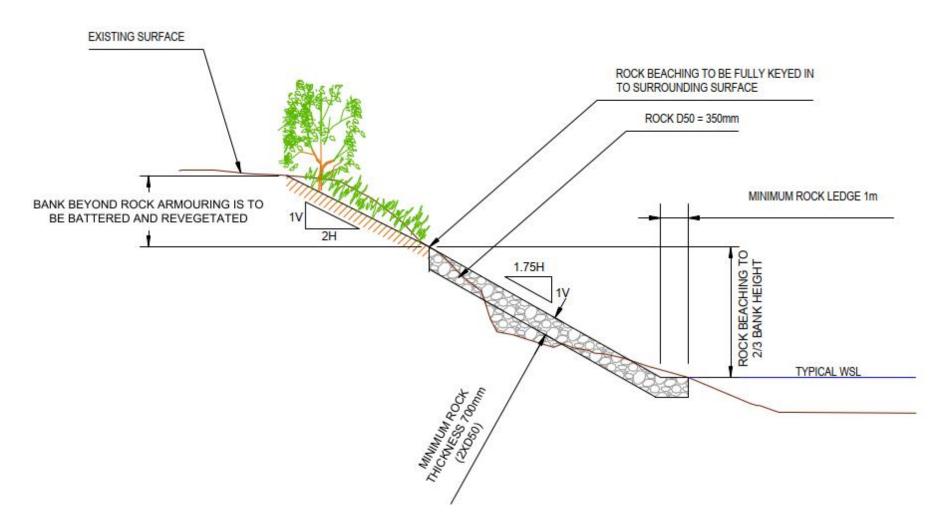
Figure 4-7 Section view of rock beaching concept

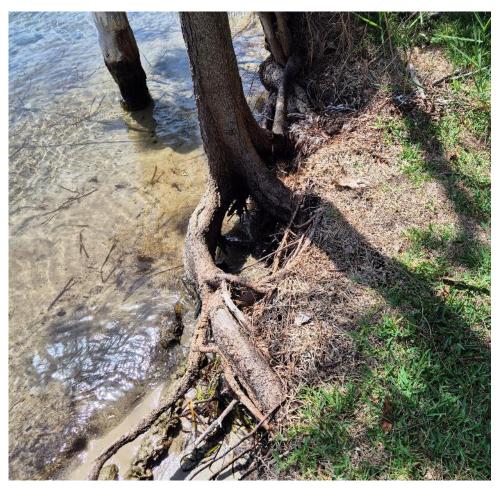
Figure 5-2 Exposed tree roots at the edge of the foreshore bank

Foreshore erosion is active on this outside bend of the inlet as the channel migrates laterally in an unconfined setting. The erosion extent various across the reach, with sporadic sections of the foreshore banks currently held together by tree roots (Figure 5-2). Overall, foreshore vegetation is discontinuous and very narrow. The mowing of the grass on the reserve extends to the edge of the foreshore banks. Seagrass appears to be doing well in the area. There are also isolated pockets of mangroves and individual seedlings identified in isolated spots along the reach.

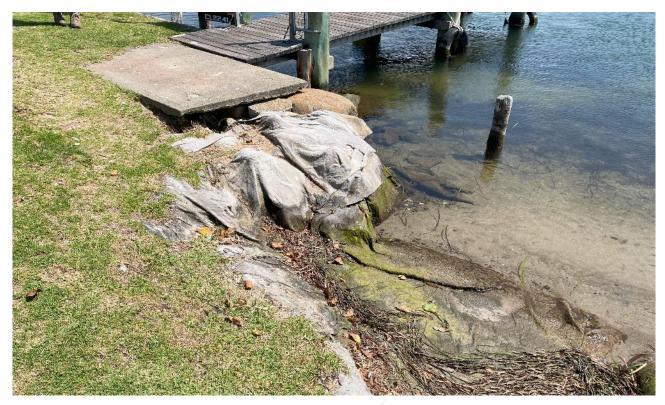
Figure 5-3 Undermined concrete slab and failed geotextiles on an eroding bank

There is an array of inconsistent and informal foreshore protection treatments installed along the reach. These include the use of timber, rocks, concrete blocks, bricks, gravel and geotextile and they all appear to be ineffective in mitigating erosion (Figure 5-3 to Figure 5-7). Many of these have failed or are failing. Scouring is evident behind some of these structures with further informal remediation treatment added to them, such as adding bricks behind the log revetment.

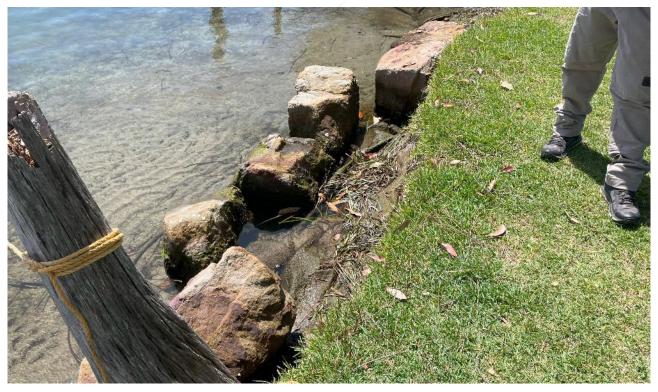
Figure 5-4 Rock beaching undermined and collapsed into the water

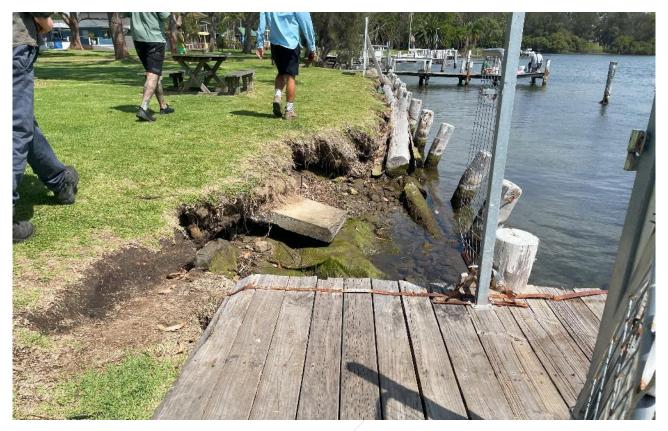
Figure 5-5 Foreshore erosion and failed log revetment

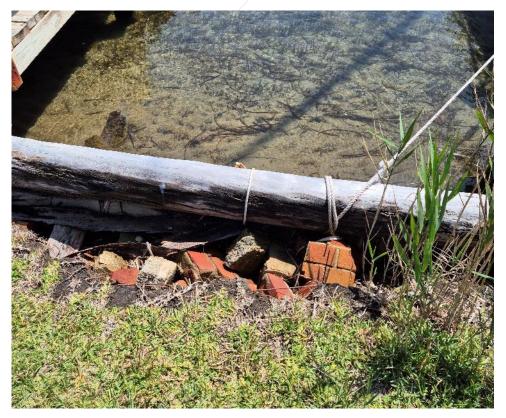
Figure 5-6 Bricks added to fill the scour hole behind the log revetment

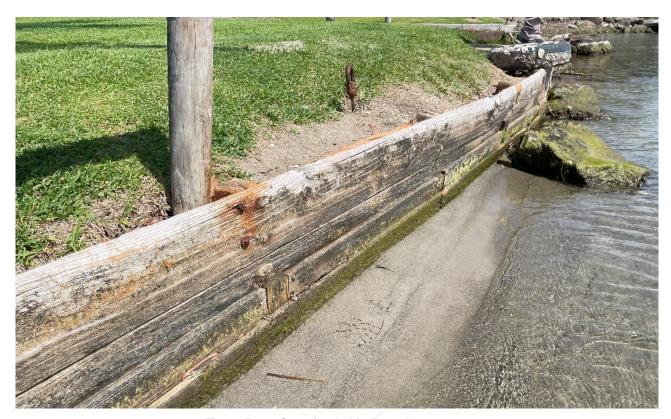
Figure 5-7 Scouring behind wood revetment

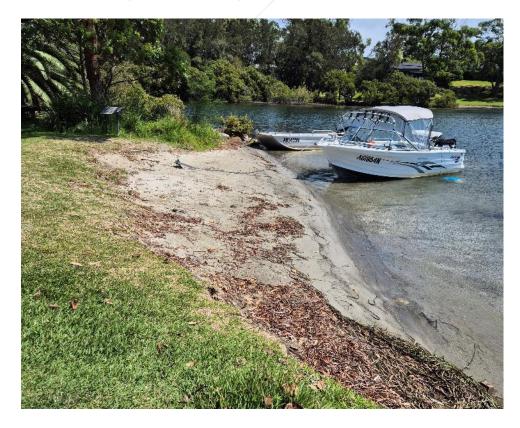
Figure 5-8 Small beach on the western end of the reach

A small beach is present at the western end of the site (Figure 5-8). The presence of beach in this location is likely facilitated by the localised hydrodynamics of flows entering Sussex Inlet from the waterway to the west. It is not typical to have a gentle sloping sandy beach on the outside bend of a waterway.

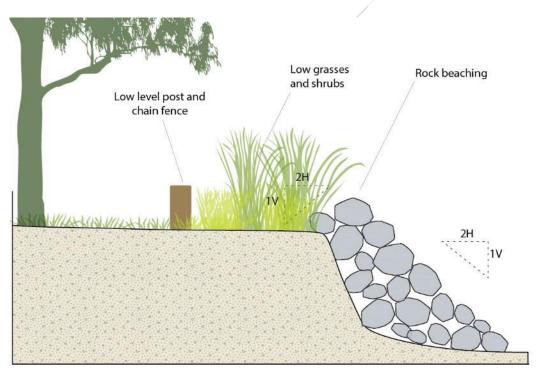
It is recommended that, where possible, the foreshore bank is treated with rock beaching. Rock beaching should consist of graded quarry rock with a d_{50} of approximately 350mm to form an interlocking rock riprap. The intent of the rock is to provide protection to the foreshore bank in such a way that is flexible enough to accommodate minor changes in the foreshore geometry that are expected to occur over time. A key physical constraint at the Sussex Inlet site is the presence of many private pontoons and jetties. The most effective rock beaching arrangement would consist of rock beaching applied consistently along a continuous reach of the foreshore. It is recognised that the presence of jetties and pontons will not allow for this to be the case. As such, rock beaching should tie in as close as practicable to the jetty infrastructure. It may also be beneficial to attempt to install rock on the bank underneath the jetties. A profile view of the recommended arrangement is shown in Figure 5-9.

Figure 5-9 Rock beaching

It is recommended that, where possible, the foreshore bank is treated with rock beaching. Rock beaching should consist of graded quarry rock with a d_{50} of approximately 350mm to form an interlocking rock riprap. The intent of the rock is to provide protection to the foreshore bank in such a way that is flexible enough to accommodate minor changes in the foreshore geometry that are expected to occur over time. A profile view of the recommended arrangement is shown in Figure 5-9.

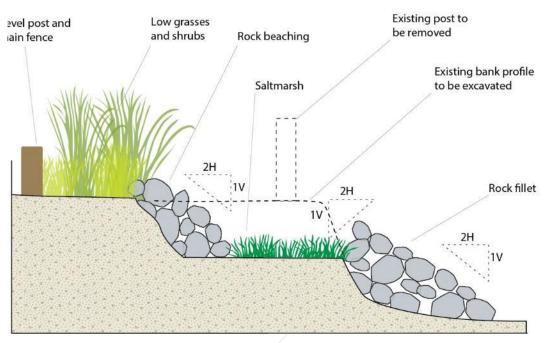
Figure 5-10 Typical design profile for saltmarsh bench

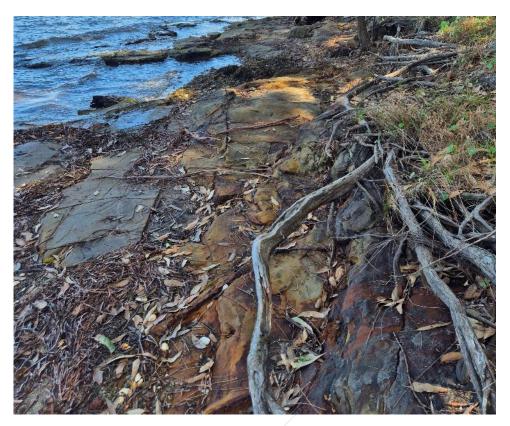
Figure 6-2 Site 3b, Reach 1 - Bedrock outcrop along the foreshore

Reach 1 extends for approximately 400m. Site was accessed from Irene Street. The foreshore gradient is fairly gentle and water level in front of the shoreline is shallow (< 0.5m). The seagrass habitat appears to be thriving near the foreshore area. Acute and significant foreshore erosion is limited in this reach. Bedrock outcrop is observed at multiple locations along the foreshore (Figure 6-2). The bedrock setting in this reach acts as a physical limit to further erosion of the foreshore.

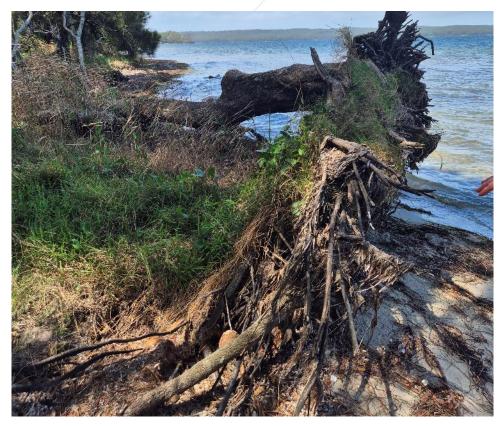
Figure 6-3 Site 3b, Reach 1 - Example of a fallen she-oak with very shallow root system

There are a number of she-oak trees that have fallen over (Figure 6-3). They appear to have very shallow root plate, likely due to the shallow soil layer available above the bedrock. Foreshore erosion processes undercutting the banks is likely to have contributed to their collapse (Figure 6-4), but the shallow root plate does not provide a strong foundation for the she-oaks.

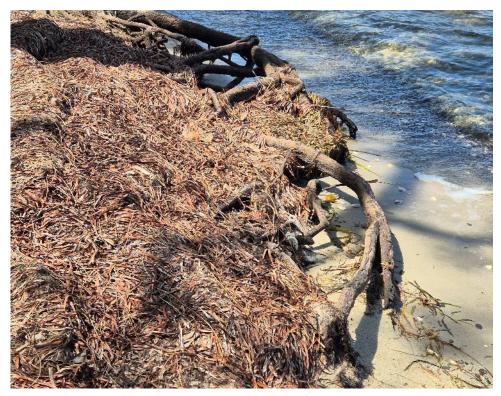
Figure 6-4 Site 3b, Reach 1- Undercutting of the foreshore exposing tree roots

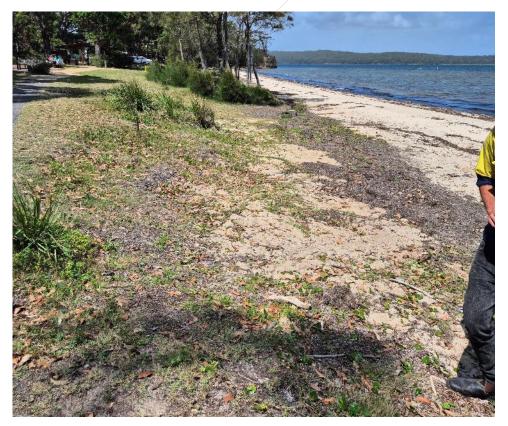
Figure 6-5 Site 3b, Reach 2 -Beach nourishment on Palm Beach

Reach 2 consists of Palm Beach and the foreshore to its west. Approximately 300m of the foreshore was assessed. Some informal beach nourishment appears to have been undertaken on the western section of Palm Beach (Figure 6-5). The foreshore to the west of the beach is similar to Reach 1 in its physical attribute. The seagrass habitat is also thriving. Similarly, the presence of bedrock outcrops will act as a control to foreshore erosion (Figure 6-6).

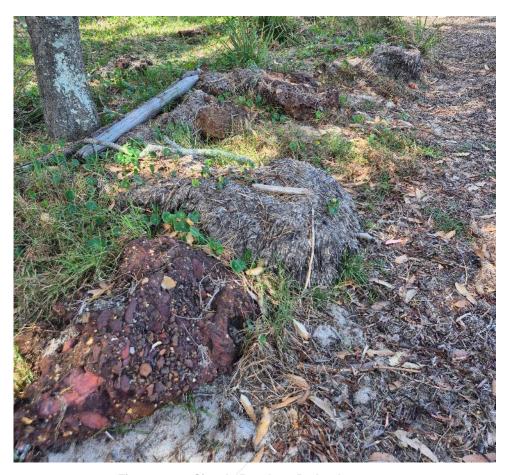
Figure 6-6 Site 3b, Reach 2 - Bedrock outcrop

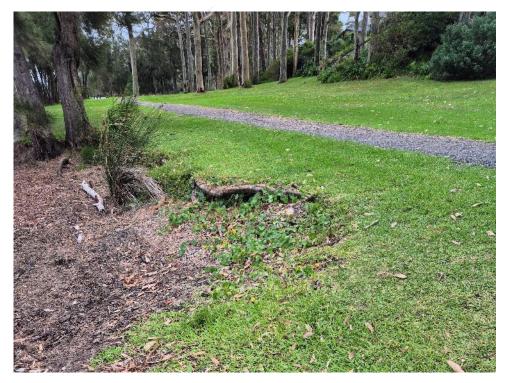
Figure 6-7 Site 3b, Reach 3 – Minor erosion on the foreshore

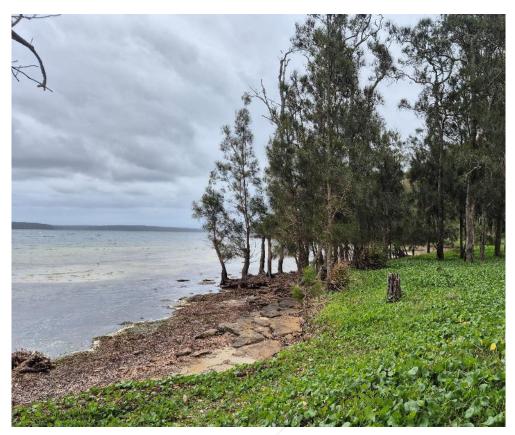
Figure 6-8 Site 3b, Reach 3 – Bedrock outcrop

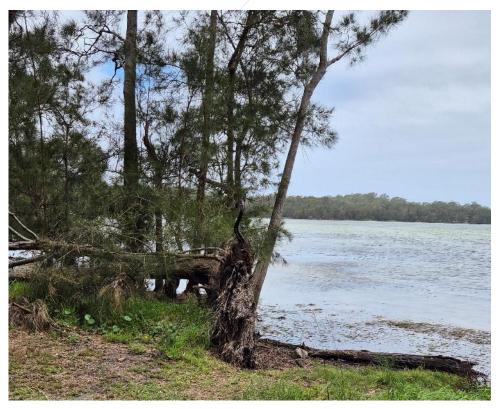
Figure 6-9 Site 3b, Reach 3 - Fallen she-oak with shallow root plate

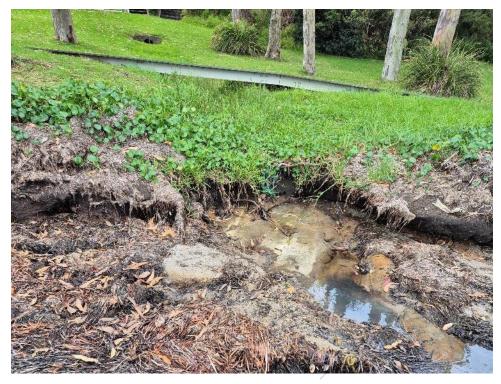
Figure 6-10 Headcut developing on a drainage line on the foreshore

There is a headcut developing at the foreshore along a drainage line. A stormwater drainage outlet is located upslope. The drainage line appears to have incised previously and informally infilled with rocks of various sizes by landholder.

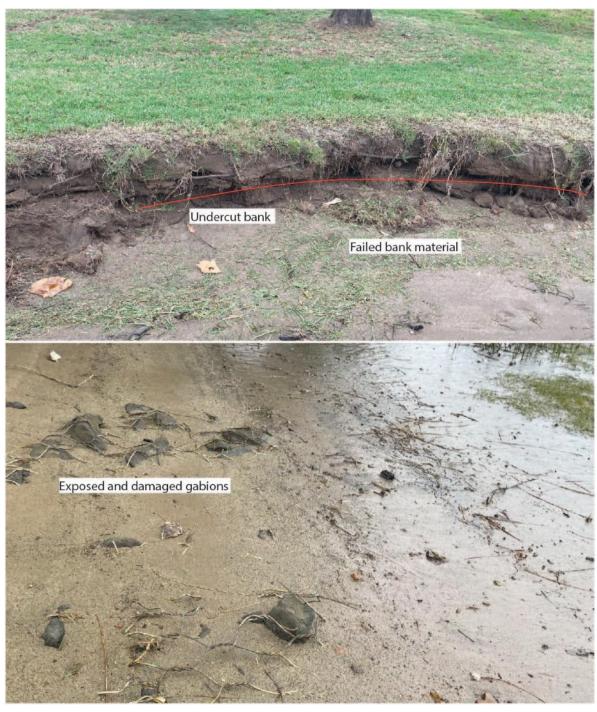
Figure 7-2 Eroding bank at the beach, with partially exposed gabions

Two stormwater outlets were observed, although council mapping indicates six in total; none of these have outfall protection. The furthest downstream outlet consists of a 375mm pipe discharging into the river via a grass swale. The outlet is currently partially buried. While the swale itself is in good condition, there is evidence of scour at the bank near the outlet (Figure 7-3). A small beach located upstream of the outlet, identified by the council as a public water access site, features an eroding bank approximately 40mm high. Partially buried gabions are present along the bank and on the beach, but they are not effectively controlling erosion (Figure 7-2).

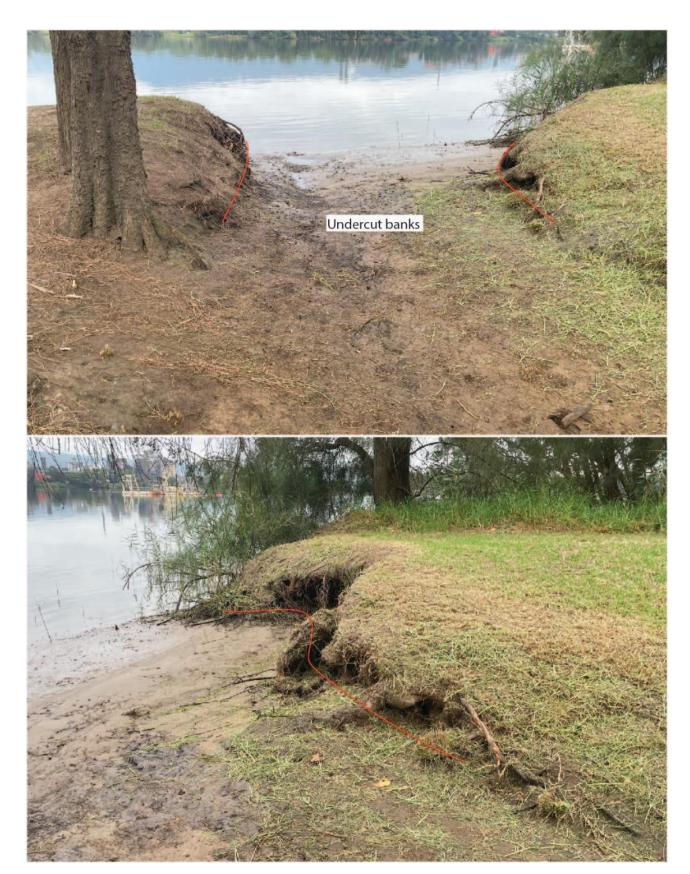
Figure 7-3 Stormwater outlet eroding at riverbank

Rock beaching at locations where erosion is acute would provide long term stability to those locations. This includes the riverbank at the furthest downstream stormwater outlet shown in Figure 7-3. A cobble beach arrangement at the small beach located upstream of the outlet, could provide erosion protection and increase public amenity at this water access site. Rock beaching could be incorporated into the design as shown in Figure 2-3. Partially buried gabions should be removed to the extent that this is possible.

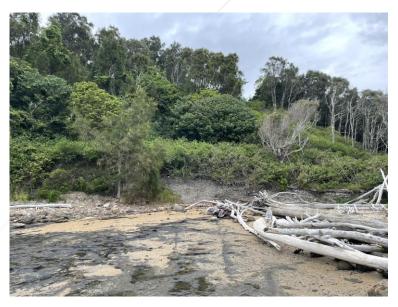
Figure 8-3 shows a front view of the site, highlighting its current state facing ongoing coastal erosion. The wide rock platform contains a scattering of natural headland reef-rocks of various dimensions, a and wooden debris trees are present in the area. At the time of writing there is no confirmation regarding the origin of those fallen trees. It is unlikely that the woody debris or scattered rocks are providing partial coastal protection to the site – as this material is not fixed in places and would be readily mobilised under storm conditions. Nevertheless, the coastal protection provided by those fallen trees are not quantifiable by any standard coastal engineering methodology, nor reliable.

Figure 8-3 Site 5A front view

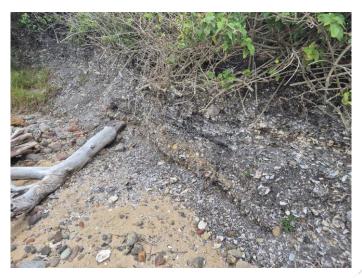
Figure 8-4 Middens exposed to coastal erosion in Site 5A

The middens at this site (see Figure 8-4), are subsequently directly exposed to the incident wave energy during periods of high spring tides and during storm events, causing accelerated erosion that threatens their fragile structure.

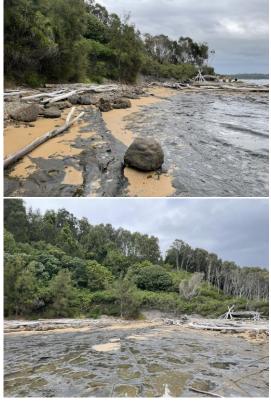
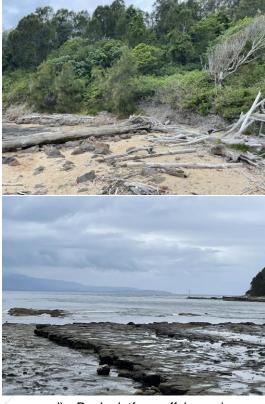
Figure 8-5 Additional overview of Site 5A

b) View from Southwest

c) Rock platform front view

Rock platform offshore view

Figure 8-5 provides additional insights into the characteristics of Site 5A. To the northeast (image a), the coastline is increasingly stable with the presence of larger rock units. Moving to the southwest (image b), the coastline becomes increasingly unstable, experiencing larger coastal retreat and with the presence of smaller rocks and loose sand. The rocky platform in the central part of the site (images c and d) is mostly free of any rocks or sand. This lack of material at the central part of the rock platform is at the same time the consequence and the cause of larger waves propagating towards the middens.

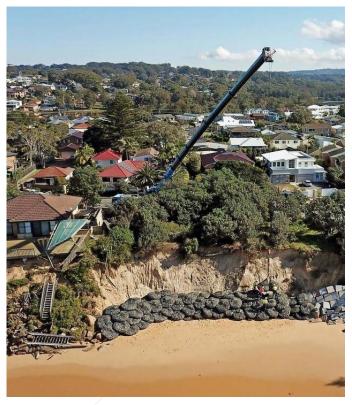
Figure 8-6 Example of rock bags being placed with a long reach boom at Wamberal Beach circa 2020.

Placement could then potentially be achieved using a long-reach boom, similar to methods employed at Wamberal Beach following the 2020 storm events (see Figure 8-7).

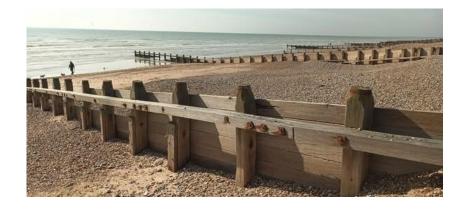
Figure 8-7 Example of timber groyne, similar to the proposed timber low crest wave barrier.

A timber low crested wave barrier presents a balanced approach to addressing the coastal erosion at Site 5A. Conceptually, the design of the barrier would be similar to that of timber groynes (see example in Figure 6), which have been proven to perform in areas with low-to-moderate open coast wave energy. The structure would be founded into the rock platform and likely between 1-1.5m high.

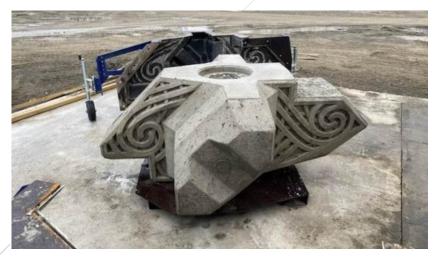
Figure 8-8 Xblock+ armour unit used in New Zealand, incorporating embedded motifs

Moreover, the concrete low crested wave barrier could be designed to avoid overt negative impacts on the natural aesthetics of the foreshore. In addition to its low height, the use of dye-packs in the concrete mix could help the structure blend in with the surrounding rock platform. The structure's design could integrate features that foster biodiversity growth, such as crevices and surfaces suitable for colonization by different organisms. Additionally, it could reflect the site's cultural value by emphasizing its cultural significance through embedded motifs. See Figure 7 for an example of a revetment concrete armour unit used in New Zealand, with similar patterning

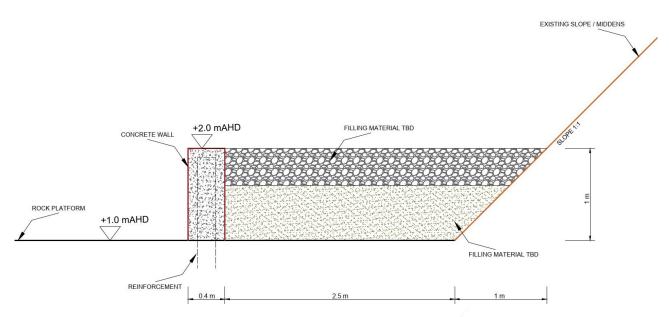
Figure 8-9 Proposed concrete low crest wave barrier

A concept design is as illustrated in Figure 8-9 and Appendix D.

Further details of the proposed concept design, including summarized technical specifications and proposed geometry, are included Appendix A for review. This annex provides additional information on the solution, recommended for its long-term durability, constructability advantages and the opportunity to use the solid foundation provided by the rocky platform.
