RE: INTERIM AUDIT ADVICE LETTER NO. 1 - GILLIESTON PUBLIC SCHOOL REDEVELOPMENT AND NEW PUBLIC PRESCHOOL SITE AUDIT - REVIEW OF RAP

As a NSW Environment Protection Authority (EPA) accredited Contaminated Sites Auditor, I am conducting an Audit (TO-139) under the NSW *Contaminated Land Management Act 1997* (CLM Act) in relation to Gillieston Public School. This initial review has been undertaken to provide an independent review of the suitability and appropriateness of a Remediation Action Plan (RAP).

Due to contamination identified at the site, a Remedial Action Plan (RAP) has been prepared for implementation during the site redevelopment. As an EPA-accredited Site Auditor, I have been engaged by DoE to review the RAP and prepare this Interim Audit Advice (IAA).

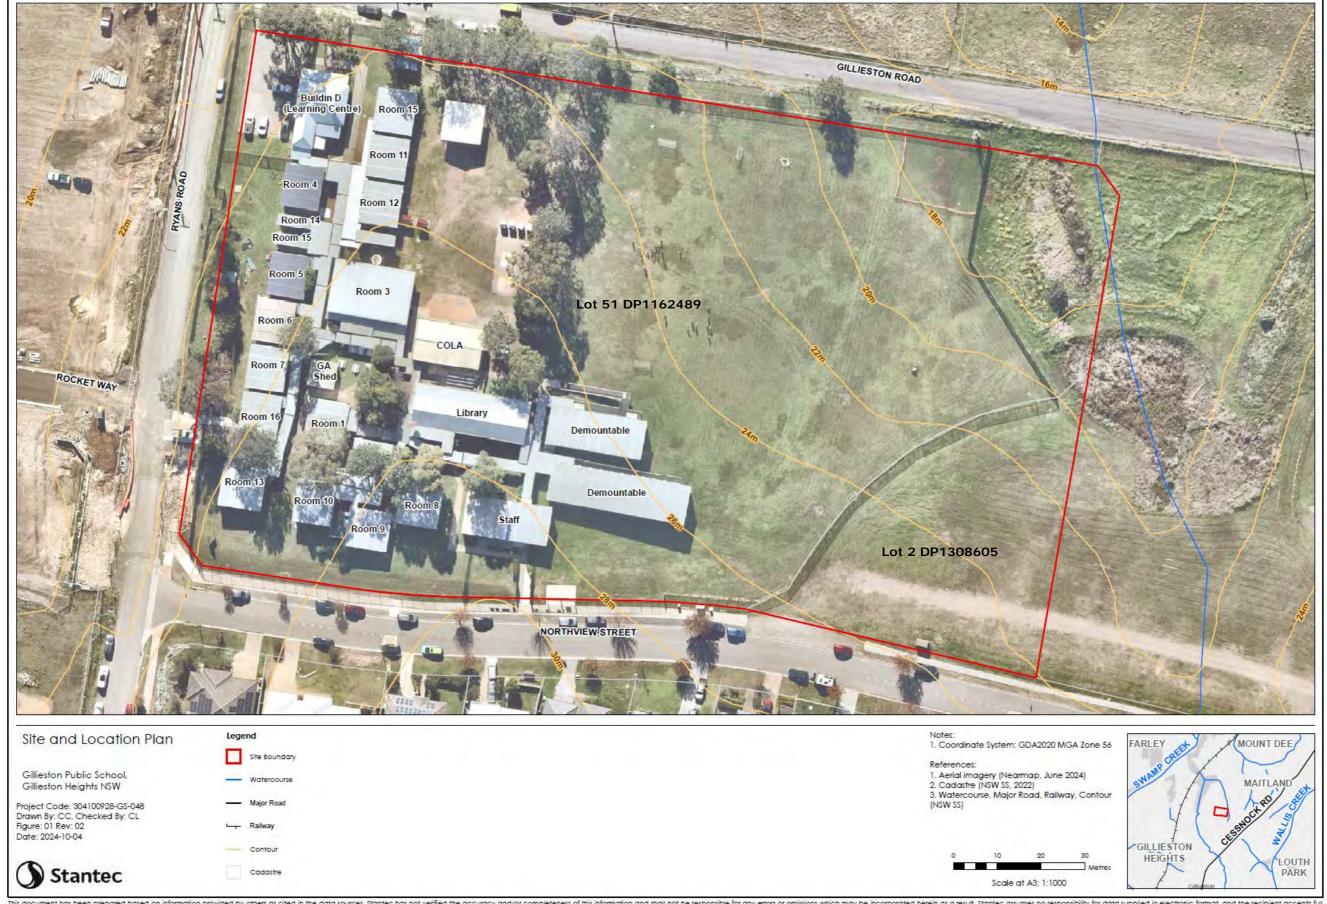
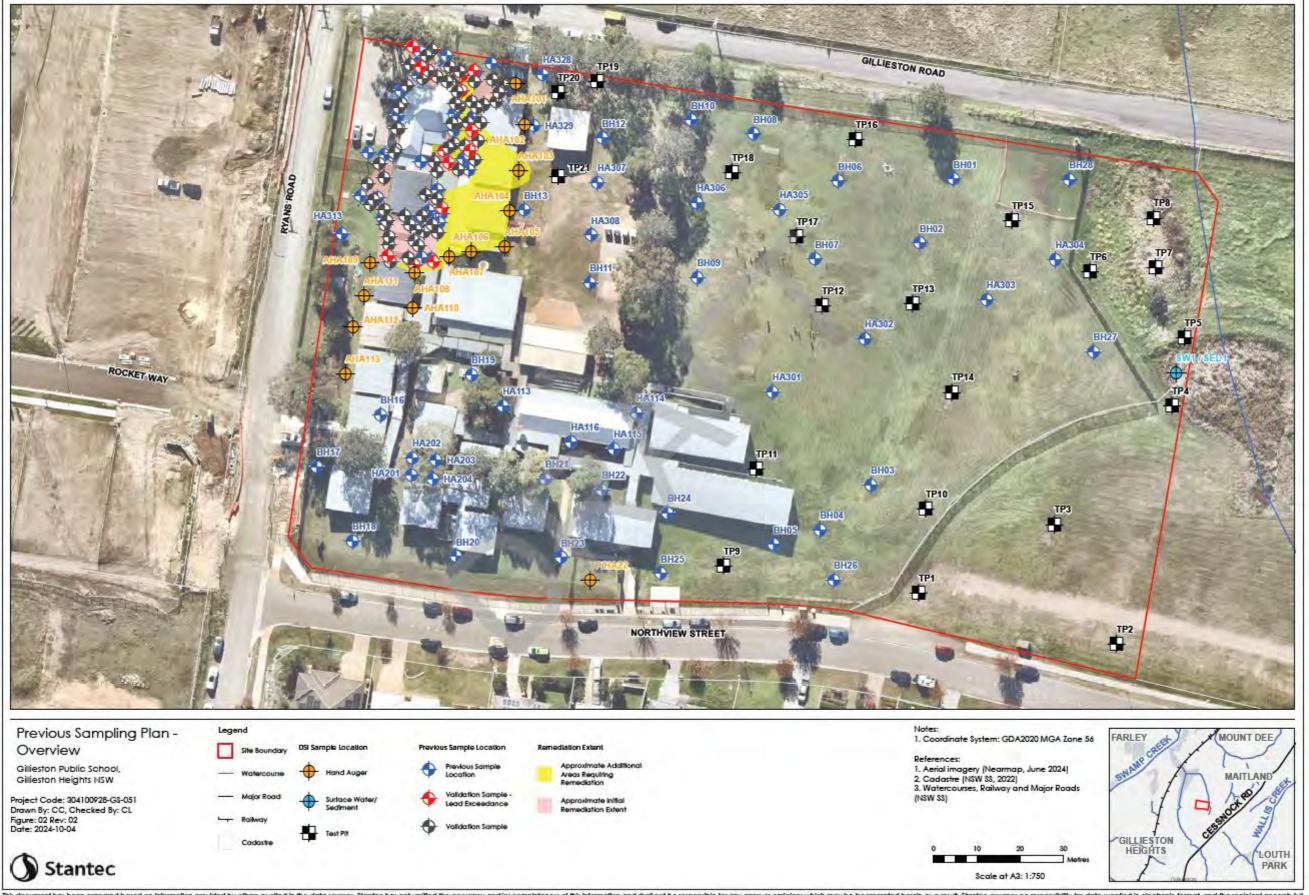
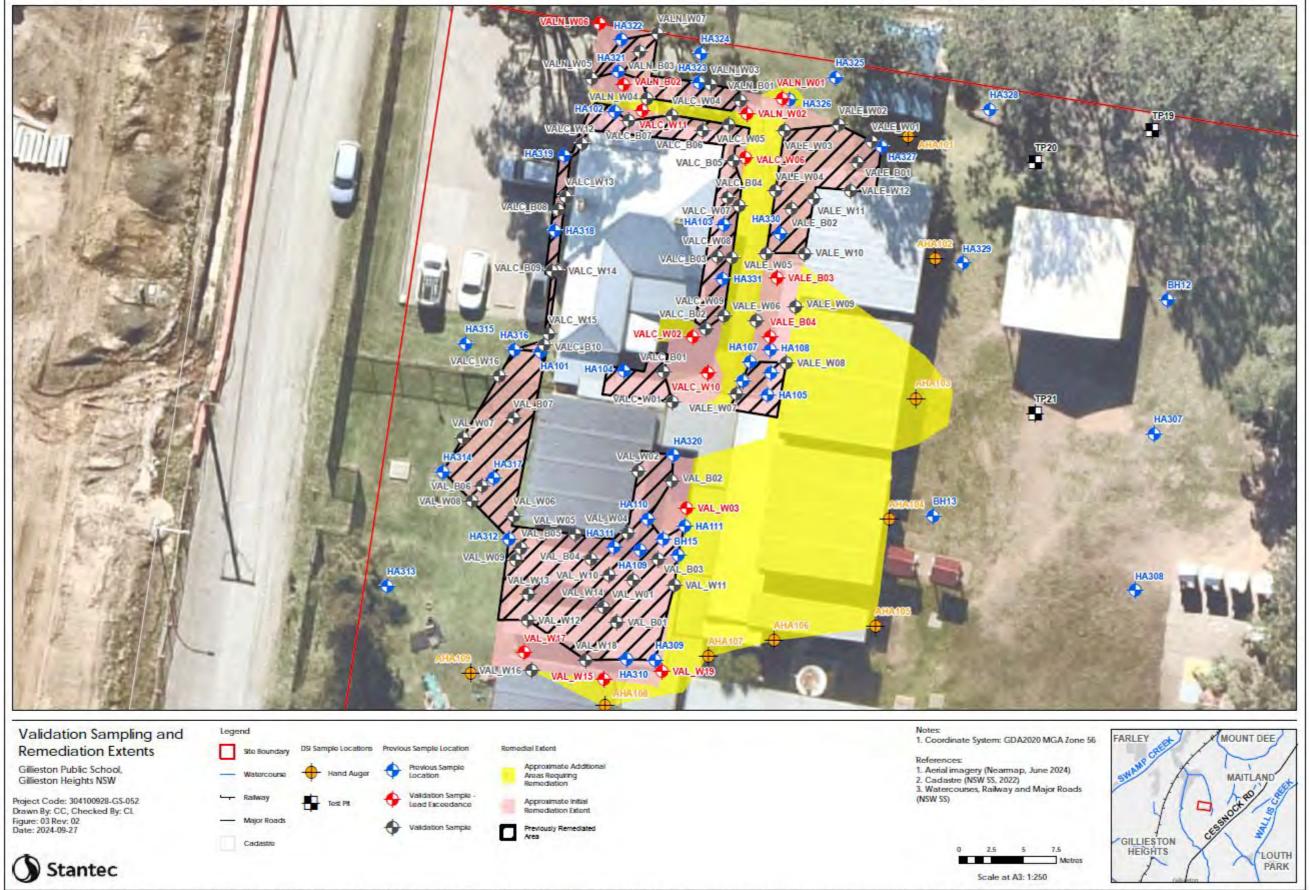
3 Proposed Remediation Extent

The CoPCs that require remediation have been summarised in **Table 4.1** based on the investigations and interim remediation previously completed by Stantec. The remedial extent is based on the current understanding, and as noted in **Section 4.1**, further investigation of data gaps is required following demolition or removal of the demountable buildings and hardstand pavements. Building D is understood to be heritage listed and will be retained as part of the redevelopment, and therefore no investigation or remediation of the building footprint is proposed.

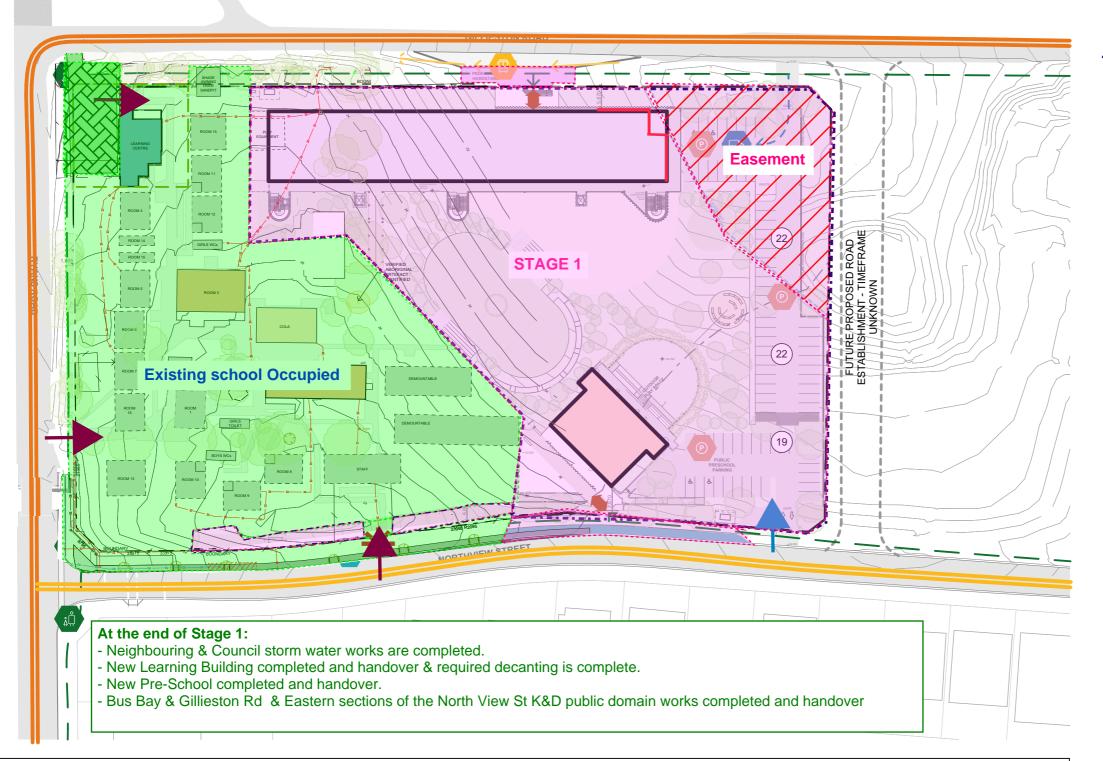
- All works required for the Completion of the new Learning Building & required decanting
- All works required for the Completion of the new Pre-School
- Bus Bay & Gillieston Rd & Eastern sections of the North View St K&D public domain works

- 1. Staff will be utilising the existing car park adjacent to Building D (Brick Cottage) on Gillieston Road during Stage 1 Construction Works
- 2. School Access on Northyiew Street is retained across Stage 1 Services corridor

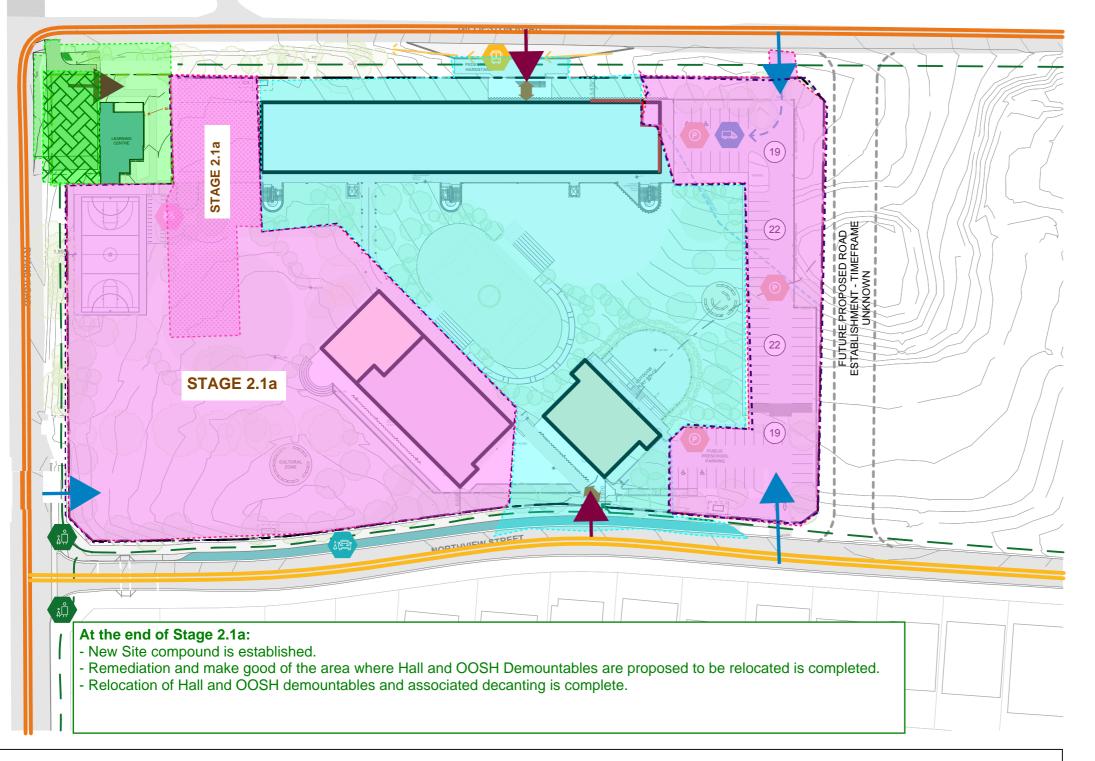
1. Staff will be utilising the existing car park adjacent to Building D (Brick Cottage) on Gillieston Road during Stage 2.1a Construction Works

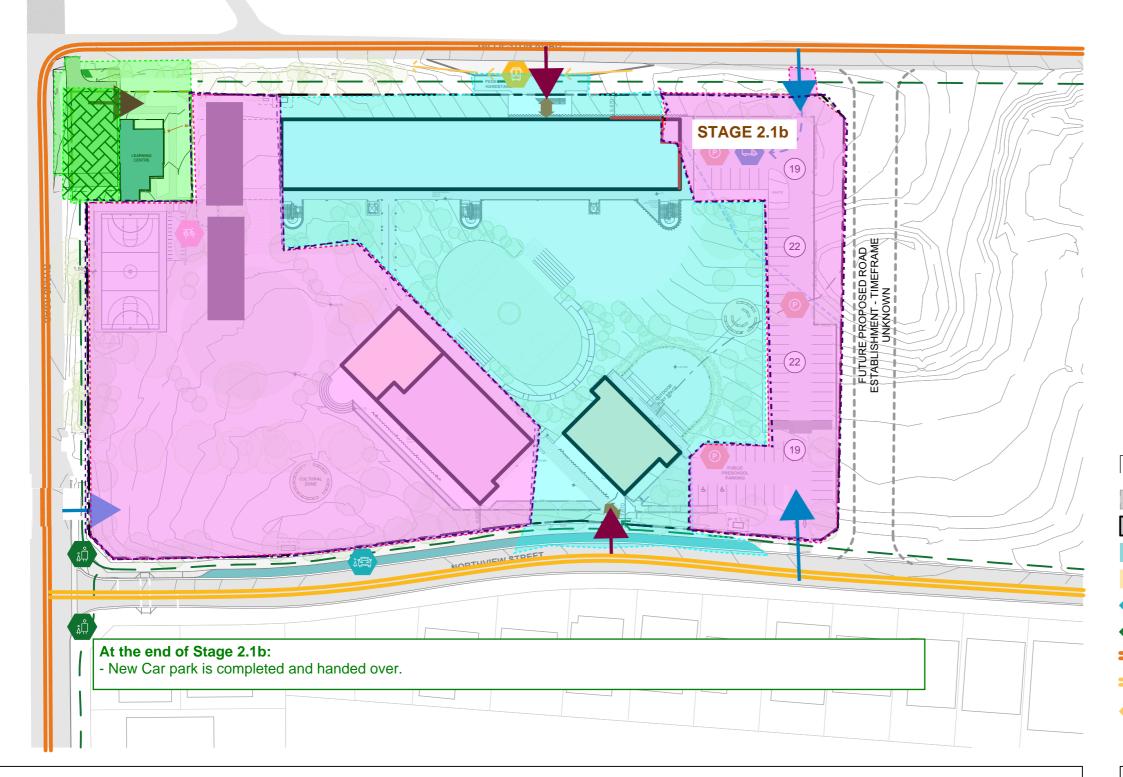
1. Staff will be utilising the existing car park adjacent to Building D (Brick Cottage) on Gillieston Road during Stage 2.1b Construction Works

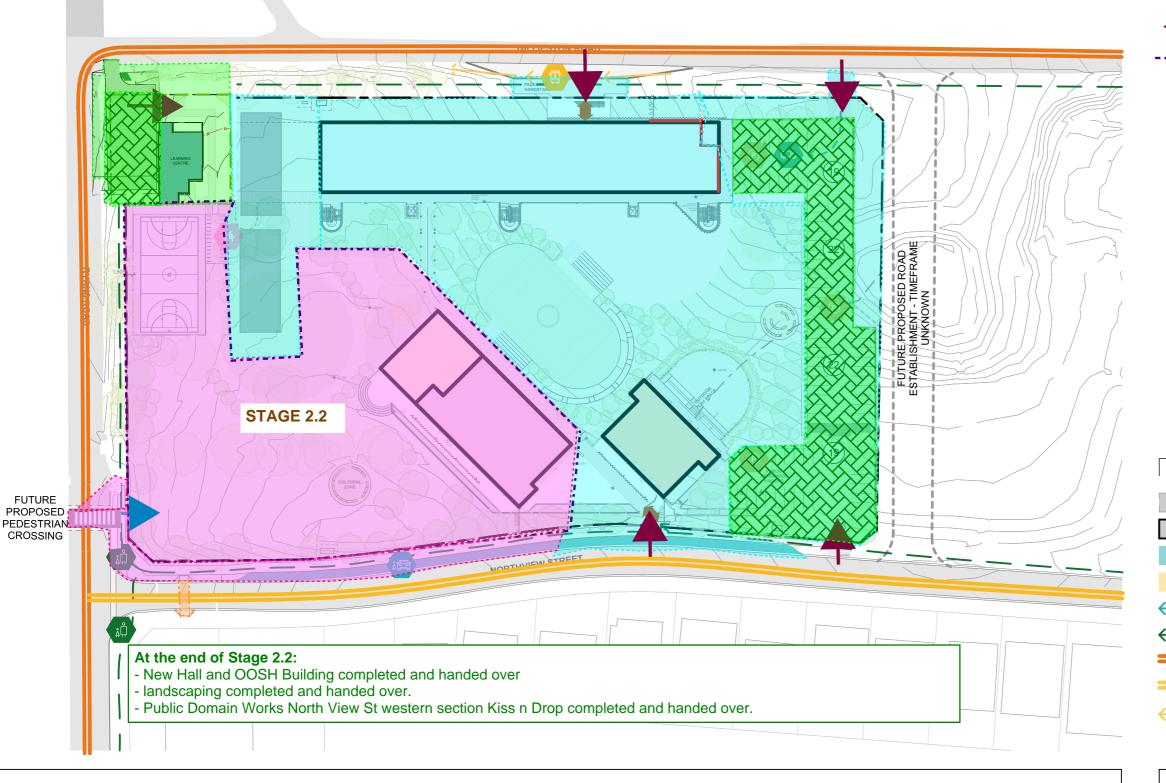
1. Staff will be utilising the existing car park adjacent to Building D (Brick Cottage) on Gillieston Road and the new car park during Stage 2.2 Construction Works

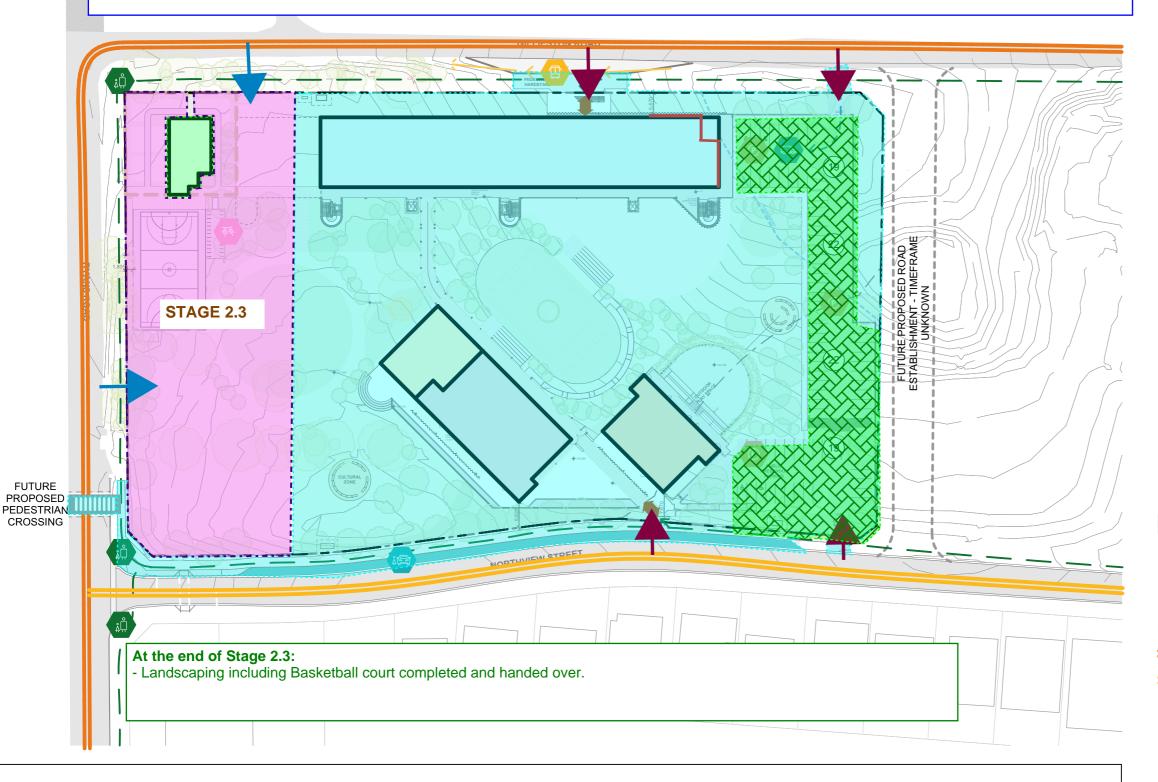
1. Staff will be utilising the new car park during Stage 2.3 Construction Works
