Department of Education

School Asbestos Management Plan

Austral Public School - 1077

Last Revision : 15-Jan-2025

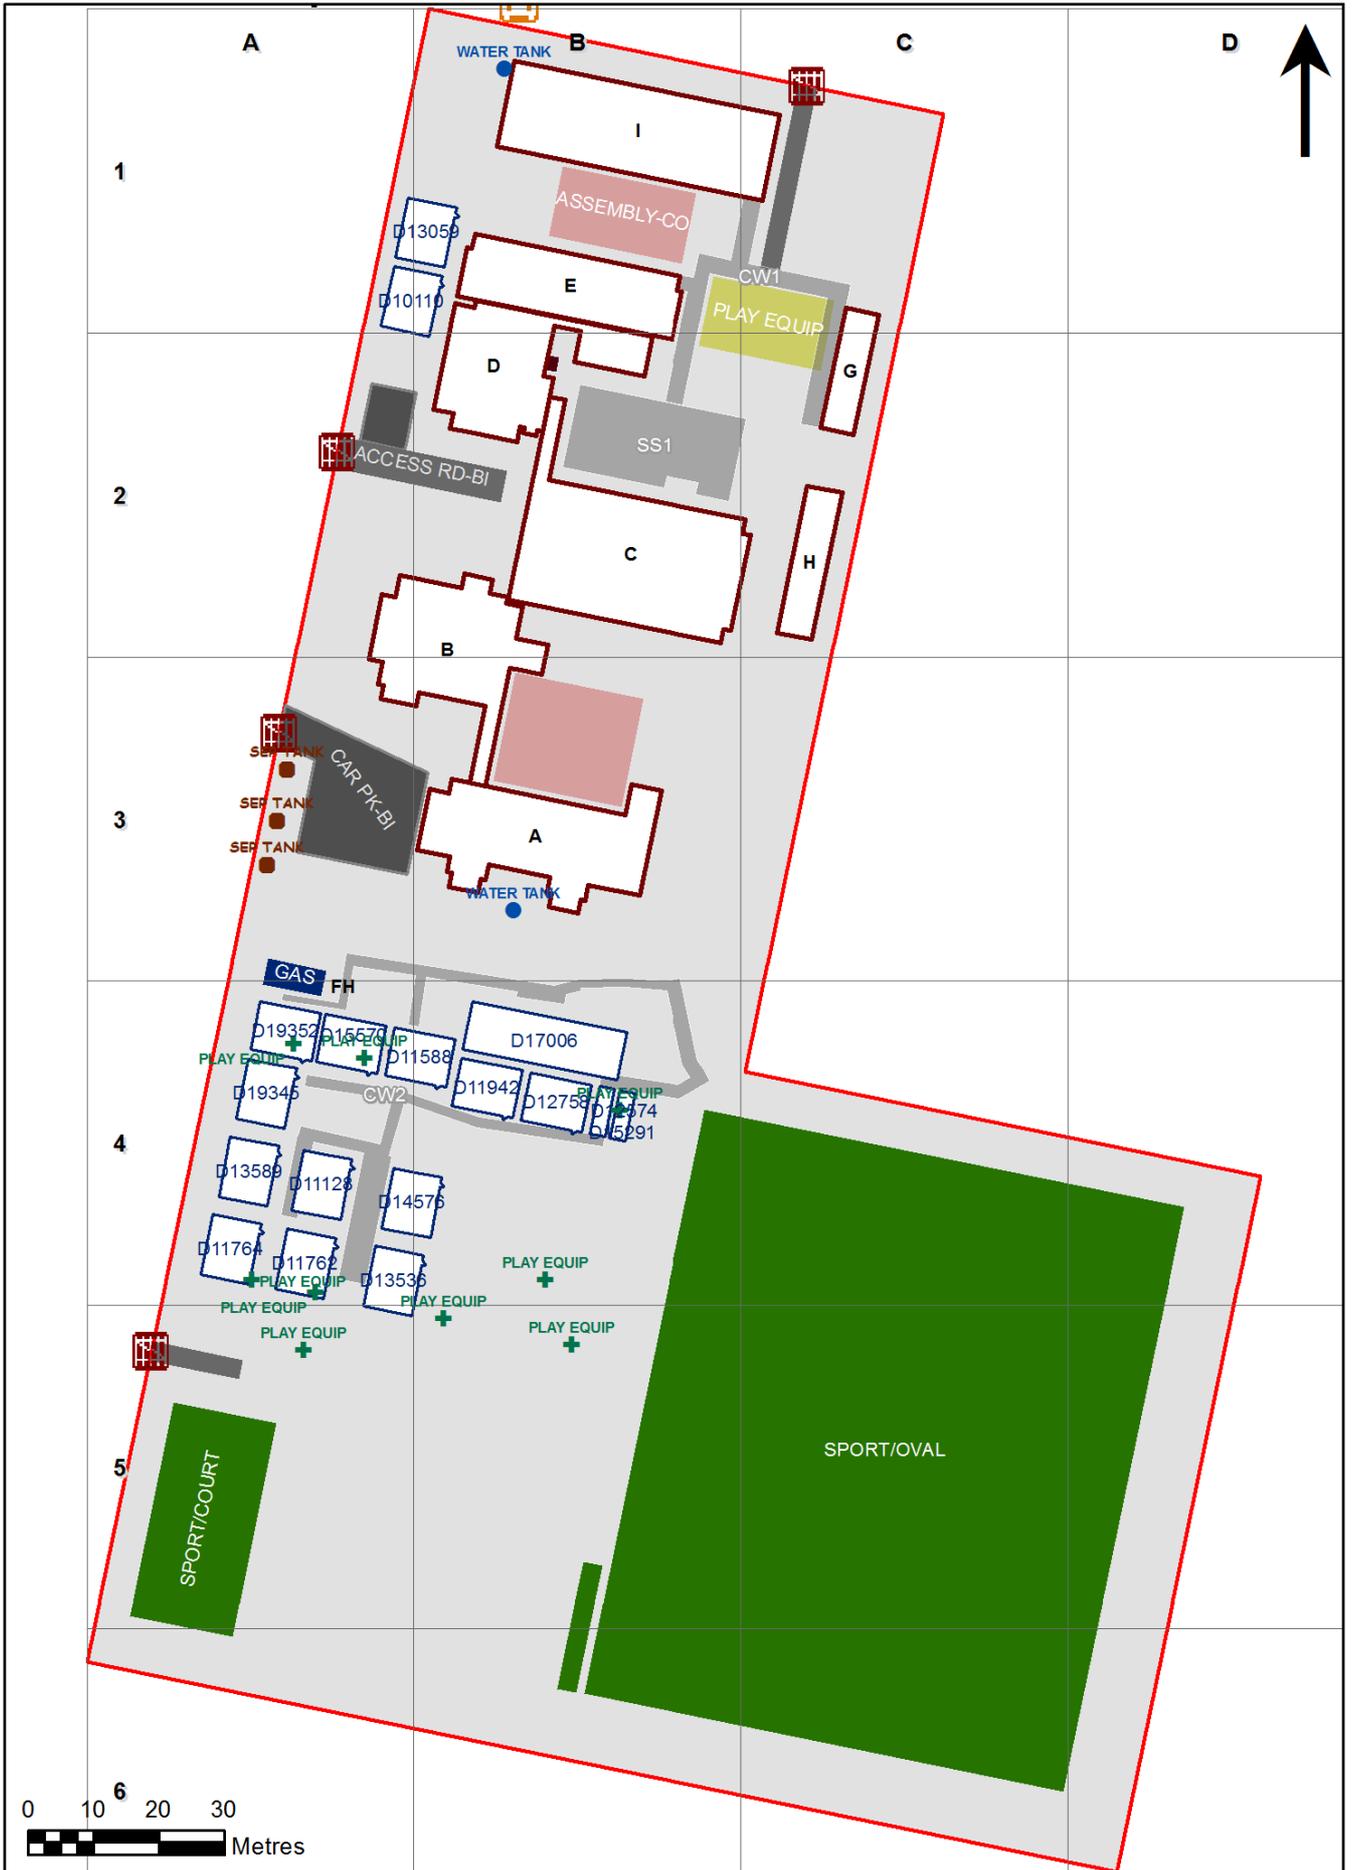
1077 - Austral Public School
Site Plan (10222)

Appendix A: Site Plan
