REPORT TO
HEALTH INFRASTRUCTURE

ON
HAZARDOUS BUILDING MATERIALS

FOR
PROPOSED ALTERATIONS AND ADDITIONS

AT
FINLEY HOSPITAL, 24 DAWE AVENUE, FINLEY,
NSW

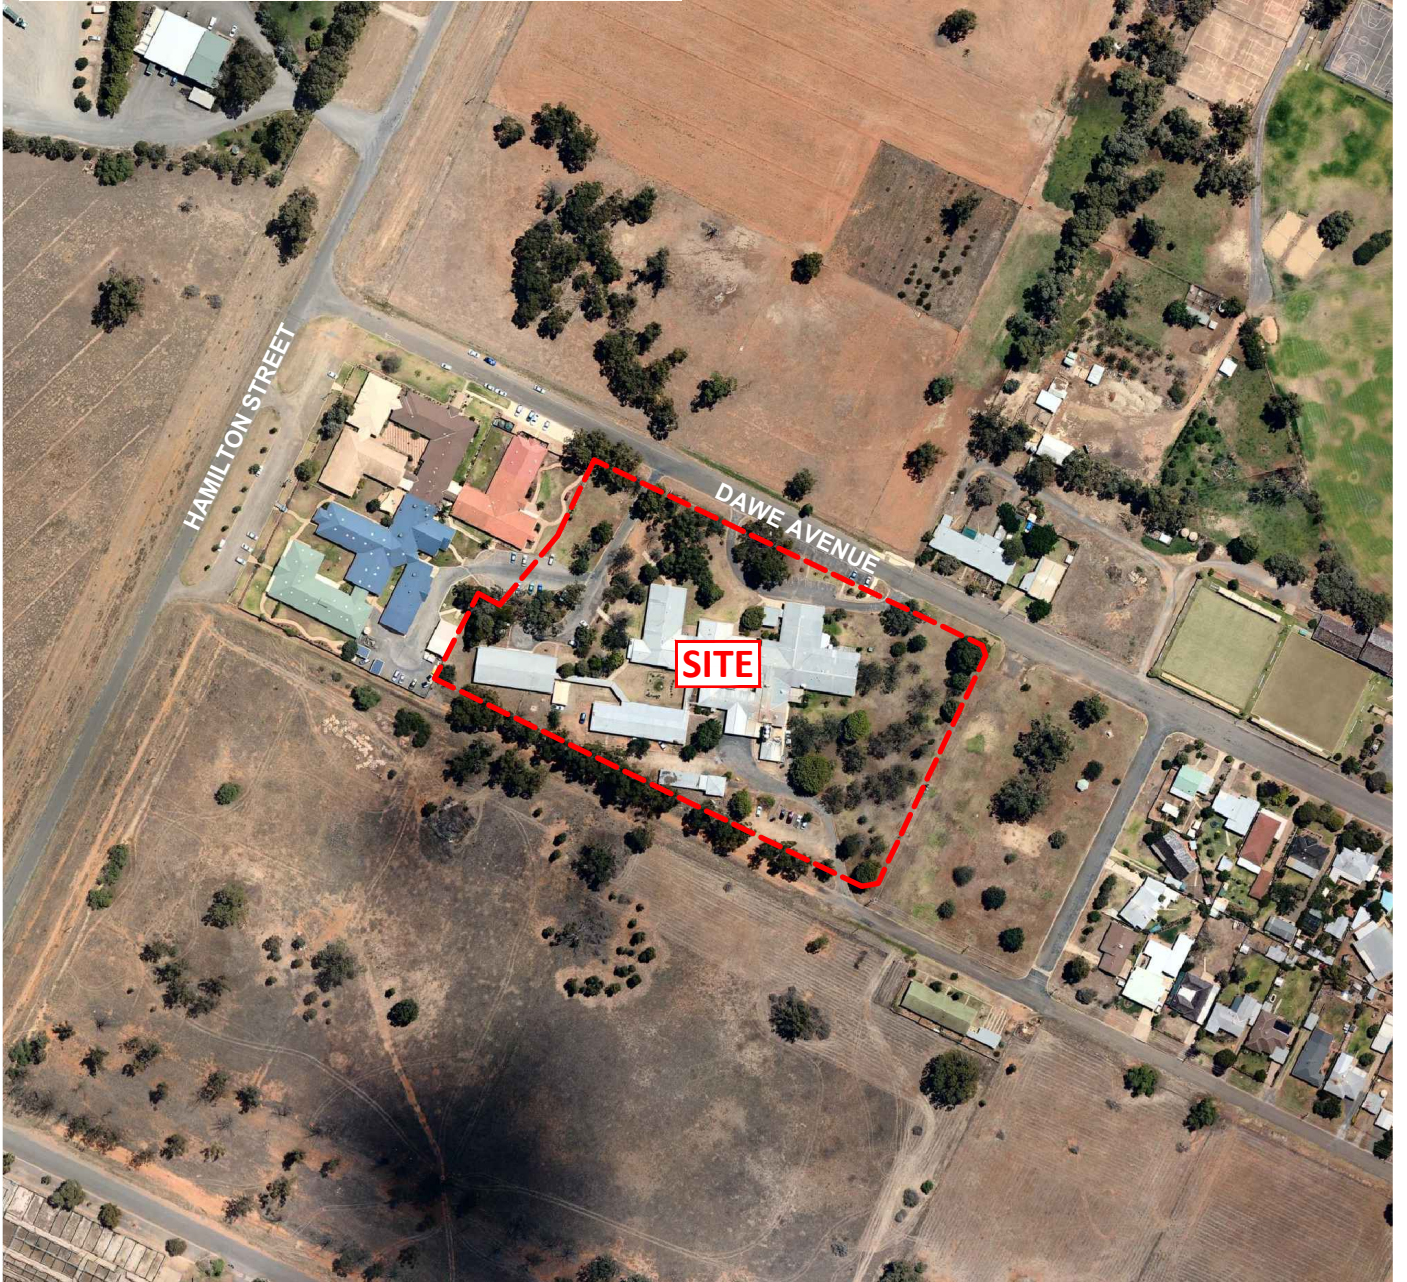
AERIAL IMAGE SOURCE: MAPS.AU.NEARMAP.COM

Health Infrastructure ('the client') commissioned JK Environments (JKE) to undertake a visual hazardous building materials survey for the proposed alterations and additions at Finley Hospital, 24 Dawe Avenue, Finley, NSW ('the site'). The site location is shown on Figure 1 and the survey was confined to the buildings within site boundaries as shown on Figure 2.

- Review and summary of existing reports and registers;
- A detailed visual inspection of the existing building and structures shown on Figure 2;
- Documentation of inspection finds including the material type, condition, friability, photographic evidence and site location; and
- Preparation of a report presenting the results of the hazardous building materials survey.
