# Response to Additional Information Requests

DA 21/11288

Perisher Views Ski Lodge
Lot 1, DP1192372

Geoanalysis Pty Ltd

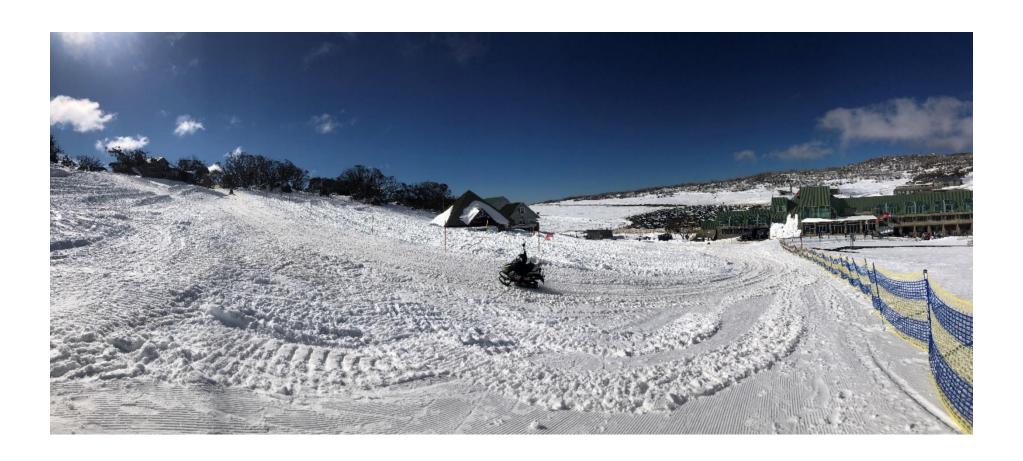
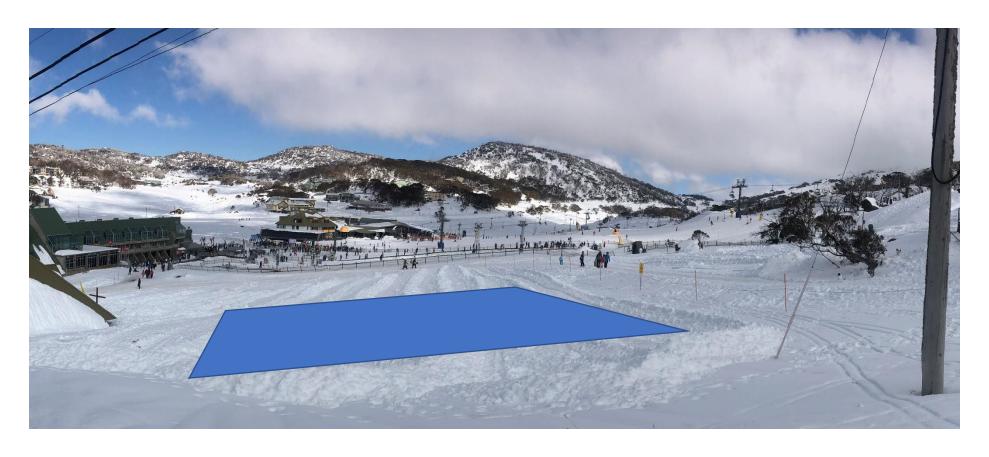
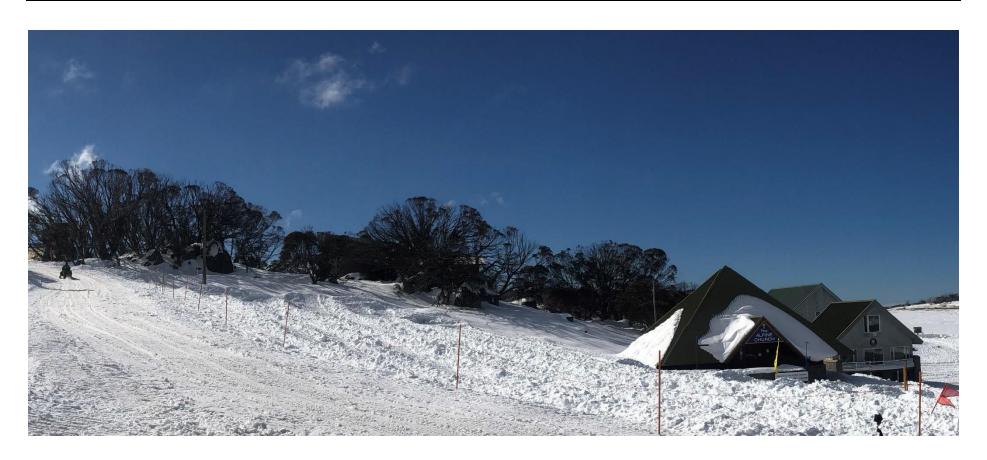
Several submissions state that the oversnow route passes through the Perisher Views lot. Whilst vehicles may illegally cut the corner of lot the lot during good snow years (saving a few seconds), the legal oversnow route exactly follows Burramys Road and is limited to a speed of 30km/h. Oversnow routes are identified in the document *Alpine Resorts Winter Access Kosciuszko National Park* (Office of Environment and Heritage, 2018), Appendix A (see below).

When the oversnow route follows Burramys Road it is a very gentle slope and a straight run past Perisher Views with good sight lines. It is common throughout Perisher for oversnow vehicles to share oversnow routes with skiers, indeed this occurs for the length of Burramys Road uphill of Perisher Views.

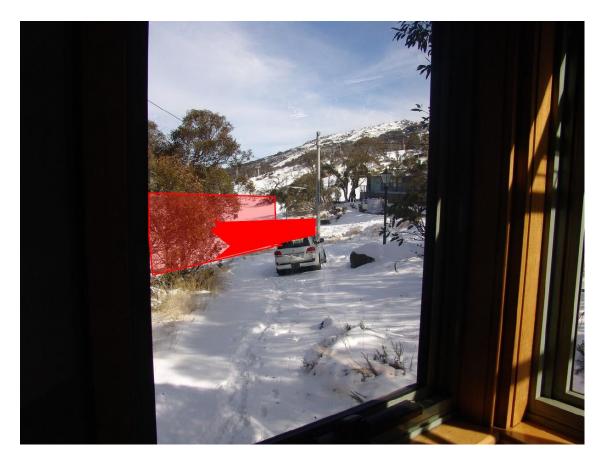
Above: KAL Submission of visual impact

The following page compares the photo provided in the KAL submission with a 3D montage of the proposed development prepared by architects Borst and Co. The KAL submission shows the building extending to the telegraph pole and being well above the height of Burramys Road. Whereas the plans below show the closest eve and wall being located approximately 8.8m and 10m respectively southeast of the telegraph pole. The architects photomontages demonstrates that the proposed building is barely visible from KAL.

The RL of the top floor level is 1743.50, this is 10mm below Burramys Road where the concrete stormwater pipe is located, whereas the KAL submissions shows the building being well above Burramys Road at this location.

Significant effort has been put into minimising impacts on the views to KAL including recessing the north-western corner of the building, whilst also maximising the setbacks from the Alpine Church. As shown on the following page the proposed lodge will not impact on the views to Mount Perisher from KALs kitchen window, is located behind tree and will be barely visible.

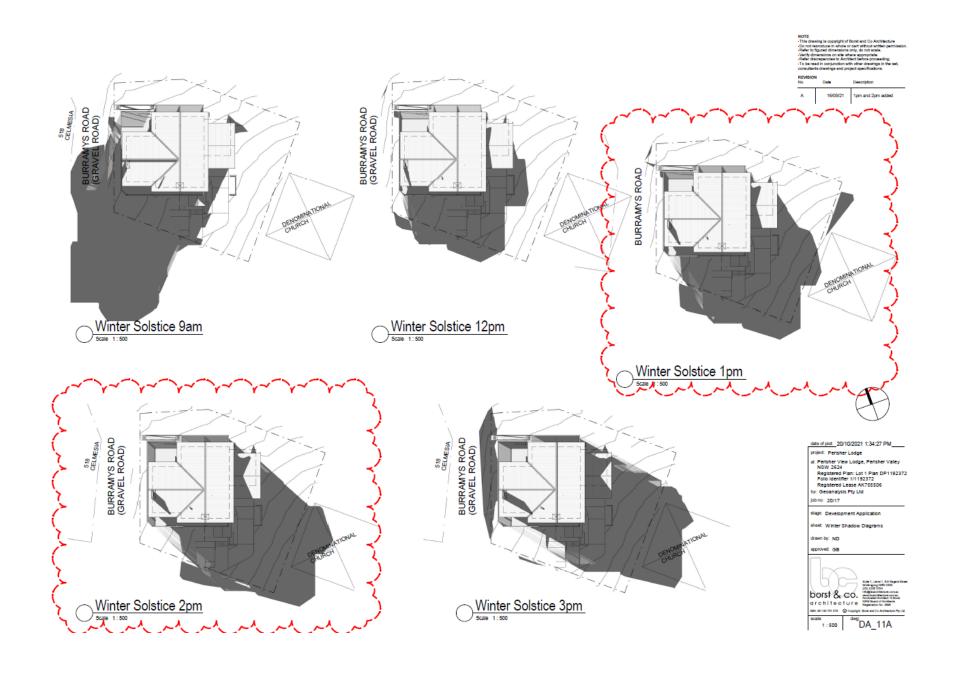
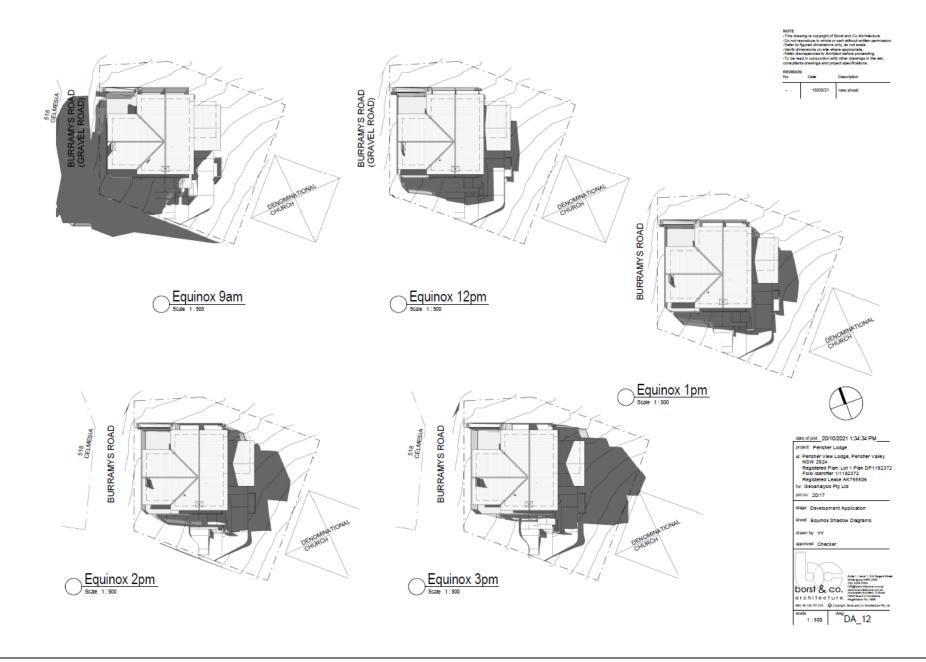
The winter solstice occurs early in the season (typically around the 22<sup>nd</sup> June) and overshadowing of the church commences at approximately 1pm, occurring later in the day each day thereafter. Church services occur from 12.30 to 1pm every Sunday. The spring equinox occurs later in the season (around 22<sup>nd</sup> September) and overshadowing at this later stage of the season starts after 3pm (shadow diagrams are provided on the following pages). Three (3) hours of sun on the solstice is a common planning standard in NSW, with the sun rising before 8am on the solstice the church would receive in excess of 5 hours of sun.

The western window of the church is recessed behind the roof structure and it is not uncommon for it be buried in snow, blocking much of the light from this aspect.

To minimise impacts on the church the proposed lodge has been relocated as close to the western boundary of the development as permissible and twisted on its axis to optimise the church prominence to front valley.
