GEOTECHNICAL SITE INVESTIGATION

Prepared by ASCT - Ballina office,
for Byron Shire Council.

Dingo Lane, Myocum, NSW 2481.

Re: Proposed Solar Farm Development at Dingo Lane, Myocum, NSW 2481.

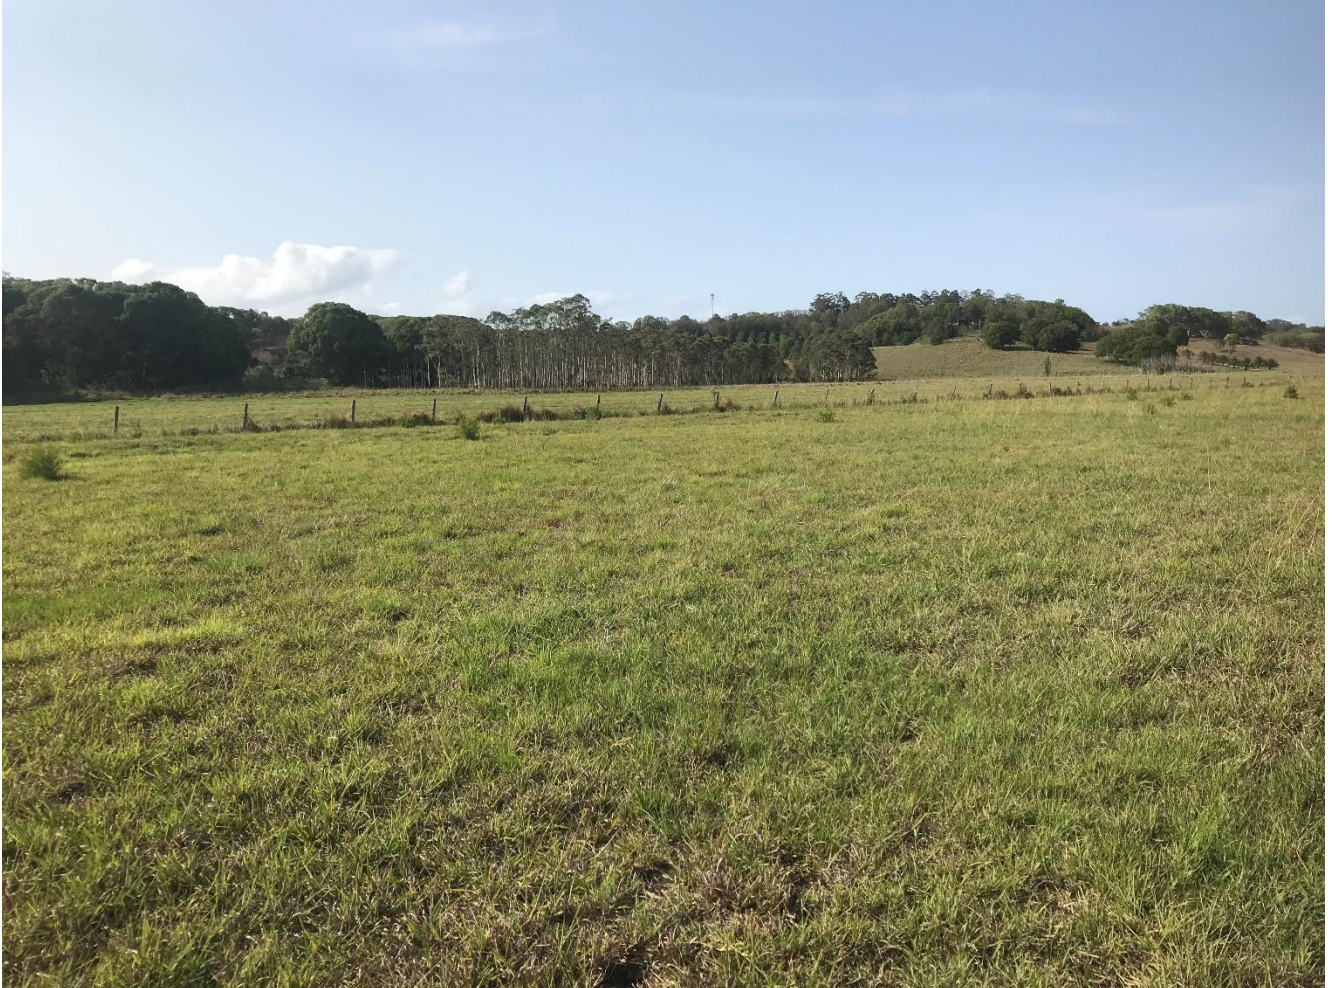
View of the site facing a southerly direction. Picture taken at test pit 1 at the northern end of the site.

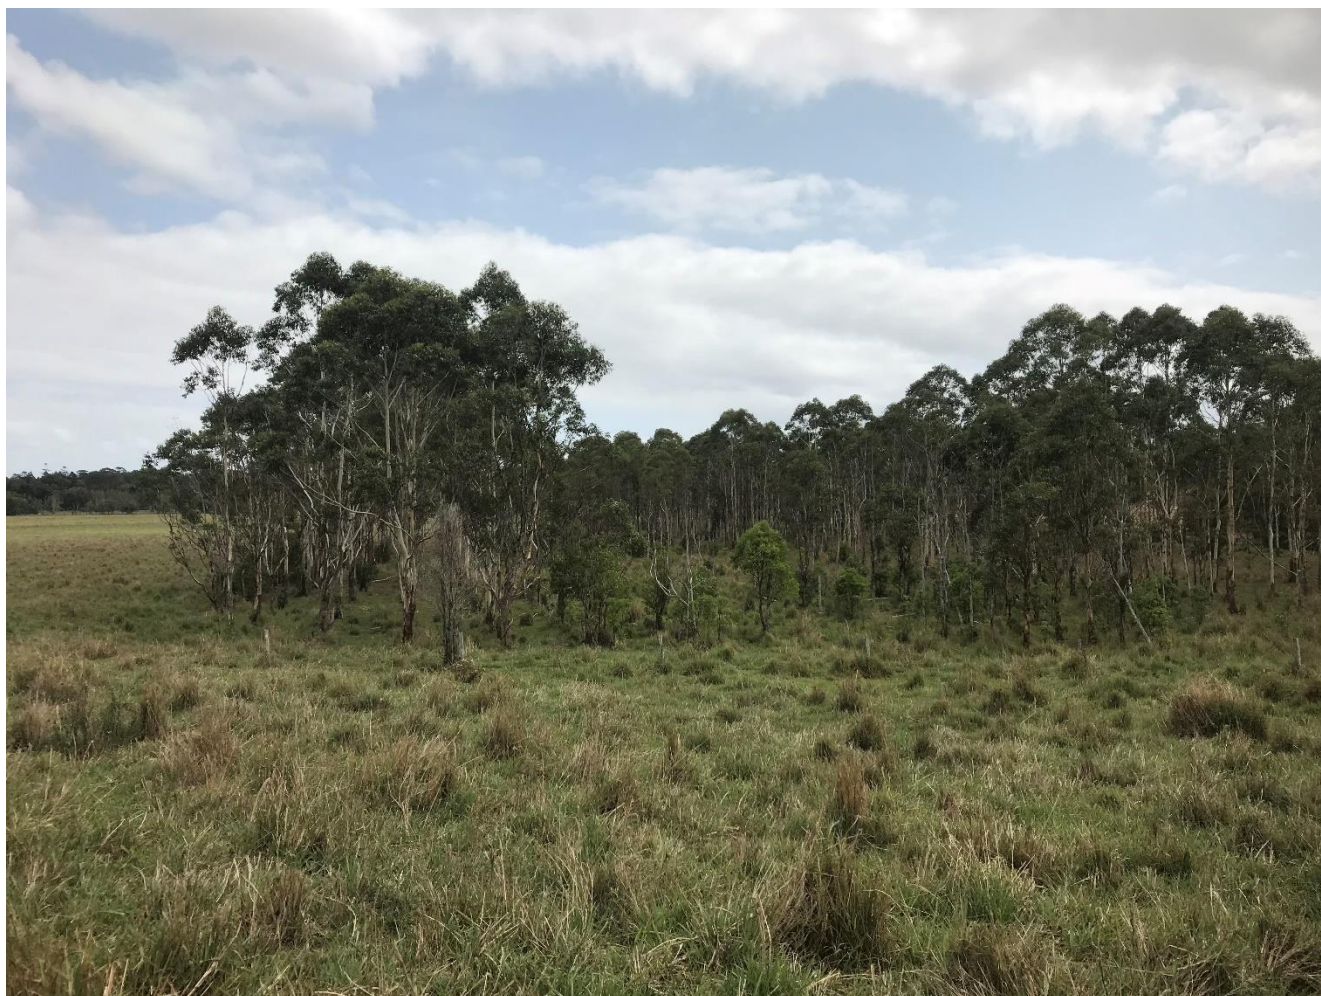
View of the site facing a northerly direction. Picture taken at borehole 3 at the southern end of the site.

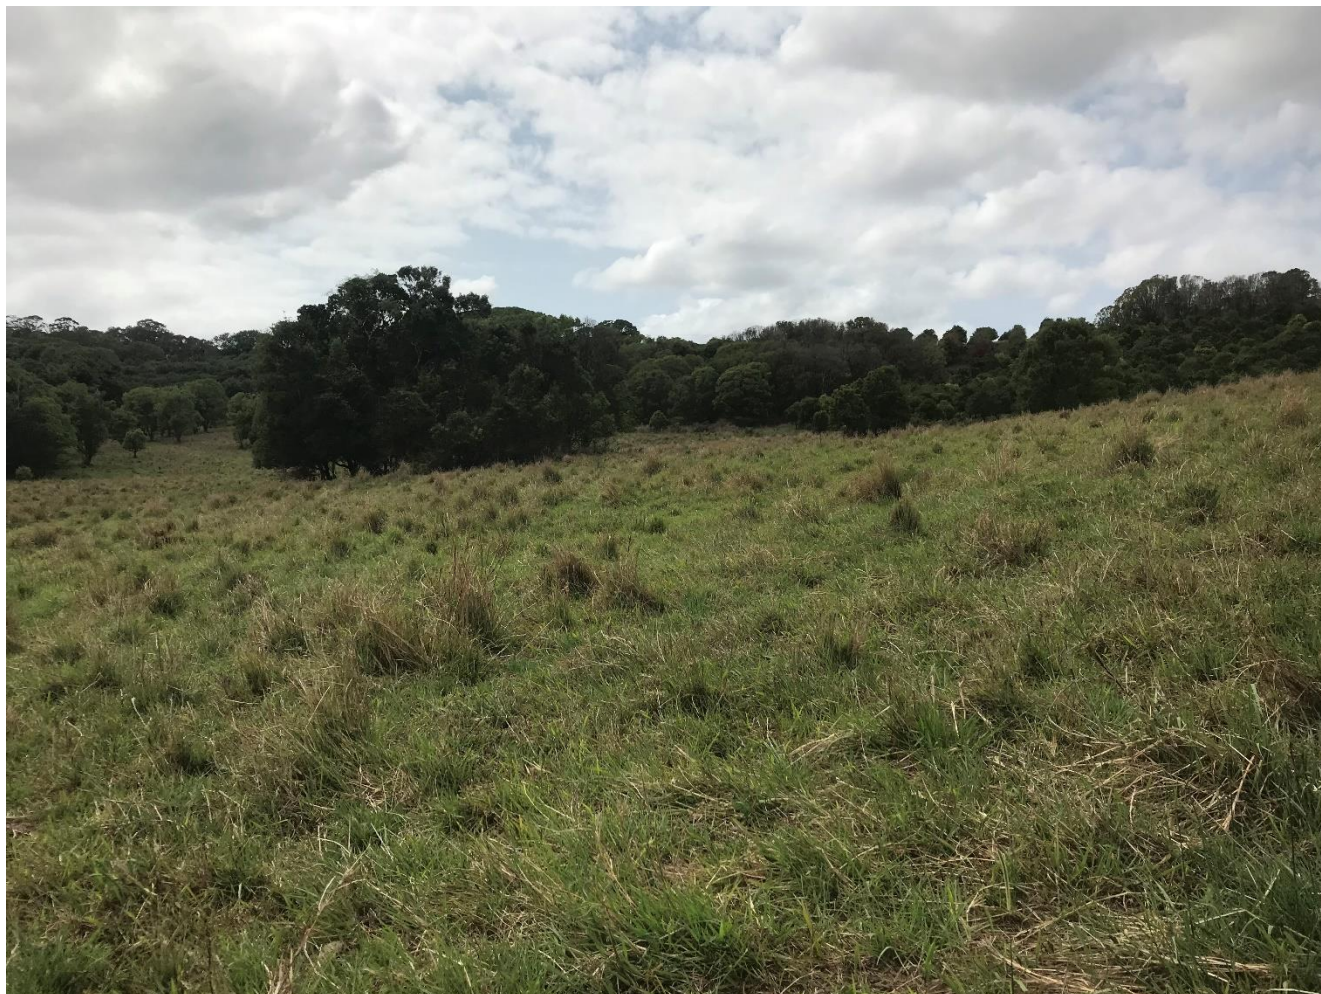
View of the southern end of the site facing a south easterly direction. Picture taken at borehole 3 looking towards test pit 2.

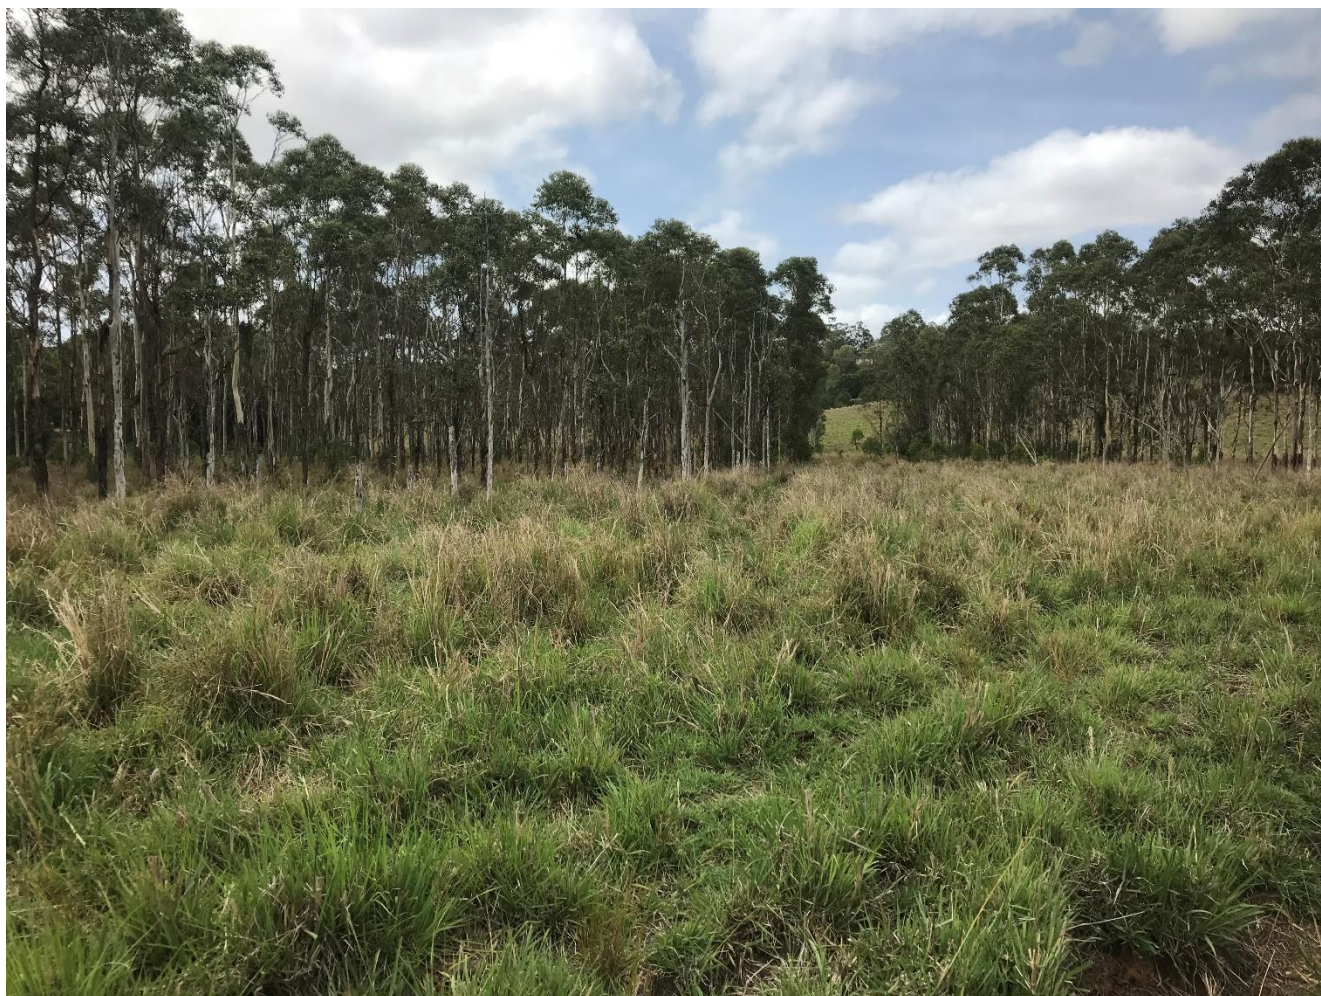
View of the site southern end of the site. Picture taken at borehole 2 facing a southerly direction.

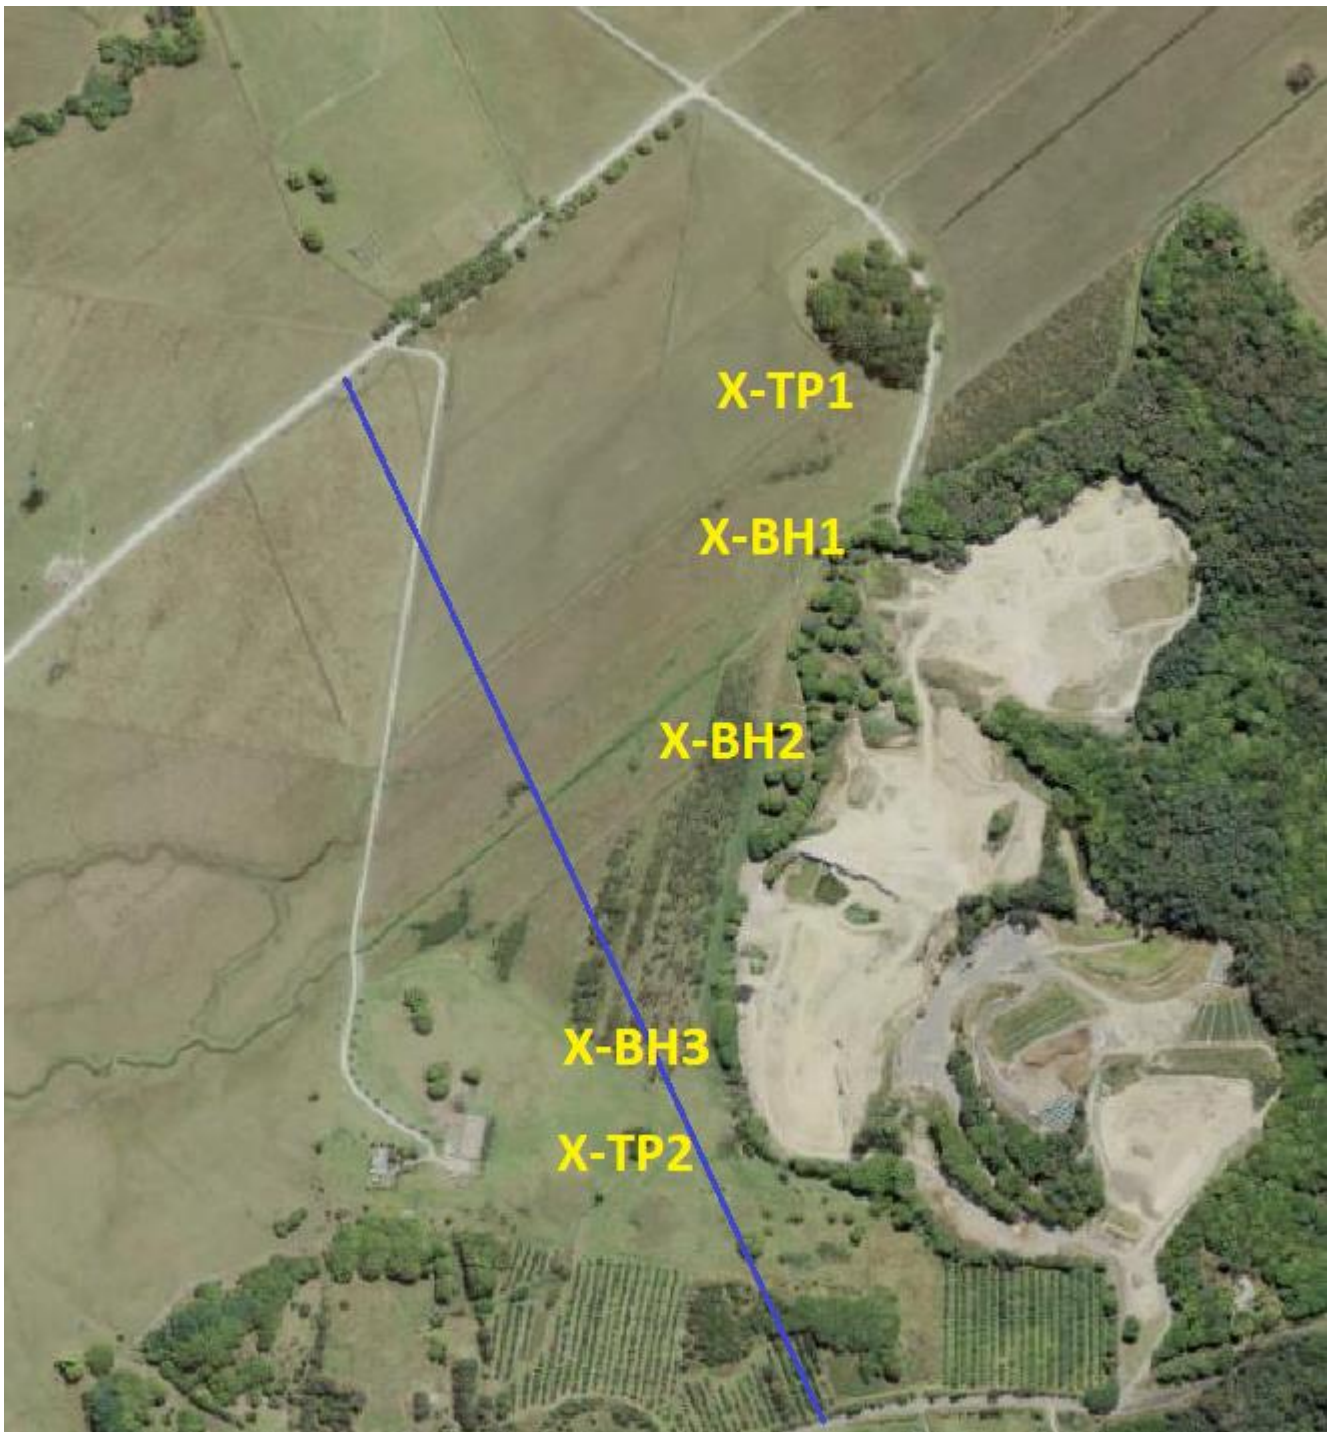
Plan of the site, with ASCT test positions. (Blue line indicates the approximate location of Telstra line)

The site as found by ASCT on the day of the field work is described below. Photo and a simple plan of the site are included in Appendix A.

Underground Telstra was observed running through the site near borehole 3 and test pit 2.

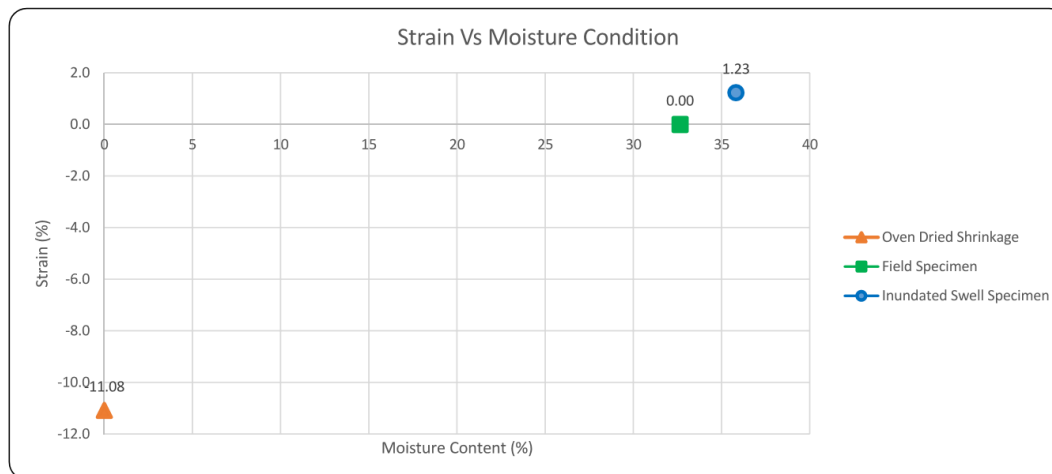
Sample Number	Sample Date	Chainage/Location	Offset	Level of Test	Test Depth
9341	18/12/2019	BH2	NA	Subgrade	0.5

Parameters	Units	Test Results	Soil Description
Shrinkage - Field Moisture Content	%	29.9	Silty Clay
Swell - Field Moisture Content	%	35.3	
Swell - Inundated Moisture Content	%	35.8	
Inert Inclusions in the soil	%	0	
Extent of Soil Crumbling	-	None	
Extent of Soil Cracking	-	Minor	
Shrink-Swell Index	%	6.5

Sampling & Test Methods (Results relate only to the items sampled/tested)	Report Remarks & Endorsement
AS 1289.7.1.1, Cl 4: Shrink Swell Index - Thin wall sampler (U50) AS 1289.7.1.1: Shrink Swell Index of a Soil

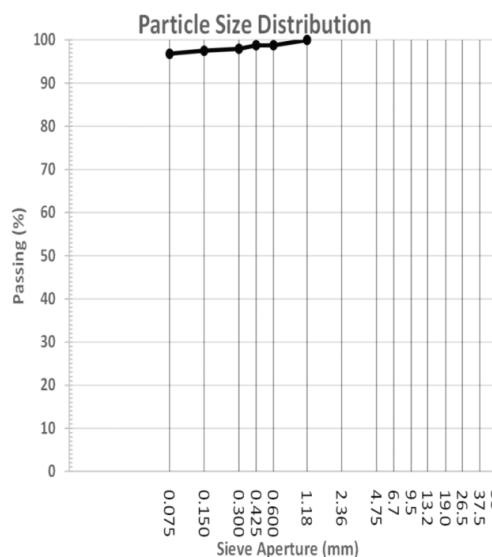
Sample Number	Sample Date	Chainage/Location	Offset	Level of Test	Test Depth
9304	18/12/2019	BH-1	NA	Subgrade	0.5m

Test Parameter	Units	Result	Specification Limits	Specification Name
Pre-Treatment	Units	Result	Specification Limits	
Retained 53.0mm Sieve	%			
Pretreatment by Weathering	%			
Pretreatment by Compaction	%			
Particle Size Distribution	Units	Result	Specification Limits	
Passing Sieve - 150mm	%			
Passing Sieve - 125mm	%			
Passing Sieve - 100mm	%			
Passing Sieve - 75mm	%			
Passing Sieve - 53mm	%			
Passing Sieve - 37.5mm	%			
Passing Sieve - 26.5mm	%			
Passing Sieve - 19.0mm	%			
Passing Sieve - 13.2mm	%			
Passing Sieve - 9.5mm	%			
Passing Sieve - 6.7mm	%			
Passing Sieve - 4.75mm	%			
Passing Sieve - 2.36mm	%			
Passing Sieve - 1.18mm	%	100		
Passing Sieve - 0.600mm	%	99		
Passing Sieve - 0.425mm	%	99		
Passing Sieve - 0.300mm	%	98		
Passing Sieve - 0.150mm	%	97		
Passing Sieve - 0.075mm	%	97

Sampling & Test Methods (Results relate only to the items sampled/tested)	Report Remarks & Endorsement
AS1289.1.2.1, Cl 6.5.3: Sampling soils - Machine - Auger AS 1289.1.1: Preparation of disturbed soil samples for testing AS 1289.3.6.1: Particle Size Distribution of a soil (Standard, by Sieving) AS 1289.3.1.2: Liquid Limit, One point Casagrande	<div>

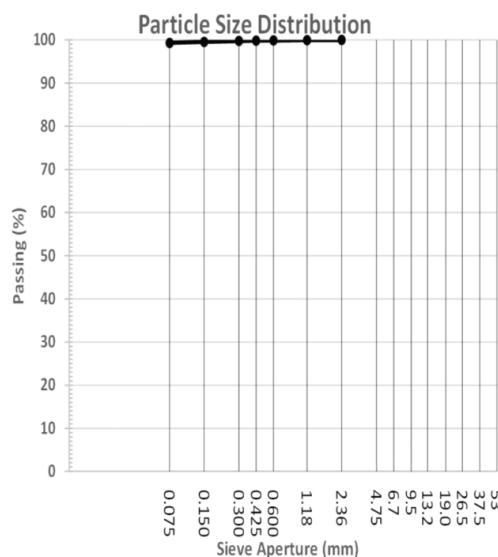
Sample Number	Sample Date	Chainage/Location	Offset	Level of Test	Test Depth
9312	18/12/2019	BH-2	NA	Subgrade	2.0m

Test Parameter	Units	Result	Specification Limits	Specification Name
Pre-Treatment	Units	Result	Specification Limits	
Retained 53.0mm Sieve	%			
Pretreatment by Weathering	%			
Pretreatment by Compaction	%			
Particle Size Distribution	Units	Result	Specification Limits	
Passing Sieve - 150mm	%			
Passing Sieve - 125mm	%			
Passing Sieve - 100mm	%			
Passing Sieve - 75mm	%			
Passing Sieve - 53mm	%			
Passing Sieve - 37.5mm	%			
Passing Sieve - 26.5mm	%			
Passing Sieve - 19.0mm	%			
Passing Sieve - 13.2mm	%			
Passing Sieve - 9.5mm	%			
Passing Sieve - 6.7mm	%			
Passing Sieve - 4.75mm	%			
Passing Sieve - 2.36mm	%	100		
Passing Sieve - 1.18mm	%	100		
Passing Sieve - 0.600mm	%	100		
Passing Sieve - 0.425mm	%	100		
Passing Sieve - 0.300mm	%	100		
Passing Sieve - 0.150mm	%	100		
Passing Sieve - 0.075mm	%	99

Sampling & Test Methods (Results relate only to the items sampled/tested)	Report Remarks & Endorsement
AS1289.1.2.1, Cl 6.5.3: Sampling soils - Machine - Auger AS 1289.1.1: Preparation of disturbed soil samples for testing AS 1289.3.6.1: Particle Size Distribution of a soil (Standard, by Sieving) AS 1289.3.1.2: Liquid Limit, One point Casagrande	<div>

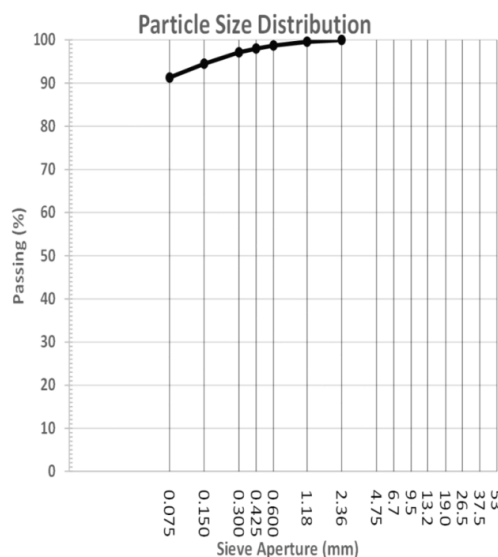
Sample Number	Sample Date	Chainage/Location	Offset	Level of Test	Test Depth
9316	18/12/2019	BH-3	NA	Subgrade	1.5m

Test Parameter	Units	Result	Specification Limits	Specification Name
Pre-Treatment	Units	Result	Specification Limits	
Retained 53.0mm Sieve	%			
Pretreatment by Weathering	%			
Pretreatment by Compaction	%			
Particle Size Distribution	Units	Result	Specification Limits	
Passing Sieve - 150mm	%			
Passing Sieve - 125mm	%			
Passing Sieve - 100mm	%			
Passing Sieve - 75mm	%			
Passing Sieve - 53mm	%			
Passing Sieve - 37.5mm	%			
Passing Sieve - 26.5mm	%			
Passing Sieve - 19.0mm	%			
Passing Sieve - 13.2mm	%			
Passing Sieve - 9.5mm	%			
Passing Sieve - 6.7mm	%			
Passing Sieve - 4.75mm	%			
Passing Sieve - 2.36mm	%	100		
Passing Sieve - 1.18mm	%	100		
Passing Sieve - 0.600mm	%	99		
Passing Sieve - 0.425mm	%	98		
Passing Sieve - 0.300mm	%	97		
Passing Sieve - 0.150mm	%	94		
Passing Sieve - 0.075mm	%	91

Sampling & Test Methods (Results relate only to the items sampled/tested)	Report Remarks & Endorsement
AS1289.1.2.1, Cl 6.5.3: Sampling soils - Machine - Auger AS 1289.1.1: Preparation of disturbed soil samples for testing AS 1289.3.6.1: Particle Size Distribution of a soil (Standard, by Sieving) AS 1289.3.1.2: Liquid Limit, One point Casagrande	<div>

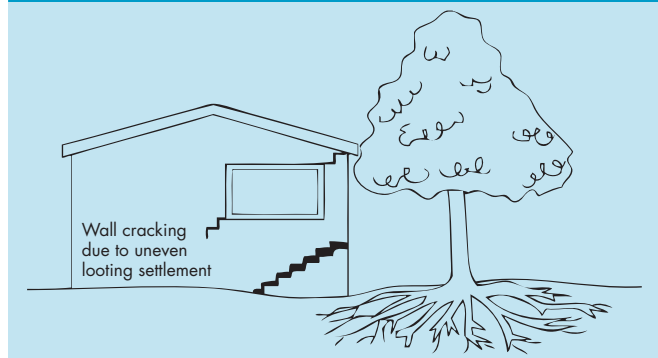
Trees can cause shrinkage and damage

As the weather pattern changes and the soil begins to dry out, the external footings will be first affected, beginning with the locations where the sun's effect is strongest. This has the effect of lowering the

external footings. The doming is accentuated and cracking reduces or disappears where it occurred because of dishing, but other cracks open up. The roof lines may become convex.

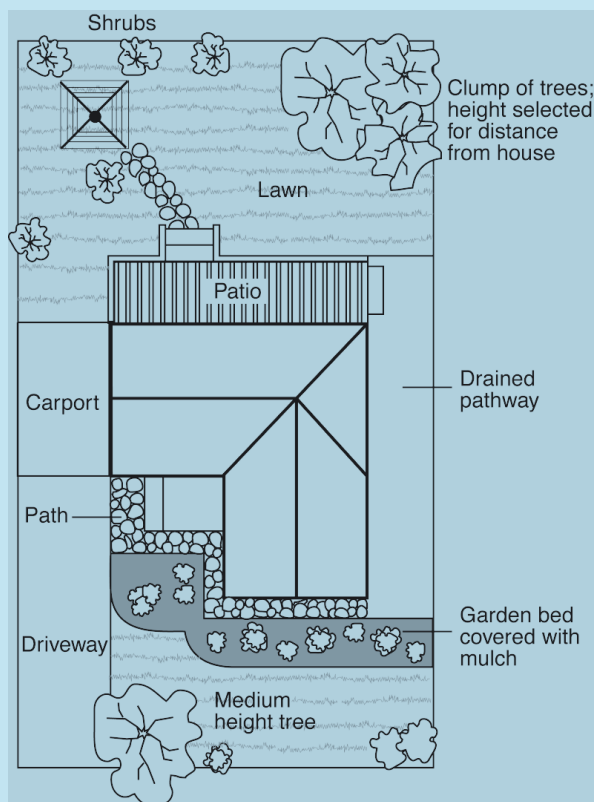
Gardens for a reactive site

extend outwards a minimum of 900 mm (more in highly reactive soil) and should have a minimum fall away from the building of 1:60. The finished paving should be no less than 100 mm below brick vent bases.
