## AS2870-2011 SITE CLASSIFICATION & SALINITY

CLIENT:  
Hudson Homes Pty Ltd  
PO Box W246  
PARRAMATTA NSW 2123

SITE ADDRESS:  
No.44 Balmoral Avenue, Croydon Park NSW

Our REF: AWT66101

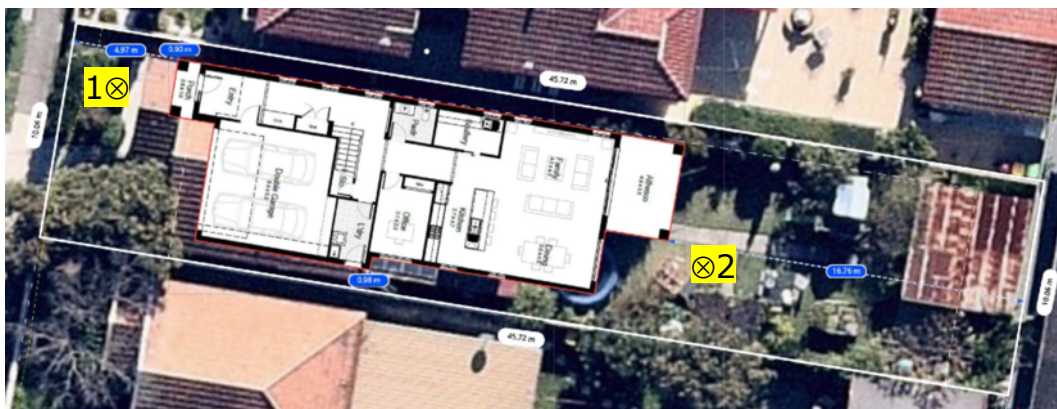
**SITE SKETCH (Not to Scale)**
