## **Geotechnical Investigation**

Our ref: 5920-G1 Rev 3  
23 December 2022

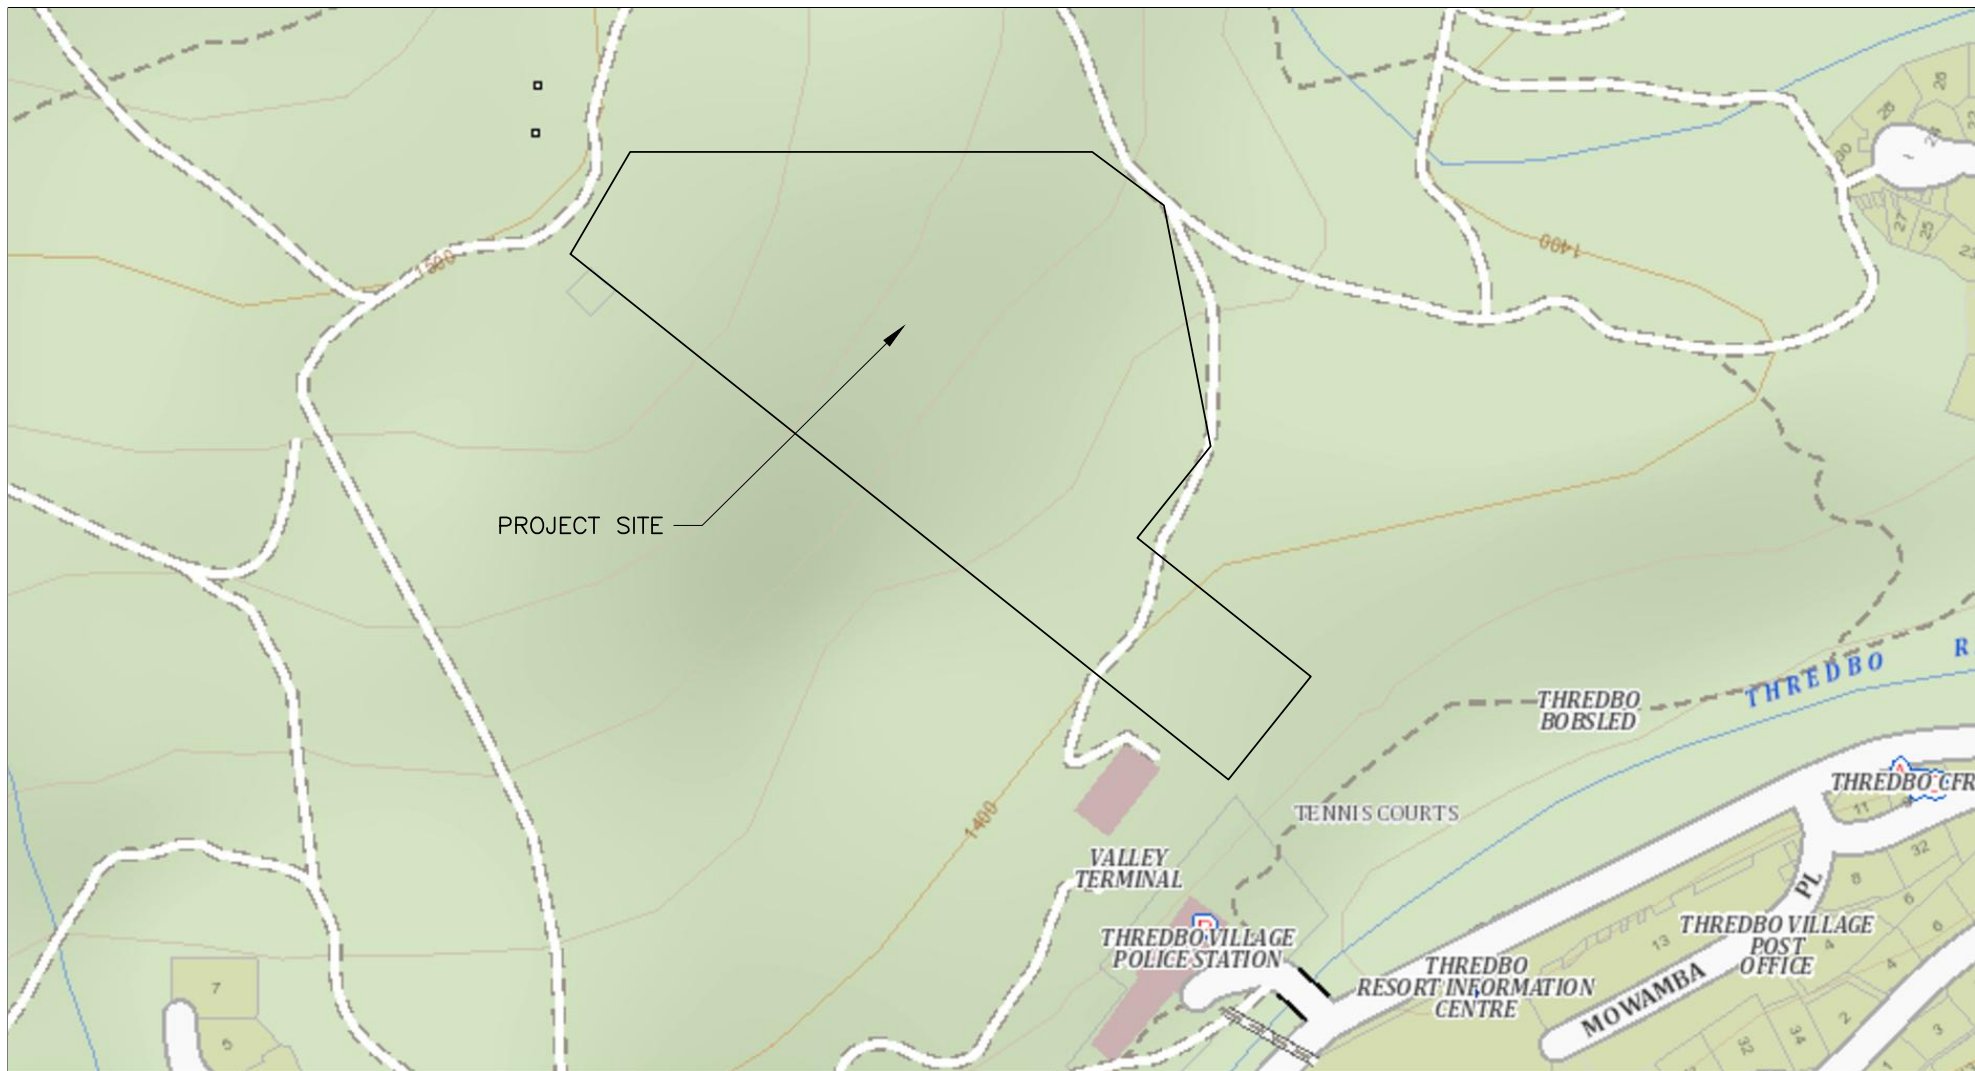
APPROXIMATE ONLY – SUBJECT TO DETAIL SURVEY.

SOURCE: SIX MAPS

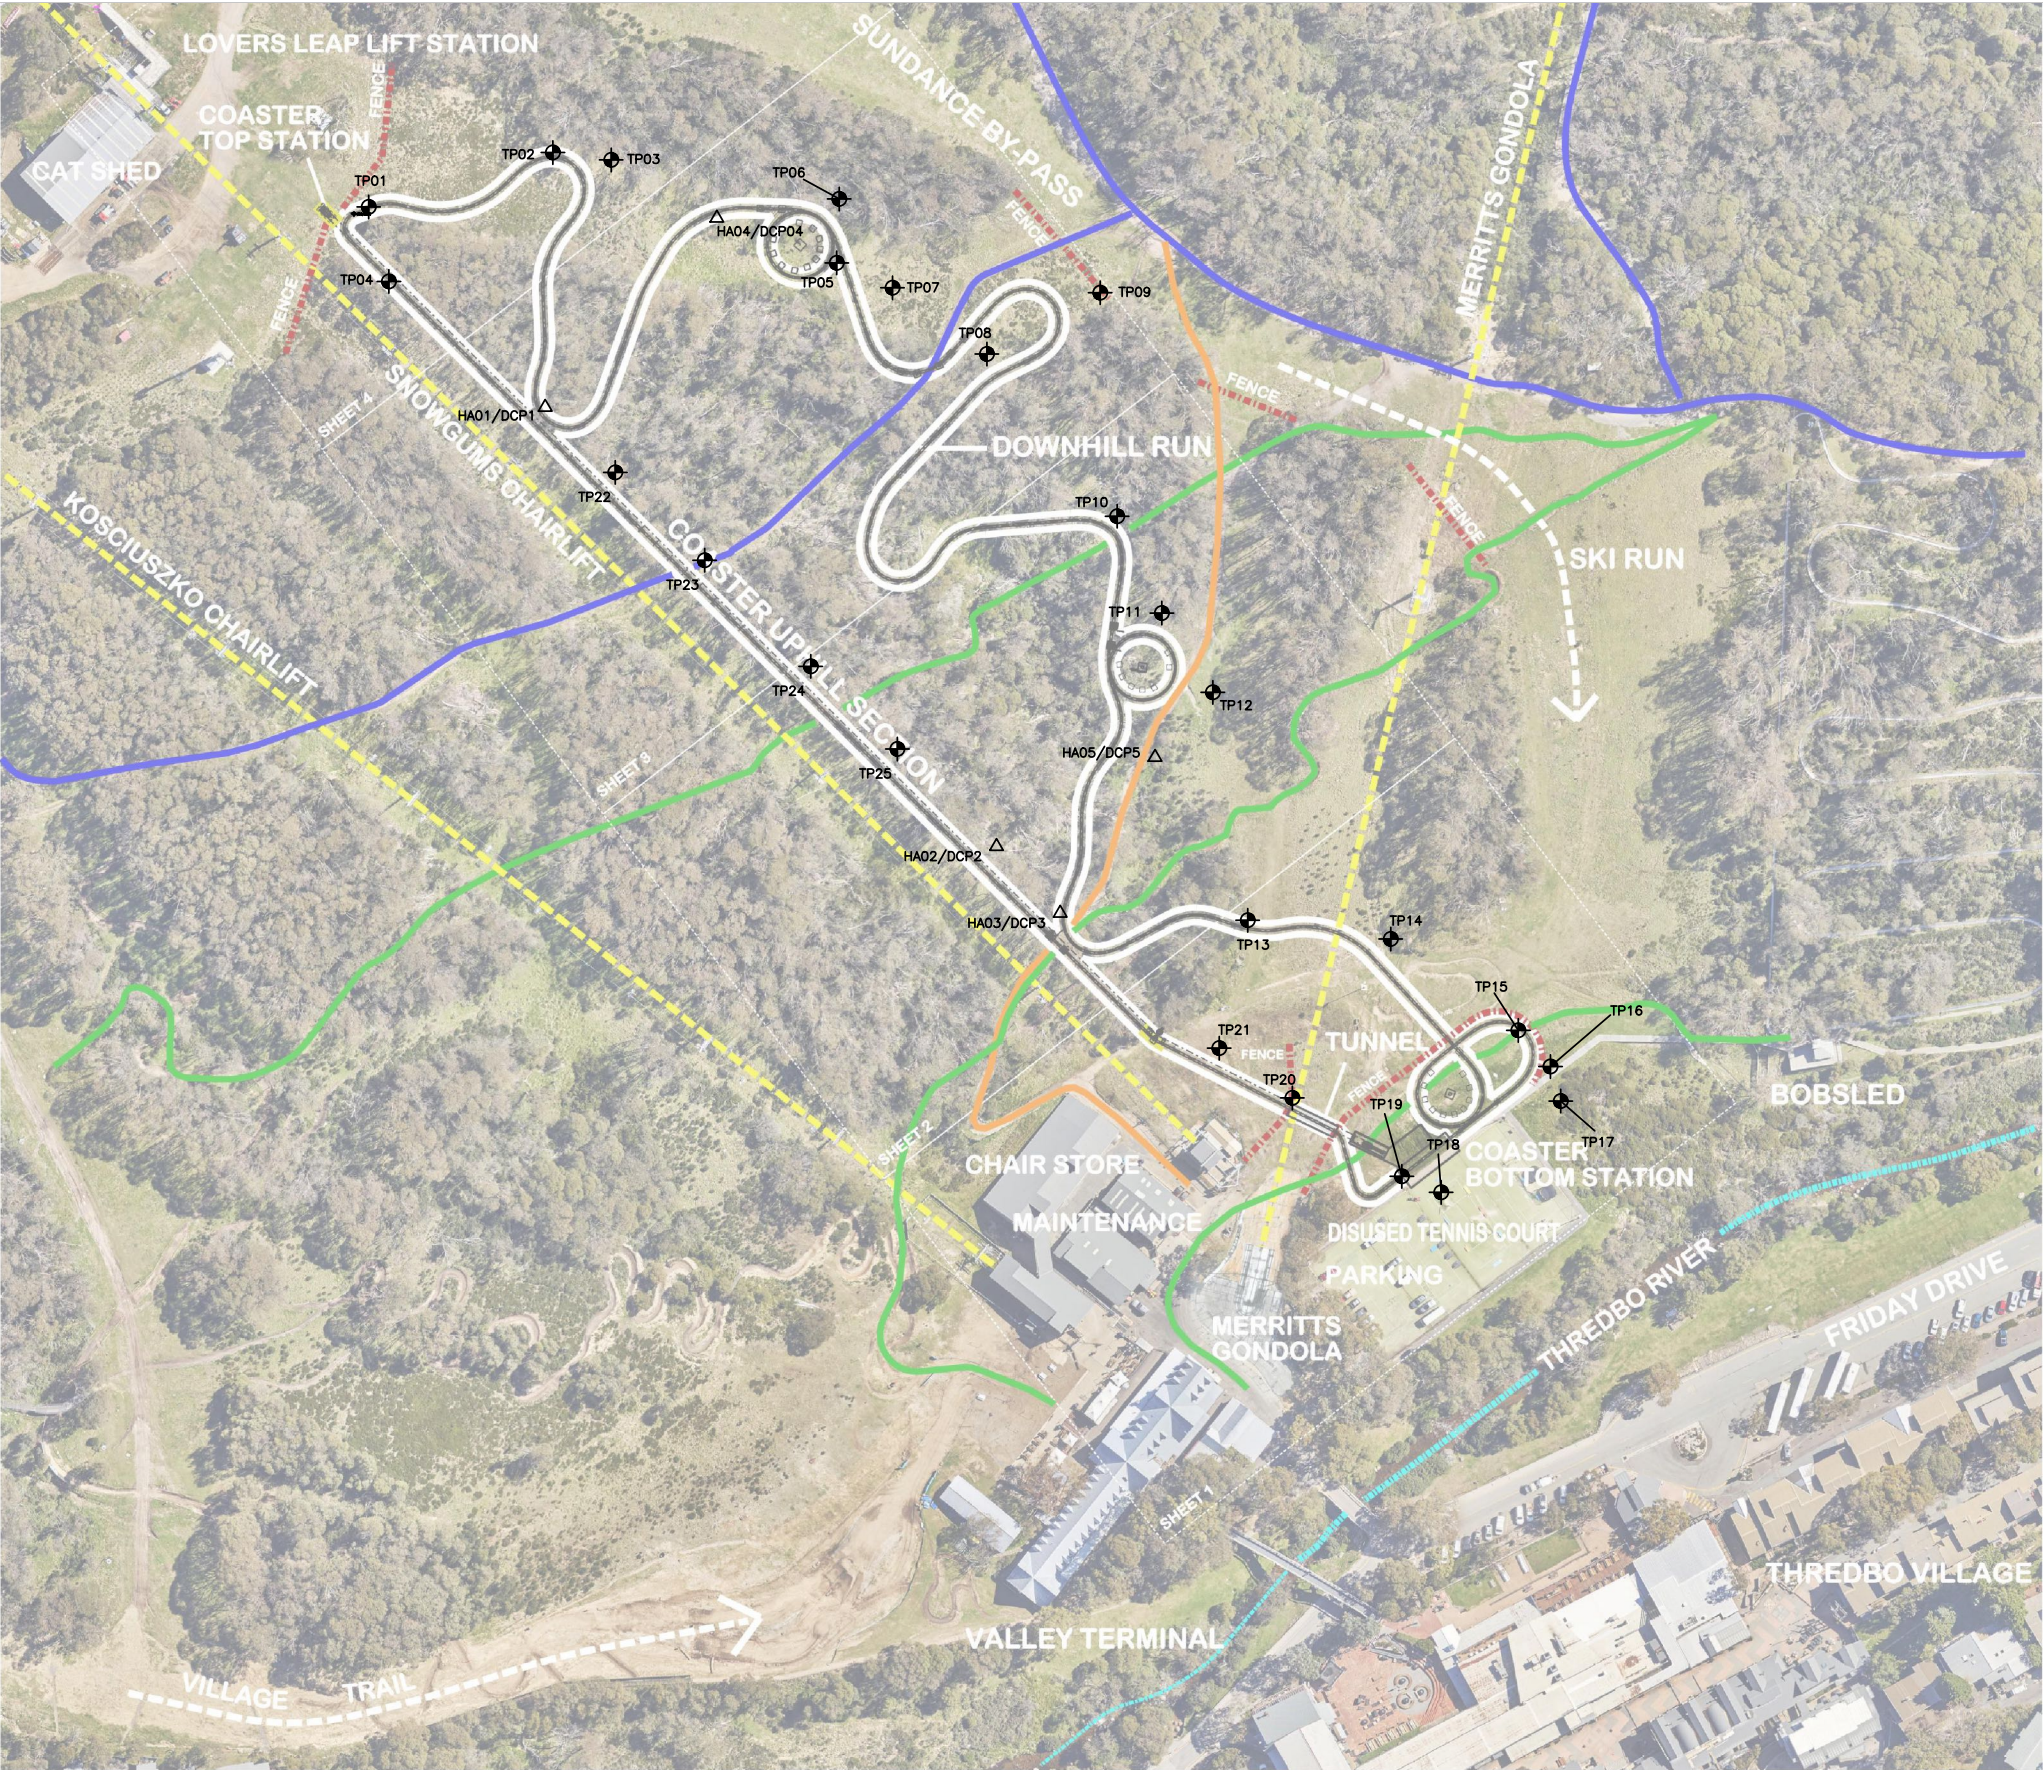
**job no.:**  
5920  
**fig:**  
2  
**issue:**  
B

APPROXIMATE ONLY –  
SUBJECT TO DETAIL SURVEY.  
SOURCE: SITE ANALYSIS PLAN, PREPARED BY DJRD  
ARCHITECTS, JOB 20413, DWG NO A1.218, REV B,  
dated 14 APRIL 2022.  
THIS DRAWING IS USED TO ILLUSTRATE TEST  
LOCATIONS ONLY, AND MUST NOT BE USED FOR  
ANY OTHER PURPOSE. COPYRIGHT OF SOURCE  
DRAWING REMAINS WITH DJRD ARCHITECTS.

4.1 (b)	Plans and sections of the site and related land from survey and field measurements with contours and key features identified, including the locations of the proposed development, buildings/structures on both the subject site and adjoining site, stormwater drainage, sub-surface drainage, water supply and sewerage pipelines, trees, and other identifiable geotechnical hazards.	Figure 1 – Site Locality Plan Figure 2 – Test Locations

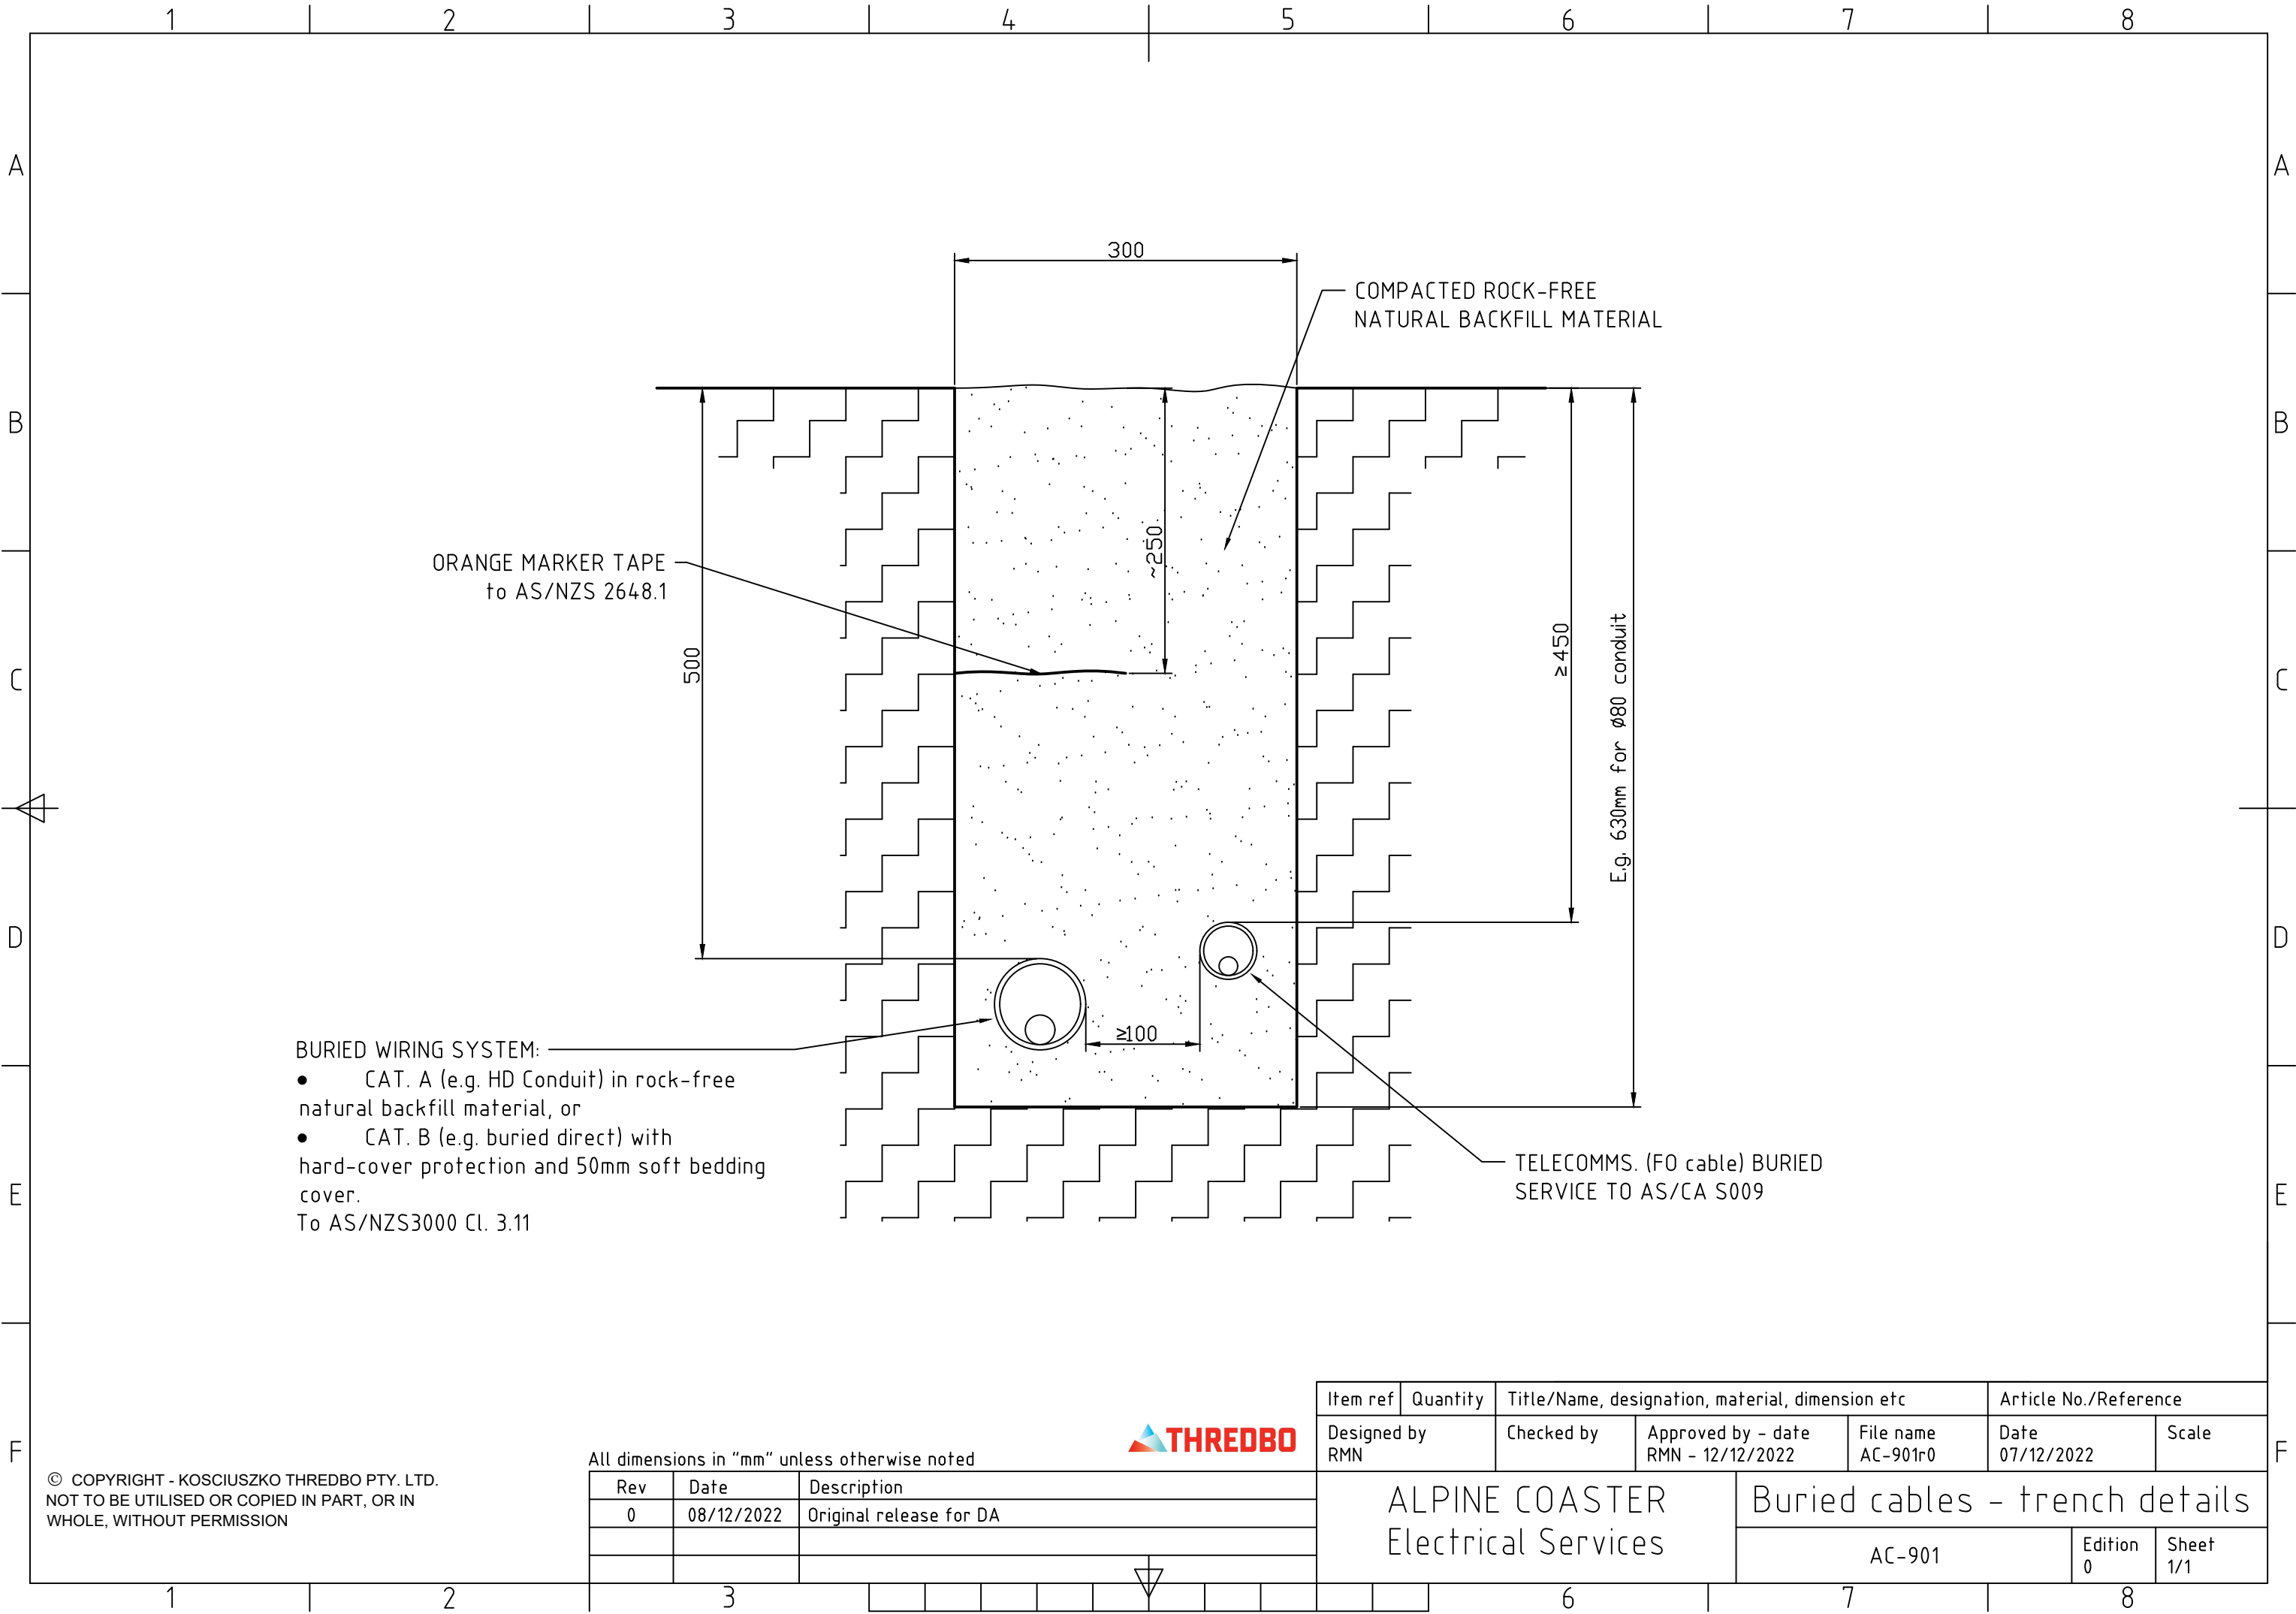
Item ref	Quantity	Title/Name, designation, material, dimension etc			Article No./Reference	
Designed by RMN	Checked by	Approved by - date RMN - 12/12/2022	File name AC-901r0	Date 07/12/2022	Scale	
ALPINE COASTER Electrical Services			Buried cables - trench details			
			AC-901		Edition 0	Sheet 1/1

BURIED WIRING SYSTEM:

- CAT. A (e.g. HD Conduit) in rock-free natural backfill material, or
- CAT. B (e.g. buried direct) with hard-cover protection and 50mm soft bedding cover.

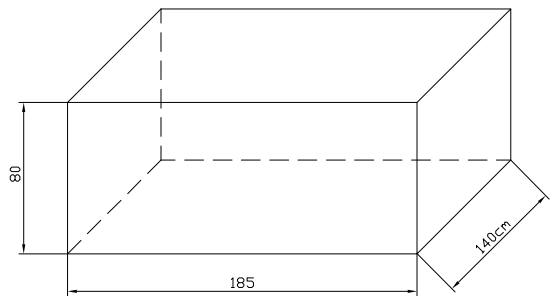
foundation 185 cm x 140 cm x 80 cm

concrete class C25/30.  
concrete cover minimum 5cm  
material Q257A

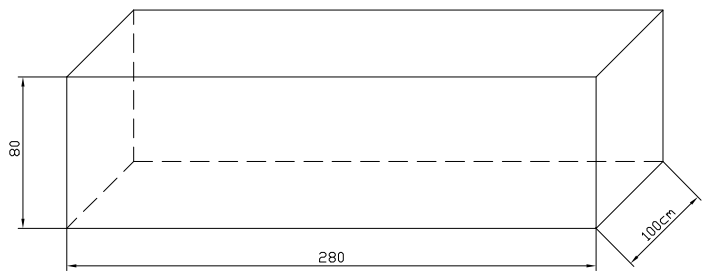
foundation 280 cm x 100 cm x 80 cm

concrete class C25/30.  
concrete cover minimum 5cm  
material Q257A

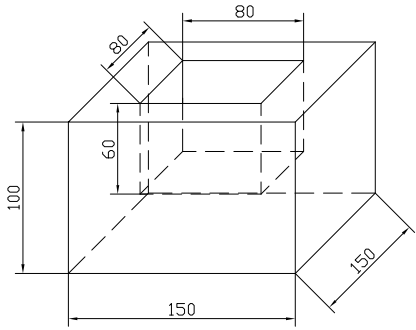
foundation 150x150x100  
quiver 80x80x60

concrete class C25/30.  
concrete cover minimum 5cm

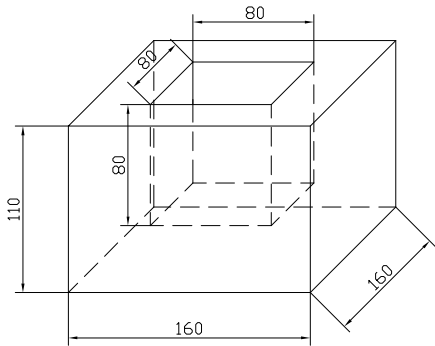
foundation 160x160x110  
quiver 80x80x80

concrete class C25/30.  
concrete cover minimum 5cm

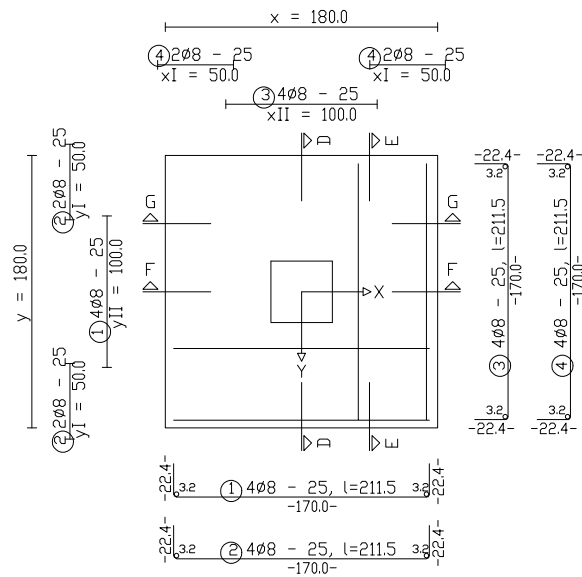
A-A. Top view of  
bottom plate reinforcement

concrete class C25/30.  
concrete cover minimum 5cm

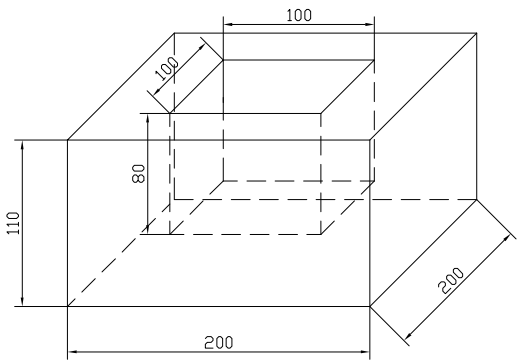
foundation 200x200x110  
quiver 100x100x80

concrete class C25/30.  
concrete cover minimum 5cm

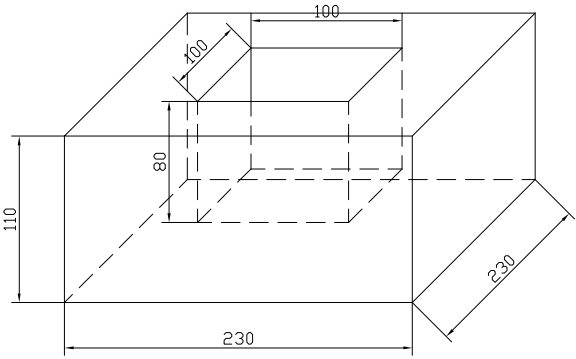
foundation 230x230x110  
quiver 100x100x80

concrete class C25/30.  
concrete cover minimum 5cm

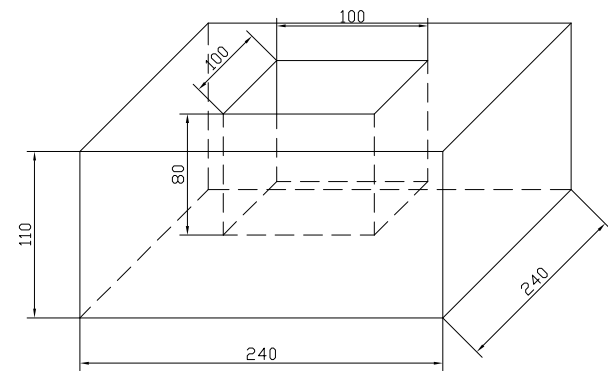
foundation 240x240x110  
quiver 100x100x80

concrete class C25/30.  
concrete cover minimum 5cm

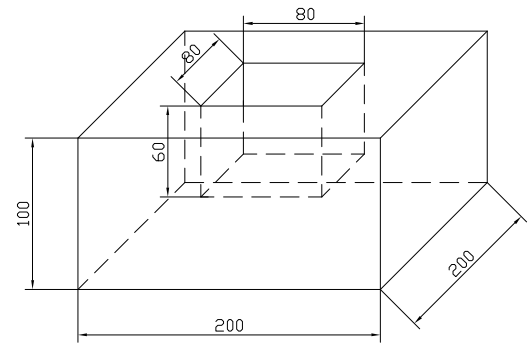
foundation 200x200x100  
quiver 80x80x60

concrete class C25/30.  
concrete cover minimum 5cm

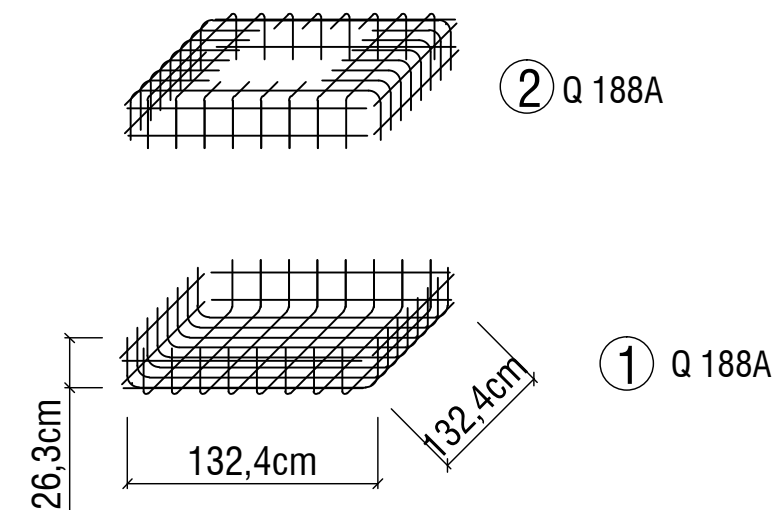
A 3D diagram of a rectangular prism. The front face is a square with side length 143 cm. The depth of the prism is 100 cm. A smaller rectangular prism is positioned inside the larger one, with its front face tilted. The dimensions of the smaller prism are 50 cm (width), 60 cm (height), and 70 cm (depth).

position 1 and 2 :  
mesh Q188 A  
material BSt 500 M (A)

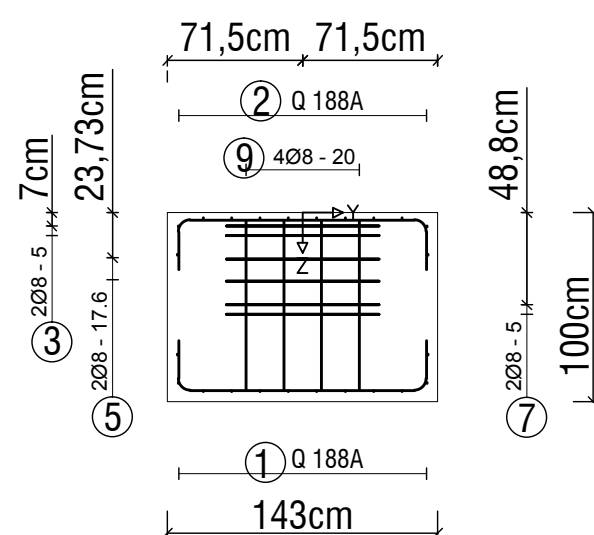
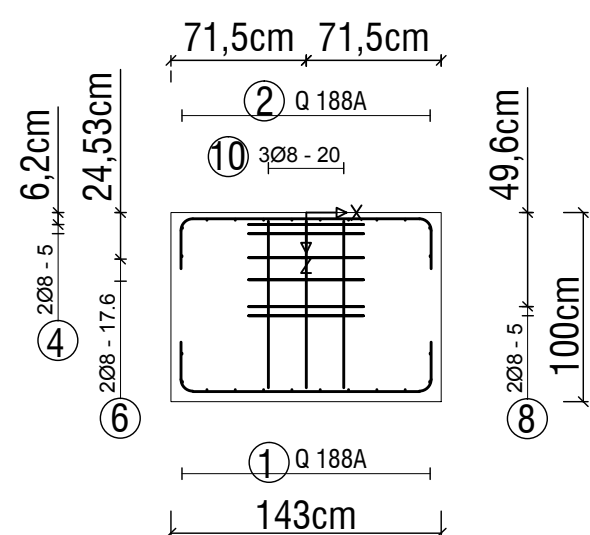
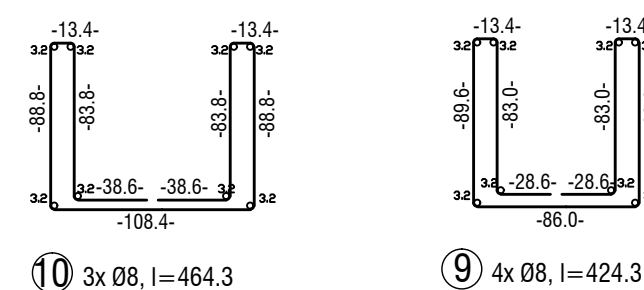
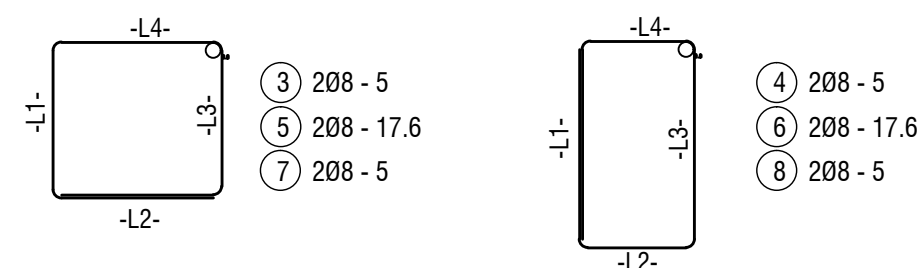
G-G: Section parallel to bucket wall in x-direction

mesh on top and bottom									
Pos Nr.	main reinforcement -direction	mesh type	weight [kg/m2]	area without splice [m2]	weight per foundation netto [kg]			total weight netto [kg]	
1	y-direction	Q 188A	3.02	3.42	10.33			10.33	
2	y-direction	Q 188A	3.02	3.42	10.33			10.33	
mesh support and ring reinforcement for quiver									
Pos Nr.	quantity per foundation	total quantity	Ø mm	cutting length [cm]	total length[m]				
					Ø8	Ø10	Ø12	Ø16	
3	2		8	422.8	8.45				
4	2		8	442.8	8.86				
5	2		8	422.8	8.45				
6	2		8	442.8	8.86				
7	2		8	422.8	8.45				
8	2		8	442.8	8.86				
9	4		8	515.2	20.61				
10	3		8	557.6	16.73				
Date:				lfdm	89.27				
				kg/lfdm	0.39	0.62	0.89	1.58	
				kg	34.82				
total weight :					32.37 + 16.34 (Lagermatten) = 48.71 kg

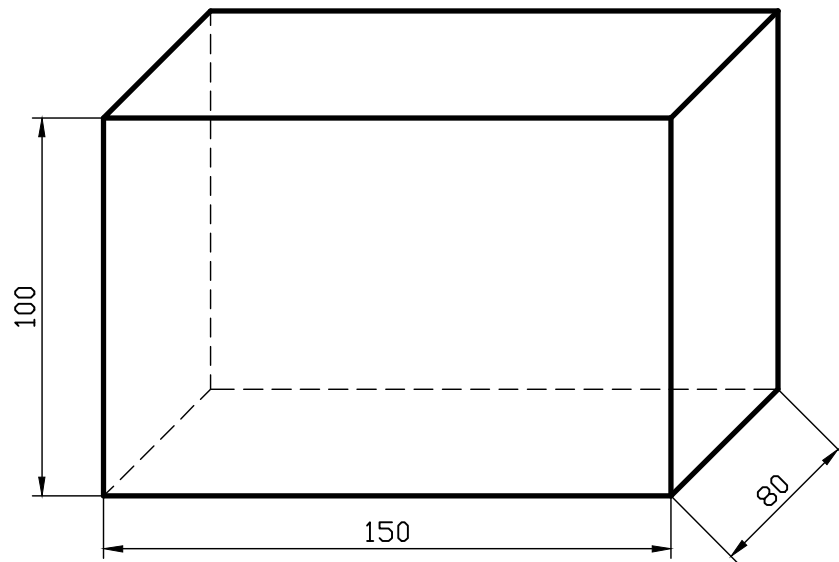
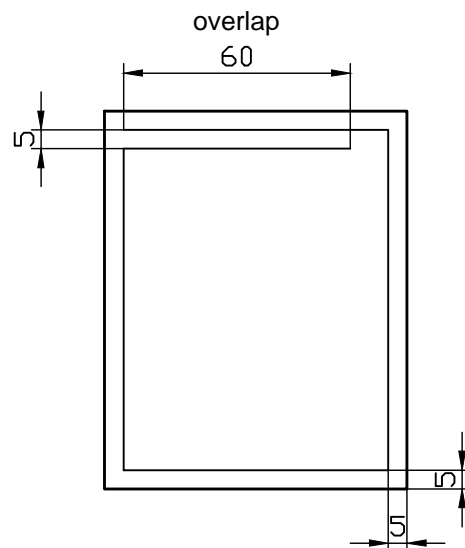
foundation 150x80x100  
concrete class: C25/30

Foundation in frost-resistant ground depending on the local conditions and requirements !  
Foundation on grown and viable soil !

Position 1 reinforcement basket 1 pces.  
reinforcing-steel-mesh Q188 (5.00 m x 2.15 m)  
surface BSt 500 M (A)  
steel-rod distances 150 mm  
steel-rod d=6 mm und d=6 mm

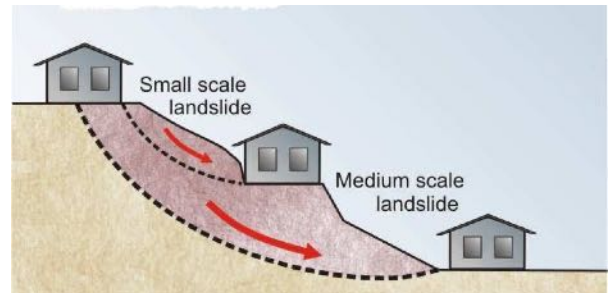
Figure 1

**Rotational or circular slip failures (Figure 1)** - can occur on moderate to very steep soil and weathered rock slopes (Table 1). The sliding surface of the moving mass tends to be deep seated. Tension cracks may open at the top of the slope and bulging may occur at the toe. The ground may move in discrete "steps" separated by long periods without movement. More rapid movement may occur after heavy rain.

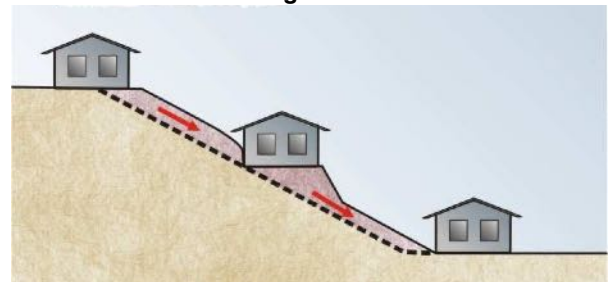
Figure 2

**Translational slip failures (Figure 2)** - tend to occur on moderate to very steep slopes (Table 1) where soil, or weak rock, overlies stronger strata. The sliding mass is often relatively shallow. It can move, or deform slowly (creep) over long periods of time. Extensive linear cracks and hummocks sometimes form along the contours. The sliding mass may accelerate after heavy rain.

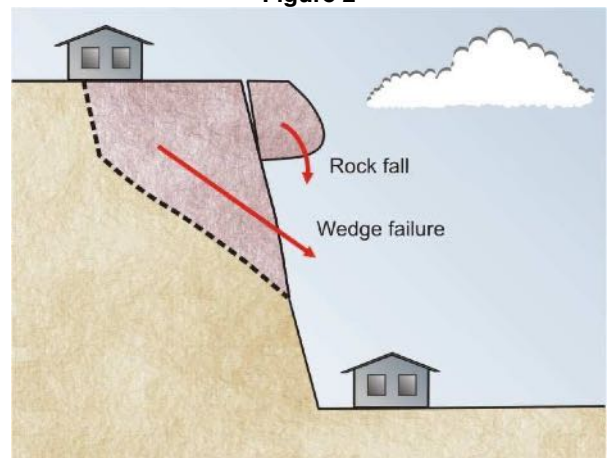
Figure 3

**Wedge failures (Figure 3)** - normally only occur on extreme slopes, or cliffs (Table 1), where discontinuities in the rock are inclined steeply downwards out of the face.

**Rock falls (Figure 3)** - tend to occur from cliffs and overhangs (Table 1).

Cliffs may remain apparently unchanged for hundreds of years. Collections of boulders at the foot of a cliff may indicate that rock falls are ongoing. Wedge failures and rock falls do not "creep". Familiarity with a particular local situation can instil a false sense of security since failure, when it occurs, is usually sudden and catastrophic.

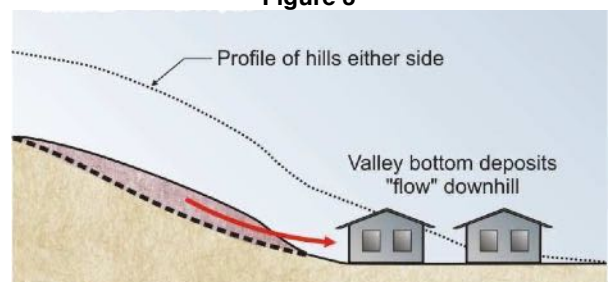
Figure 4

**Debris flows and mud slides (Figure 4)** - may occur in the foothills of ranges, where erosion has formed valleys which slope down to the plains below. The valley bottoms are often lined with loose eroded material (debris) which can "flow" if it becomes saturated during and after heavy rain. Debris flows are likely to occur with little warning; they travel a long way and often involve large volumes of soil. The consequences can be devastating.

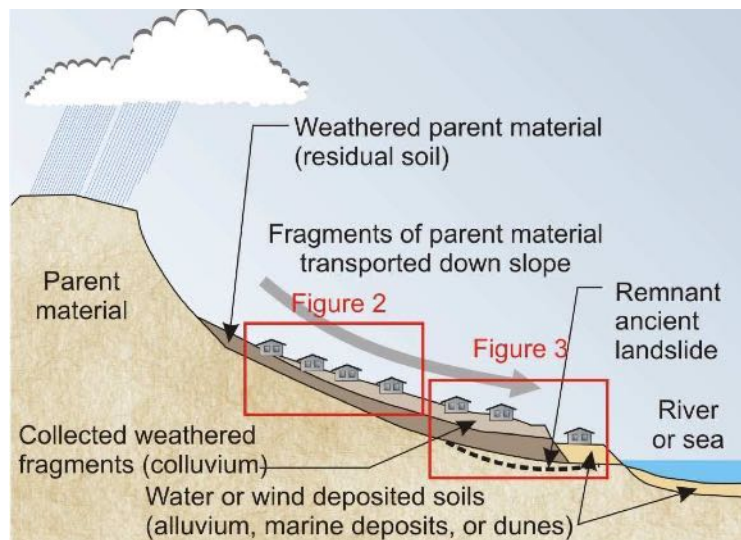
**Figure 1**

It is always worth asking the question *"why is this slope here?"*, because the answer often leads to an understanding of what might happen in the future. Slopes are usually formed by weathering (breakdown) and erosion (physical movement) of the natural ground - the "parent material". Many factors are involved including rain, wind, chemical change, temperature variation, plant growth, animal activity and our own human enthusiasm for development. The general process is outlined in Figure 1.

The upper levels of the parent material progressively weather over thousands, or millions, of years, losing strength. This can result in a surface layer which looks similar to the parent material (although its colour has probably changed) but has the strength of a soil - this is called "residual soil". At some stage the weathered surface layer is exposed to the elements and fragments are transported down the slope. In this context a fragment could be a single sand grain, a boulder, or a landslide. The time scale could be anything from a few seconds to many thousands of years. The transported fragments often collect on the lower slopes and form a new soil layer that blankets the original slope - "colluvium". If material reaches a river or the sea it is deposited as "alluvium" or as a "marine deposit". With appropriate changes in river and sea level this material can again find itself on the surface to commence another cycle of weathering and erosion. In places often, but not only, near the coast, this can include sand sized fragments which form beaches and are sometimes blown back onto the land to form dunes.

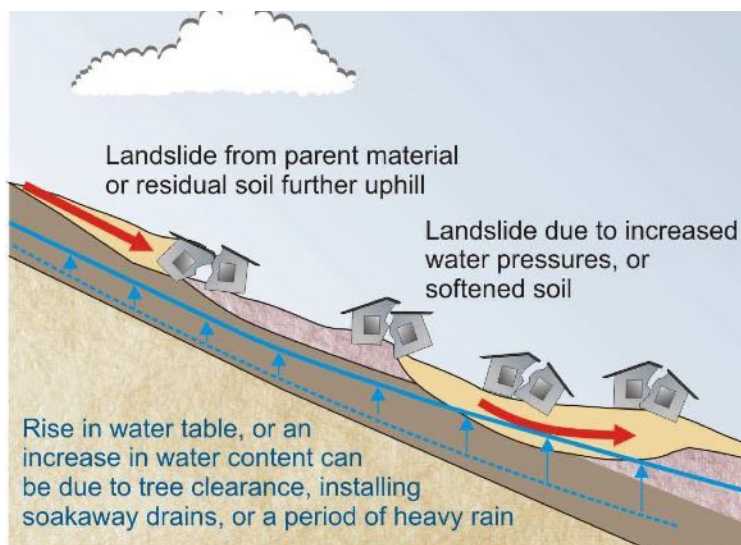
**Figure 2**

Landslides can occur almost anywhere on a soil slope. Slides can be rotational, translational, or debris flows (see GeoGuide LR2) and may have a number of causes.

- 1) Falls of the parent material or residual soil from above, due to natural weathering processes (Figure 2).
- 2) Increased moisture content and consequent softening of the soil, or a rise in the water table. These can be due to excessive tree clearance, ill-considered soak-away drainage or septic systems, or heavy rainfall (Figure 2).
- 3) Excavation without adequate support, increased surface load from fill placement, or inadequately designed shallow foundations (Figure 3).
- 4) Natural erosion at the toe of the slope due to scour by a river or the sea (Figure 3).
- 5) Re-activation of an ancient landslide (Figure 3).

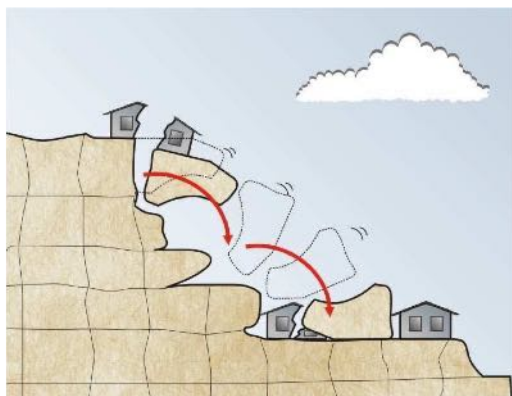
**Figure 1 - Failure of an undercut block**

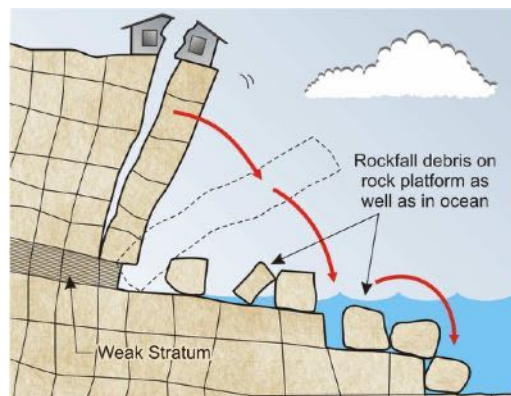
**Figure 2 - Toppling failure**

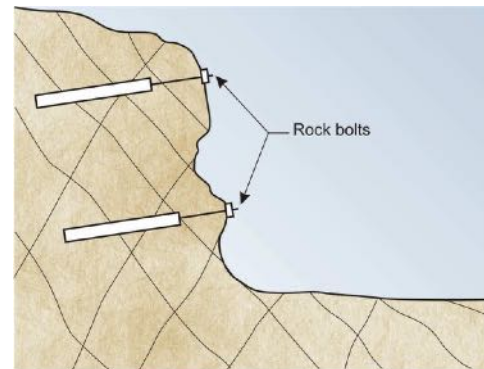
Figure 5

**Rock bolts and rock anchors** (Figure 5) - can be installed in the ground to improve its strength and prevent individual blocks from falling. Rock bolts are usually tightened using a torque wrench, whilst rock anchors carry higher loads and require jacking. Both can be designed to be "permanent" using stainless steel, or sheathing, to inhibit corrosion, but the cost can be up to 10 times that of the "temporary" alternative. You should inspect rock bolts and rock anchors for signs of water seepage, rusting and deterioration around the heads at least once every 5 years. If you notice any of these warning signs, have them checked by a geotechnical practitioner. It is recommended that you keep copies of design drawings and maintenance records (GeoGuide LR11) for the anchors on your site and pass them on to the new owner should you sell.

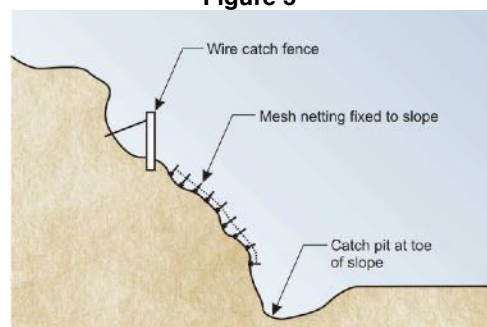
Figure 6

**Rock fall netting, catch fences and catch pits** (Figure 6) - are designed to catch or control falling rocks and prevent them from damaging nearby property. You should inspect them at least once every 5 years, and after major falls, and arrange for fallen and trapped rocks to be removed if they appear to be filling up. Check for signs of corrosion and replace steel elements and fixings before they lose significant strength.

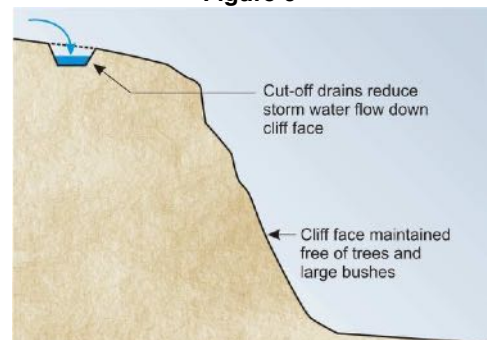
Figure 7

**Cut-off drains** (Figure 7) - can be used to intercept surface water run-off and reduce flows down the cliff face. Suitable drains are often excavated into the rock, or constructed from mounds of concrete, or stabilised soil, depending on conditions. Drains must be laid to a fall of at least 1% so they drain adequately. Frequent inspection is needed to ensure they are not blocked and continue to function as intended.

**Clear trees and large bushes** (Figure 7) - from slopes since roots can prize boulders from the face increasing the landslide hazard.

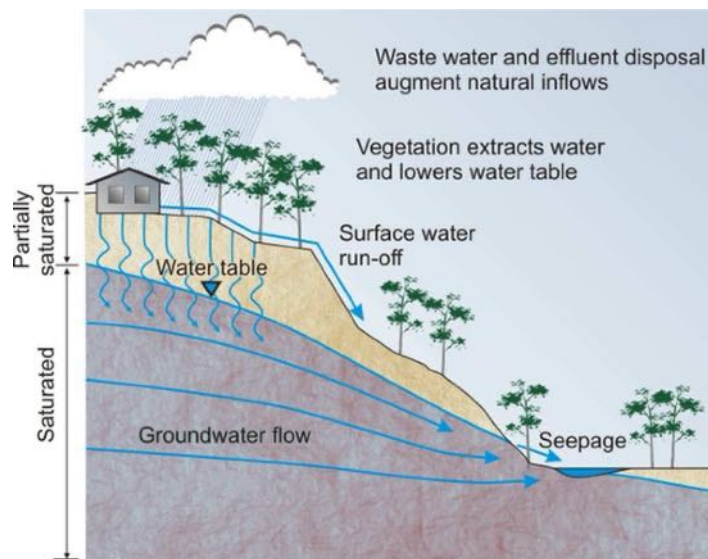
The ground is permeable and water flows through it as illustrated in Figure 1. When rain falls on the ground, some of it runs along the surface ("surface water run-off") and some soaks in, becoming groundwater. Groundwater seeps downwards along any path it can find until it meets the water table: the local level below which the ground is saturated. If it reaches the water table, groundwater either comes to a halt in what is effectively underground storage, or it continues to flow downwards, often towards a spring where it can seep out and become surface water again. Above the water table the ground is said to be "partially saturated", because it contains both water and air. Suctions can develop in the partially saturated zone which have the effect of holding the ground together and reducing the risk of a landslide. Vegetation and trees in particular draw large quantities of water out of the ground on a daily basis from the partially saturated zone. This lowers the water table and increases suctions, both of which reduce the likelihood of a landslide occurring.

**Figure 1 - Groundwater flow**

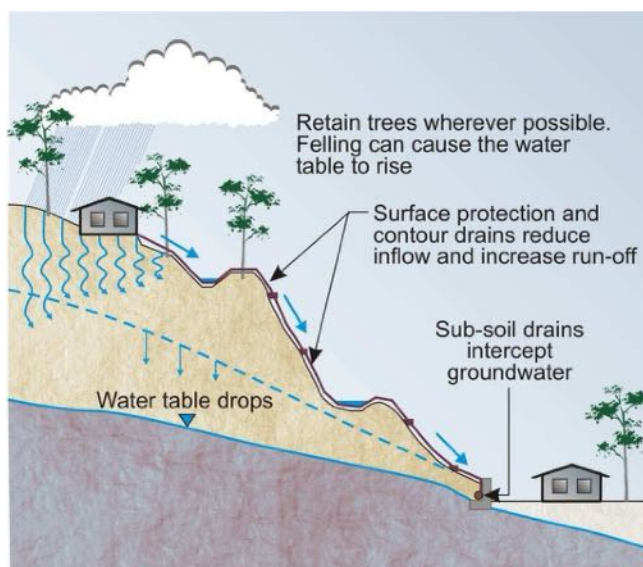
The following techniques may be considered to limit the destabilising effects of rising groundwater due to development and are illustrated in Figure 2.

Figure 2 - Techniques used to control groundwater flow

**Surface water drains** (dish drains, or table drains) - are often used to prevent scour and limit inflow to a slope. Other than in rock, they are relatively ineffective unless they have an impermeable lining. You should clear them regularly, and as required, and not less than once a year. If you live in an area with seasonal rainfall, it is best to do this near the end of the dry season. If you notice that soil or rock debris is falling from the slope above, determine the source and take appropriate action. This may mean you have to seek advice from a geotechnical practitioner.

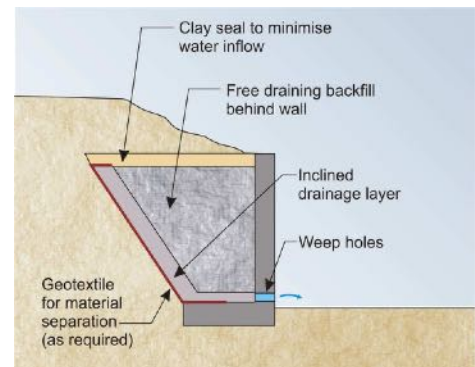
**Figure 1- Typical formed concrete wall**

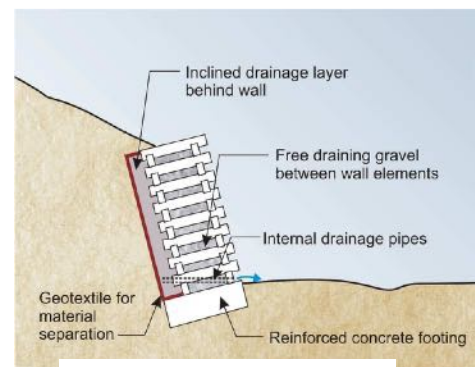
**Figure 2 -Typical crib**

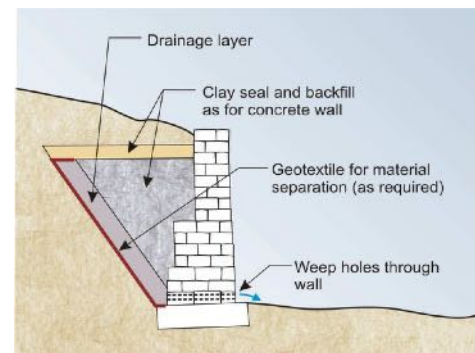
**Masonry walls: natural stone, brick, or interlocking blocks** (Figure 3) - more than about 1m high, should be wider at the bottom than at the top and include specific measures to permit drainage of the backfill. They should be checked as for formed concrete walls. Natural stone walls should be inspected for signs of deterioration of the individual blocks: strength loss, corners becoming rounded, cracks appearing, or debris from the blocks collecting at the foot of the wall.

**Figure 3 -Typical masonry wall**

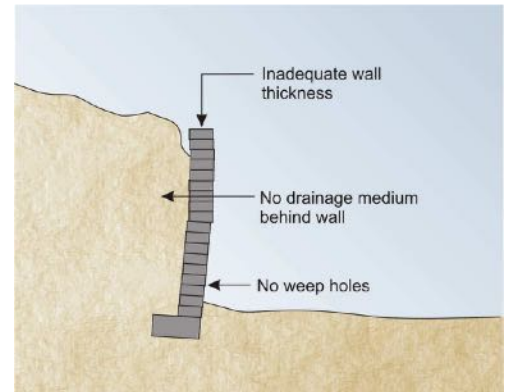
**Old Masonry walls** (Figure 4) - Many old masonry retaining walls have not been built in accordance with modern design standards and often have a low "factor of safety" (GeoGuide LR1). They may therefore be close to failure and a minor change in their condition, or loading, could initiate collapse. You need to take particular care with such structures and seek professional advice sooner rather than later. Although masonry walls sometimes deflect significantly over long periods of time collapse, when it occurs, is usually sudden and can be catastrophic. Familiarity with a particular situation can instil a false sense of confidence.

Figure 4 - Poorly built masonry wall

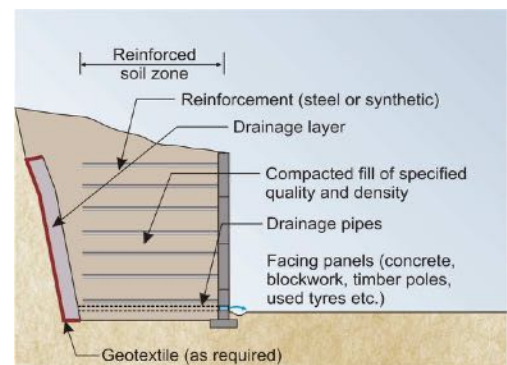
**Reinforced soil walls** (Figure 5) - are made of compacted select fill in which layers of reinforcement are buried to form a "reinforced soil zone". The reinforcement is all important, because it holds the soil "wall" together. Reinforcement may be steel strip, or mesh, or a variety of geosynthetic ("plastic") products. The facing panels are there to protect the soil "wall" from erosion and give it a finished appearance.

Figure 5 - Typical reinforced soil wall

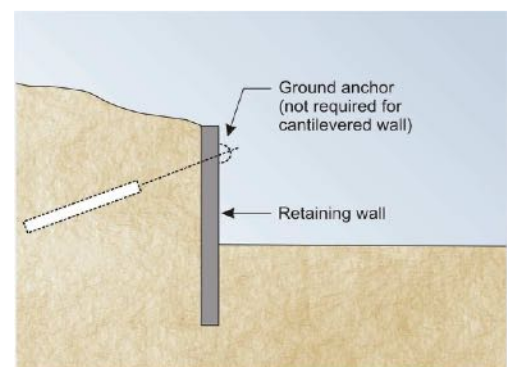
Figure 6 - Typical cantilevered or anchored wall

**Cantilevered and anchored walls** (Figure 6) - rely on earth pressure on the low side, rather than self-weight, to provide the restoring force and an adequate factor of safety. These walls may comprise:
