## **Geotechnical Investigation**

Our ref: 5920-G1 Rev 3  
23 December 2022

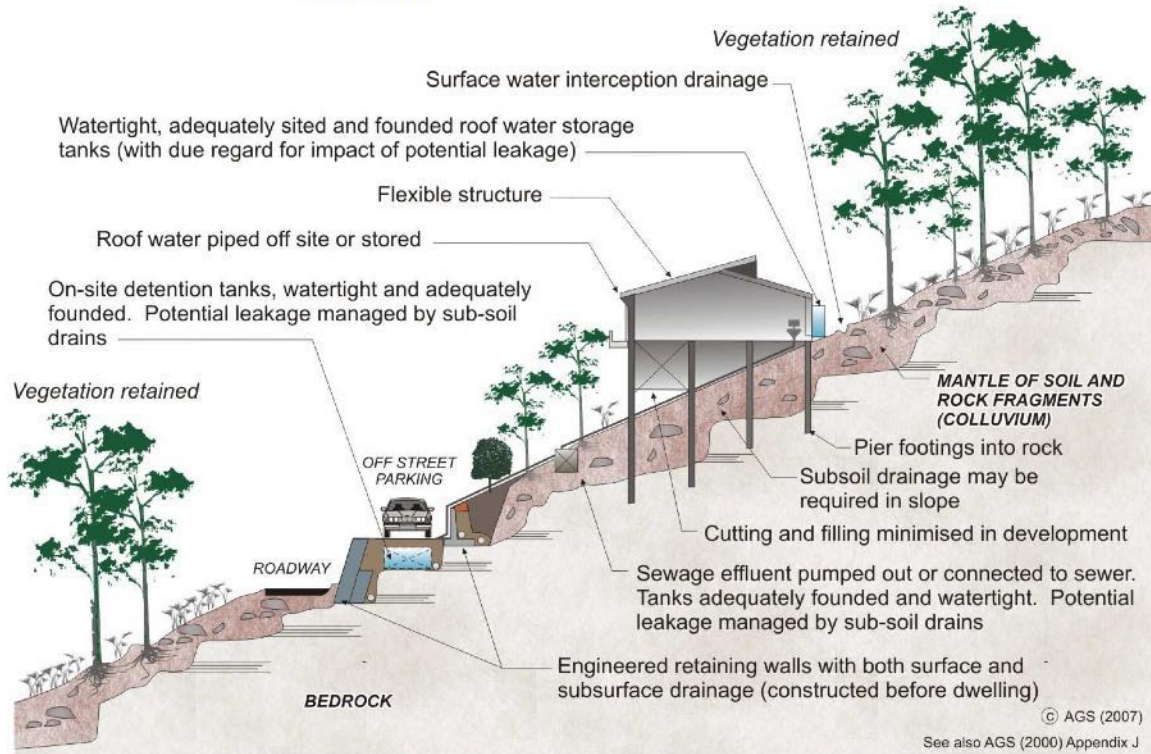
### EXAMPLES OF GOOD HILLSIDE CONSTRUCTION PRACTICE

Sensible development practices are required when building on hillsides, particularly if the hillside has more than a low risk of instability (GeoGuide LR7). Only building techniques intended to maintain, or reduce, the overall level of landslide risk should be considered. Examples of good hillside construction practice are illustrated below.

**Roadways and parking areas** - are paved and incorporate kerbs which prevent water discharging straight into the hillside (GeoGuide LR5).

**Sewage** - whether treated or not is either taken away in pipes or contained in properly founded tanks so it cannot soak into the ground.

**Surface water** - from roofs and other hard surfaces is piped away to a suitable discharge point rather than being allowed to infiltrate into the ground. Preferably, the discharge point will be in a natural creek where ground water exits, rather than enters, the ground. Shallow, lined, drains on the surface can fulfil the same purpose (GeoGuide LR5).

**Surface loads** - are minimised. No fill embankments have been built. The house is a lightweight structure. Foundation loads have been taken down below the level at which a landslide is likely to occur and, preferably, to rock. This sort of construction is probably not applicable to soil slopes (GeoGuide LR3). If you are uncertain whether your site has rock near the surface, or is essentially a soil slope, you should engage a geotechnical practitioner to find out.

**Vegetation clearance** - on soil slopes has been kept to a reasonable minimum. Trees, and to a lesser extent smaller vegetation, take large quantities of water out of the ground every day. This lowers the ground water table, which in turn helps to maintain the stability of the slope. Large scale clearing can result in a rise in water table with a consequent increase in the likelihood of a landslide (GeoGuide LR5). An exception may have to be made to this rule on steep rock slopes where trees have little effect on the water table, but their roots pose a landslide hazard by dislodging boulders.

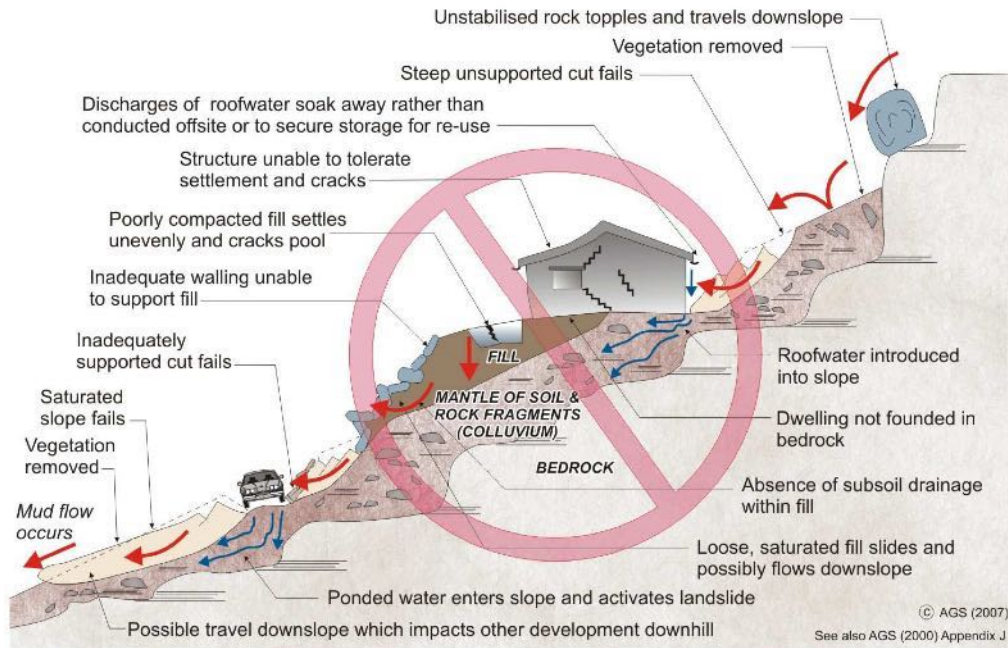
### EXAMPLES OF **POOR** HILLSIDE CONSTRUCTION PRACTICE

**Roadways and parking areas** - are unsurfaced and lack proper table drains (gutters) causing surface water to pond and soak into the ground.

**Cut and fill** - has been used to balance earthworks quantities and level the site leaving unstable cut faces and added large surface loads to the ground. Failure to compact the fill properly has led to settlement, which will probably continue for several years after completion. The house and pool have been built on the fill and have settled with it and cracked. Leakage from the cracked pool and the applied surface loads from the fill have combined to cause landslides.

**A heavy, rigid, house** - has been built on shallow, conventional, footings. Not only has the brickwork cracked because of the resulting ground movements, but it has also become involved in a man-made landslide.

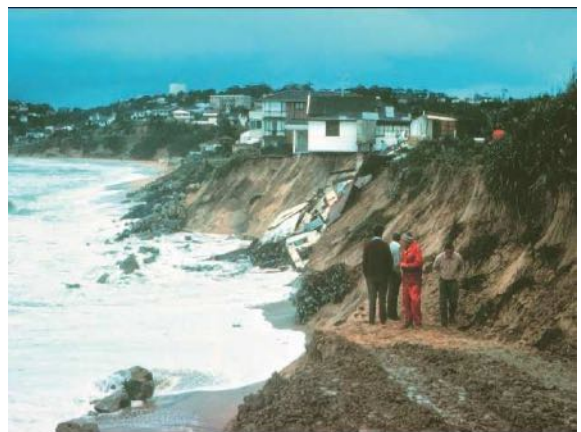
An understanding of coastal processes is essential when determining beach erosion potential. Waves produced by large oceanic storms can erode beaches and cut escarpments into dunes. These may be of relatively short duration, when beach rebuilding happens after the storm, but can be a permanent feature where long term beach recession is taking place. In many locations, houses and infrastructure are sited on or immediately behind coastal dunes. After an escarpment has eroded, those assets may be lost or damaged by subsequent slumping of the dune. It is important that, on erodible coastal soils, the potential for landward incursion of an erosion escarpment is determined. Having done this, the likelihood of slope instability can be established as part of the landslide risk management process. Injury, death and structural damage have occurred around the Australian coast from collapsing sand escarpments.

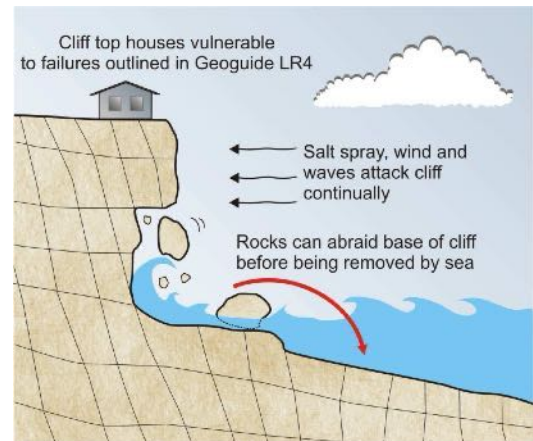
Figure 1

Coastal cliffs and headlands exist because the rock that they are made from is able to resist erosion. Even so, cliff-faces are not immune and will continue to collapse (Figure 1) by one or other of the mechanisms shown on GeoGuide LR4. If you live on a coastal cliff, you should undertake inspection and maintenance as recommended in LR4 and the other GeoGuides, as appropriate. The top of the cliff, its face, and its base should be inspected frequently for signs of recent rock falls, opening of cracks, and heavy seepage which might indicate imminent failure. Since the sea can remove fallen rocks rapidly, inspections should be made shortly after every major storm as a matter of course. **If collapses are occurring seek advice from an appropriately experienced geotechnical practitioner. Advise you local council if you believe erosion is rapid or accelerating.**

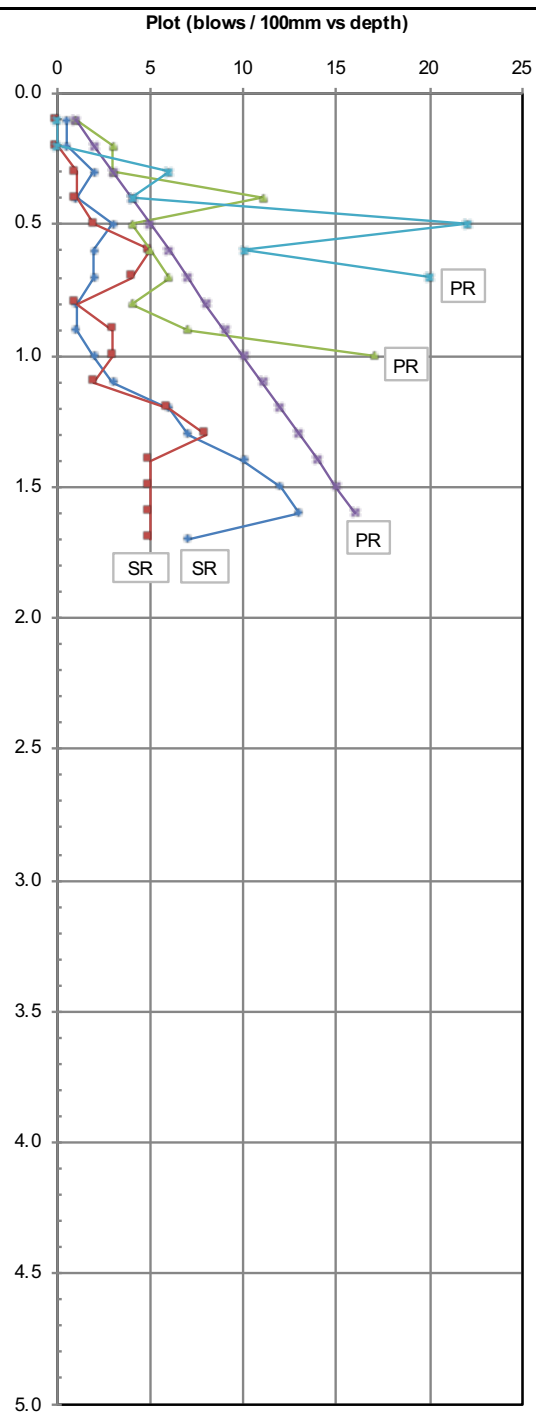
RL = ground surface level (m) AHD
