AS2870-2011 SITE CLASSIFICATION & SALINITY

VOGUE HOMES

Lot 2, No 193 William Street, Bankstown NSW

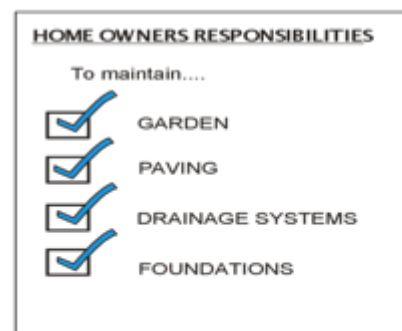
Fig.7

The home owner should read and become familiar with the Site Classification report provided prior to construction and the type of footing system used in the building. To comply with Australian Standard 2870 – "Residential slabs and footings", and achieve acceptable performance and safety during the design life of the house, the owners shall maintain the garden and foundation soil moistures, paving and drainage systems. (Fig. 7)
