STRUCTURAL INVESTIGATION REPORT

SIGNAGE BOARDS

Pedestrian bridge over Windsor Road, near
Norbick Avenue, Bella Vista, NSW

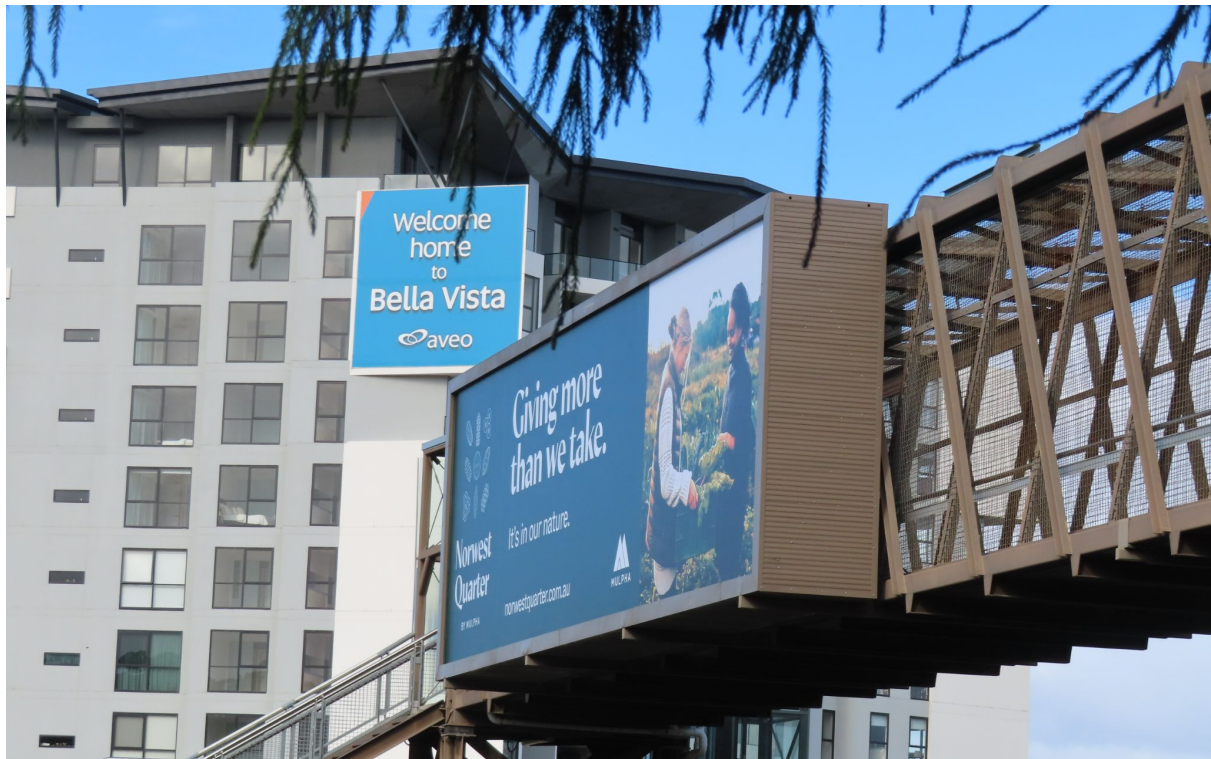
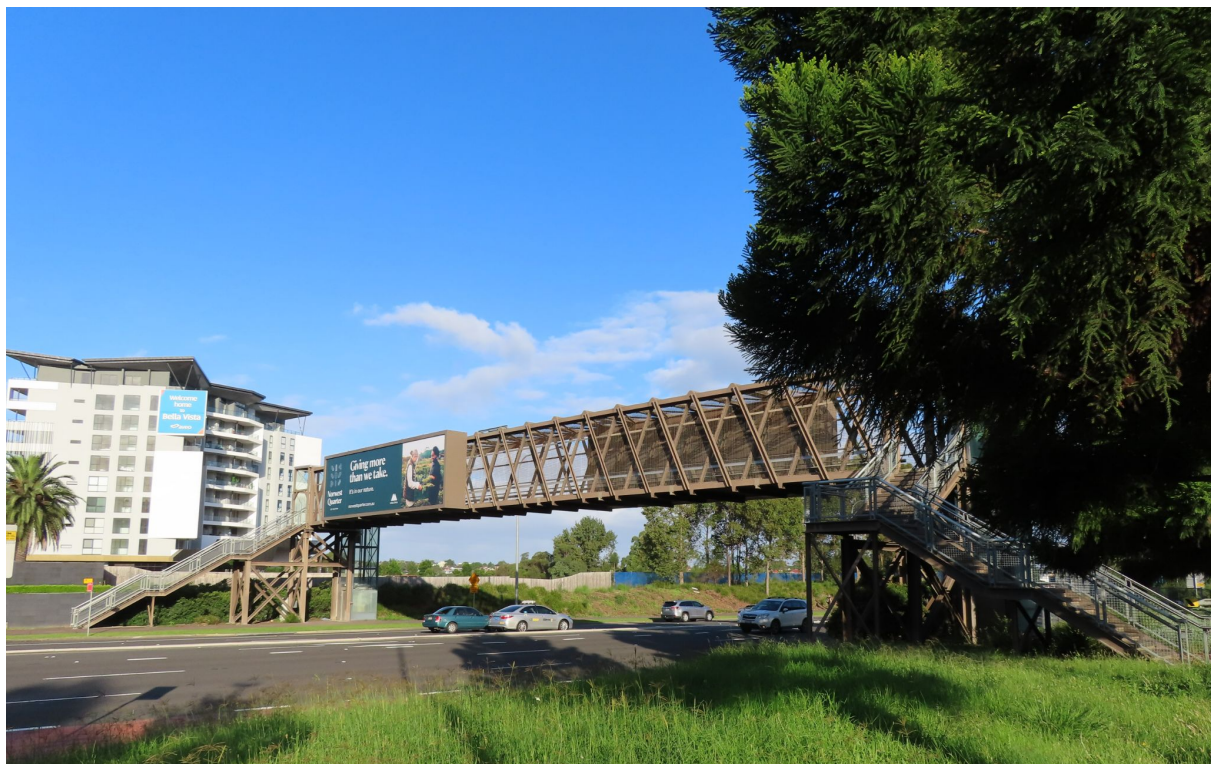
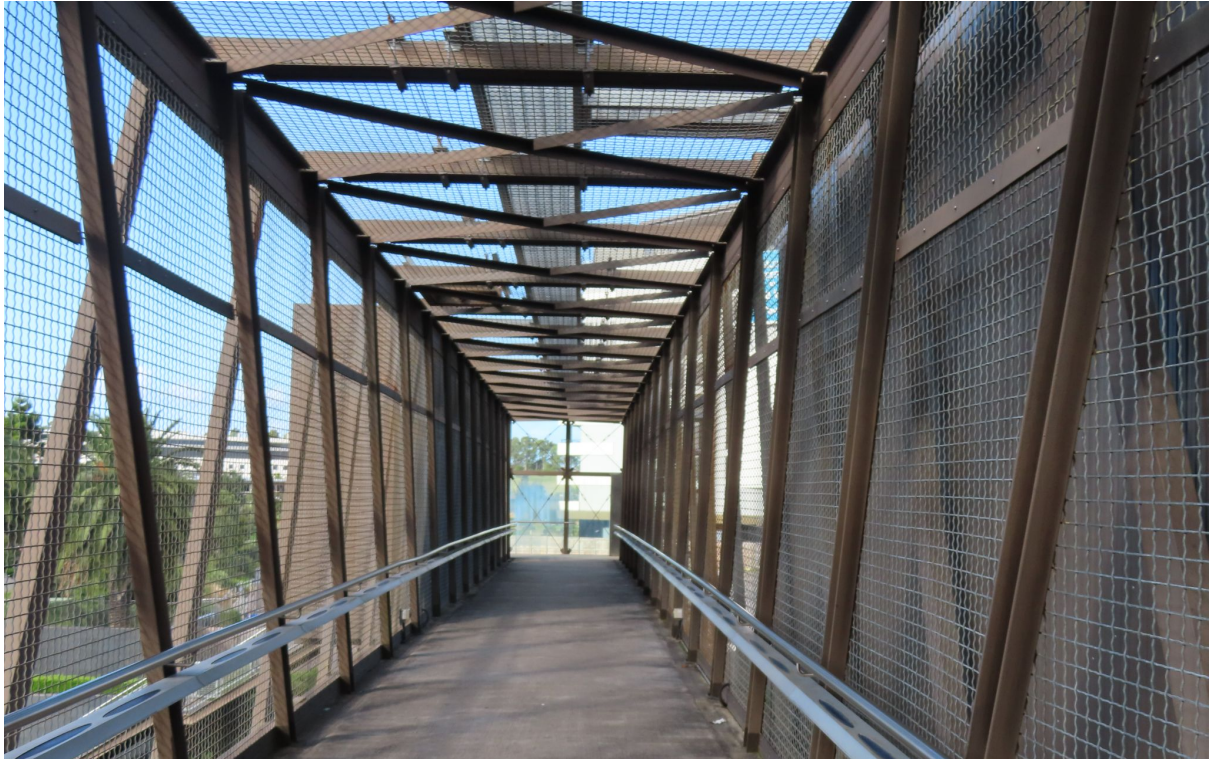
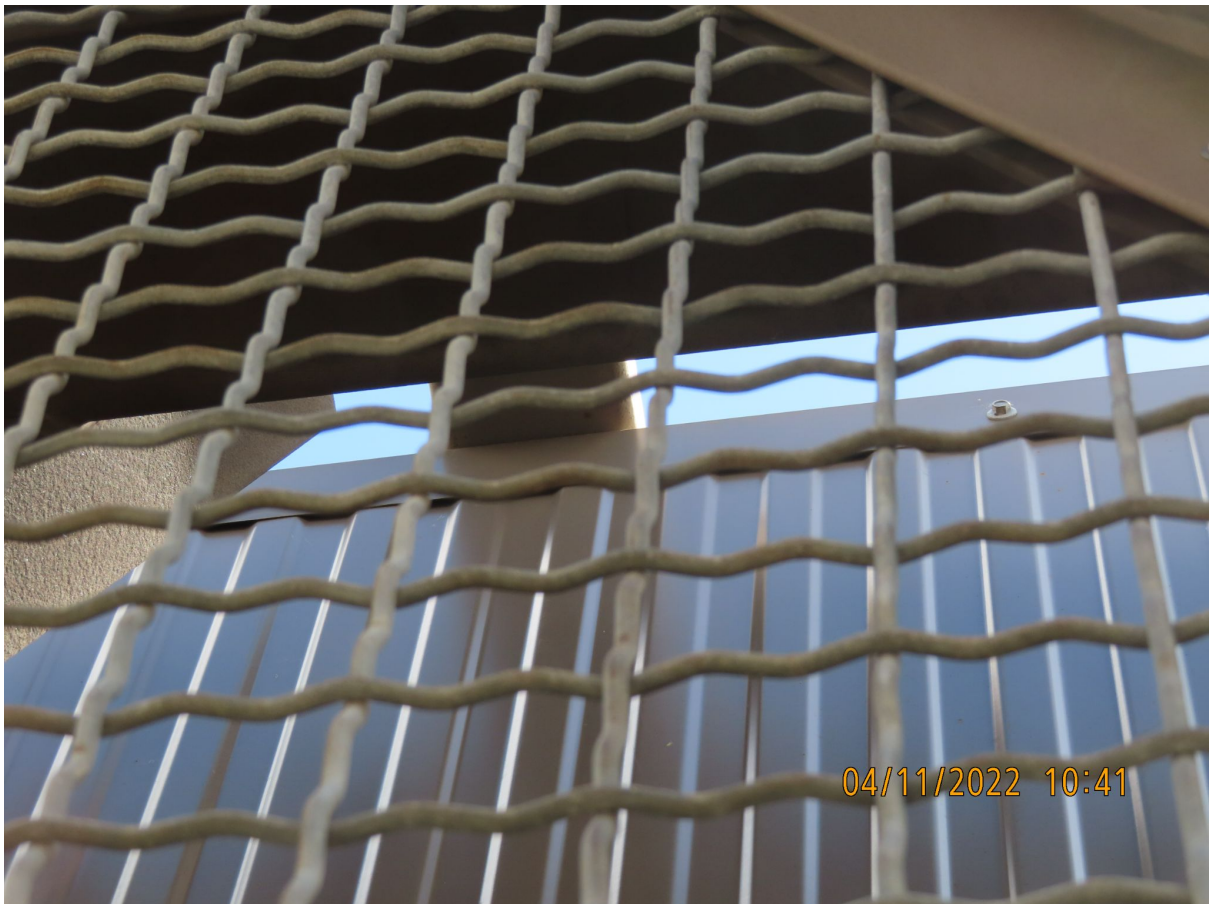
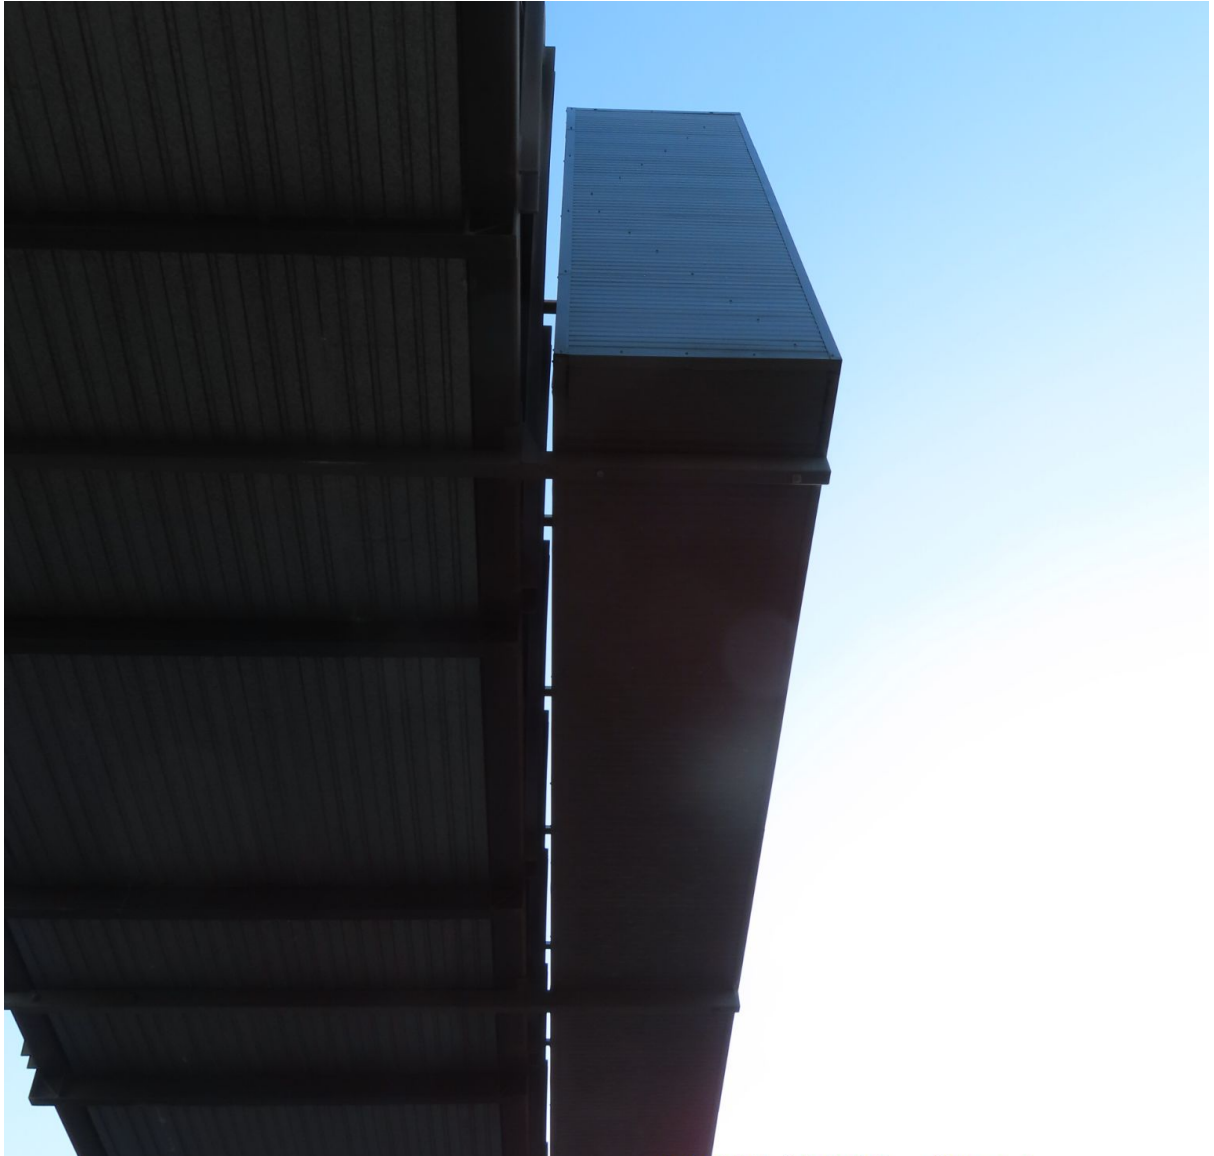
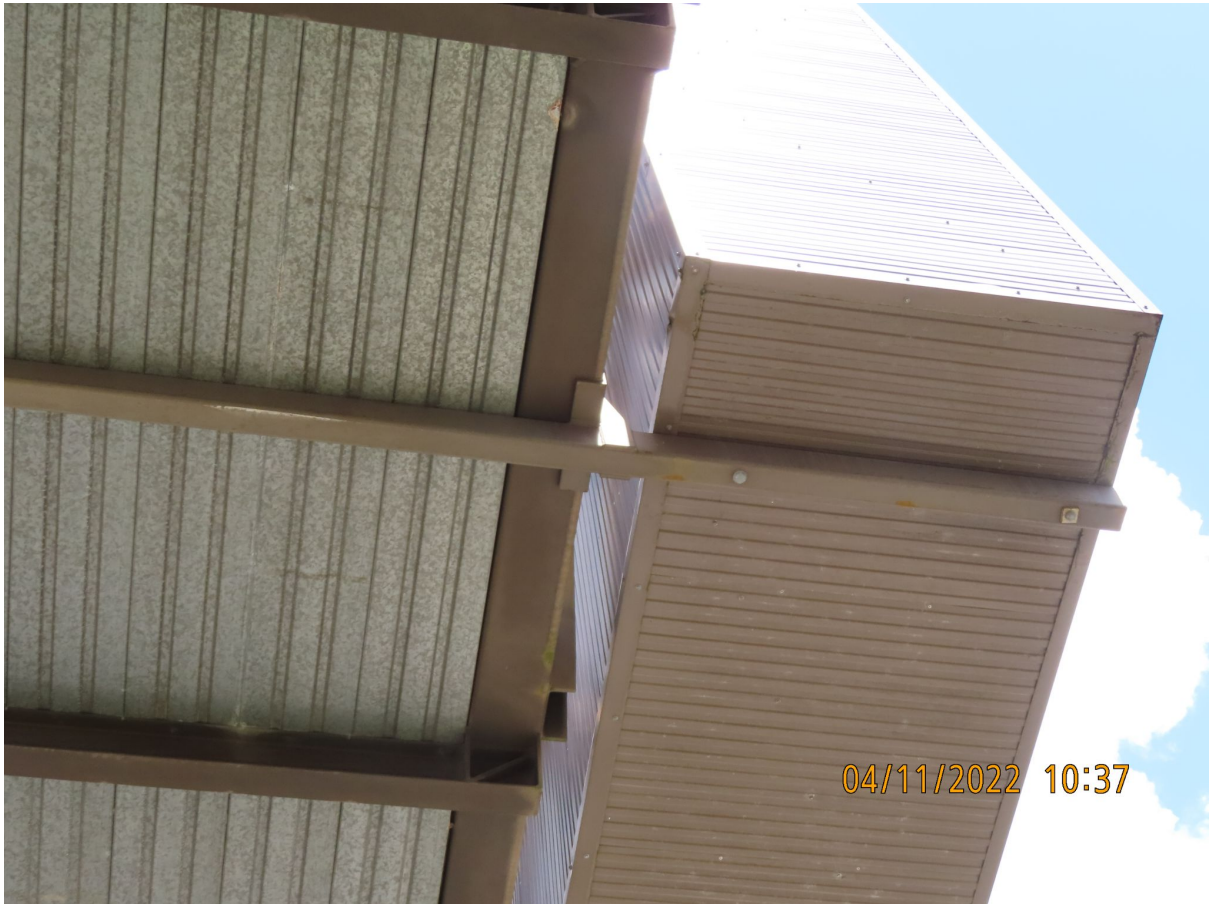
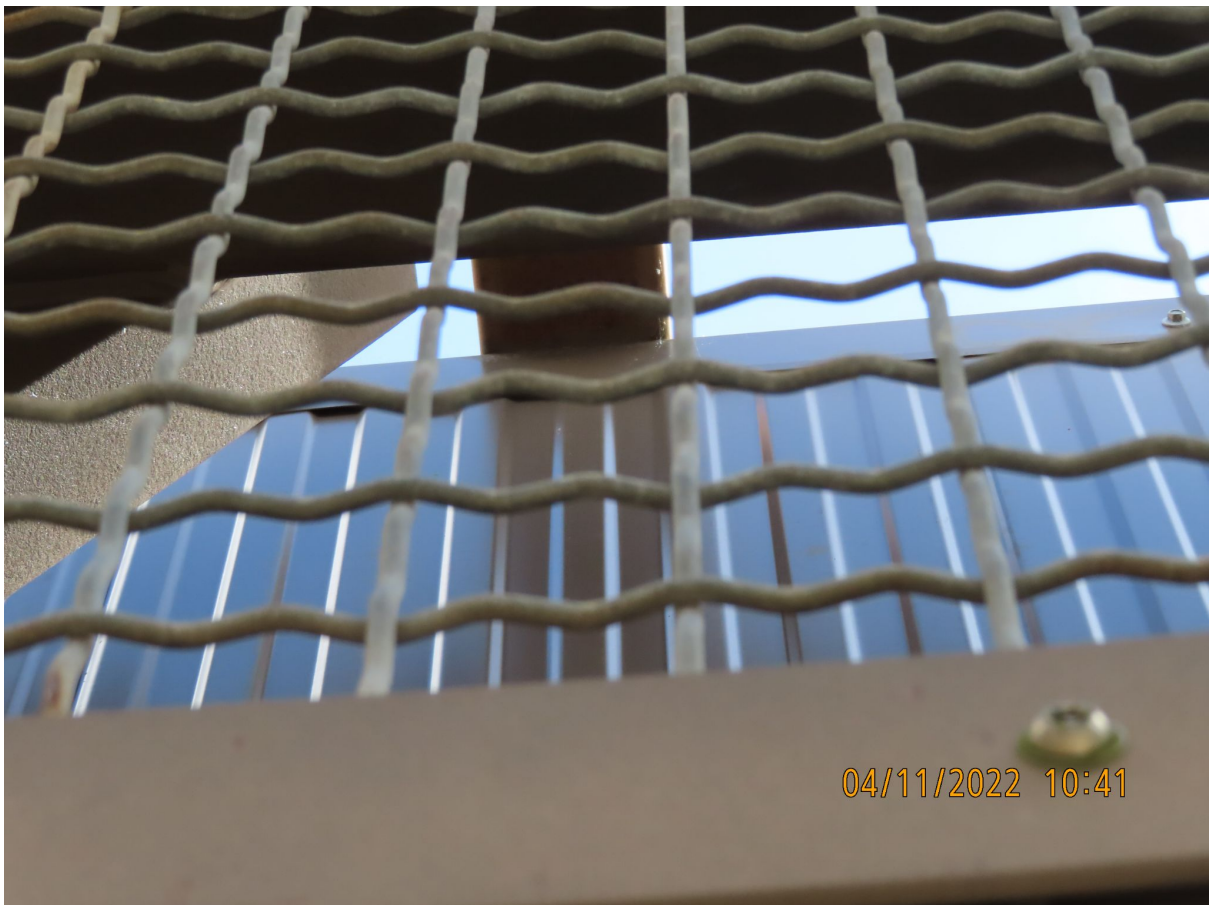
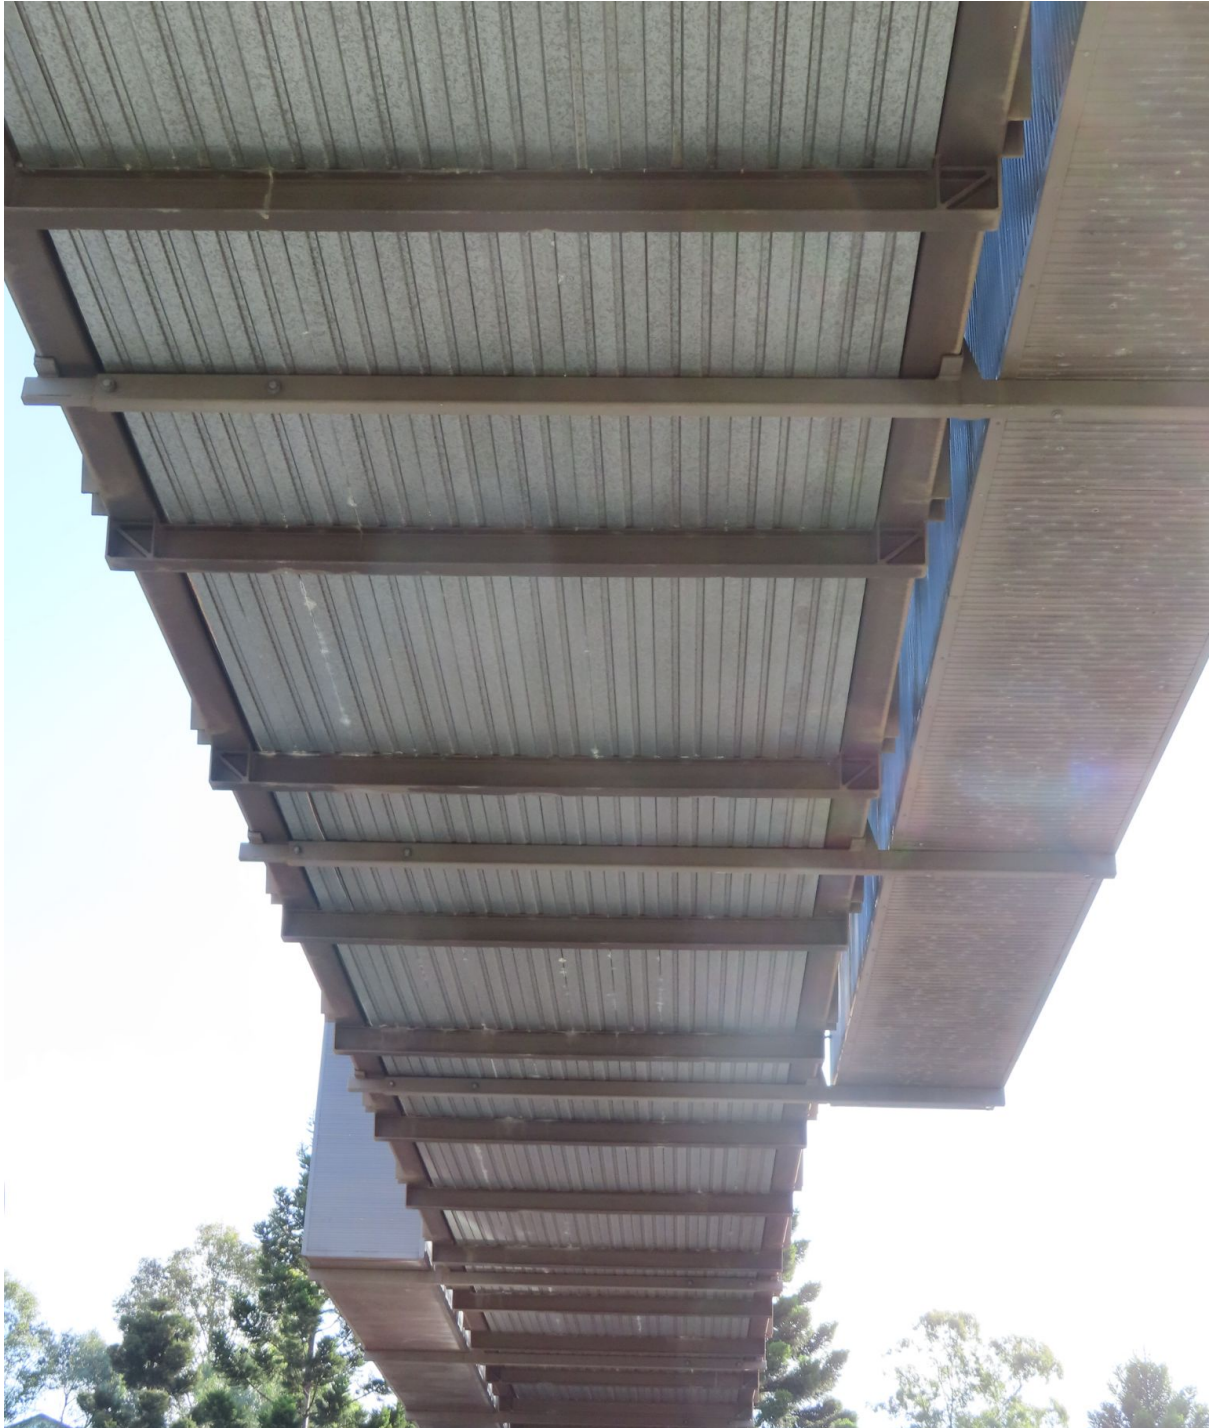
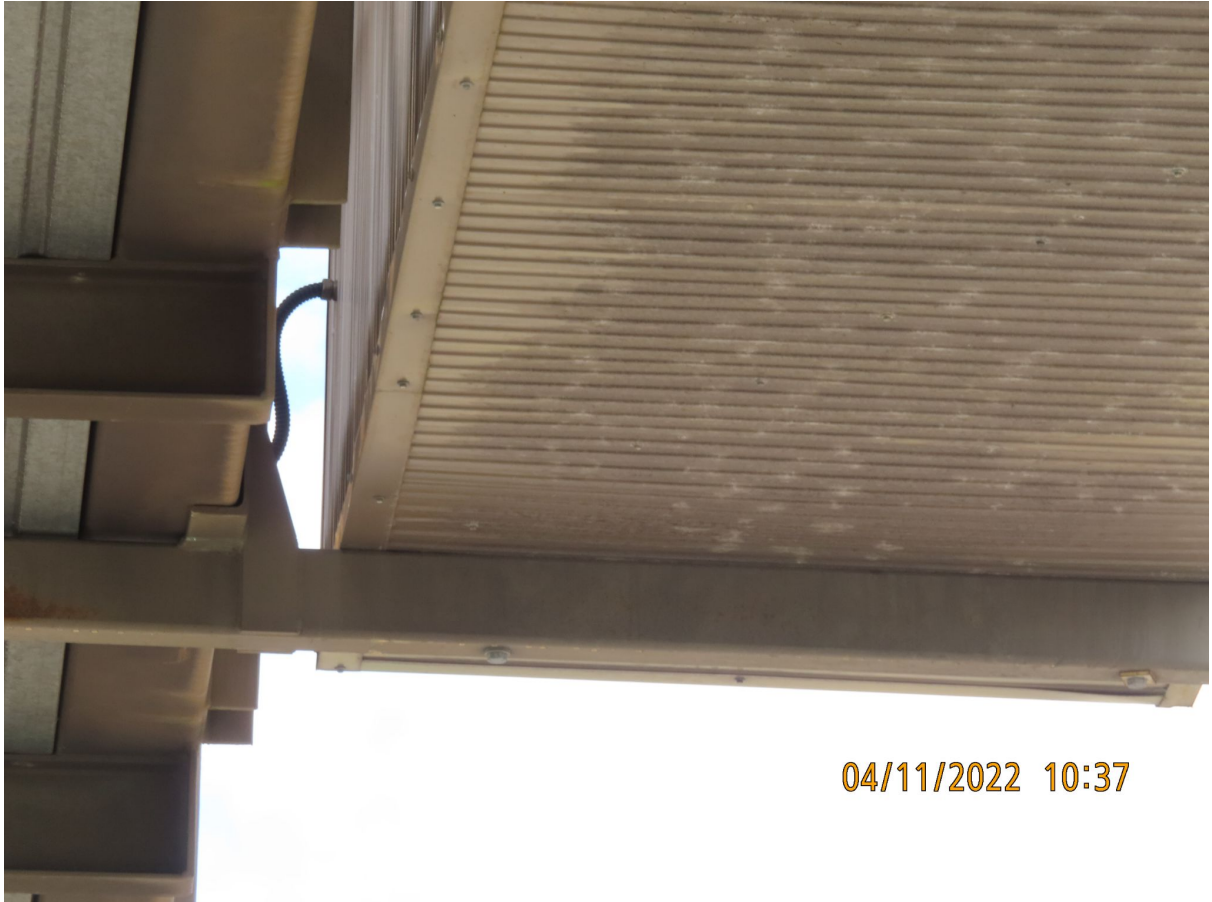
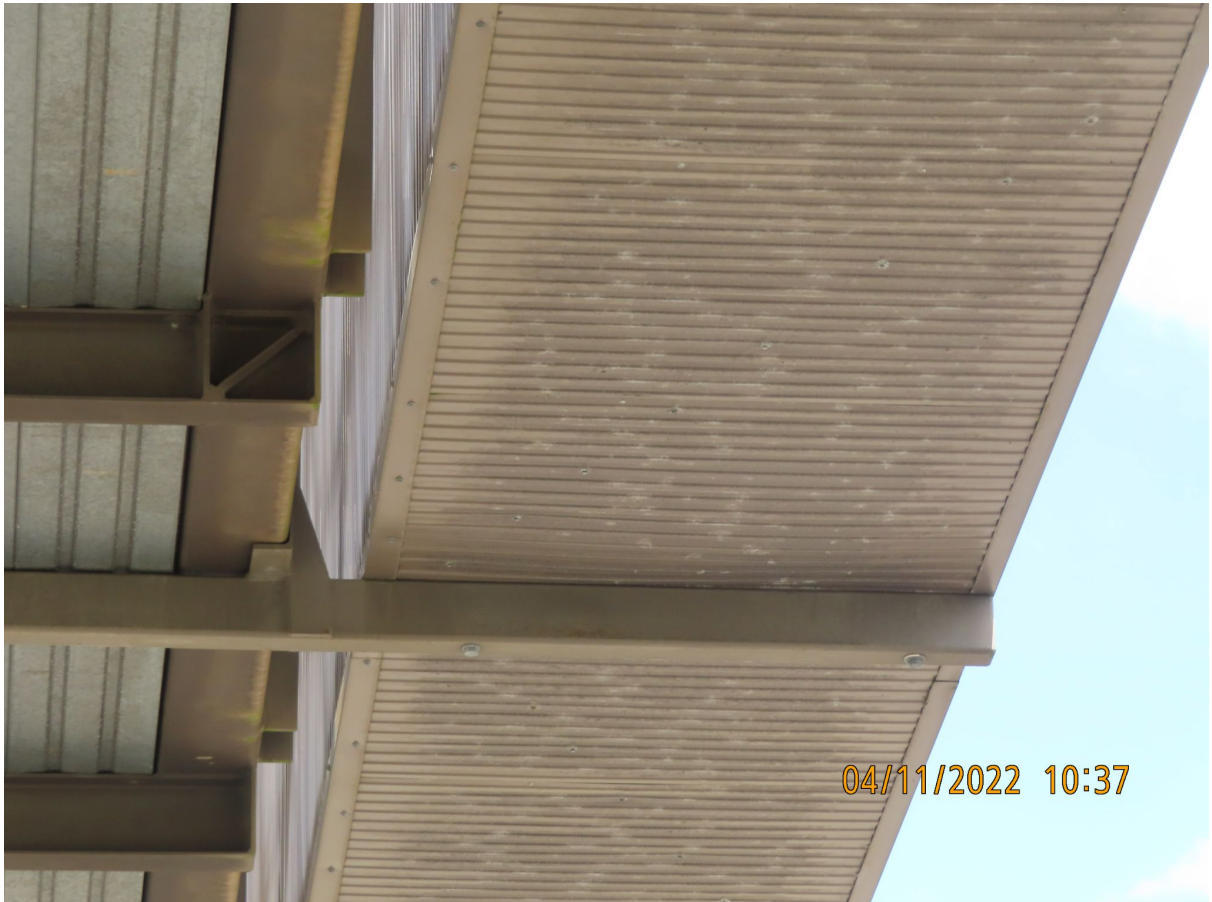
8. Appendix A - Inspection Photos

- The signboards are positioned on either side of the bridge, and centred over the carriageway direction of travel
- The signboard subframes were covered with cladding, and thus were not visible at the time of inspection.
- Connections between the signboards and the bridge framing were observed to consist of the following:
 - 6 x Bolted steel plate connections to the top of the bridge truss.
 - These connections were not entirely visible due to access limitations, however we observed steel members from the signboard subframe connected to the top cross members of the bridge truss.
 - 4 x steel beam outriggers clamped to the bridge truss bottom chords, and bolted to the bottom of the signboards.
 - The outriggers included a bolted spigot connection underneath the bridge, with welded plate clasps, clamped to the truss bottom chords.

- Given that the signboard subframes were covered with cladding, only a visual assessment of the signboards was possible.
- No apparent signs of overstressing were observed, including excessive deflections, distortions, or movement of the signboards relative to the bridge.
- Given the age of the structure (Approx. 13 years), and lack of any significant structural defect, we believe that the signboard subframes are structurally sound in terms of compliance with proven design.

- As observed on site, the signboard frames are attached to the bridge structure at Ten (10) connection points.
- A conservative worst case wind pressure of 2.5kPa can be assumed to act horizontally on the back of the signboards, without any shielding from the bridge structure.
- Imposing an approximate shear force of 11kN at the base connections and 7.5kN at the top connections.
