REGULATED DESIGN RECORD				
Project Address:		30 Diggings Terrace, Thredbo NSW		
Project Title:		Hidali P/L – Black Bull Inn – Temporary Ground Anchors		
Consent No:		DA-22-4825	Body Corporate Reg No: Alliance Geotechnical	
Report Title:		Geotechnical Investigation Report		
Report Reference No:		13526-GR-1-1 Rev G		
Rev	Date DD/MM/YY	Description	DP Full Name	DP Reg No.
G	29/8/2023	Geotechnical Report	Mark Green	DEP0001911

# Geotechnical Investigation Report

**Proposed Apartments – Black Bear  
30 Diggings Terrace, Thredbo NSW**

**13526-GR-1-1 Rev G**

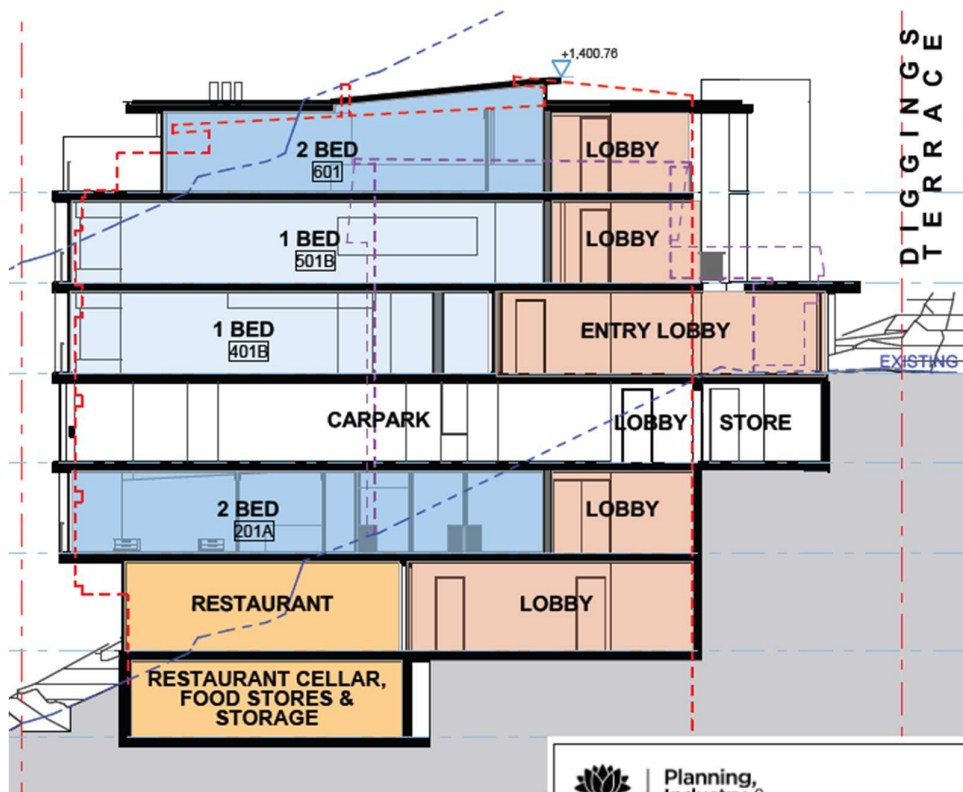
**Figure 1: Approved Building Section looking East  
(extracted from Popov Bass Architectural Drawings)**

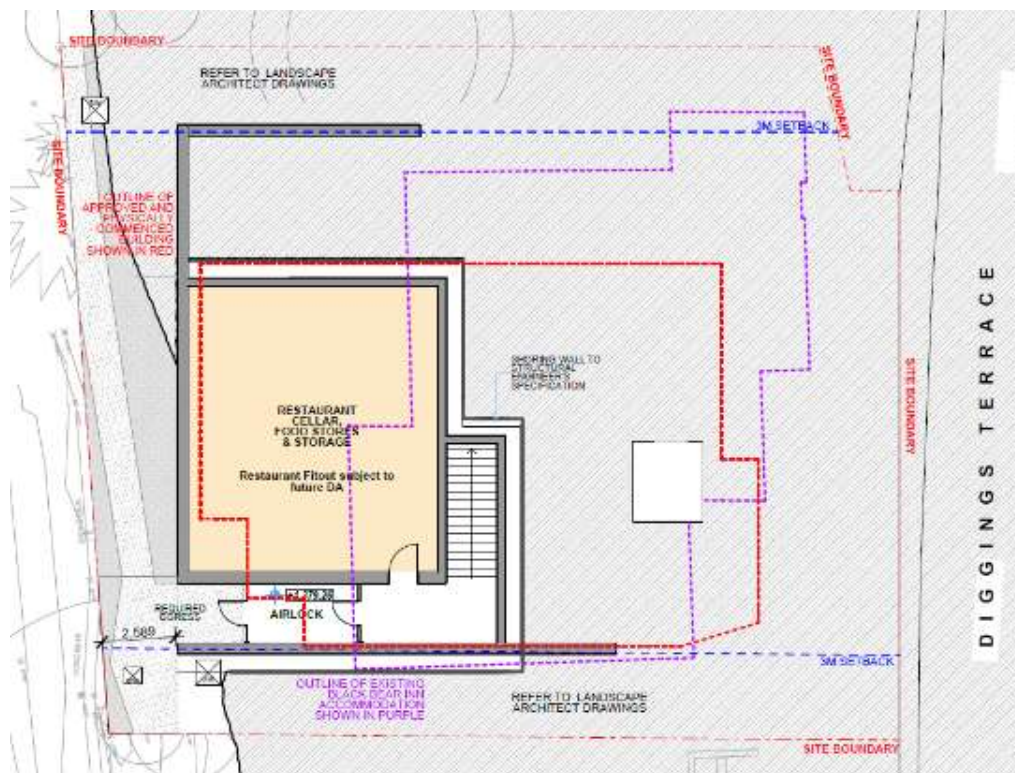
Figure 2 – Approved cellar basement floor level RL 1,379.26m (Level 00)

- The deletion of the basement footprint and stair access from level 01 to level 01 on the west boundary).
- The reduction of the restaurant / lobby level FFL height (from RL 1,382.06m) (to RL: 1381.760m) so reduced benching level of -300mm.

This is best described by way of the image following:

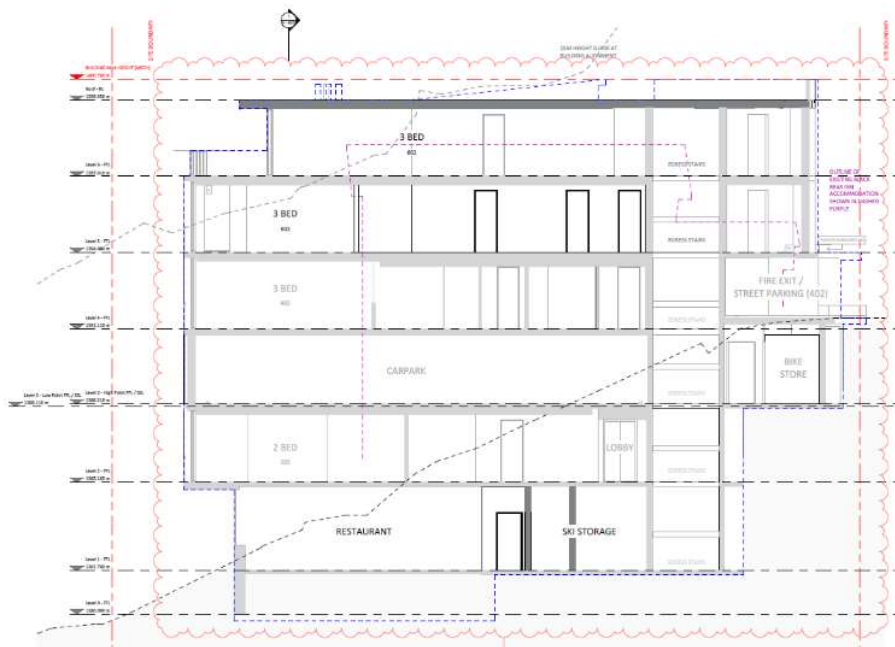
**Figure 4 – Proposed building section cellar floor level deletion & lowering of basement floor level**

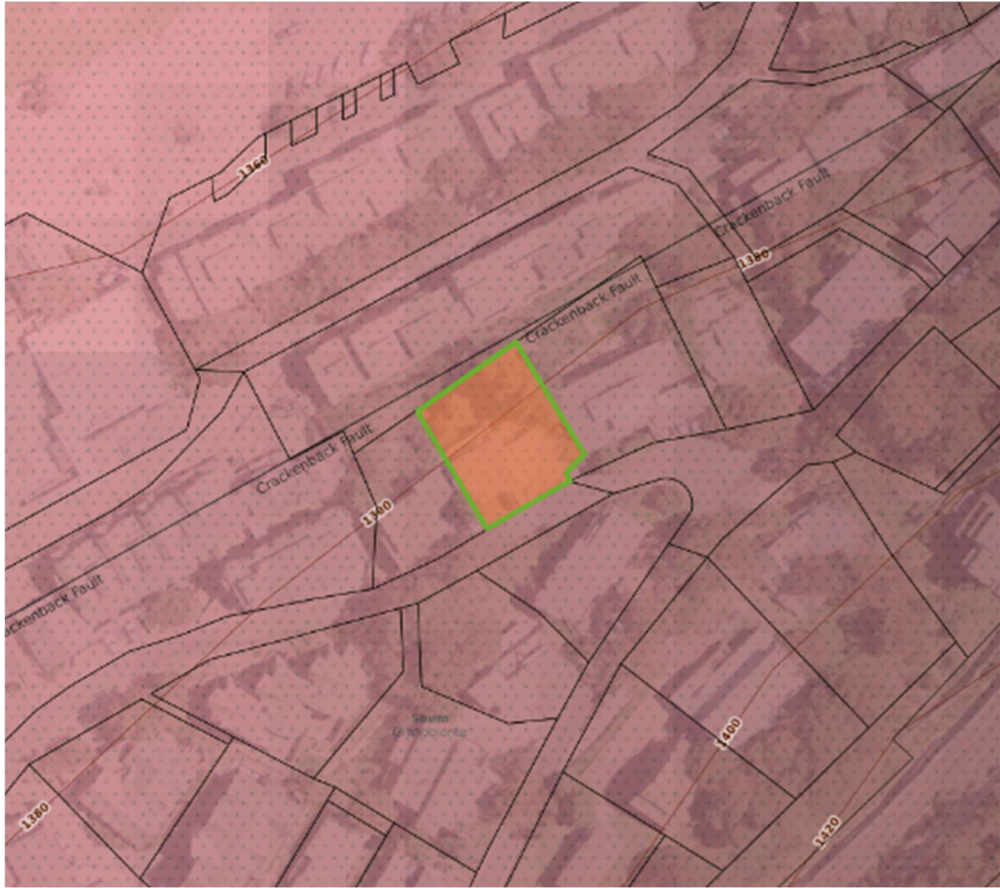
**Figure 5: Site boundary with respect to the NSW Seamless Geology Map and 20m contours  
(extracted from [minview.geoscience.nsw.gov.au](http://minview.geoscience.nsw.gov.au))**

The site is located within the Thredbo Alpine Village and Ski Resort, an area which consists predominantly of ski lodges, restaurants and other commercial buildings. The Site is irregular square-shaped block of land with an approximate total area of 675m<sup>2</sup>. Based on aerial images and publicly available information, it is currently occupied by "Black Bear Inn", a three-storey ski lodge and restaurant. It is bound by other ski lodges to the North, East and West, and Diggings Terrace to the South as shown in Figure 5.

The NSW Seamless Geology Project (May 2021) indicates the site is underlain by Mowambah Granodiorite (*Sbum*). Granodiorite is a medium to coarse grained intrusive igneous rock, similar to granite, containing quartz and plagioclase feldspar as its primary constituents.

We note the Crackenback Fault runs parallel and very close (less than 10 m) to the northern boundary of the site. This could locally impact the integrity of the bedrock at the site.

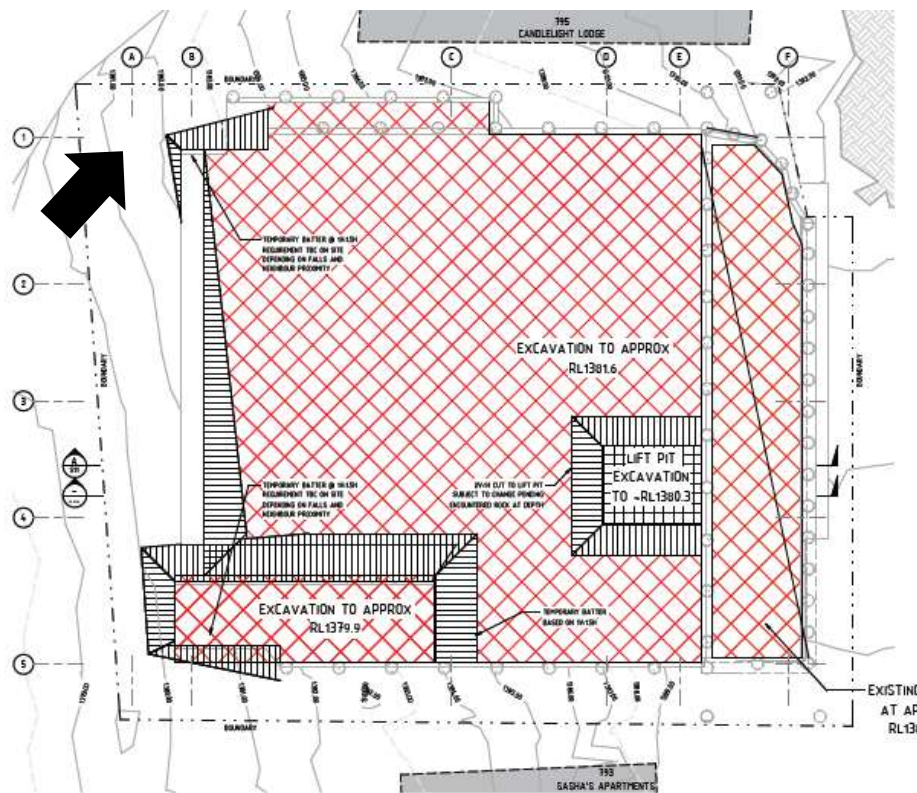
**Figure 7 : Excavation plan (by PMI) showing the locations where unsupported cuts may be feasible**

Based on the proposed basement excavation setbacks, temporary and permanent unsupported batter slopes within highly weathered granodiorite may be feasible on the southern, eastern and western boundaries of the lowest level (see Figure 7).

Temporary batters within highly weathered granodiorite can be excavated to a maximum batter slope of 1H:1V, provided they are above the water table or within dewatered ground, and not exposed for longer than three

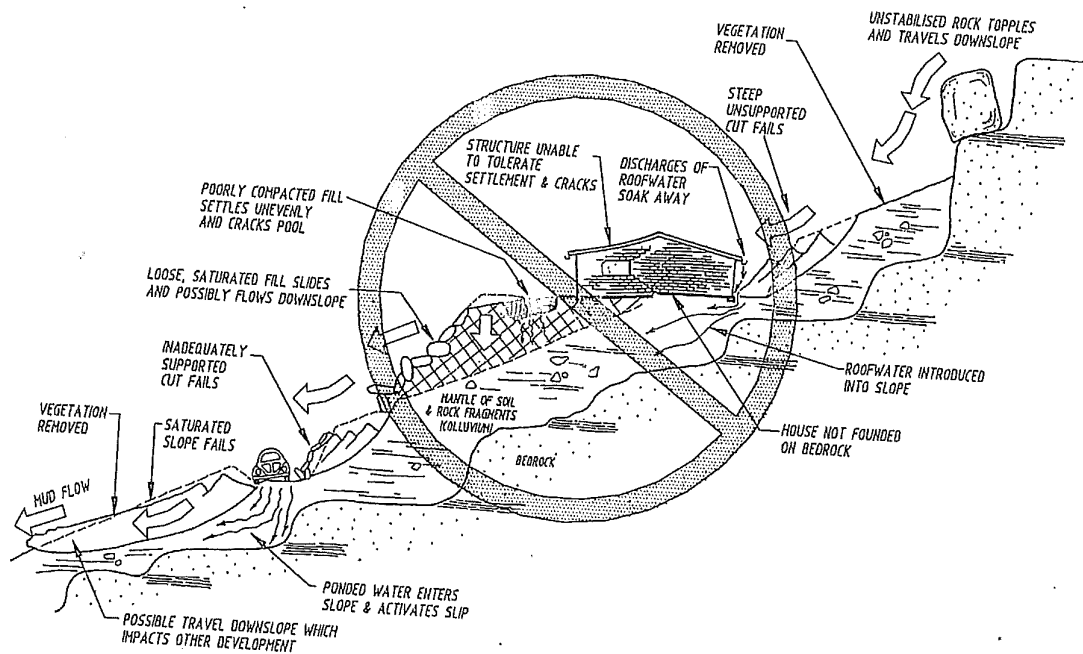
**FIGURE 2: ILLUSTRATIONS OF GOOD AND POOR HILLSIDE PRACTICE**

This figure is an extract from LANDSLIDE RISK MANAGEMENT CONCEPTS AND GUIDELINES as presented in *Australian Geomechanics*, Vol 35, No 1, 2000 which discusses the matter more fully.

In general terms, the proposed development is shown to comprise one large excavation for the lowermost three levels. Based on the results of the geotechnical investigation, the excavation is likely to be through fill and colluvial materials into the underlying extremely to highly weathered granodiorite. The retention of the excavation through an engineer designed retaining wall is in line with good hillside construction practices as shown in Appendix D - Figure 2.

All development on the lot is to be undertaken in accordance with sound engineering principles and good hillside practice as set out in Appendix D – Figure 2.

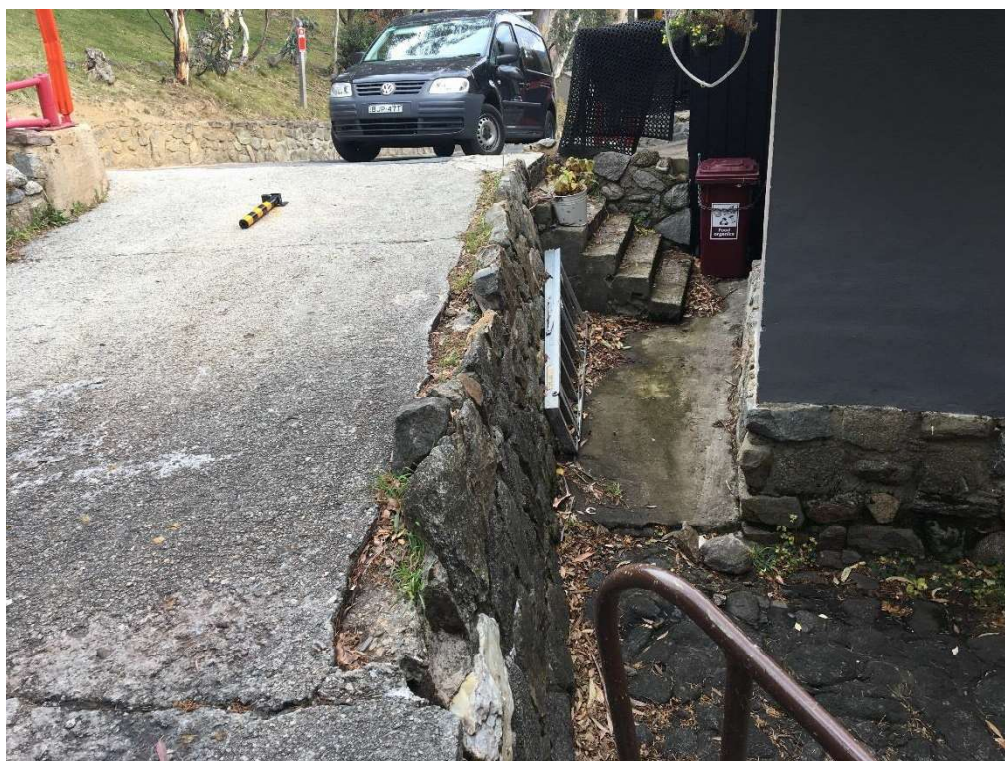
*Photograph: 2 – South-east corner of site showing neighbouring (No. 5) driveway and retention.*

The neighbouring property to the east No. 5 'Candelight Lodge' contains a three level masonry and timber development on the front half of the block located within approximately 1.0m off the eastern boundary of the site. A concrete driveway provides access to the south-west corner of this property at lower floor level, past the south-east corner of the site. This driveway is retained along the boundary by an approximately 1.5m high sloped rock retaining wall, see Photograph: 2. The building structure appears of similar age to the existing 'Black Bear Inn' building and appears formed above ground surface levels. There were no indications on external walls of any foundation/footing movement adjacent to the site.

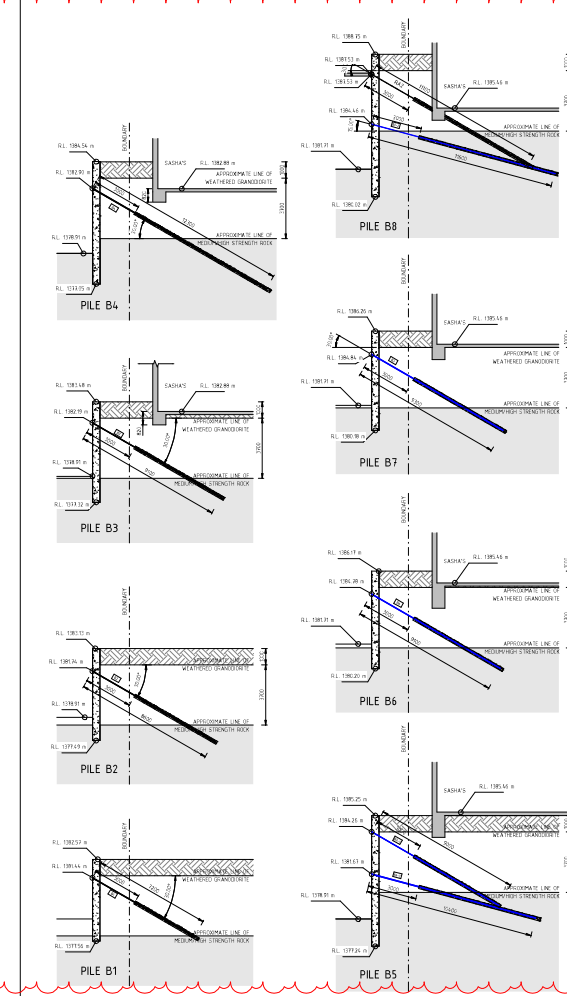
ALL ANCHORS TO BE LOCATED WITHIN 250mm OF THE STATED RL  
WITHIN 5 DEG OF STATED ANGLE OF INCLINATION  
ALL ANCHORS TO BE PERPENDICULAR TO INCLINATION CUT WITHIN 5 DEG  
MAXIMUM PER LENGTH TOLERANCE OF ALL ANCHORS TO BE 10mm
